DOT/FAA/AR-06/58

Anti-Icing Pavement Coating Study at Chicago O'Hare International Airport

March 2007

Final Report

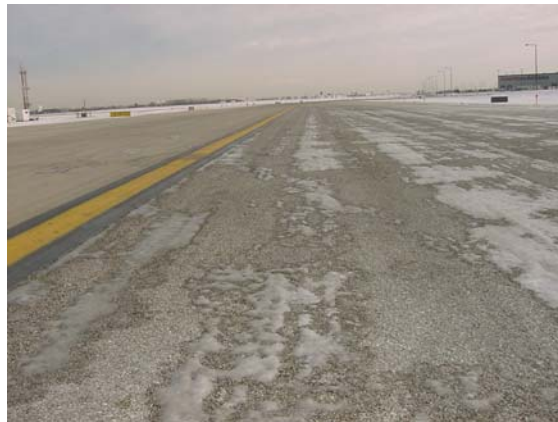
Strict icing events were difficult to isolate from the footage obtained by the camera. The camera's optical zoom capability could not show clear images of just icing, which is even difficult to detect with the naked eye. Also, a lack of light during nighttime recording made it difficult to distinguish ice. Two still images of ice on the test section were taken during on-site visits and are shown in figures 4 and 5. Snow, on the other hand, was very visible and easy to isolate and document. Snow events produced the best still images and were easiest to follow for performance measuring. The best examples of snow events were used in section 2.2.3.

Figure 4. Ice Patches Located on the Test Section, but not on the Adjacent Taxiway, 11/23/04

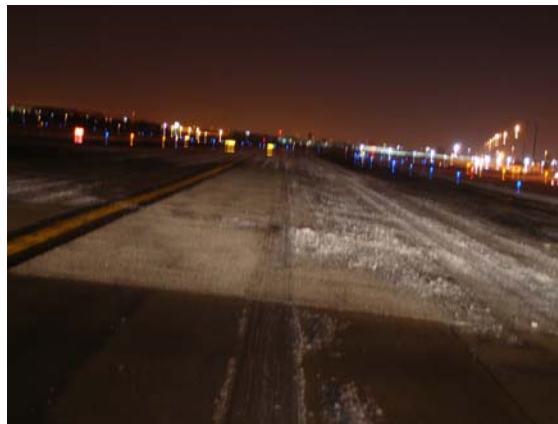
Figure 5. Ice and Slush Located on the Test Section, but not on the Adjacent Taxiway, 2/23/2005

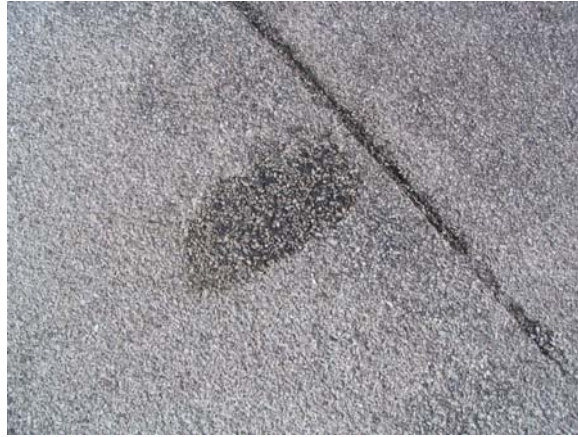
During each visit to the test site, loose aggregate was observed. The aggregate was noticed across the entire test section, with the largest quantity accumulating at the shoulders. These areas of large accumulation were probably created from aircraft engines blowing the debris to the edges of the pavement. Aggregate was missing in small amounts from many regions of the test section, but was absent in larger quantities near the joints of the underlying pavement. An example of missing aggregate near a joint is shown in figure 6. Also, note the oval patch with significant aggregate loss.

Figure 6. Aggregate Loss at the Test Section Pavement Joint

The presence of loose aggregate on the test section indicated that the epoxy was not holding all the aggregate in place. The majority of the loose aggregate seemed to come from areas that were laid near the joints in the pavement. At these points, considerable amounts of the aggregate were

missing, exposing the underlying pavement. Close inspection of the test section revealed that aggregate was also missing in small amounts across the entire area.

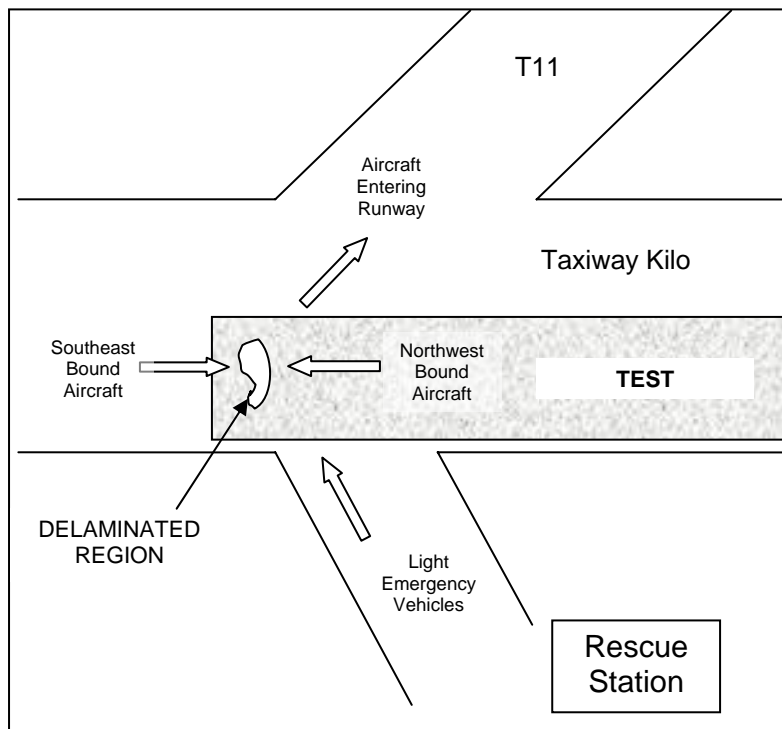
Figure 7. Traffic Flow Diagram of the Test Section Region

Along with small amounts of aggregate loss, major delamination occurred at one region of the overlay. The area was documented and observed throughout the life of the project. The region was located at the intersection of multiple-traffic paths. All southeast- and northwest-bound aircraft had one set of wheels impact the area. It was also observed that the area was a pivot point for some aircraft while turning to enter or leave the runway via taxiway T 11. The last traffic path was from small emergency vehicles entering taxiway K after leaving the adjacent rescue station. A schematic of traffic flow for the area is shown in figure 7.

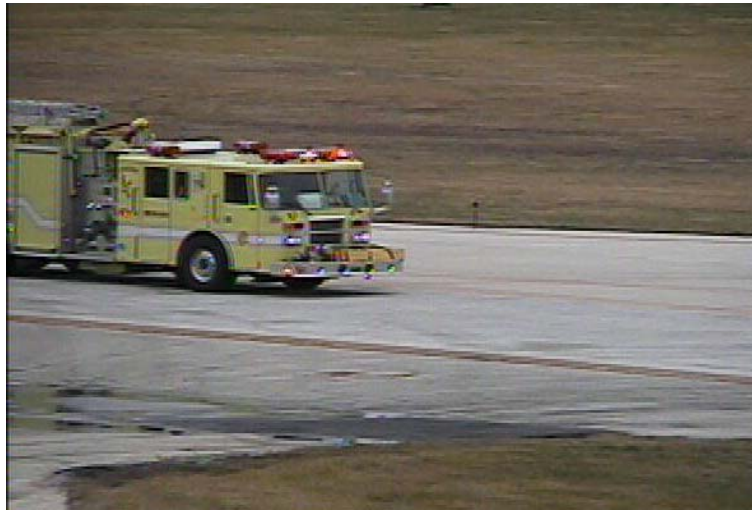
Figure 8. Emergency Vehicle on the Test Section

Examples of traffic activities are shown in figures 8 through 11. As shown in figure 8, emergency vehicles often passed over the delaminated region. These vehicles commonly turned off of Taxiway K via the road in the foreground. Figure 9 shows a northwest-bound aircraft. It can be seen that the rear dual wheel will cross directly over the delaminated region. Figure 10 shows a southeast-bound aircraft whose rear right dual-tandem wheel is almost over the delaminated area. Figure 11 shows an aircraft that has just turned onto the taxiway and shows that the belly dual-tandem wheel is still pivoting as it approaches the delaminated region.

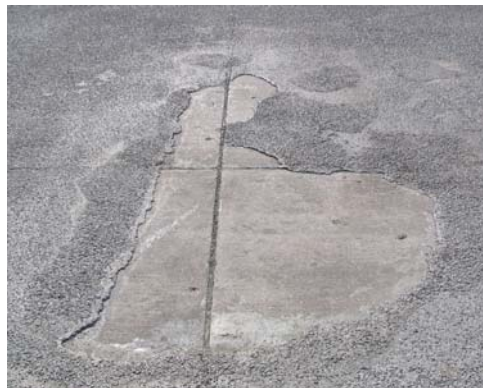
Figure 12. Delaminated Region of the Test Section

The delaminated region shown in figure 7 and pictured in figure 12 was monitored throughout the observation cycle. Initial radial measurements of the region were taken on December 10, 2004, and used to develop an approximation of the missing area. These measurements served as a baseline measurement of the region. The same radial measurements were taken approximately 3 months later on March 24, 2005, to establish the approximate rate of growth. Table 3 shows the change in radial dimensions over the 3-month period.

Some loose aggregate could also be coming from the large delaminated region. Radial measurements taken of one such delaminated area indicated that the region is slowly continuing to delaminate. Some of the radial dimensions changed as much as 4 inches in length over a 3-month period.

It is unknown at this time why this area delaminated, but a few observations may provide some insight into the cause(s). First, information was provided stating the area was a problem point during and just after overlay construction. The aggregate and epoxy would not adhere as well in this area and, therefore, the area had to be repaired. Second, it was noted that this area is located at a point of considerable traffic. The area is impacted from every direction by aircraft and emergency vehicles. It was also observed that the wheels of aircraft leaving and entering taxiway K and the test section pivoted on the region while the aircraft turned toward or away from the runway. It is speculated that the large shear force caused by a pivoting wheel caused this delamination.

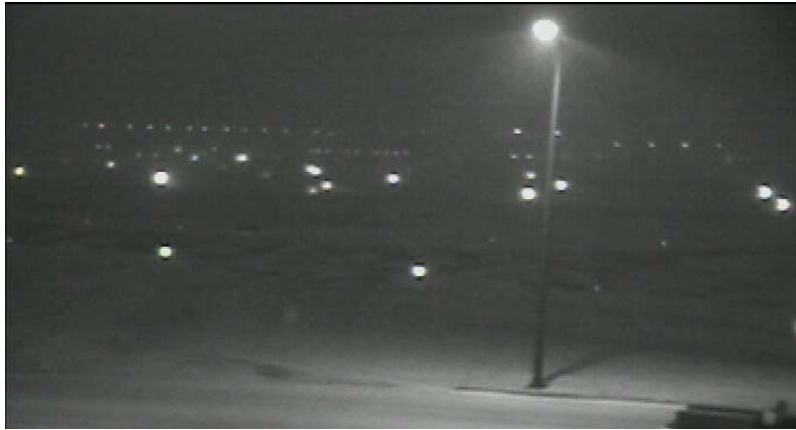
Figure 42. Moderate Snowfall, Pavement Covered, 1/21/05, 8:00 p.m., 19°/25.2°F
