**DOT/FAA/TC-12/43**

# **Crash Simulation of Transport Aircraft for Predicting Fuel Release**

## **First Phase—Simulation of the Lockheed Constellation Model L-1649 Full-Scale Crash Test**

Final Report

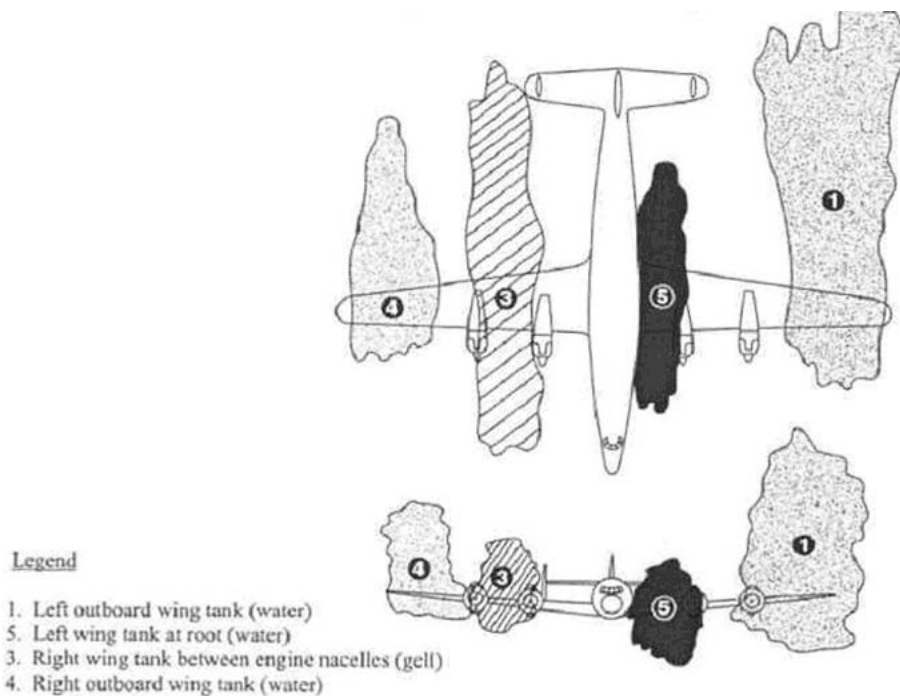
Figure 3. Fuel Spillage Occurring 2.24 Seconds After Impact With Main Gear Barriers [5]

Initial impacts removed the landing gear, causing the aircraft to be airborne. Once airborne, the left inboard engine broke loose and impacted the wing, the left wing struck an earthen barrier, and the right wing struck two vertical telephone poles. The resulting spill patterns of each wing tank were well documented in the test, as shown for example, in figure 3. The L-1649 had only integral wing fuel tanks and no bladder tanks.

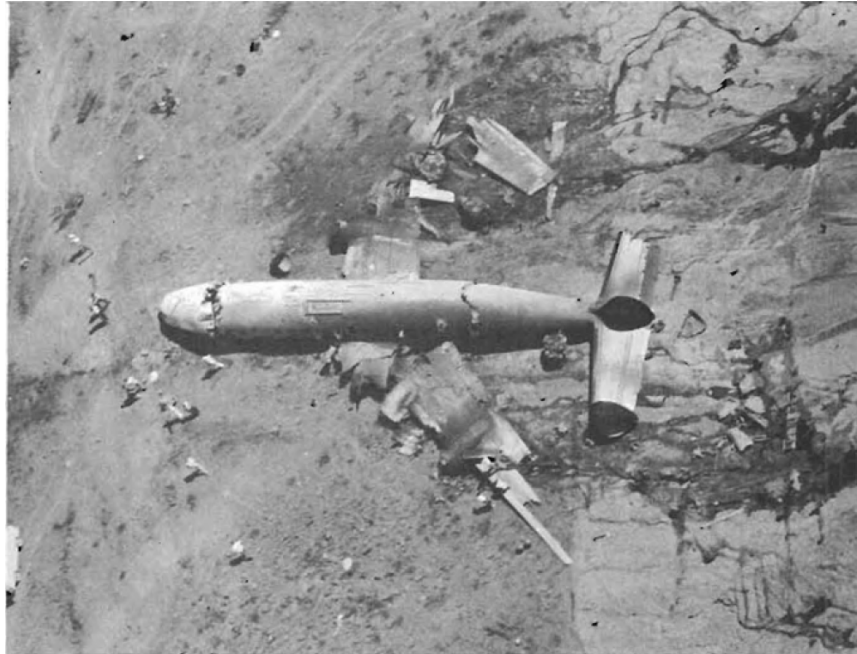
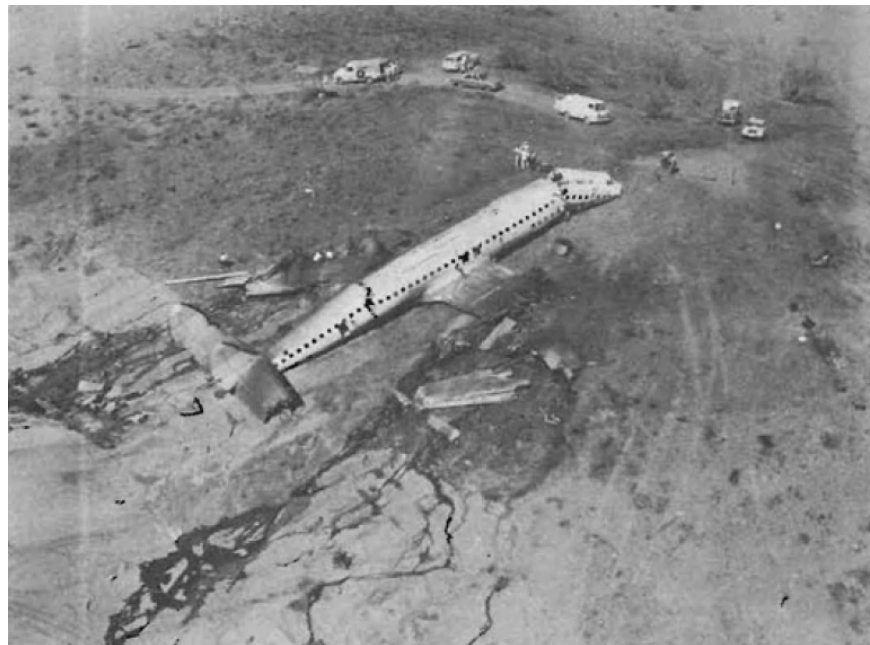
Figure 52. The L-1649 Wreckage (aerial view) [5]

Figures 52 and 53 show the L-1649 wreckage in its final resting place on the 20° slope. All four engines detached from the wing. The left (port) wing was detached at the root, showing the compromised fore and aft spars. The wing was also broken off just outboard of the outboard engine nacelle. There appears to be a wing section extending out further than this, but it is actually just a wing fragment in that location.

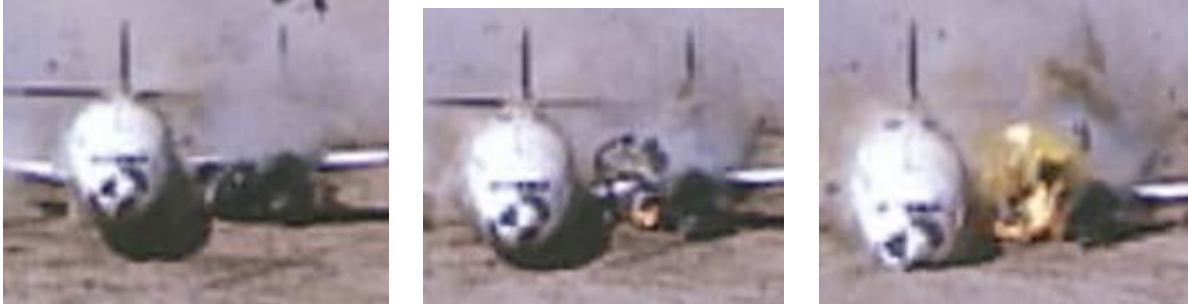
Figure 55. Video Footage of Engine Impact With the Wing Leading Edge at Tank 5 (close up)

The report does not mention the engine impacting the wing at Tank 5. There was mention of it rolling under the wing, and the high-speed photography clearly shows this event occurring just as the nose of the aircraft first touches the 6° slope, as shown in figure 55.
