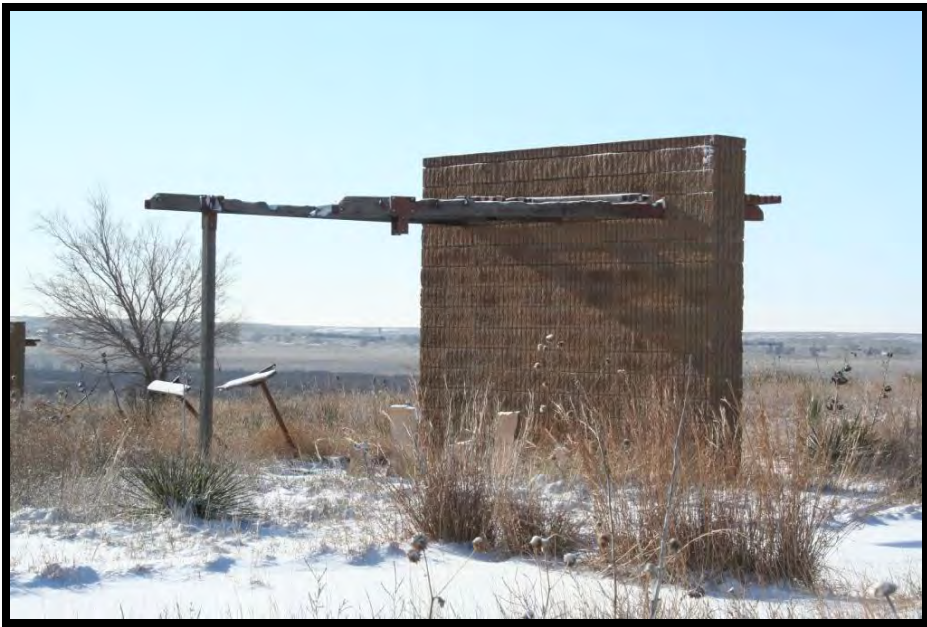
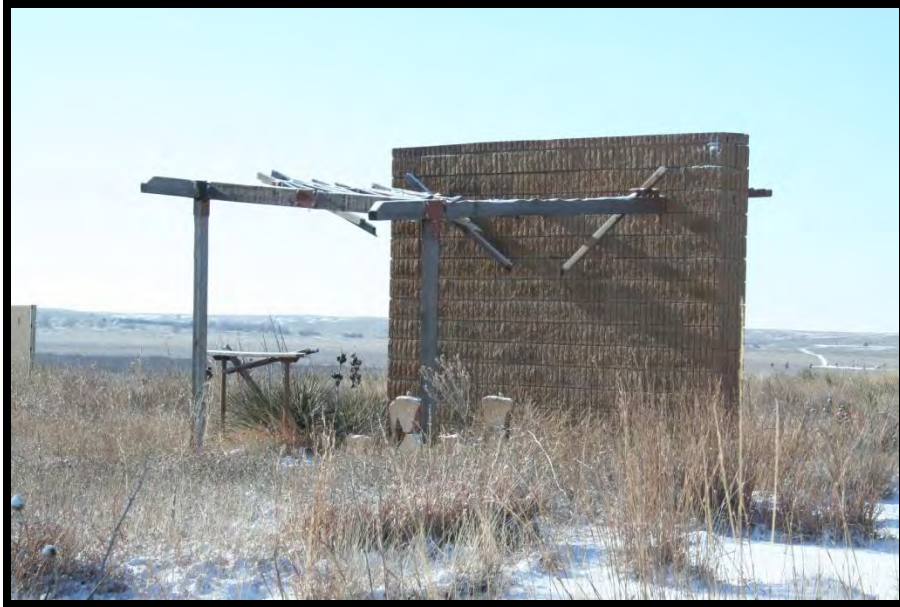
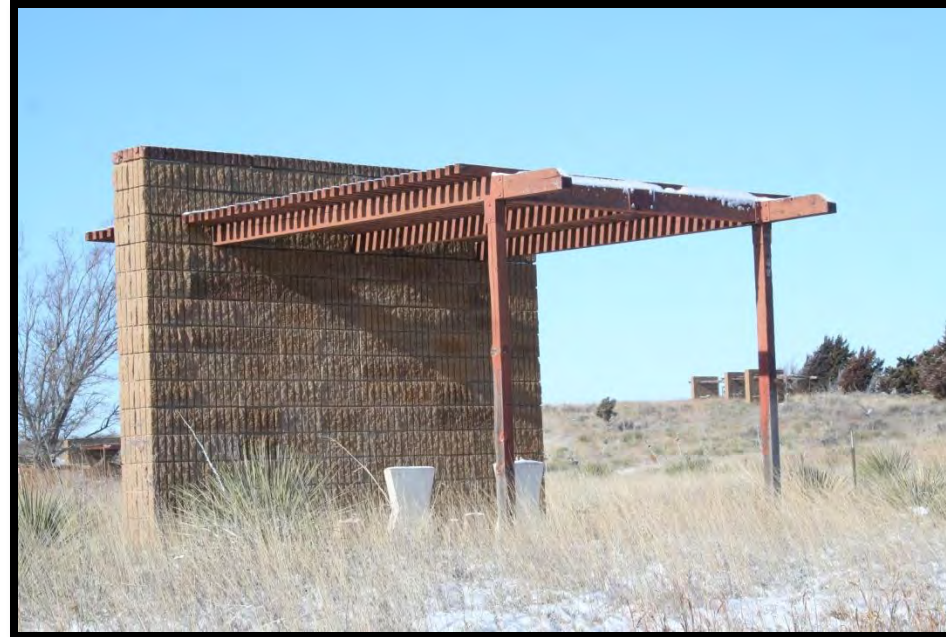
Dilapidated table shelters with dangerous overhanging masonry and wood structure

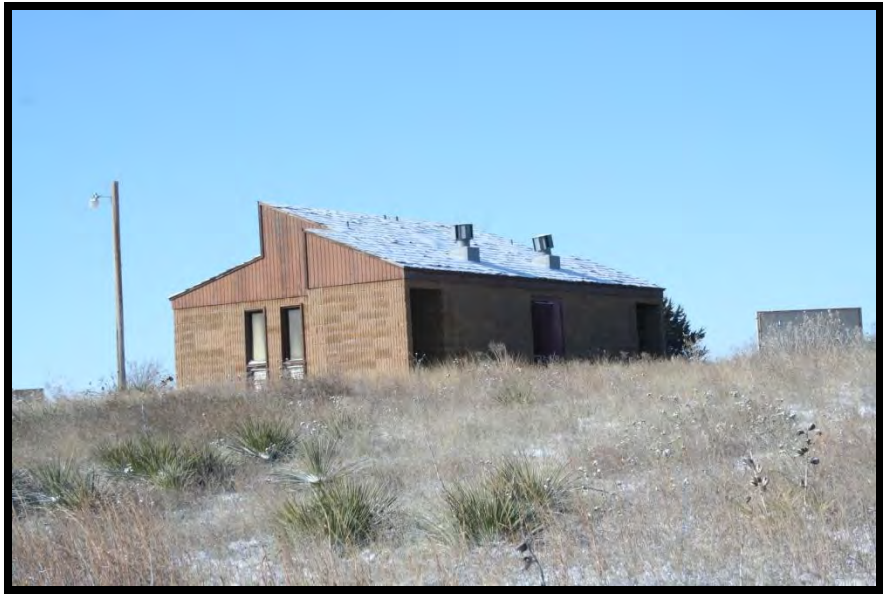
Toilet building in disrepair with the roof structure collapsing

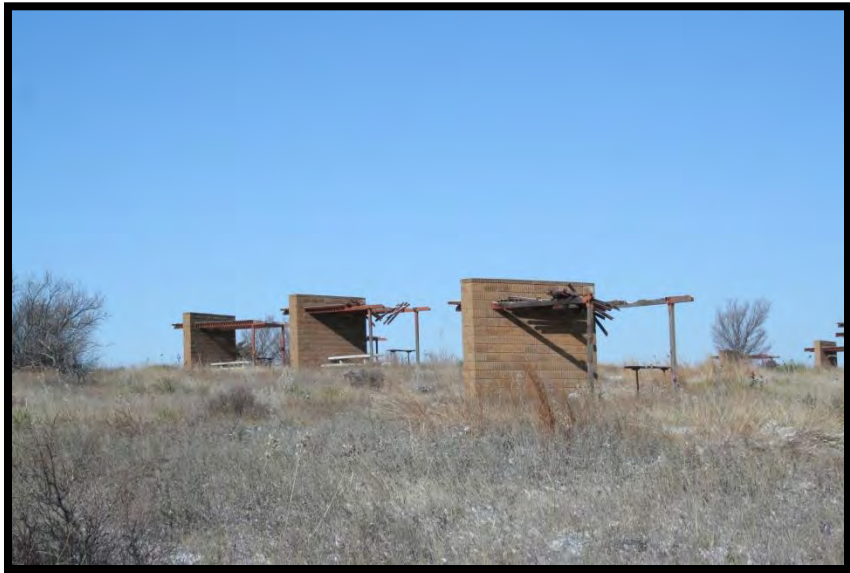
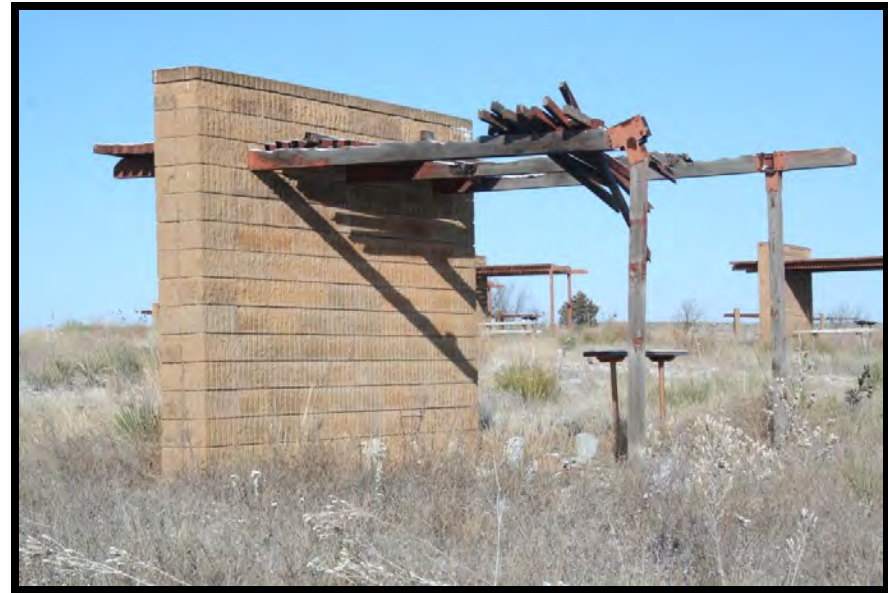
Numerous table shelters in various stages of failure

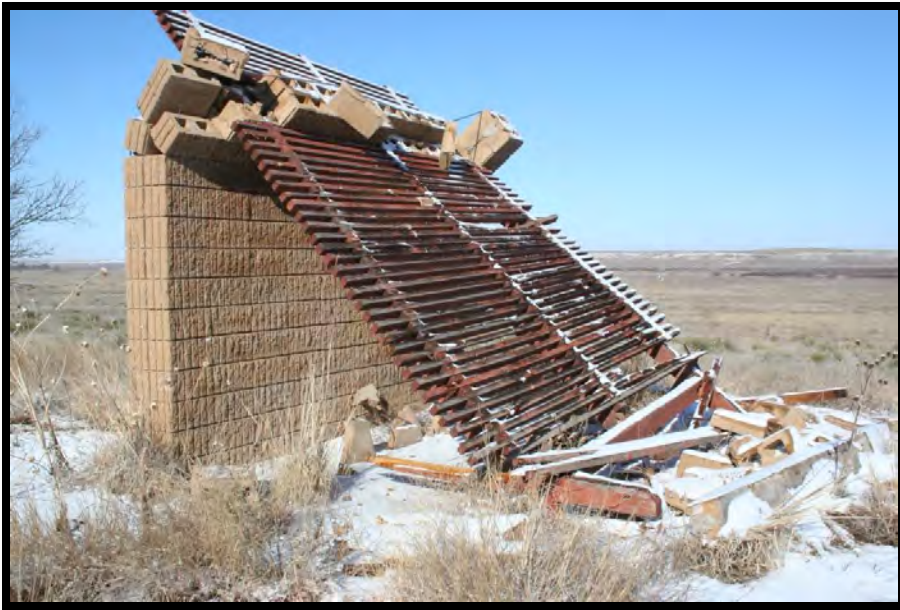
Table shelter damaged by fire and vandalism

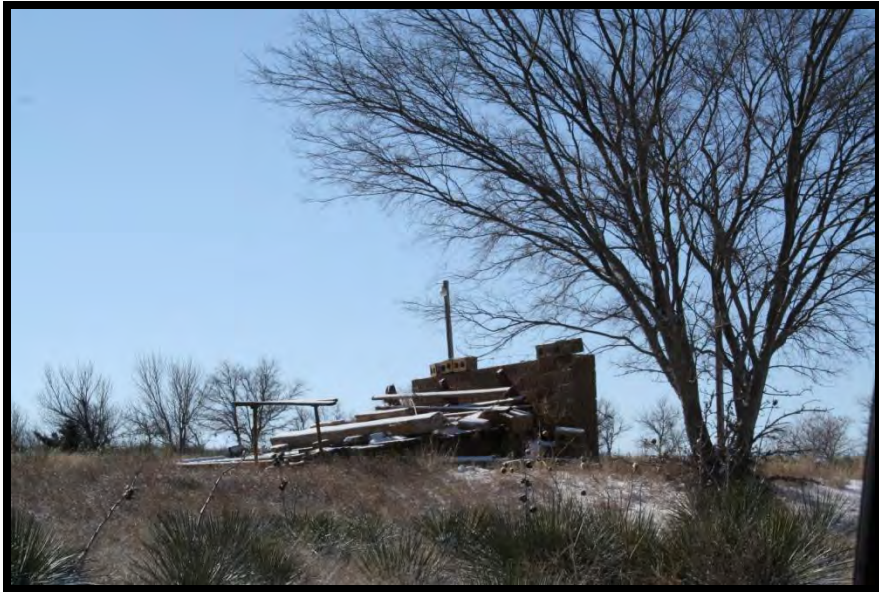
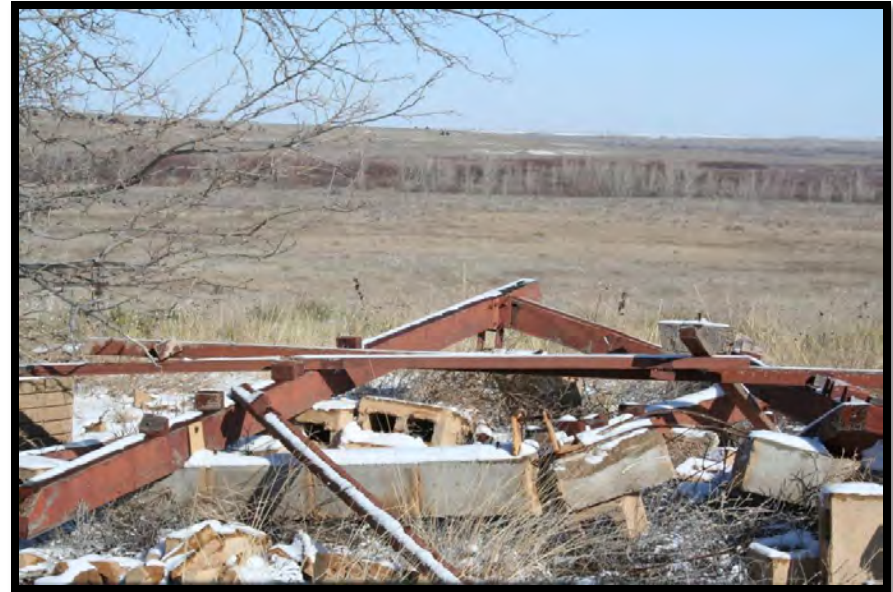
Some shelters were completely collapsed with scattered debris

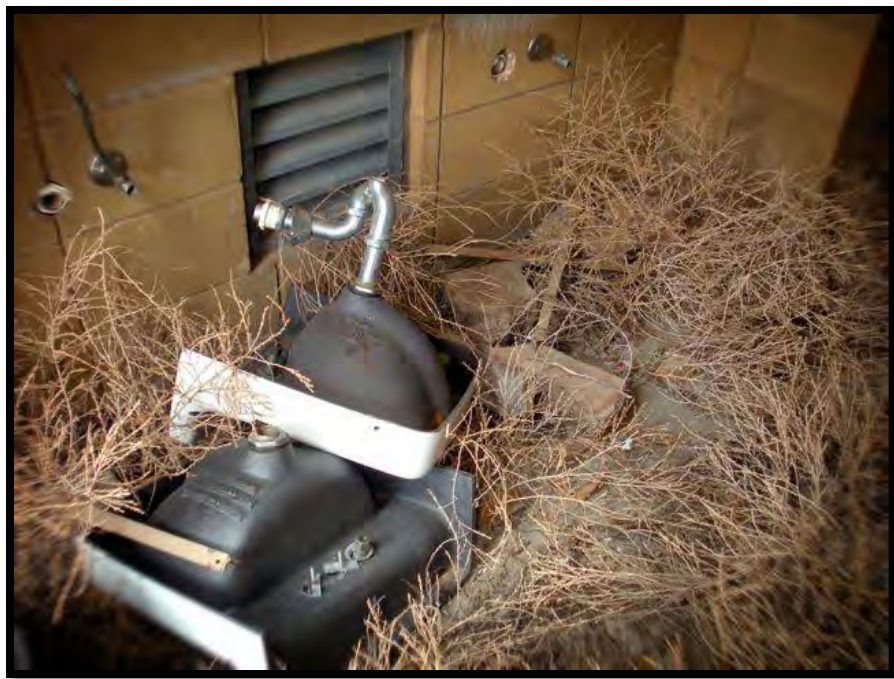
Vandalized restroom

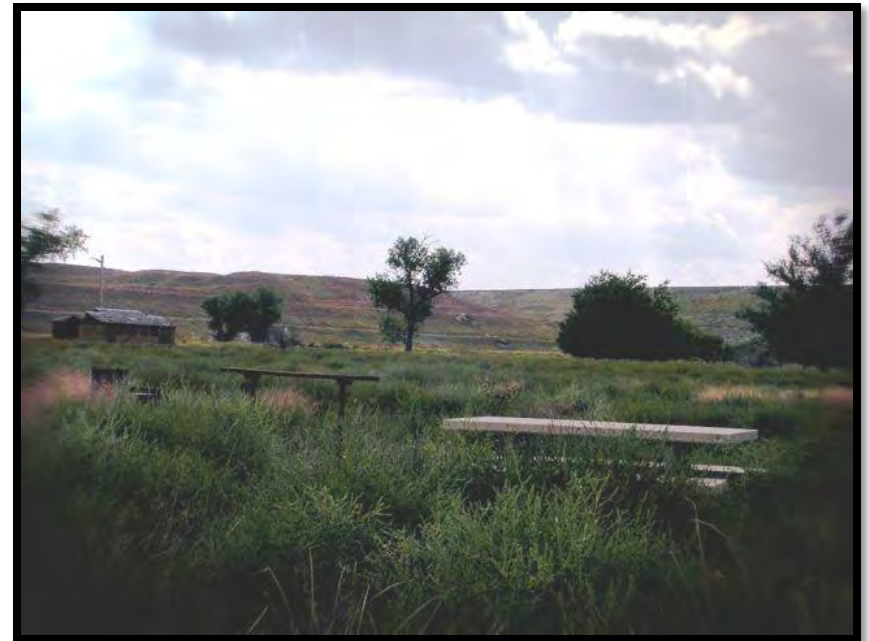
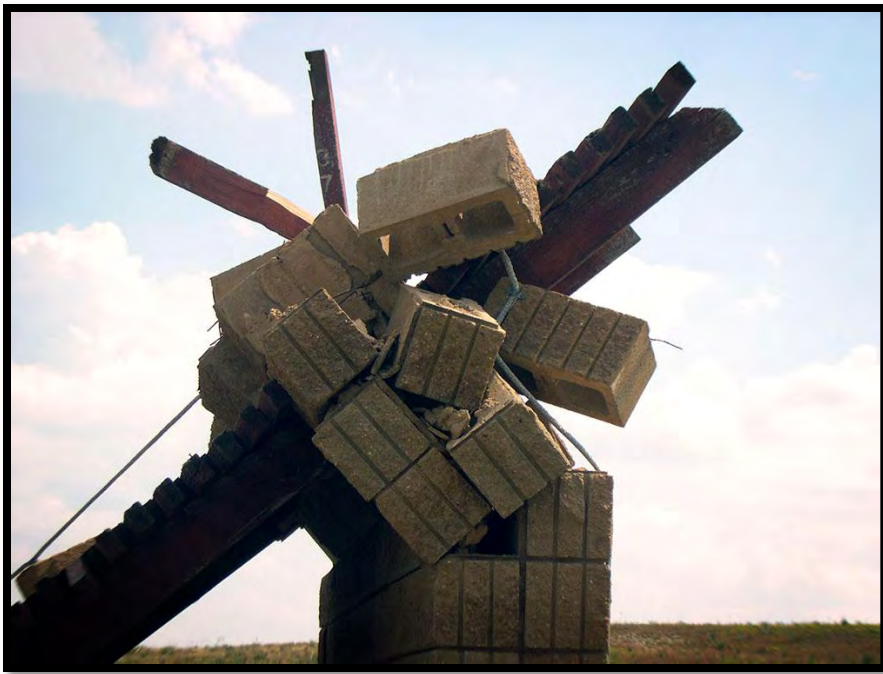
Collapsed table shelter with dangerous hanging masonry

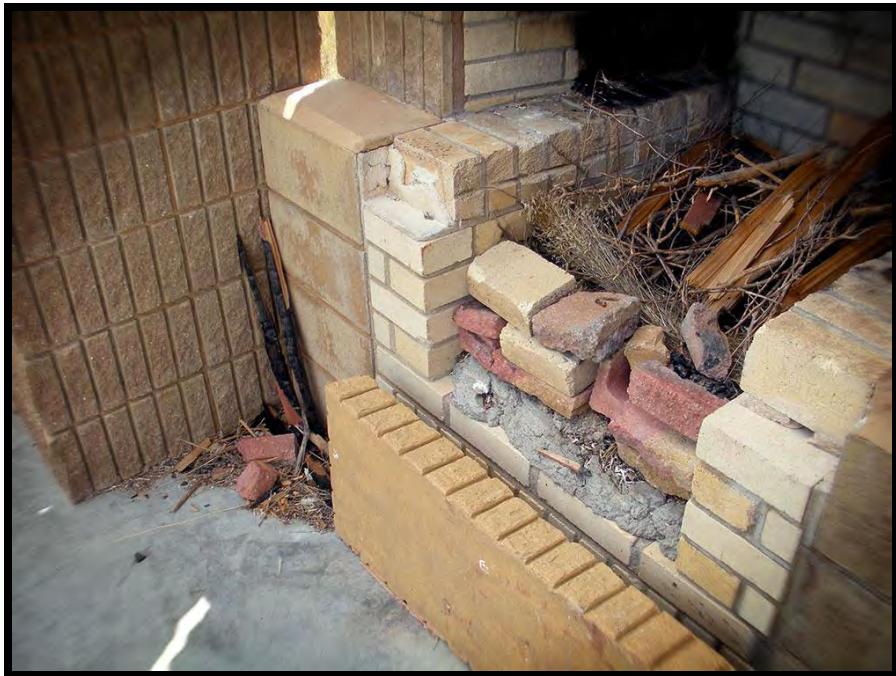
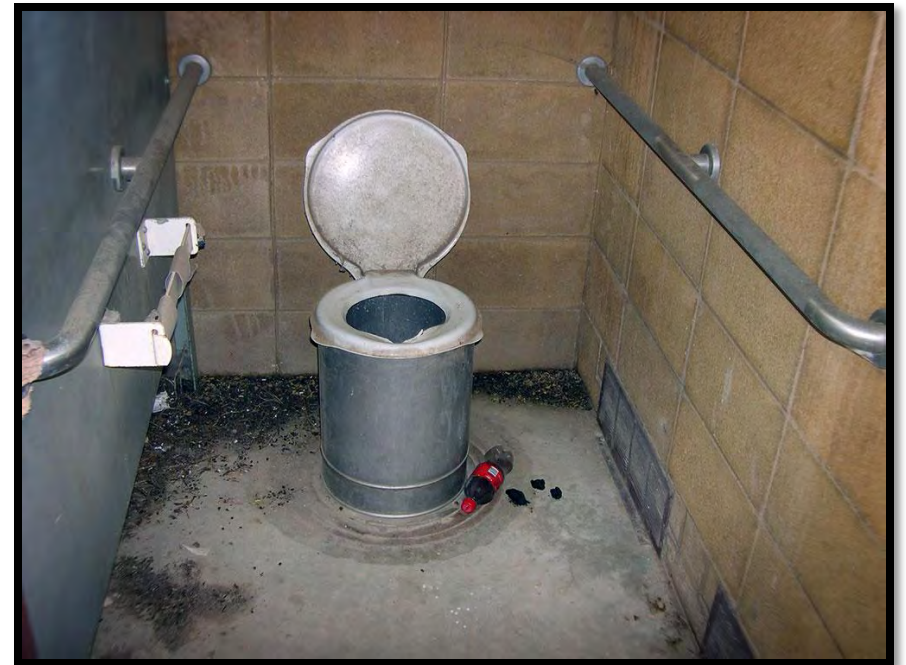
Dilapidated toilet buildings in various states of failure

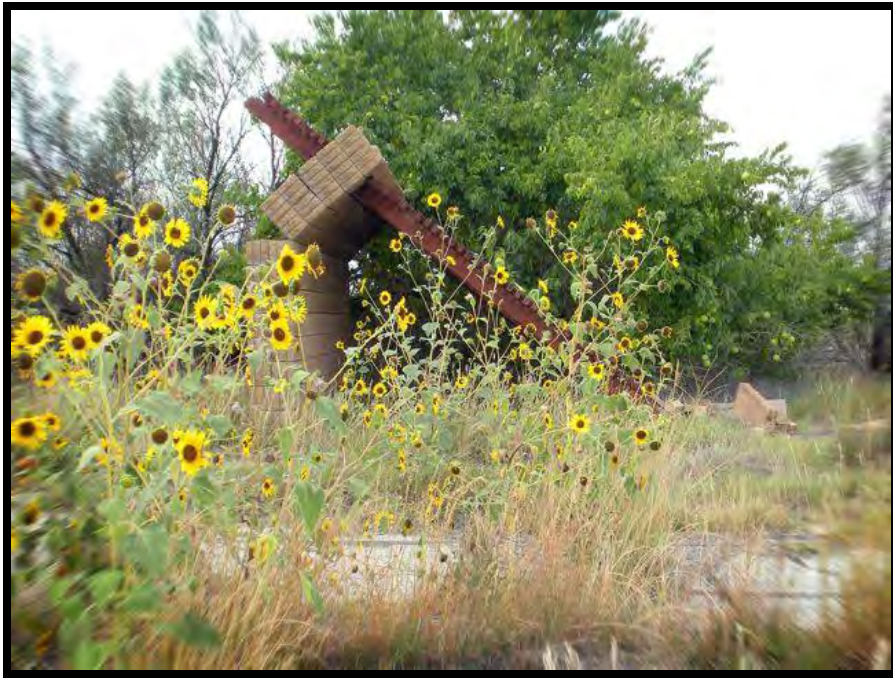
Topped canopy

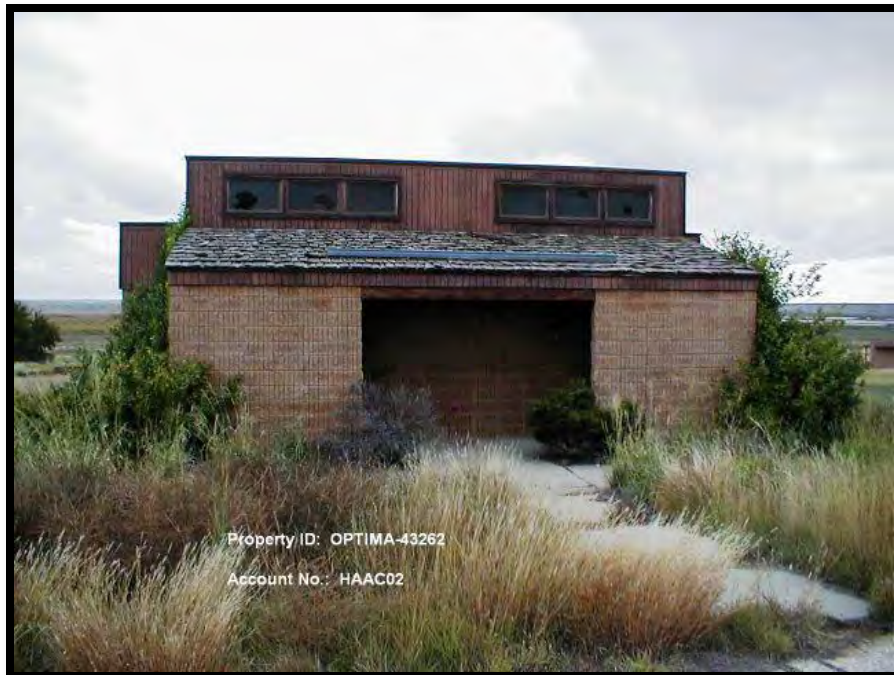
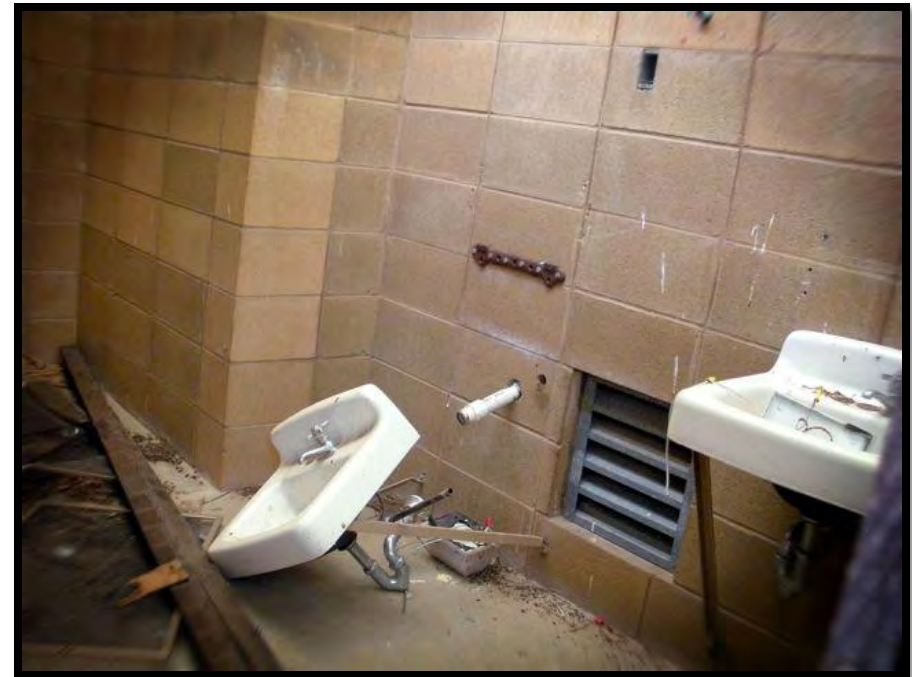
Failed table shelter and vandalized toilet buildings with
failing roof structures considered unsafe for public use

Vandalized restroom

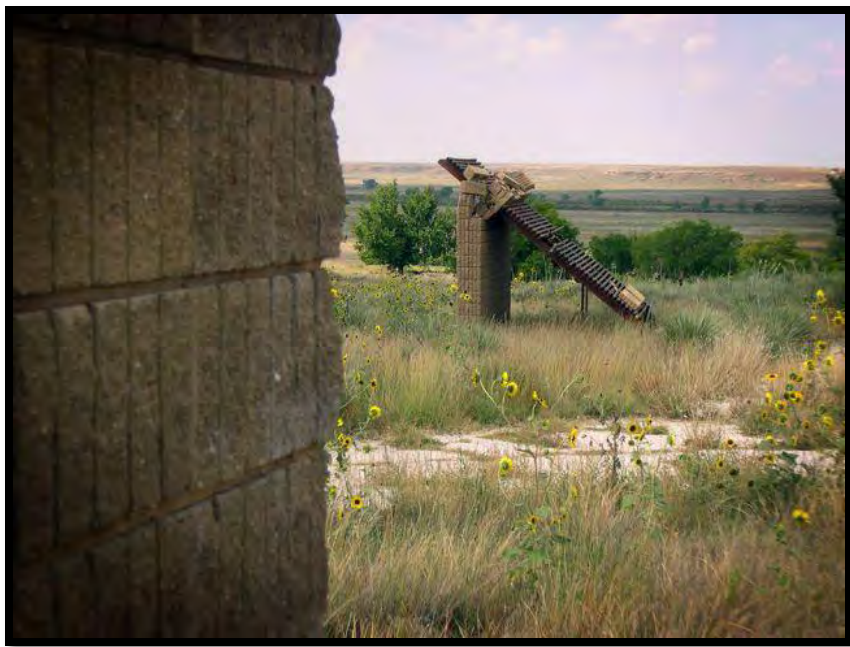
Canopy falling down

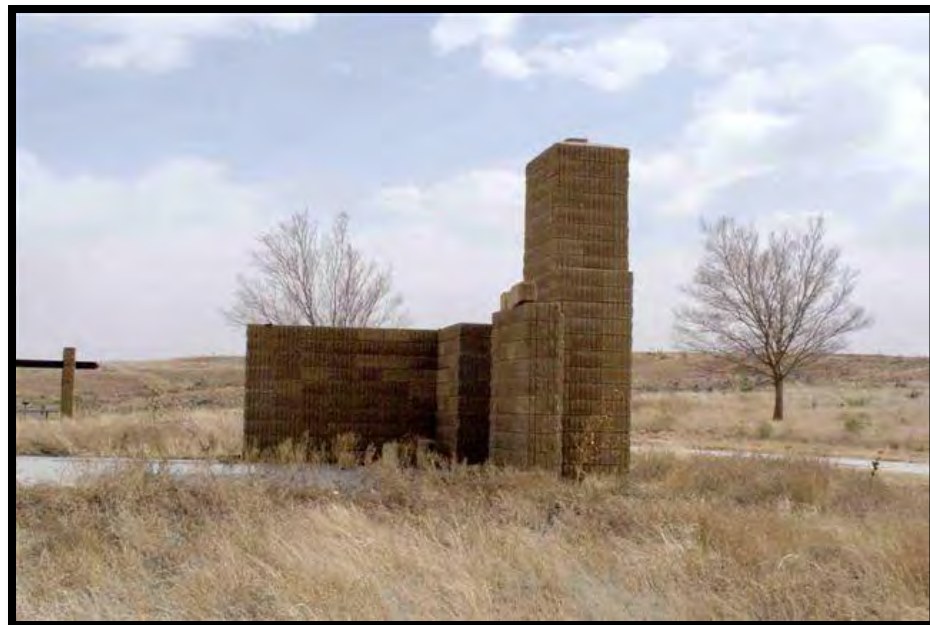
Failing fire pit facility at location of group shelter

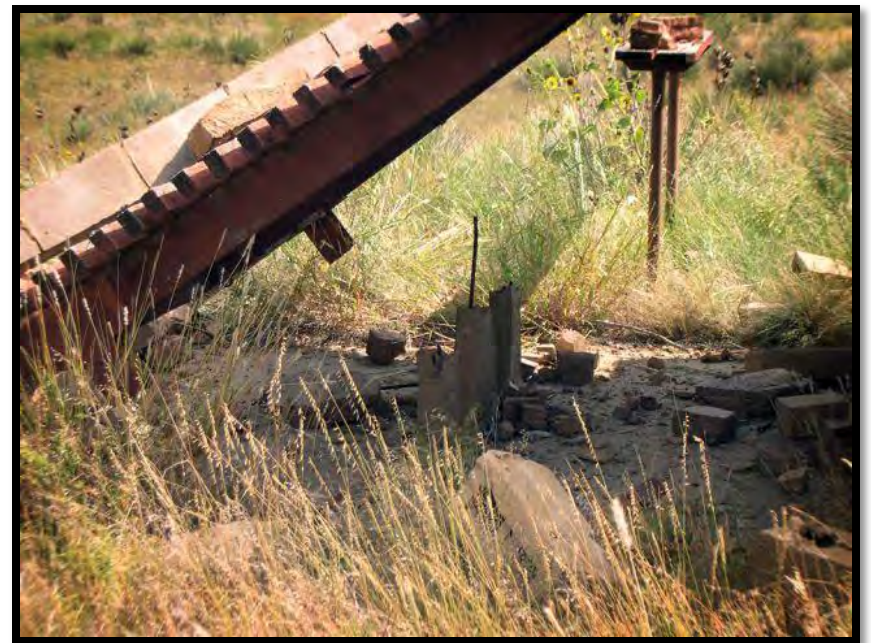
Closeup of campsite pad

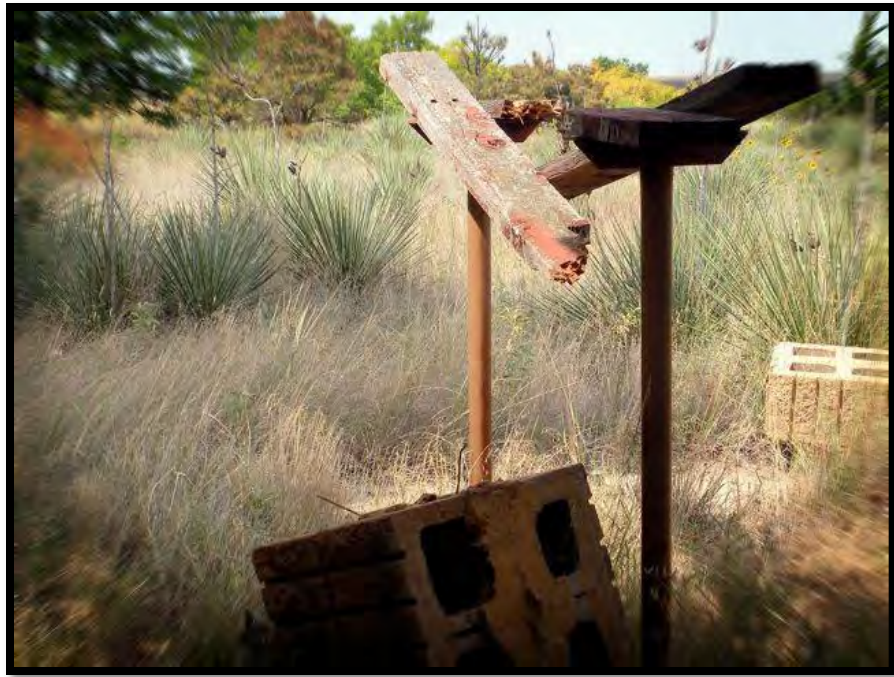
Busted utility table

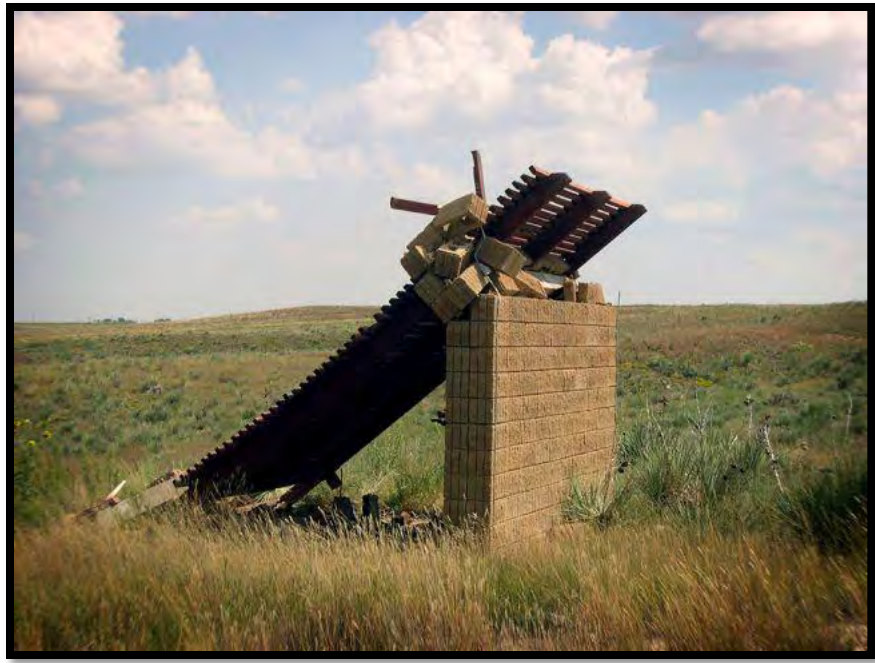
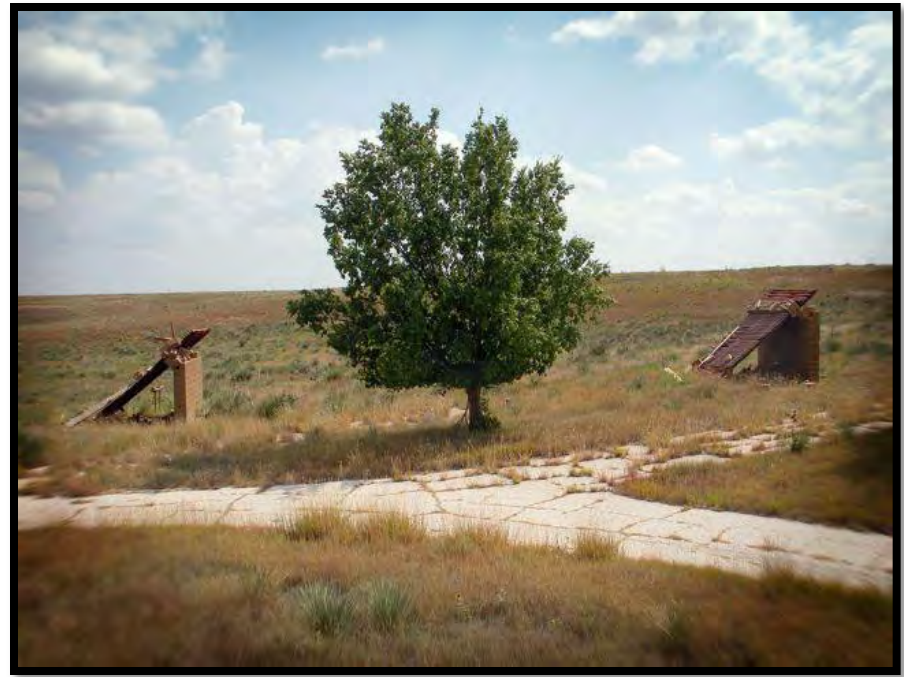
Failed table shelters typical throughout the campgrounds

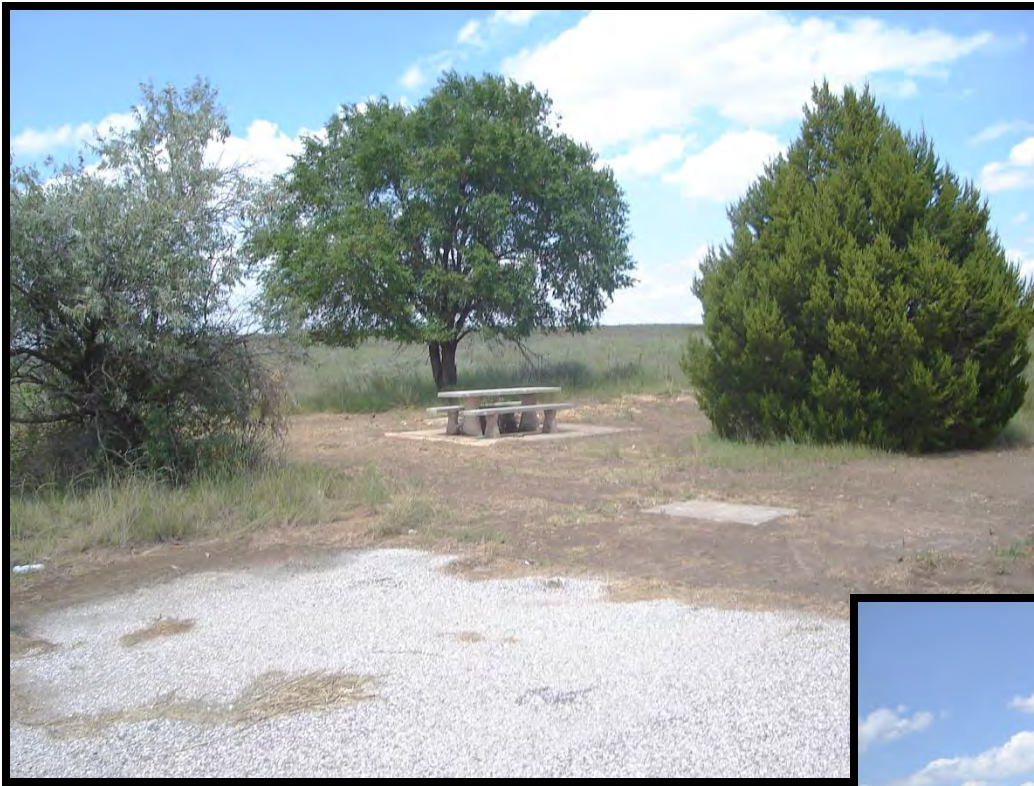
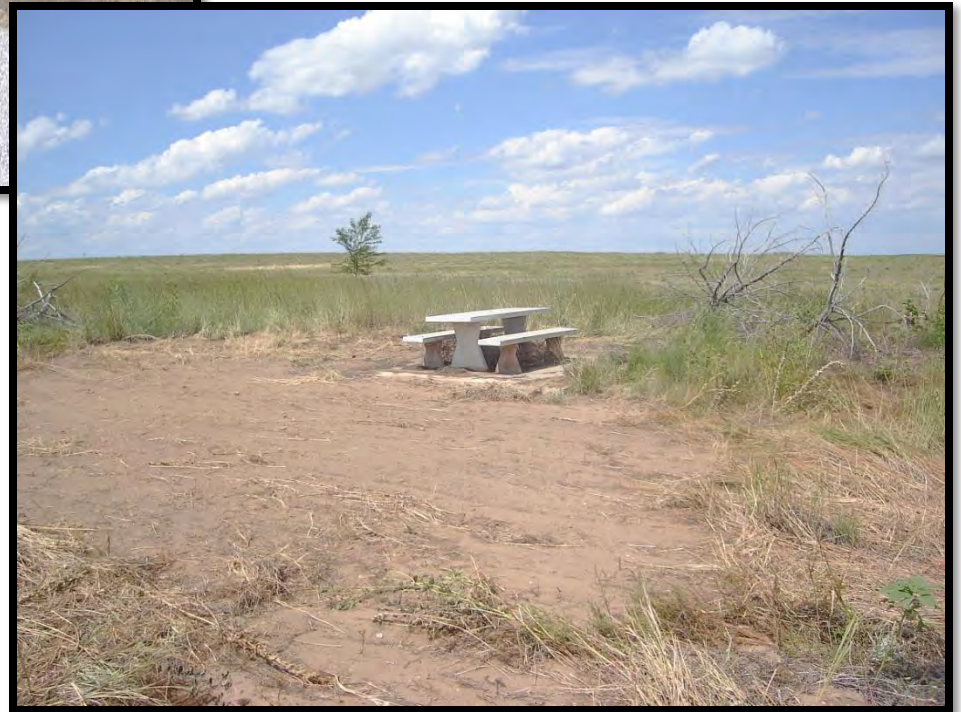
After Shots

Safe picnic tables in good repair left in place for public use
