# Evaluation of Wind-Loading on Airport Signs

June 2000

DOT/FAA/AR-TN00/32

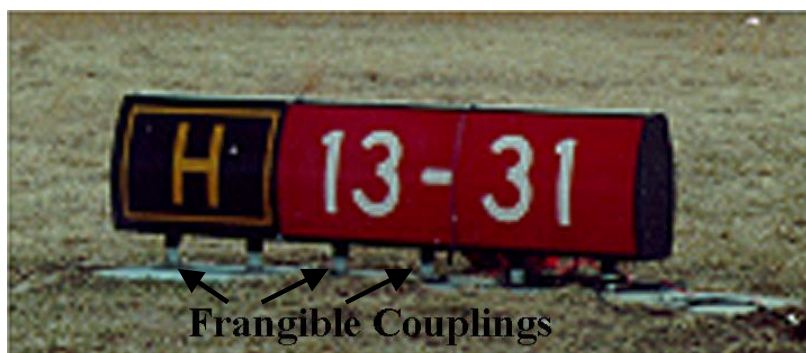
FIGURE 1. THREE-PANEL, SIZE-2 SIGN ARRAY

However, signs similar to those depicted in figure 1, at certain critical locations at O’Hare International Airport and other major U.S. airports are being sheared off their mounting legs at the frangible coupling from aircraft jet engine blast and/or wake turbulence forces. This sign damage increases the chance of aircraft foreign object damage (FOD) as well as a loss of visual guidance for other aircraft. If much stronger couplings are installed, the sign panel itself is damaged and the advantages of frangibility are lost. Consequently, there is a need to better understand and to more precisely determine the forces at these locations.

A third mode of signs designed to withstand wind loads greater than 300 mph with a 2.0 psi load factor as opposed to the current 1.3 psi should be implemented. A change to AC 150/5345-44F, *Specifications for Taxiway and Runway Signs*, is necessary due to the increase in the size of the new generation aircraft as well as the increased thrust in the new generation aircraft engines. This recommendation is based on the overwhelming success of the new strength signs installed at O'Hare International Airport.

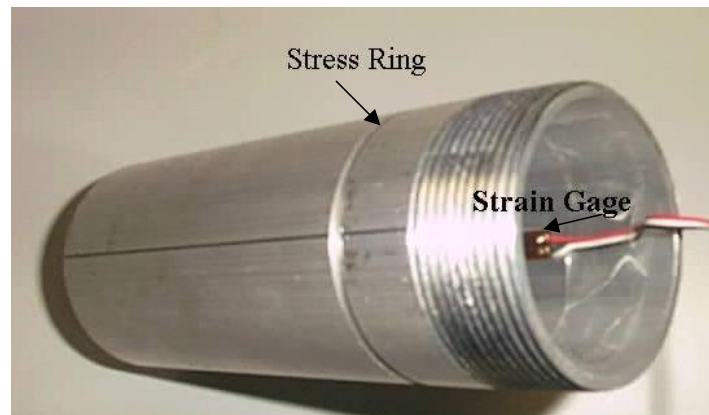
FIGURE 2. SIZE-2 FRANGIBLE COUPLING

Prior to the field installation of an instrumented airport sign similar to one depicted in figure 1, numerous design-specified frangible couplings were tested using a servo-hydraulic MTS to record their elastic limits and breaking points under varying loading conditions. The couplings were instrumented with a strain gauge inside of the coupling bridging the stress ring as depicted in figure 2.

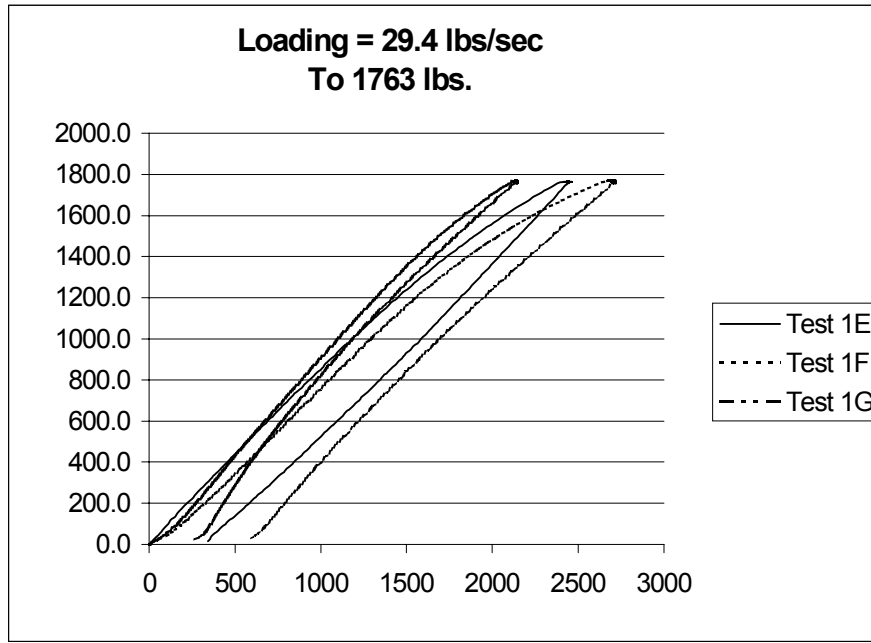
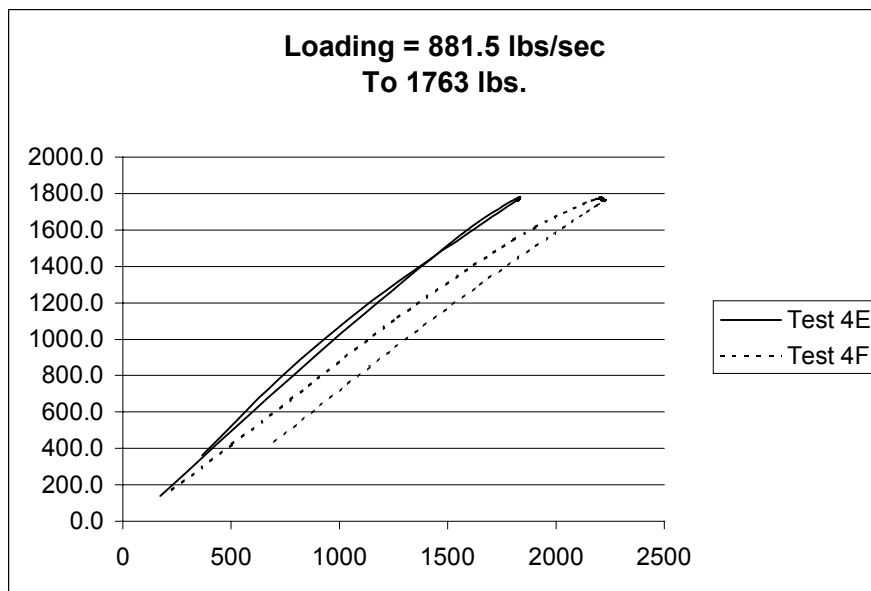
FIGURE 5. MTS COUPLING (STANDARD RATE) LOADING TO 0.9 psi

The MTS test data indicated that the couplings remained, for the most part, elastic through loads of approximately 1800 lb. (slightly greater than 0.9 psi) although there was some indication that 0.9 psi (minimum design load) was at the very fringe of the elastic limit of some of the couplings.

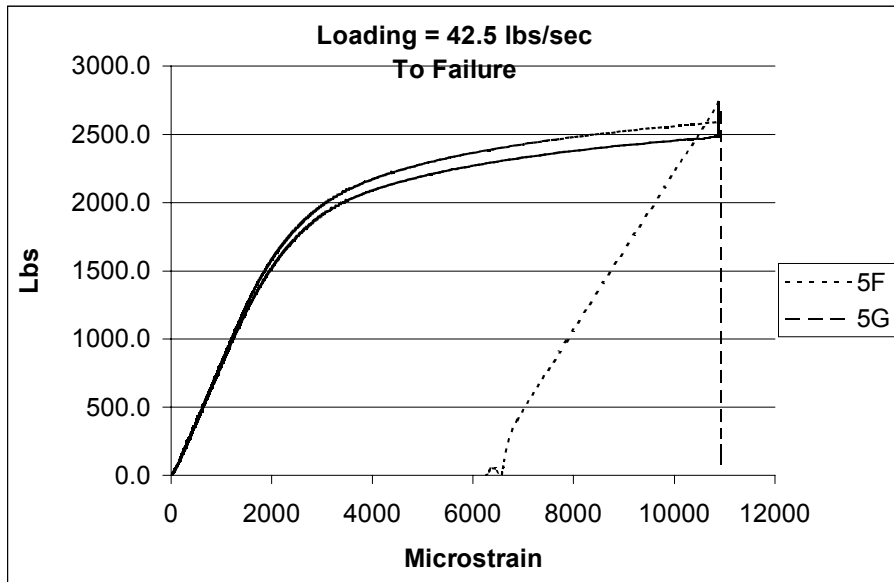
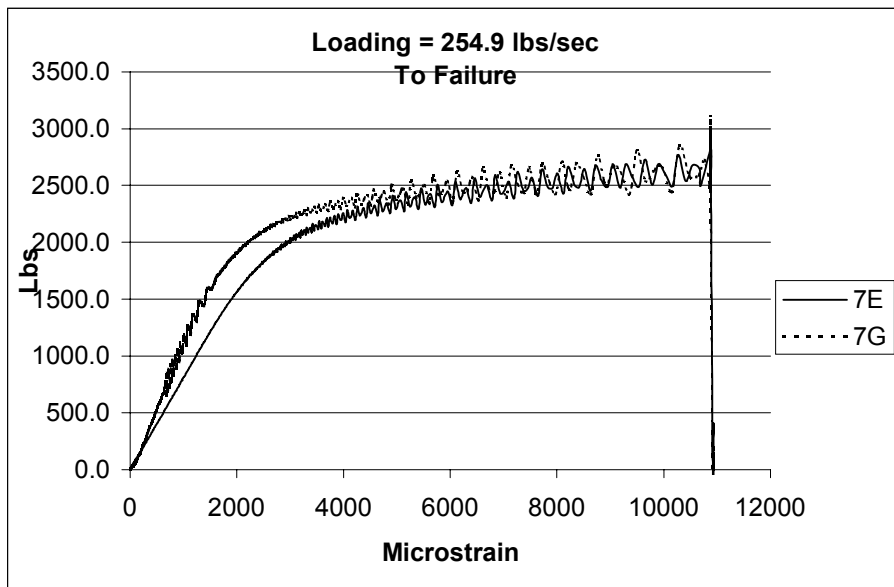
FIGURE 7. MTS LOADING TO 1.3 psi (OR FAILURE)

The MTS test data also indicated that the couplings failed with loads of more than the maximum design load (2600 lb. or 1.3 psi) on the sign face. The results of the tests also demonstrated that the elastic limit and failure point of the couplings are independent of the rate of loading. Sample results for the standard and highest load rates are illustrated in figures 5 through 8.

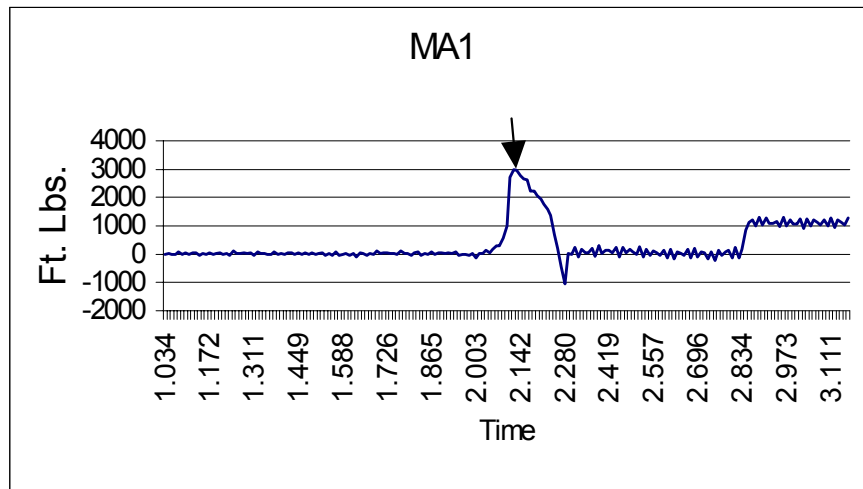
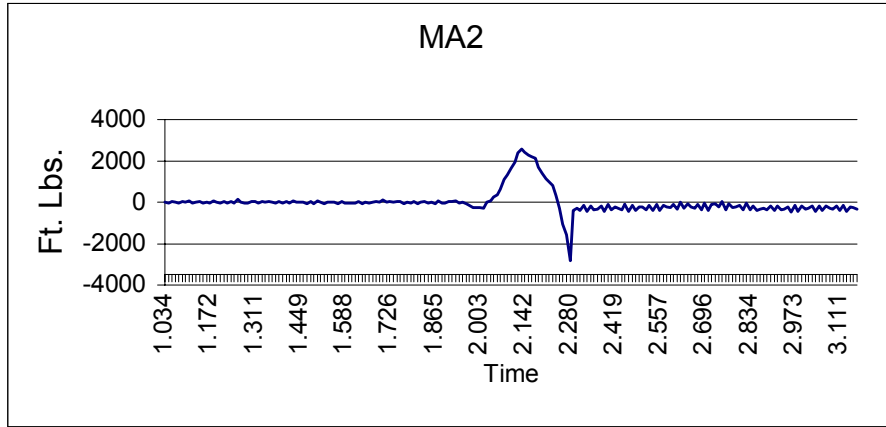
FIGURE 11. FRANGIBLE COUPLING 1, MA1

The measured moments at MA1 and MA2 differed in magnitude by 20% indicating that there was some bending (twisting) about the horizontal plane. The values for MA1 and MA2 in figures 11 through 18 were zeroed (MA2 values are absolute) for comparison.

The data also showed that the sign failed at the frangible point (couplings) under a load of only approximately 0.62 psi; which is less than the minimum frangibility requirements of the Advisory Circular. Moreover, the failure appeared to occur within the elastic limits of the laboratory tested couplings. It should be noted that the loading was applied to the sign over a time frame of less than 0.05 second, almost 200 times faster than in the laboratory tests. Although the measured wind speed was only 14.95 and 19.43 mph respectively, the data are considered to be unreliable since it was measured with a mechanical device that is not capable of providing accurate measurements over such a short period of time.

Further investigation of events prior to the total failure of the frangible couplings showed loads that exceeded the elastic limits of the couplings, causing permanent deformation of the couplings and actual failure (cracking) of the couplings well before the sign broke completely free of the couplings.

As a result of this test, it became apparent that the current design criteria may not be adequate for signs installed on airports that service the largest transport aircraft. In order to determine the maximum forces that a sign can experience on an airport, it was necessary to reinforce a second test sign to withstand much greater loads and more accurately measure wind speeds. A second fully instrumented sign was modified with additional couplings to withstand greater loads. Maintaining some degree of frangibility was an important safety factor in this evaluation. Every effort was made to reinforce the sign without creating too rigid an object on the airfield.
