NASA Engineering and Safety Center Technical Assessment Report	Version: 1.0
Title:	National Highway Traffic Safety Administration Toyota Unintended Acceleration Investigation	Page #: 1 of 177

**Technical Support to the National Highway Traffic Safety
Administration (NHTSA) on the Reported Toyota Motor
Corporation (TMC) Unintended Acceleration (UA)
Investigation**

January 18, 2011

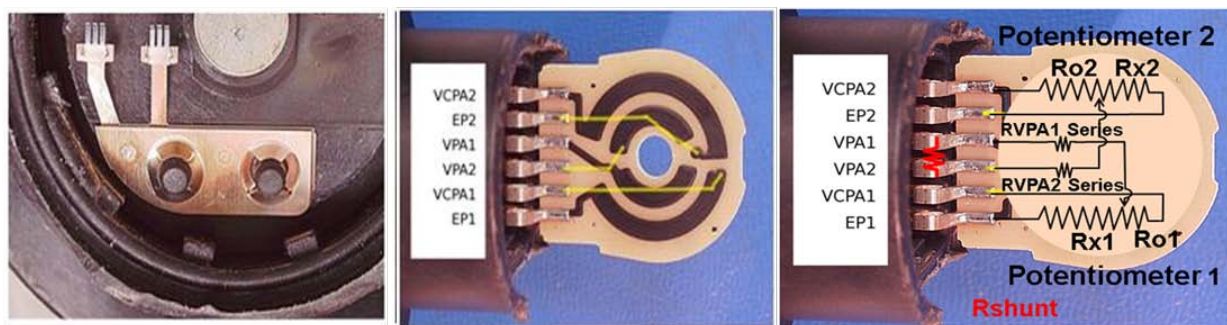
Figure 6.6.2.3-1. One of two rotating contact assemblies (left), resistive elements (center), and electrical diagram (right) for the potentiometer pedal sensors showing defective accelerator pedal assembly fault region

Vehicle testing using a defective potentiometer accelerator pedal assembly from a VOQ vehicle with a resistive short, within a narrow range of values between the sensors outputs, identified a vulnerability that may compromise nominal limp home mode fail-safe operation on subsequent ignition key cycles and affect the malfunction indicator lamp (MIL) display and/or DTC generation under certain specific conditions.

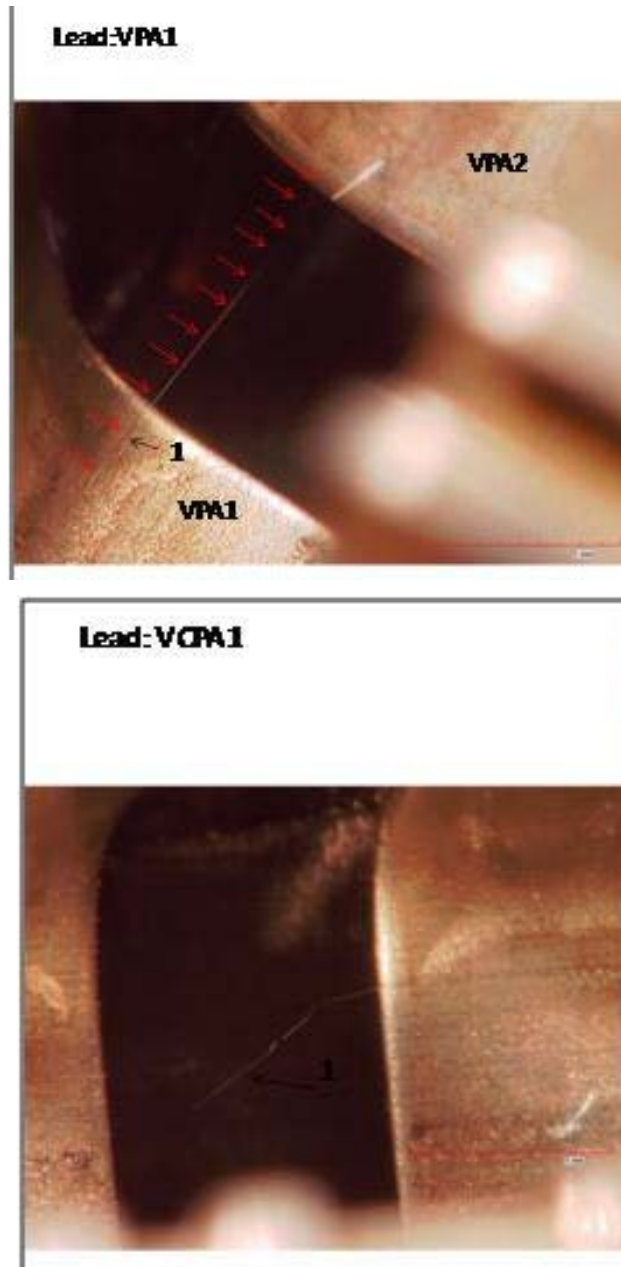
Figure 6.6.2.3-6. Shorting whisker VPA1 to VPA2 (top) and long whisker on VCPA1 (bottom)

Destructive physical analysis of this pedal assembly found tin whiskers², one of which had formed the resistive partial short circuit between the pedal signal outputs. A second tin whisker of similar length was also found in this pedal assembly that had not caused an electrical short. If a resistive short between the potentiometer accelerator pedal signal outputs exists, the system may be vulnerable to a specific second fault condition that could theoretically lead to UA. However, if resistive faults were occurring during normal use, DTCs would be expected from at least the first ignition key cycle and the following cycles that did not meet the specific criteria. Subsequent review of the warranty data does not support an observable failure signature of pedal-induced DTCs. Electrical measurements on six VOQ vehicles found no indication of the resistive paths necessary for this failure scenario.
