MANAGEMENT REVIEW COMMITTEE KIF DREDGE CELL FAILURE - 2006

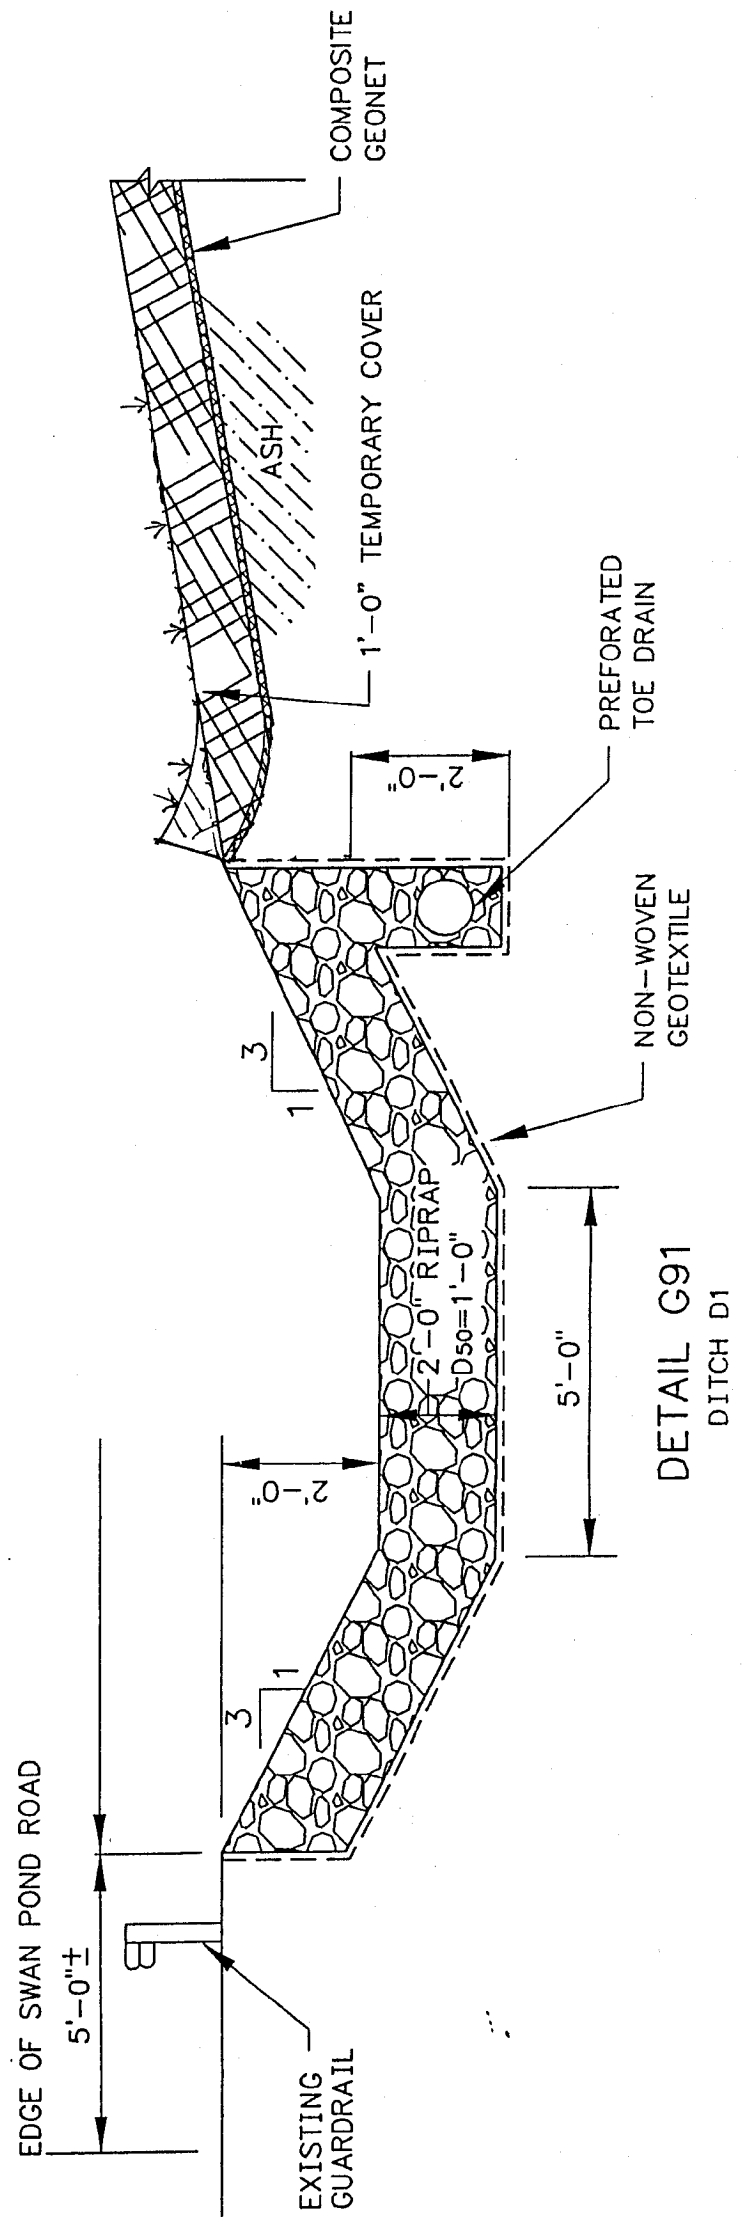
WHAT
ACTUALLY
GOT
BUILT

Indications are we *also* have a local problem that was masked by the global problem. (2003 the entire slope was saturated - 2006 only two local areas were saturated)
