## Summary of Approach and Conclusion:

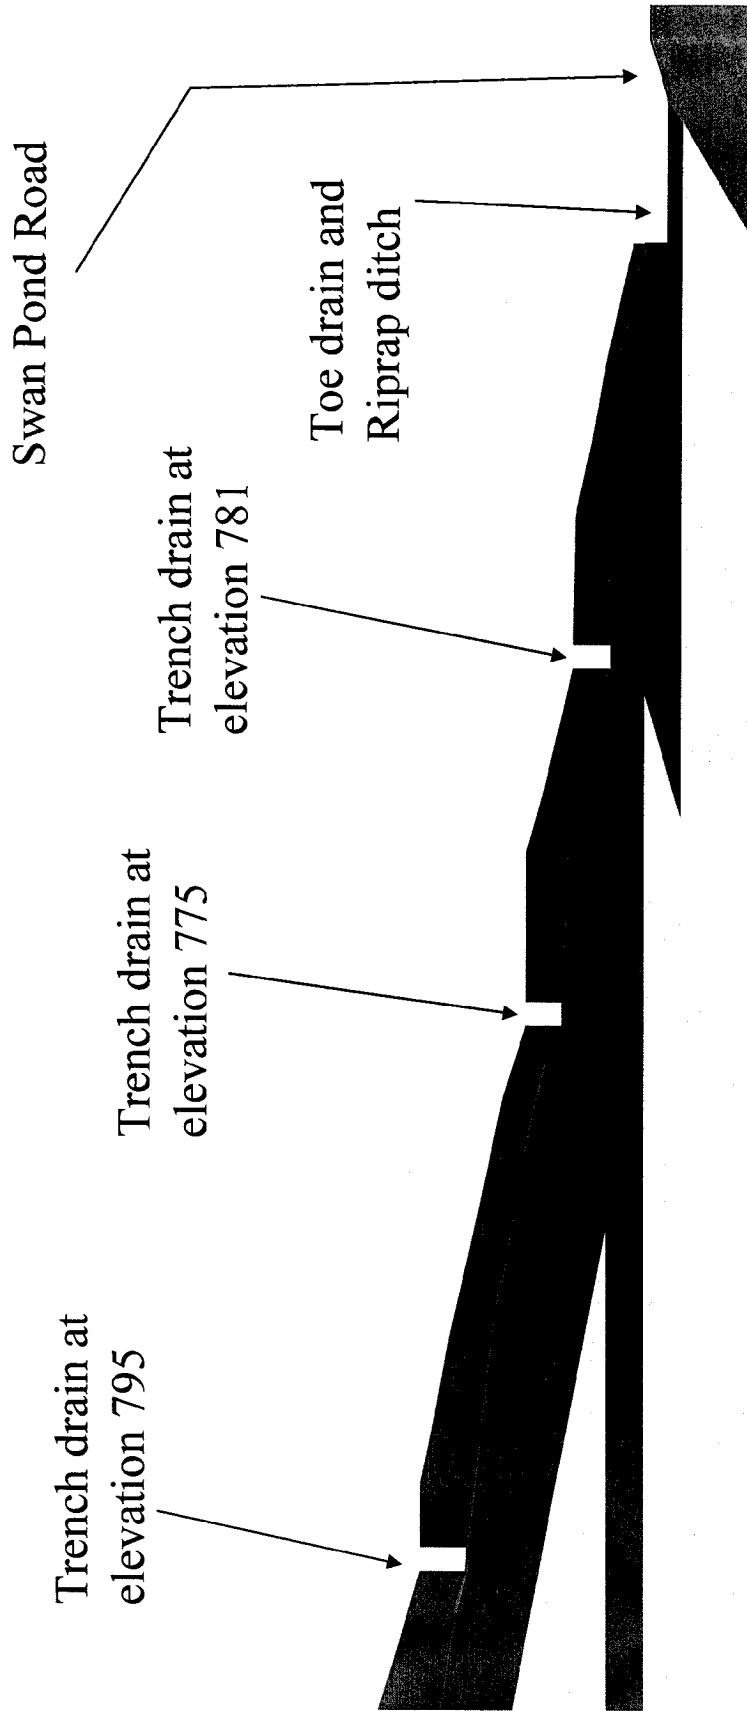
**Figure 1 – Generalized Section Along Swan Pond Road**

The above modeling efforts resulted in a proposed "fix" consisting of 6 ft deep trench drains at the 795 bench, a 5 ft deep trenches at the 781 and 775 benches; and a buttress toe drain and a riprap channel to stop seepage uplift. (See Figure1).

The extensive analysis performed by TVA and its contractors confirmed the cause of the failure was piping and excessive seepage. The proposed fix will lower the phreatic surface away from the face of the side slope, significantly reducing the future potential for piping. The calculated uplift factor of safety in the toe ditch is 4.005 for the postulated 900 FT elevation (Parsons E&C).

As further insurance against piping, TVA is proposing the installation of a Geonet membrane to elevation 775 in the vicinity of the failure. It should also be noted that the 5 ft trench drain in the bench at elevation 795 overlaps the exiting interior drain near that elevation. This redundancy was not modeled (conservative); only the shallower (new) drain was modeled.

To insure that the proposed fix is successful TVA will install piezometers on the north, south and western faces of the dredge cells. To monitor performance of the drainage system, the phreatic surface measured in these piezometers will be compared with that predicted in the models.
