KINGSTON FOSSIL PLANT (KIF)—ANNUAL INSPECTION OF WASTE
DISPOSAL AREAS

TENNESSEE VALLEY AUTHORITY
KINGSTON FOSSIL PLANT

ANNUAL INSPECTION OF
WASTE DISPOSAL AREAS

**KINGSTON FOSSIL PLANT
NPDES PERMIT NO. TN0005452
ANNUAL ASH POND DIKE INSPECTION
2000**

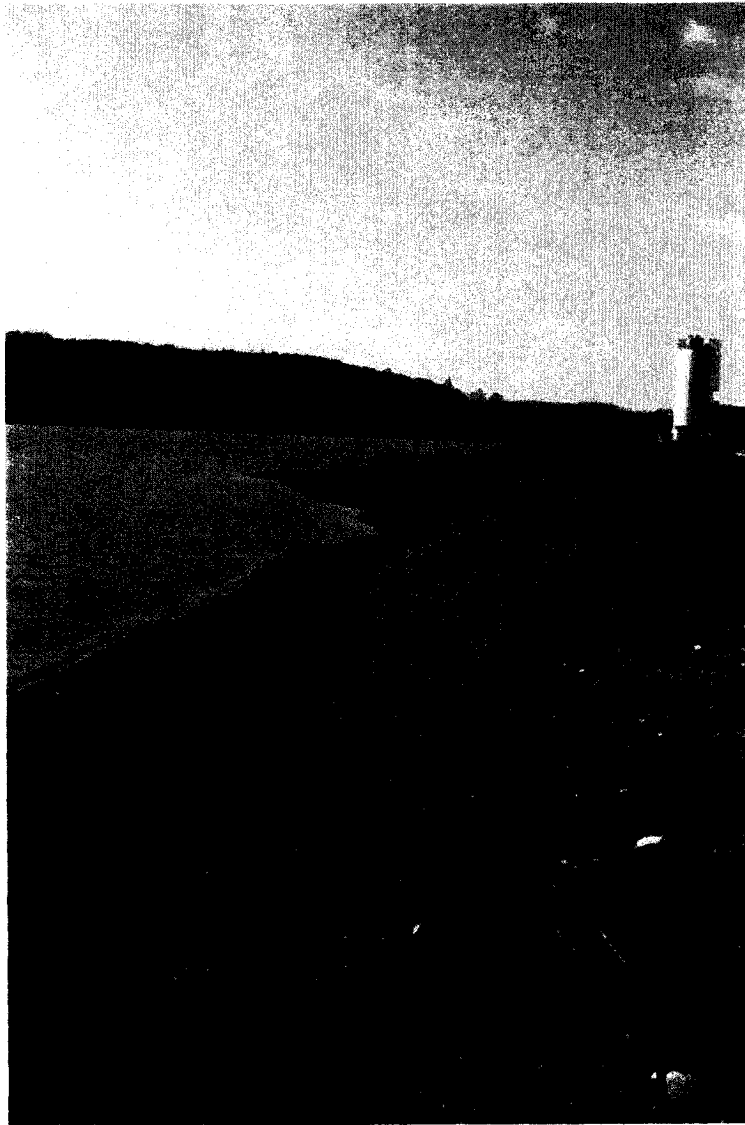
- Riprap has been placed on the interior dikes of the stilling pool; however, some additional areas are showing signs of erosion, requiring riprap.
- The divider dike road has been maintained by adding bottom ash to eroded areas, but other areas are showing signs of erosion. (see photo #1)
- The ditch along Swan Pond Road has been graded and seeded. Some heavy rains have washed part of the mulch requiring some additional attention as the growing season progresses to insure sufficient ground cover. (see photo #2)
- Rutted areas noted at the southeastern end of the ditch adjacent to Cell 1 require riprap.
- Plant personnel have continued to monitor any known seep and slough areas for material movement.

Photo 1—Looking southwest: Divider dike slope

- Plant personnel should repair the rutted areas at the southeastern end of the ditch adjacent to Cell 1 by placing riprap in eroded areas.
- Place additional riprap along slopes of stilling pool and divider dike.

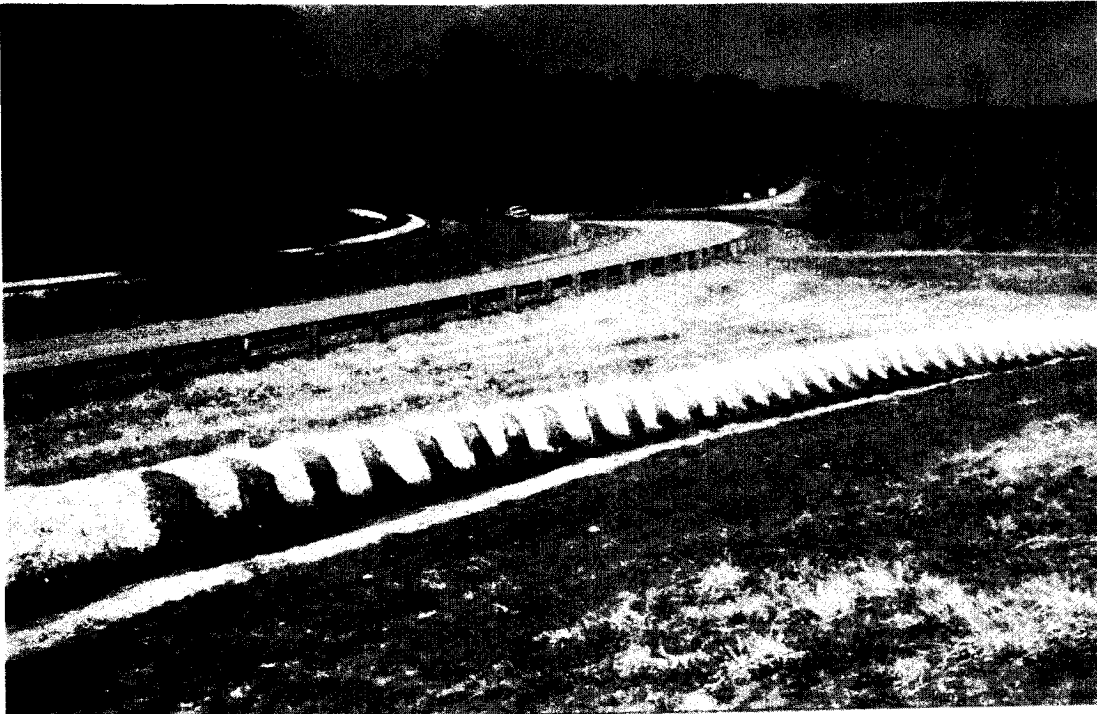
Photo 2—Looking northeast: Drainage ditch along Swan Pond Road

- Maintain ditch along Swan Pond Road, ensuring erosion does not begin.
- Plant personnel should regrade the area between the perimeter ditch and dike "C" to eliminate low spots and insure drainage, place clay cover as needed, and seed and mulch to establish vegetation.

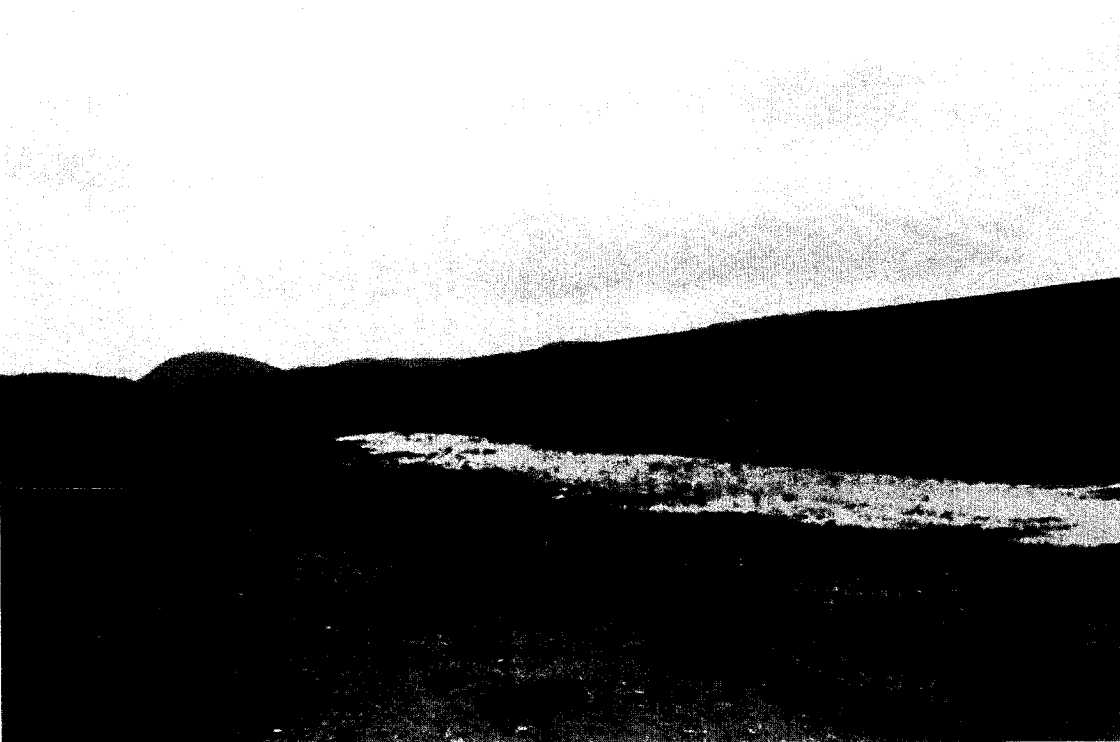
is standing, additional grading to correct erosion, and the area reseeded (see photos #3 and 4). Just south of the perimeter ditch where the outlet drains into the active ash pond, there are several trees and undergrowth that should be removed (see photos #5 and #6).

Photo 3—Looking southwest: Standing water in perimeter ditch

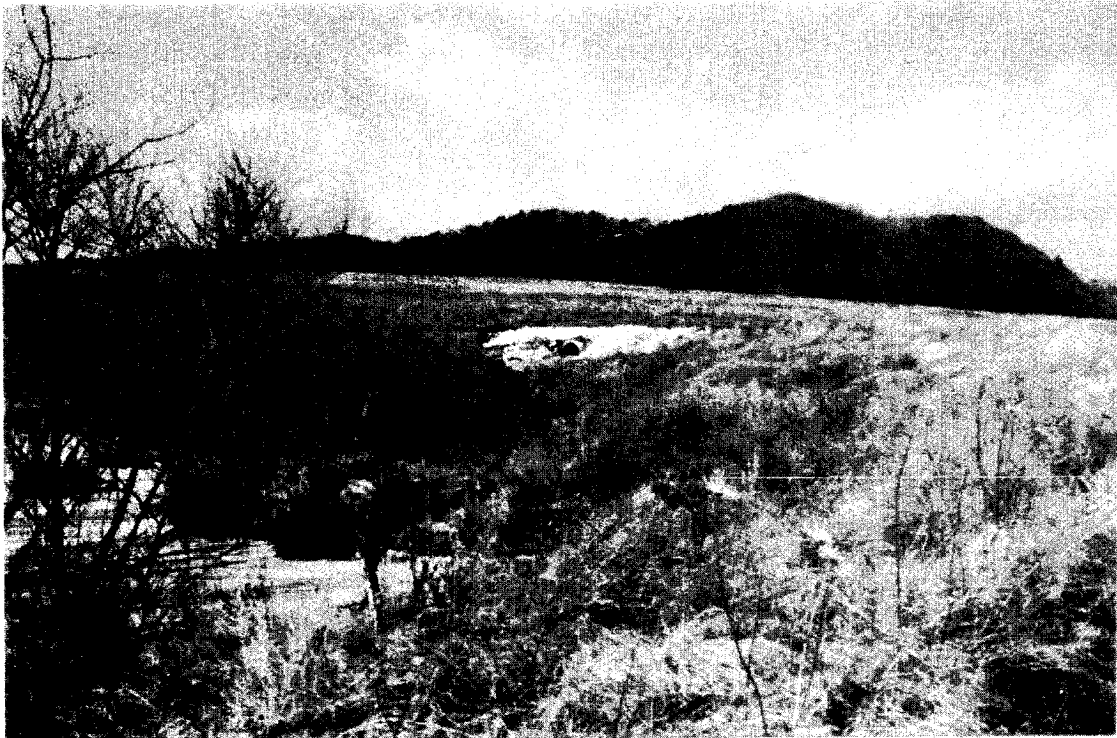
Photo 5—Looking northwest: Trees and brush at discharge of perimeter ditch

- Remove trees and other growth from northeast corner of ash disposal pond.
- Fill should be added and riprap placed to prevent further erosion at a few outlet drains on the eastern slope of the stage A dike.

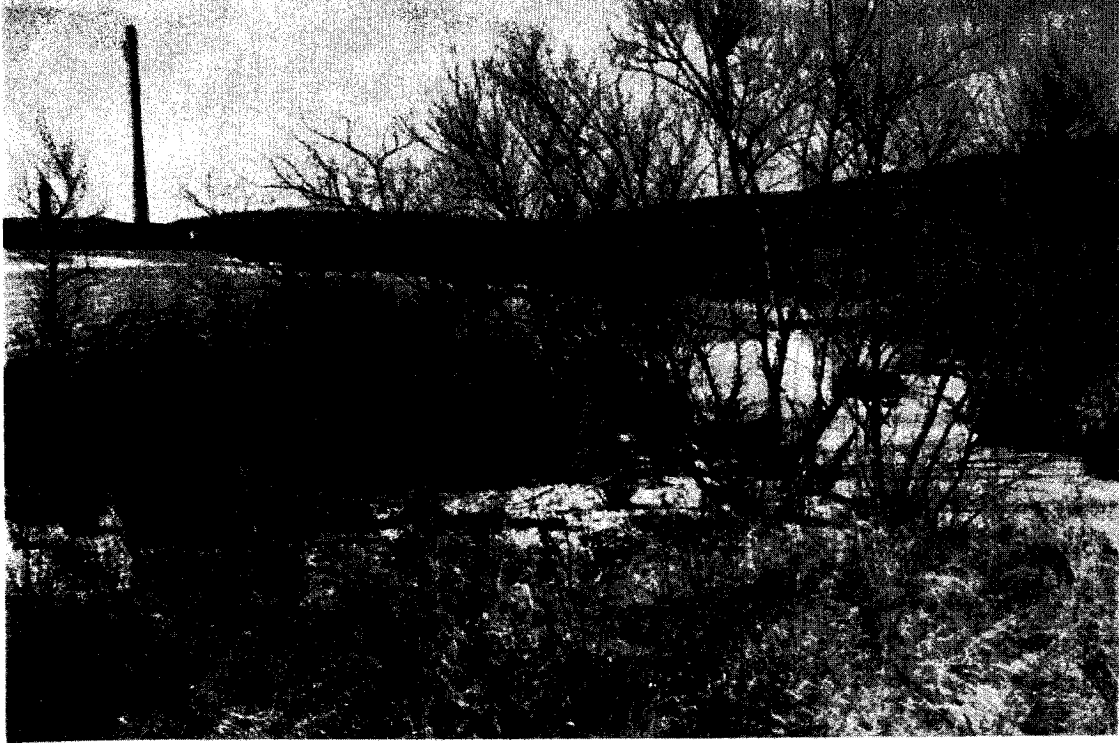
Photo 6—Looking west: Trees and brush at discharge of perimeter ditch

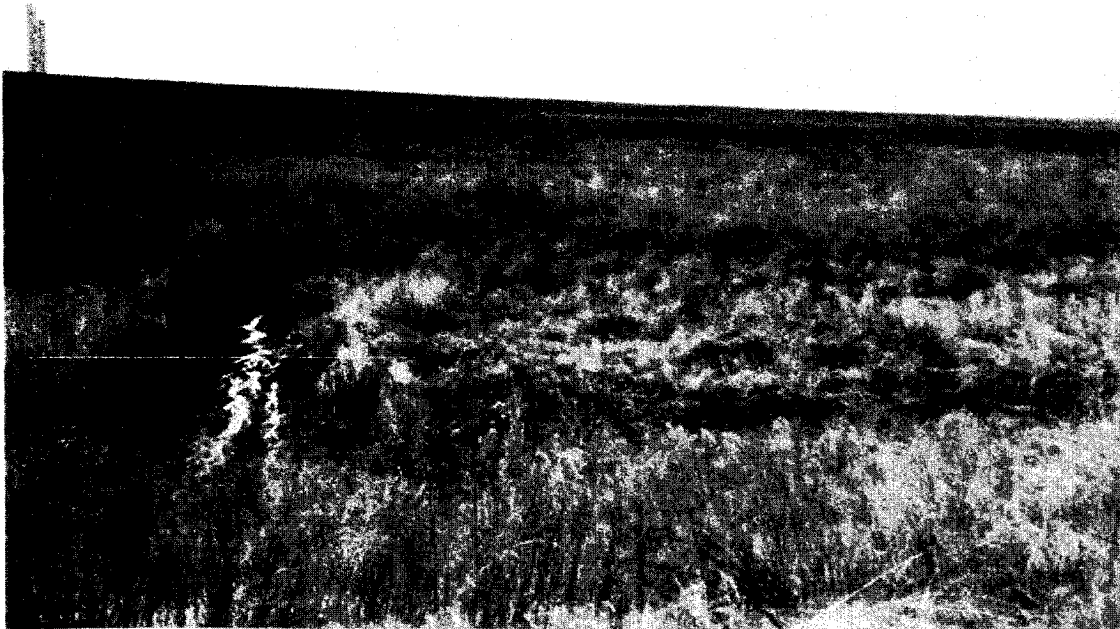
On the eastern slope of the stage A dike, there are several areas where the outlet drains are starting to erode (see photo #7). All along the stage B lift, there were signs of erosion (see photo #8).

Photo 7—Looking west: Outlet drain erosion
