KINGSTON FOSSIL PLANT - ANNUAL INSPECTION OF WASTE DISPOSAL AREAS

KINGSTON FOSSIL PLANT (KIF)—ANNUAL ASH POND DIKE
STABILITY INSPECTION

TENNESSEE VALLEY AUTHORITY
KINGSTON FOSSIL PLANT

ANNUAL ASH POND DIKE
STABILITY INSPECTION

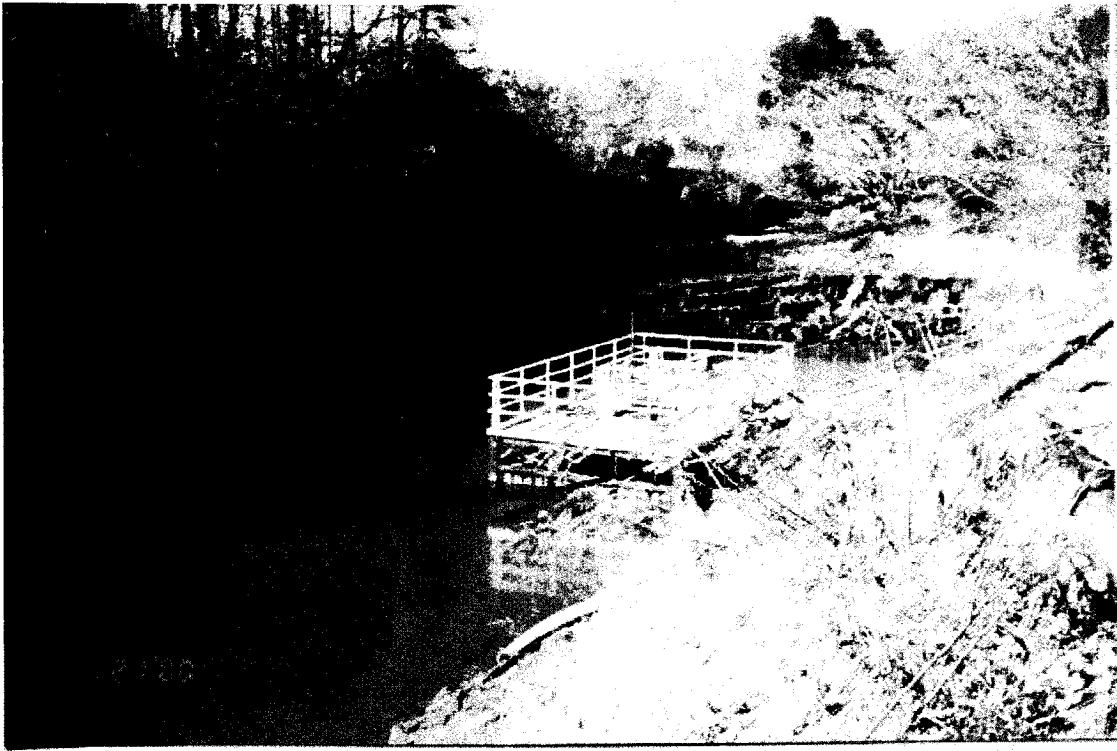
The coal yard drainage basin is located at the southwest corner of the coal pile. This basin was excavated below grade; therefore, there are no exterior dikes. All discharge from this basin is pumped into the fly ash discharge ditch which flows to the active ash disposal area. At the time of inspection, water in the pond was at a low level. The slopes appeared to be in satisfactory condition. (photo #1) Currently, there is a project underway to excavate more sediment from this pond.

Photo 1—Looking northeast: Coal yard drainage basin

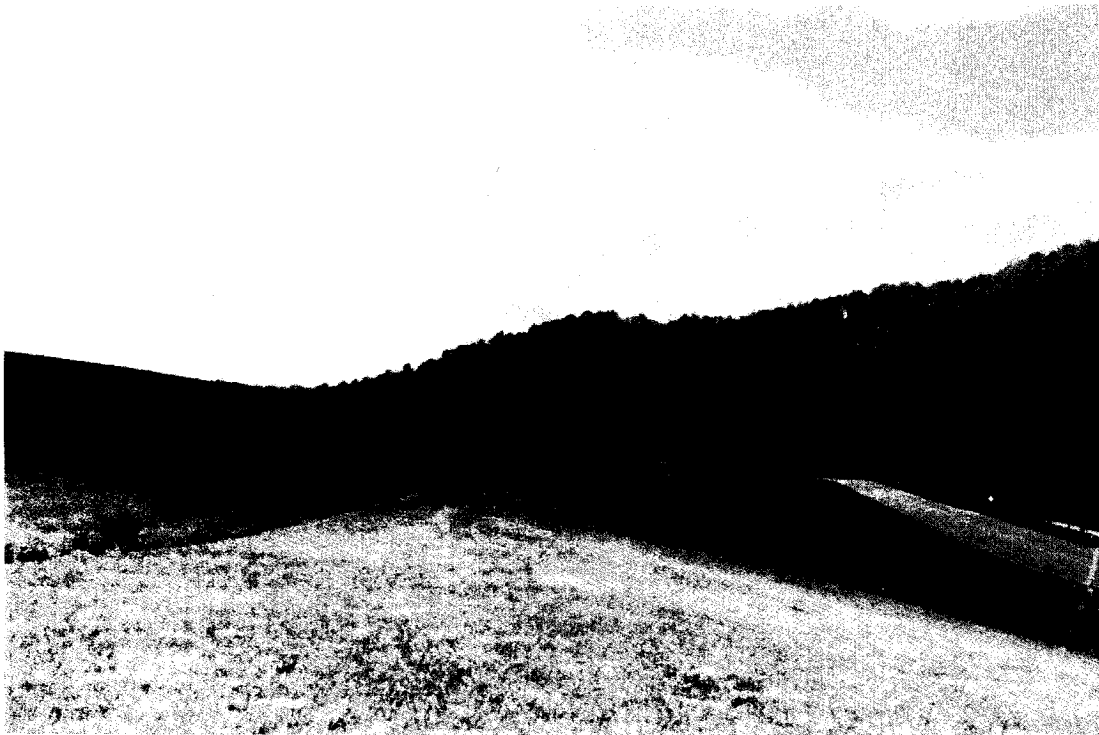
All exterior dike slopes around this area were in sound condition with excellent vegetative cover. On the eastern side of the dikes extending to the area of Swan Pond Road, the vegetation along both the upper and lower portions of the slope had been mown; but the central portion had some small trees present and needed mowing. No sloughs or seepages were detected. The divider dike between the active pond and the stilling pool had some areas of rill erosion and gullies. Some clay material had been added on the dike, but there are some areas where no vegetation is present, and erosion continues to persist. The dike roads were in good condition with a good ash or crushed stone surface.

Photo 2—Looking southwest: Slopes and drainage ditch along Swan Pond Road

- Plant maintenance should continue to periodically mow grass and remove small trees and brush from all dike slopes, including the middle portion not mowed last time..
