KINGSTON FOSSIL PLANT (KIF) - ANNUAL ASH POND DIKE STABILITY INSPECTION

TENNESSEE VALLEY AUTHORITY
KINGSTON FOSSIL PLANT

ANNUAL ASH POND DIKE
STABILITY INSPECTION

**KINGSTON FOSSIL PLANT
ANNUAL ASH POND DIKE STABILITY INSPECTION—2002**

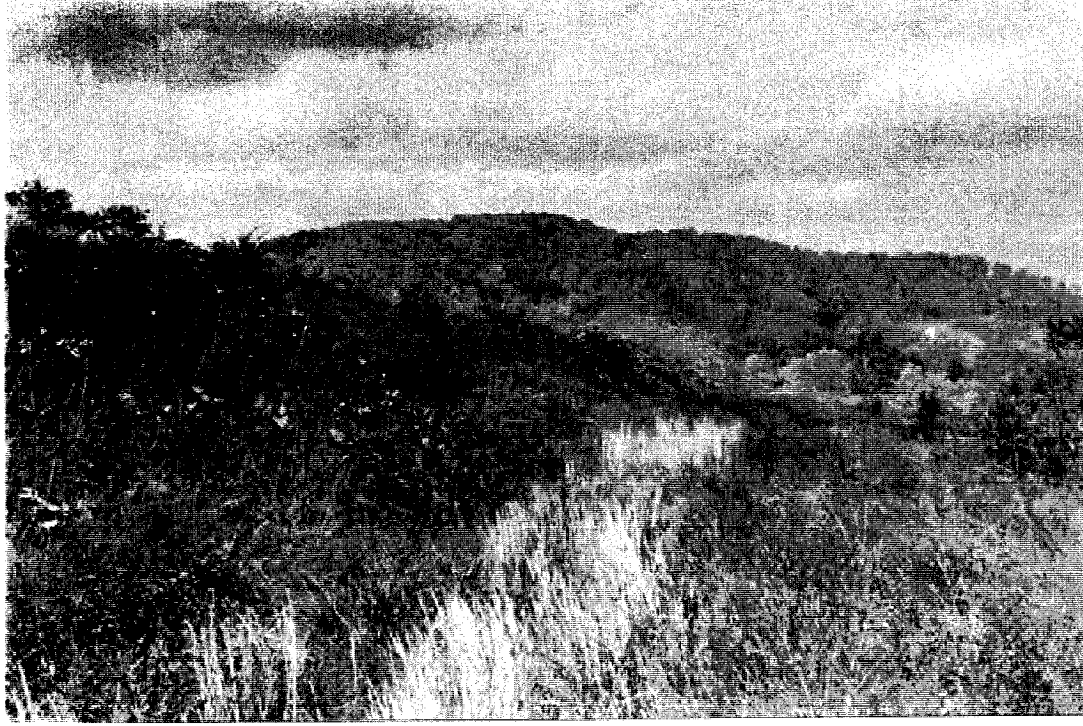
Photo 1 - Dike C and Lower Dike Road

All dike roads were in good condition with a good ash or crushed stone surface except for the lower dike road along the east side of the pond (Dike C). The lower road has grown up with vegetation (see photo 1). There were two areas of the lower dike road that were rutted and held water making vehicle passage difficult.

- Remove trees and other growth along the eastern slopes of Dike C. At this point the trees are small enough to be mowed. Any trees larger than 3" in diameter at the base must be pulled from the dikes, roots and all and the damage repaired.

- Repair the ruts in the lower dike along the stilling pool and Dike C by filling with soil, compacting it, grading the road to turn water to the outside, and covering the repairs with ¾" crushed stone. It is estimated the length of both repairs is 30 feet, requiring about 3 yards of soil to fill the ruts and 12 tons of stone for cover.

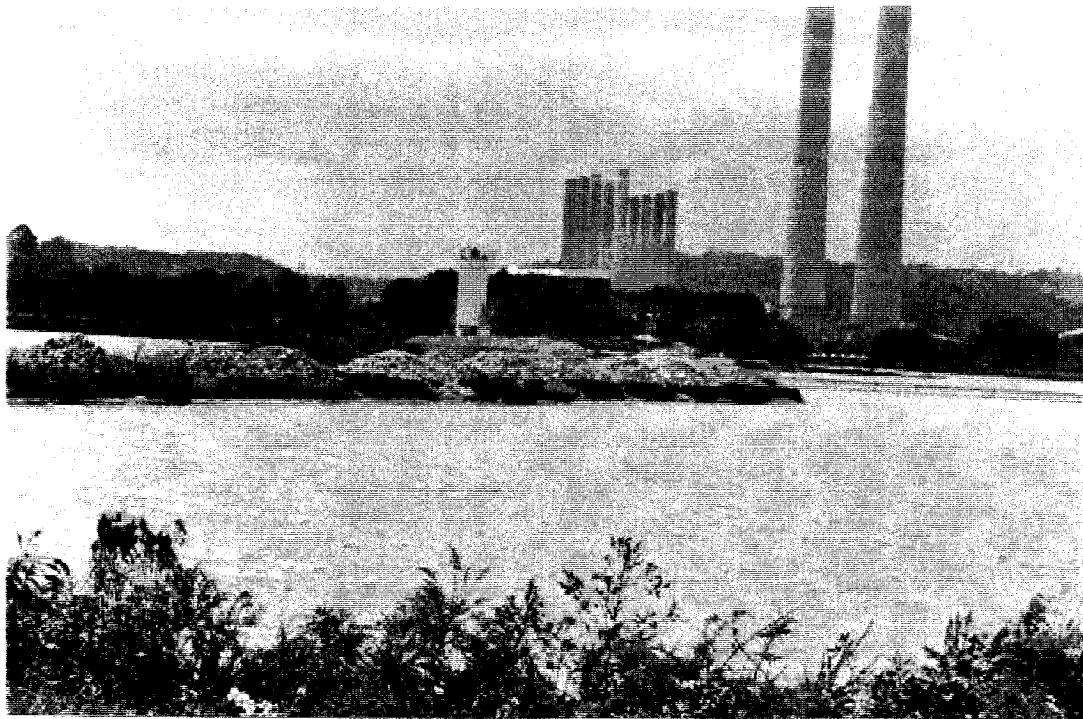
Photo 2 - Riprap on Stilling Pool Divider Dike

All exterior dike slopes around this area were in sound condition with excellent vegetative cover. No animal activity was observed in the active pond, however, there was a beaver den in the bottom ash sluice trench. On the eastern side of the dikes, extending to the area of Swan Pond Road, the vegetation along both the upper and lower portions of the slope had not been mowed since the spring. The dikes were in need of mowing as several small trees had grown to a height of 3 to 5 feet (see photo 1). No sloughs or seepage were detected. In fact, two areas outside the stilling pool that were active seeps in years past no longer seeped. Those areas are detectable only from the sparse vegetation probably due to the low pH in the soil caused by the seeps. The divider dike between the active pond and the stilling pool had some areas of rill erosion and gullies, but appeared stable otherwise. Some clay material had been added on the dike, but there are some areas where no vegetation is present, and erosion continues to persist. The riprap placed on the inside slopes of the stilling pool is effective in preventing erosion of the slopes. However, there are additional areas that would benefit from riprap on the slopes. The plant has bought rip-rap and placed it on the divider dike in preparation for placement on the pond side of the divider dike (see

photo 2). The divider dike road will then be sloped to turn storm water into the ash pond and down the rip-rapped slope.

- Dredge cell dike slopes with sparse vegetation should continue to be seeded and mulched until a good vegetative cover is present.
- Place additional riprap along slopes of stilling pool and divider dike. Estimated to be approximately 2,000cy of riprap with minimum thickness of 6" and 50% of the stone with a nominal diameter of 4" or greater. Slope the top of the divider dike to direct runoff into the ash pond; 1% is enough and repair eroded areas and grade the stilling pool side of the divider dike to a uniform slope of 2H:1V.

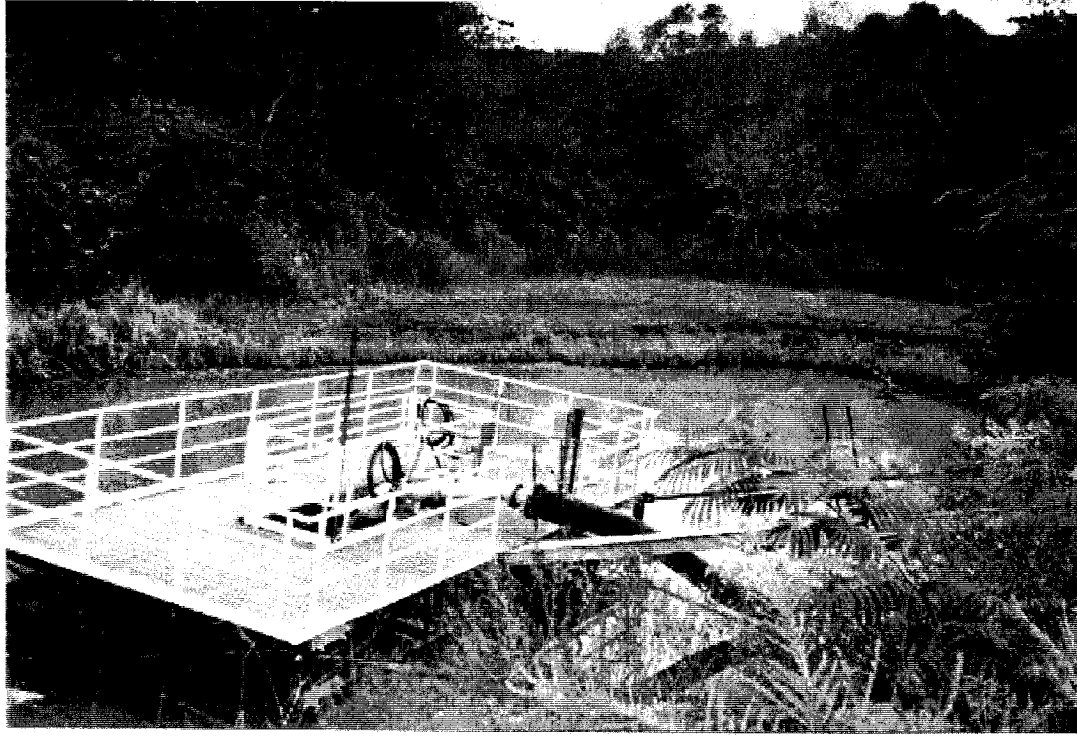
Photo 3 - Coal Yard Drainage Basin

The coal yard drainage basin is located at the southwest corner of the coal pile. This basin was excavated below grade; therefore, there are no exterior dikes. All discharge from this basin is pumped into the fly ash discharge ditch which flows to the active ash disposal area. At the time of inspection, water in the pond was at a low level. The slopes appeared to be in satisfactory condition. (see Photo 3)

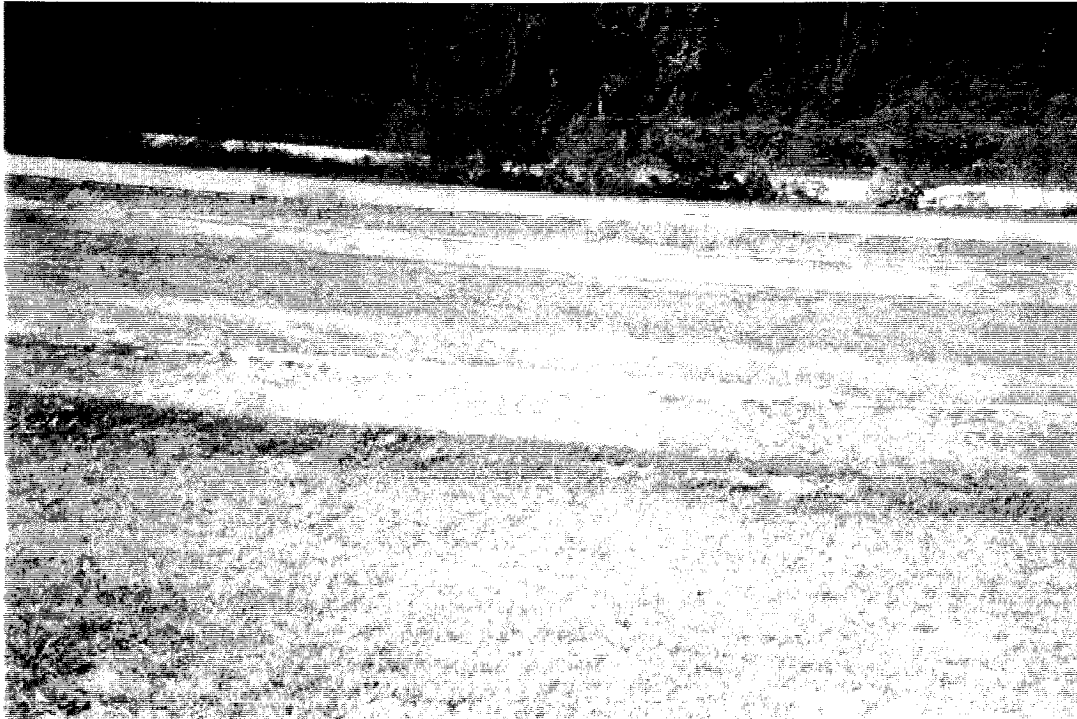
Photo 4 - Reseeding on Dredge Cell Dikes

The dike slopes around this area were all stable with some rill erosion in places. Most of the Stage C2 lift has a vegetative cover; however, there are some areas where minor erosion is occurring and reseeding will need to be done as in Photo 4. Photo 6 shows the typical condition of the lower lifts of the dredge cell dikes. Lift C2 is complete except for a short section adjacent to the main pond. This section needs to be covered with soil. At completion of Lift C2, plant operations will seed and mulch Lift C2 to establish vegetation. Dike slopes with sparse vegetation should continue to be reseeded and mulched until a good vegetative cover is apparent. Plant operations continue to do a commendable job of mowing the slopes.

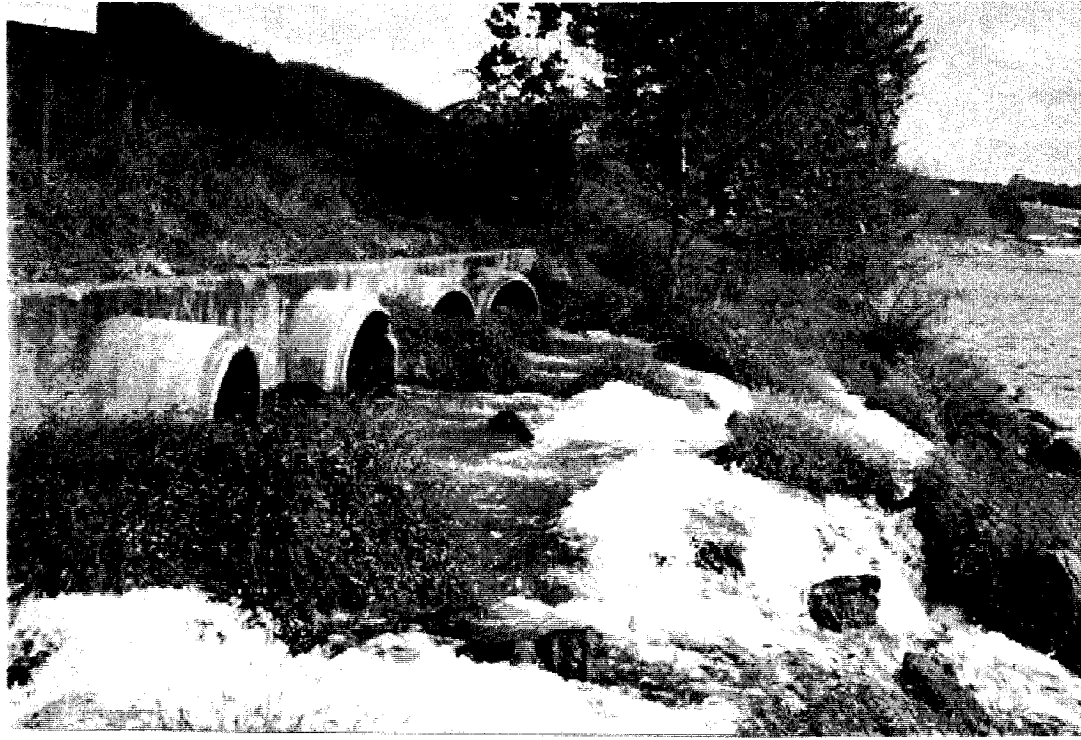
Photo 5 - Ash Pond Spillway Discharge

The ash pond discharge spillways are in good condition with no noticeable erosion (see photo 5).

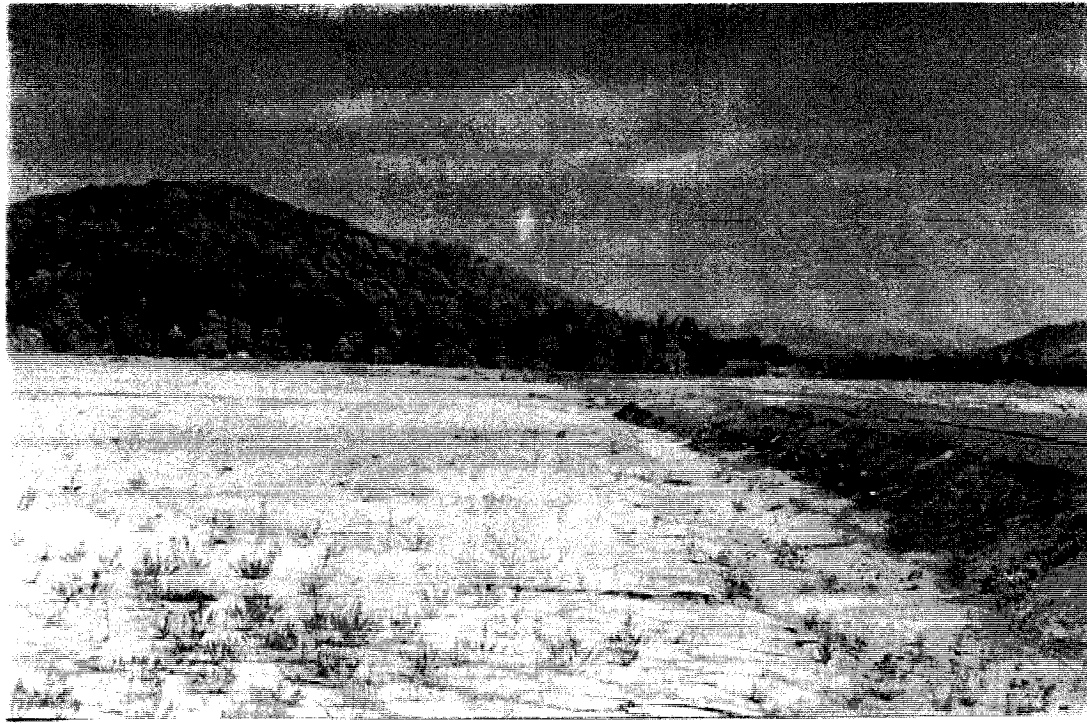
Photo 7 - Current Condition Of Cell 2/3

Dredge cells No. 2 and 3 were combined last year. The top of dike elevation for Cell 2/3 is now elevation 805. The dike for Cell No. 1 is also at elevation 805. Cell 1 was being dredged into at the time of inspection. Cell 2/3 was dry, but a combination of sparse vegetation and a crust on the ash was preventing dusting.

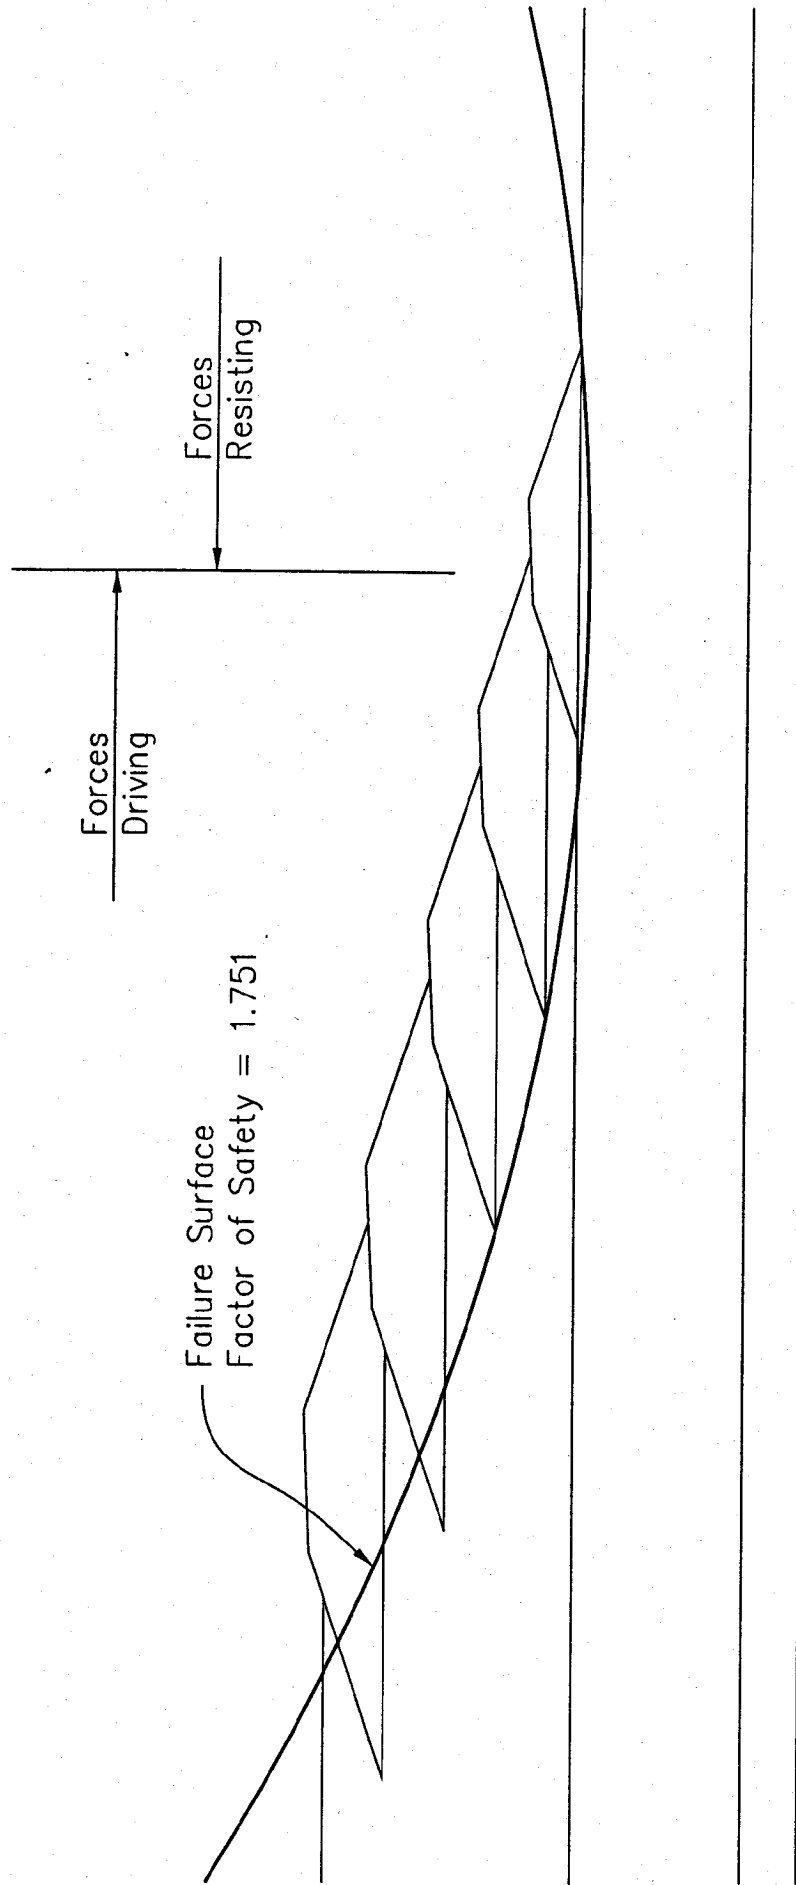
Figure 1 – Original Materials

The factor of safety for long term stability using these parameters is 1.75. The earthquake factor of safety is 1.17. These were presented to the state in the permit. Figure 1 shows the failure plan for this condition as analyzed using UTexas3.

Studying the difference between Figures 1 and 2 shows how the factor of safety went up slightly after substituting the apparently weaker material in the dikes. The weakest failure plane remains thru the base of the stack. The reduction in the cohesion values (mixed ash to fly ash) does not play a significant role in the stack's long term Factor of Safety. The lighter weight of the material applied at the upper driving wedge of the failure circle has the most influence in the static force computations to increase factor of safety. Had pure fly ash been used at the lower levels of the dredge cell construction there could have been a dramatic reduction in the factor of safety.

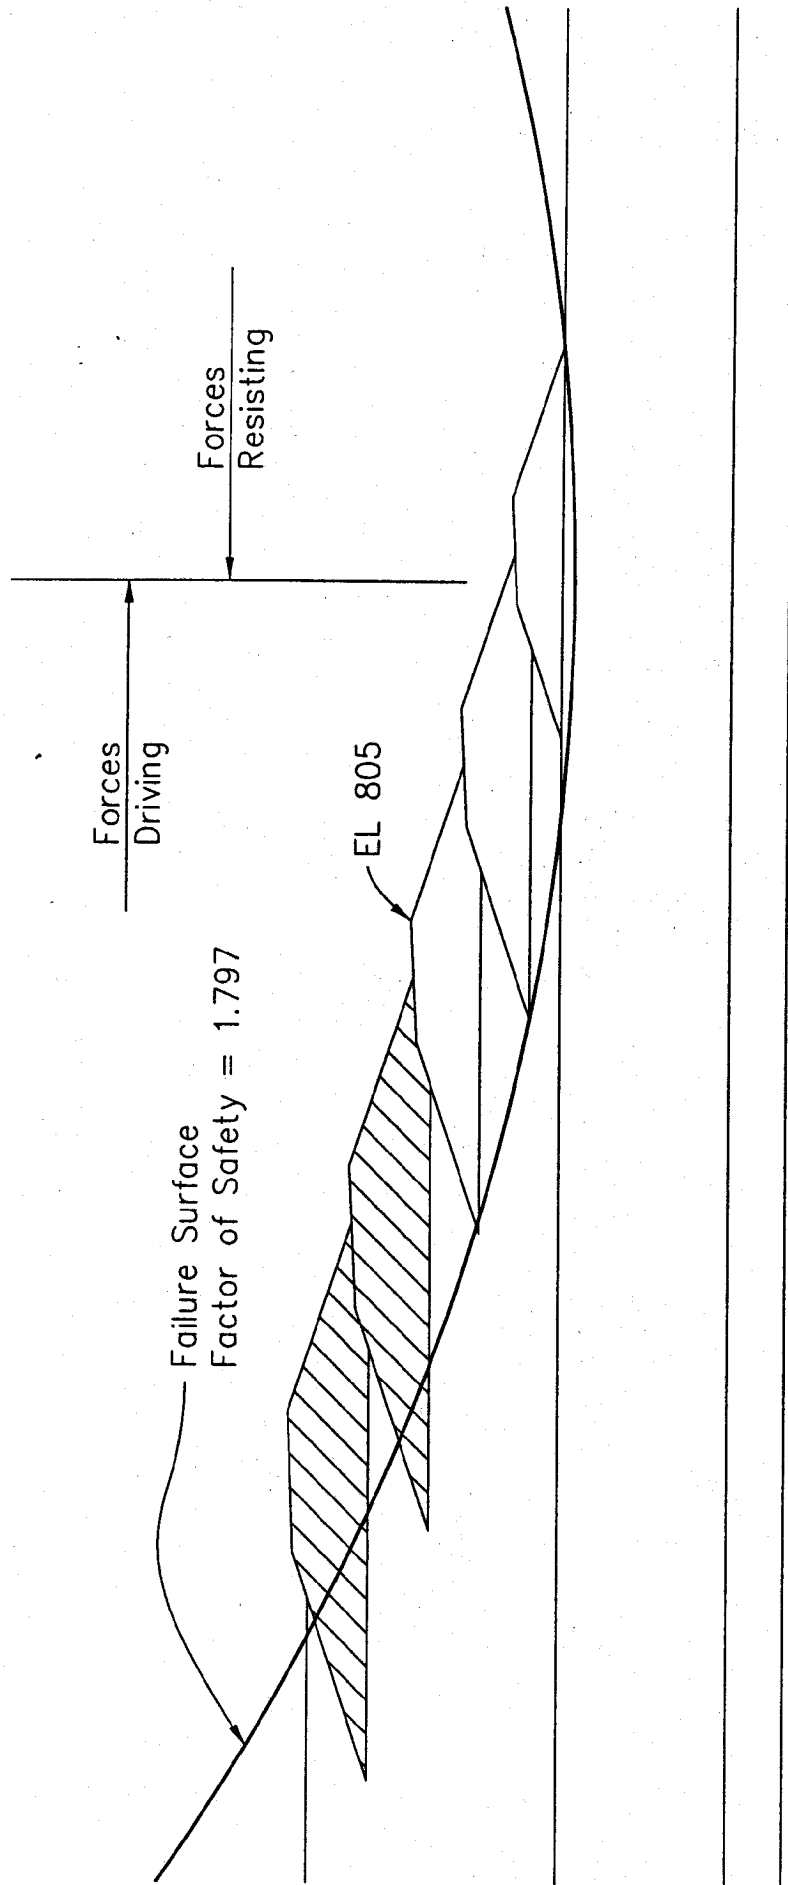
Figure 2 - Revised Materials

At face value the fly ash parameters are lighter in weight and weaker than the mixed ash. The analysis was performed by replacing these values for the previous values in the dike section above elevation 805.0, the current dike height. The factor of safety for

long term stability using these parameters is 1.80. The earthquake factor of safety remains the same at 1.17. Figure 2 shows the failure plan for this condition as analyzed using UTexas3.

Consequently, we concur that it is acceptable to construct the remaining lifts of the dredge cell using fly ash compacted to at least 95% Standard Proctor density.

An increase in localized sloughing of the dikes is likely to occur. We expect this to be tolerable and to best be handled by daily inspections and rapid attention to small rills before they expand.
