KINGSTON FOSSIL PLANT (KIF) - ANNUAL ASH POND DIKE STABILITY INSPECTION

ANNUAL ASH POND DIKE
STABILITY INSPECTION

Prepared by: John Albright
Date: October 25, 2002

**KINGSTON FOSSIL PLANT
ANNUAL ASH POND DIKE STABILITY INSPECTION—2002**

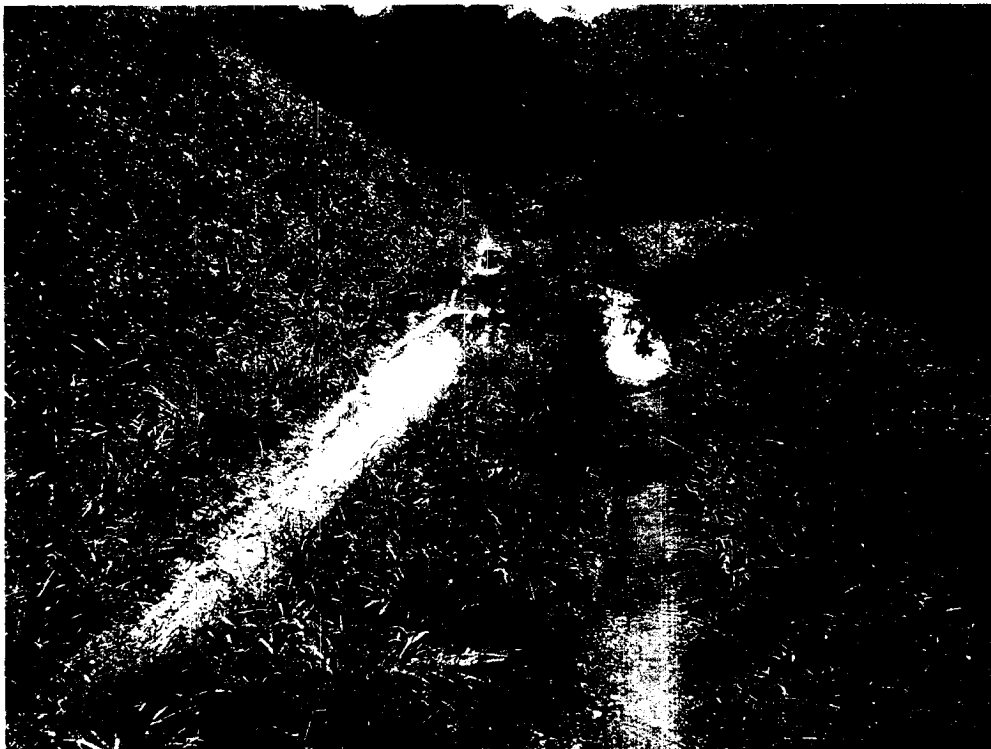
All dike roads were in good condition with a good ash or crushed stone surface except for the lower dike road along the east side of the pond (Dike C). The lower road has grown up with vegetation (see Photo 1). Two areas of the lower dike road were rutted and held water making vehicle passage difficult (see Photo 3).

Photo 3 – Wheel Ruts in Dike Road

- Repair the ruts in the lower dike along the stilling pool and Dike C by filling with soil, compacting it, grading the road to turn water to the outside and covering the repairs with ¾" crushed stone. It is estimated the length of both repairs is 30 feet, requiring about 3 yards of soil to fill the ruts and 12 tons of stone for cover.

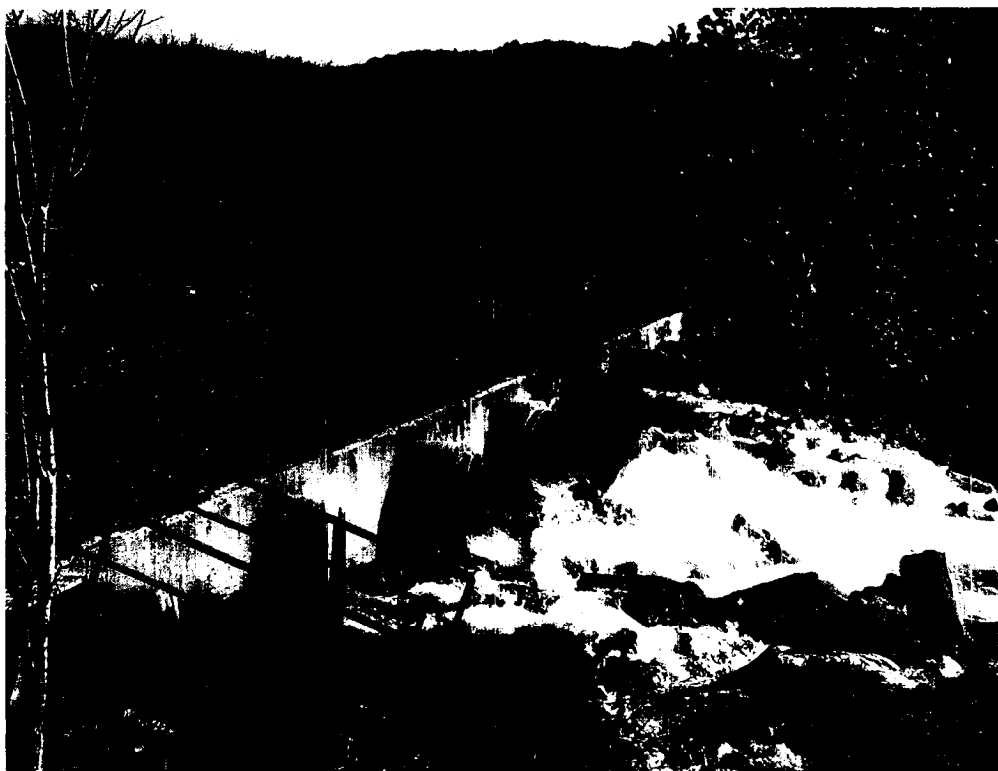
The ash pond discharge spillways are in good condition with no noticeable erosion (see Photos 4 and 5). A recent flow experiment plugged all of the ash pond discharge spillways at their outlets overnight. When the plugs were released, some of the rip-rap at the discharge was washed away and later replaced.

Photo 4 - Ash Pond Spillway Discharge

- Future flow control of the ash pond discharge should only be done by raising the standpipes. The outlets must not be plugged. Plugging the outlets puts the joints in the concrete pipe under pressure they were not intended to withstand. This pressure could cause the joints to leak and wash out a portion of the dike causing the dike to fail.
- Dredge the Coal Yard Drainage Basin to restore its design contours and protect the pumps from further damage. There is an estimated 2,200 cubic yards of sediment in the original pond and an extra 2,750 cubic yards in the "V" section that needs to be removed as soon as reasonable. See the attached copy of 10W225-1.

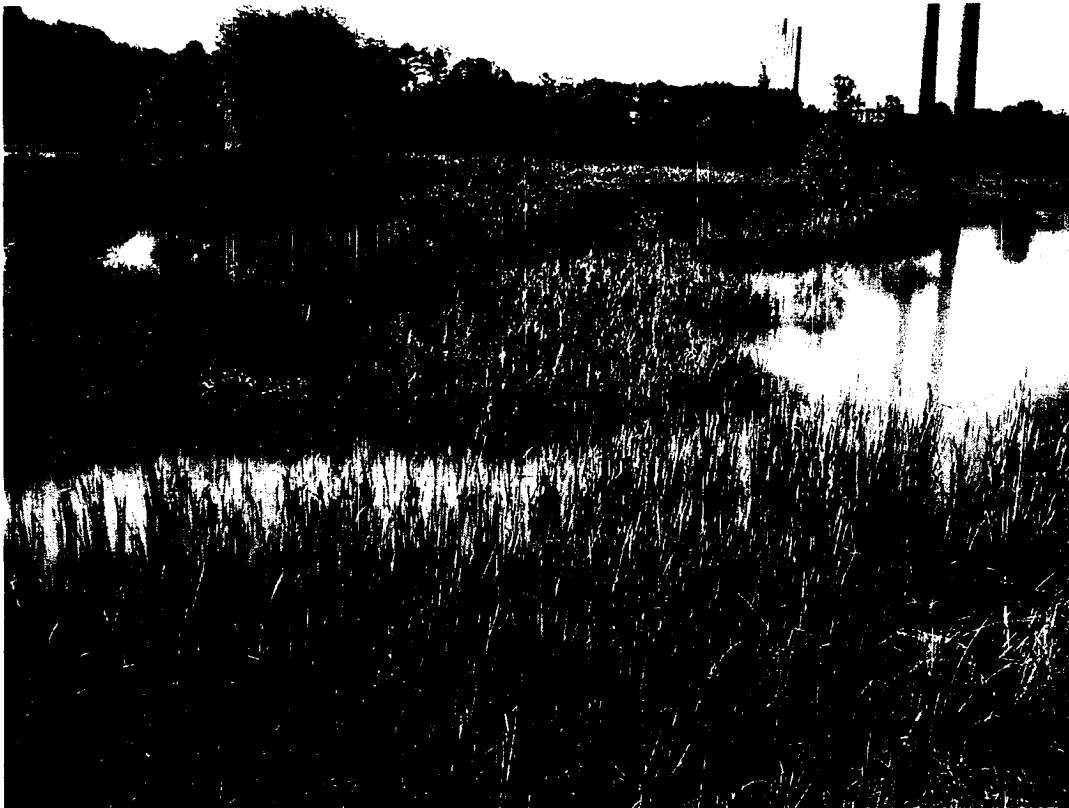
The engineered wetland along the southeast dike receives seepage that collects in the anoxic limestone drain at the toe of the slope. The wetland appeared to be functioning, at least partially, though the discharged is still pumped to the ash pond. See Photo 6.

Photo 6 - Engineered Wetlands

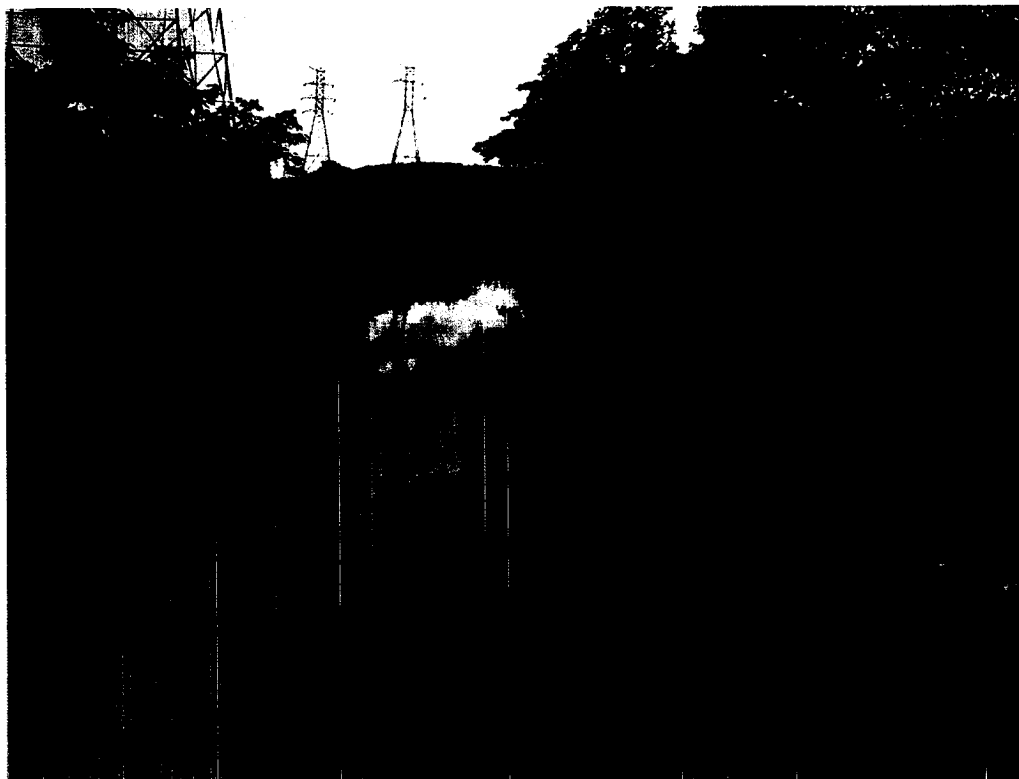
The coal yard drainage basin is located at the southwest corner of the coal pile. This basin was excavated below grade; therefore, there are no exterior dikes. The interior slopes appeared to be in satisfactory condition (see Photo 8). Normal discharge from this basin is pumped into the fly ash discharge ditch and flows to the active ash disposal area. At the time of inspection, water in the pond was at a low level, about 6"

below the first pump start switch and the platform was grounded. The basin was sounded at 5 places and found to have a depth of 2.7 feet average when the water was at elevation 751. This indicates the sediment in the bottom occupies 3.3 feet of the basin's storage capacity. Since it was dredged just over a year ago, we forecast the basin will need to be dredged annually. The bottom of the pond should be no higher than elevation 745. Elevation 745 allows 2 feet of clearance below the pump intakes to prevent the pumps from pumping solids; the elevations indicate the pumps have been pumping solids for some time. In addition, the "V-shaped" pond extensions added during the summer of 2001 to increase the pond storage volume were visually undetectable. TVA drawing 10W225-1 shows the pond and its intended bottom contours.

Photo 8 – Coal Yard Drainage Basin

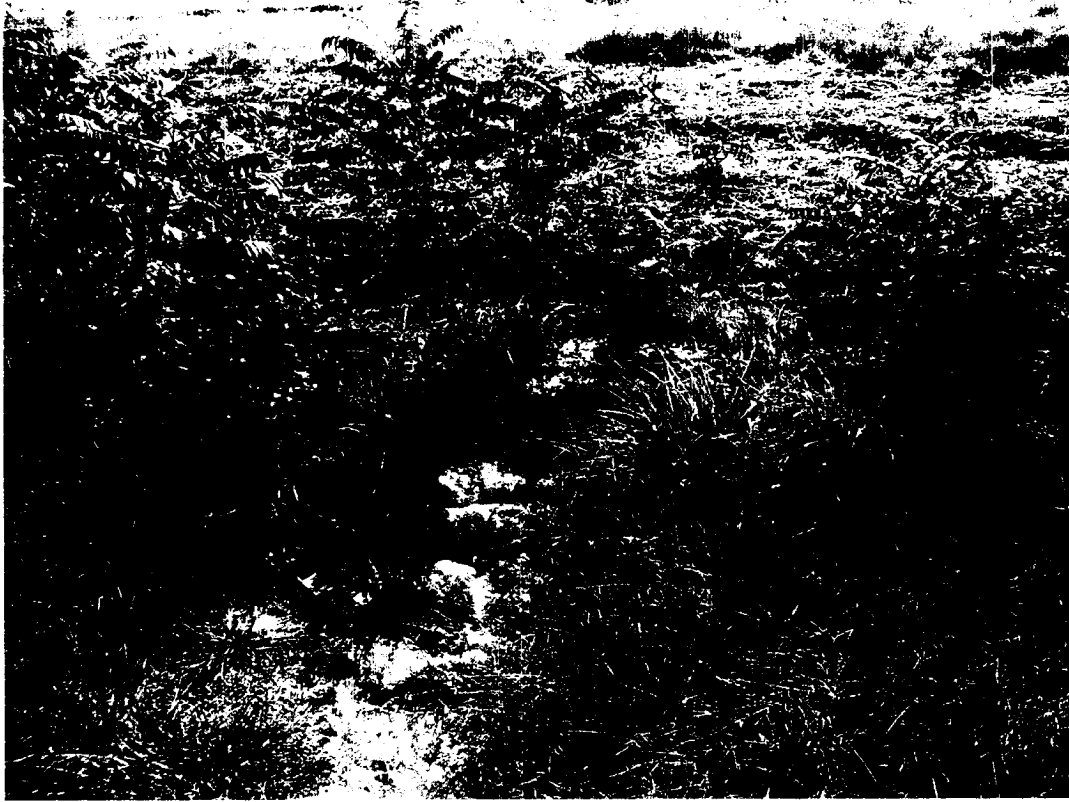
Photo 9 – Cell 2/3 French Drain

- Fill should be added and riprap placed to prevent further erosion at a few outlet drains on the northern slope of the dredge cell 2/3 dike, one in particular. See Photo 9. Estimated quantity is 7 cubic yards of rip-rap.
