KINGSTON FOSSIL PLANT (KIF) - ANNUAL ASH POND DIKE STABILITY INSPECTION

KINGSTON FOSSIL PLANT

ANNUAL ASH POND DIKE
STABILITY INSPECTION

KINGSTON FOSSIL PLANT
ANNUAL ASH POND DIKE STABILITY INSPECTION --2004

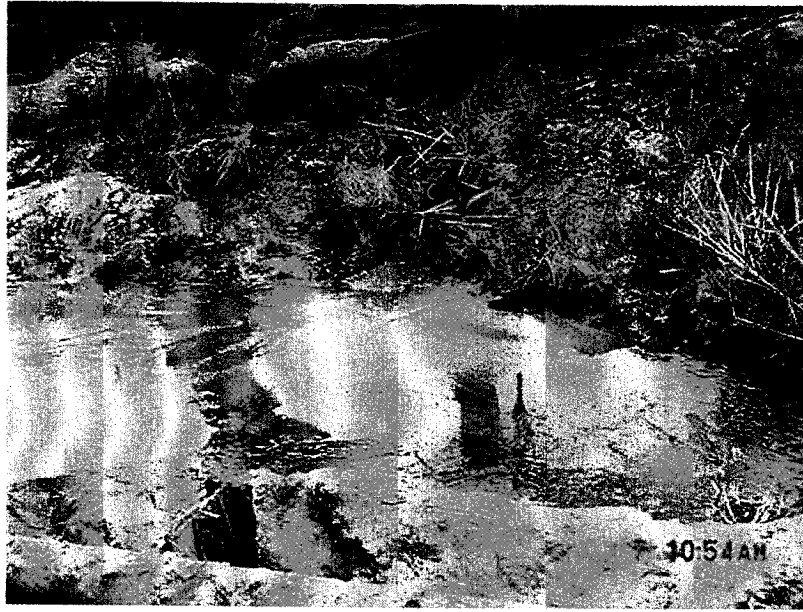
In November 2003 dredging operations ceased because of a leak in the toe of the dike slope for dredge cells 2/3 (Photos 1 and 2). Presently ash is removed from the pond with track hoes (Photo 5), placed on the edges of the road adjacent to the pond and allowed to dewater before being loaded onto trucks and hauled to the top of the dredge cells where it is unloaded and used to help construct the next lift for dredge cell 1.

The top of the dikes elevation is 811 feet. A leak occurred at the toe of the slope on the east side slope of dredge cells 2/3 on November 6, 2003 (Photos 1 and 2). Dredging operations were ceased immediately. Yard Operations personnel began draining dredge cells 2/3. Cell 1 had already been drained. On November 7, 2003 plant personnel with instruction from EDS Civil Engineering (see attached e-mail) began efforts to try to stabilize the leak area. Over 100 tons of riprap was placed on the toe of the slope to help stabilize it (Photo 3). The next day ash and water was observed seeping from the dike approximately 10 feet further up the slope. A filter fabric was placed over the seepage area and twenty feet beyond each side of it. Approximately twelve inches of crush stone was then put on top of the fabric (Photo 4). EDS Civil Engineering and its design partner MACTEC are trying to determine the cause of the leak, the best method of repairing the dike, an alternate location for a new dredge cell if needed and if/when dredging operations can resume.

Photo 1. Leak in the toe of the slope of dredge cells 2/3

I talked to Jeff again this morning. Nothing appears to have changed overnight; that's a good sign. The recommended repair, initially, is to place significant quantities of rip-rap in the ditch to begin the stabilization. Then, add crusher run stone as a "filter blanket", a layer of filter fabric, another layer of crusher run and finally cover the area with more rip-rap.

The crusher run is both a filter for the ash and protection for the fabric. All of the rock weights the toe so it will not slide out into the road. The crusher run layers need to be 4 - 6" thick and the rip-rap should be 3 feet thick on top and as much as needed on the bottom to get up to the original ditch bottom or a little higher. The top layer of rip-rap should be extended back to the dike slope and the top kept level. The top layer of rip-rap will likely be above the road elevation. The repair should extend 50 feet in both directions from the "blowout" to ensure another one does not happen.

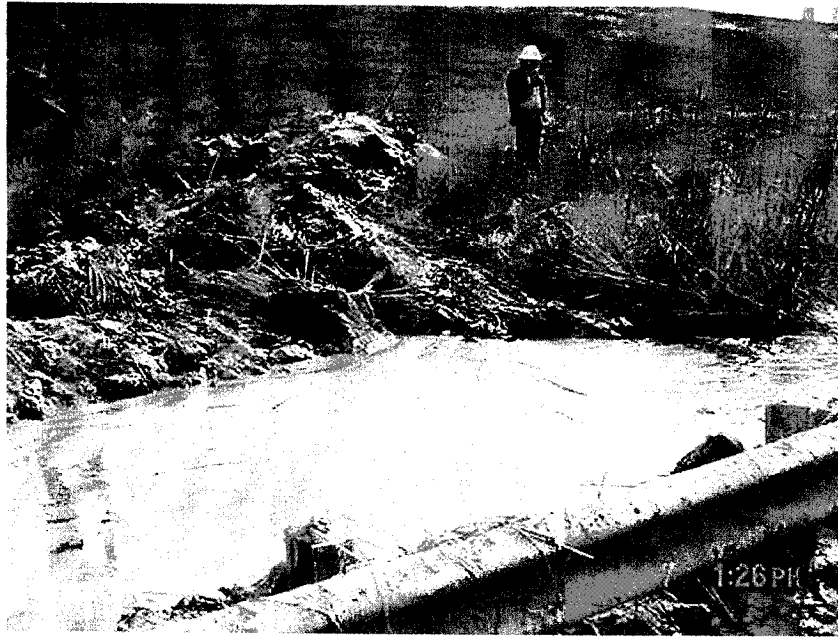
Photo 2. Leak in toe of the slope of dredge cell 2/3

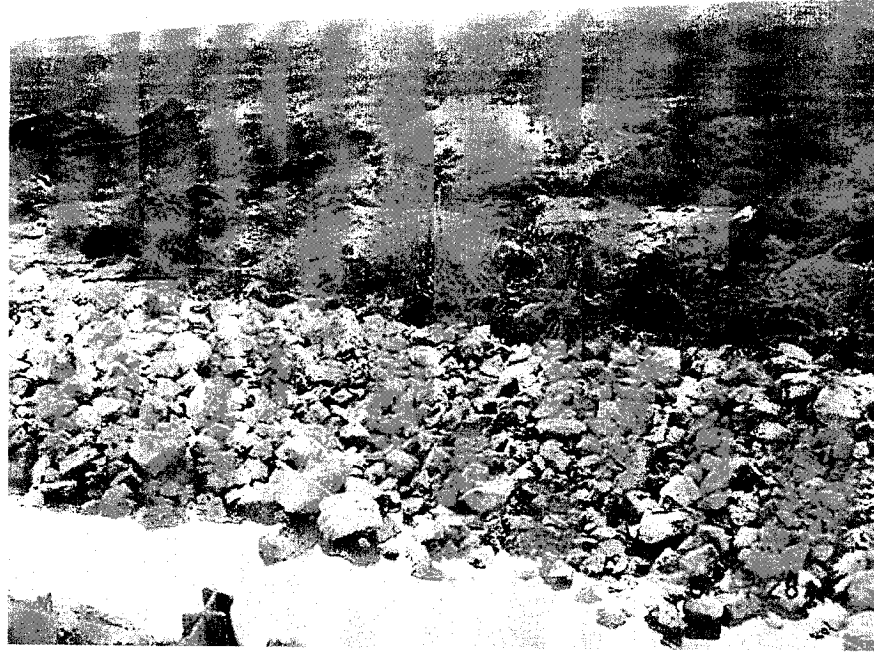
Photo 3. Ripraps put on toe of the slope to stabilize it.

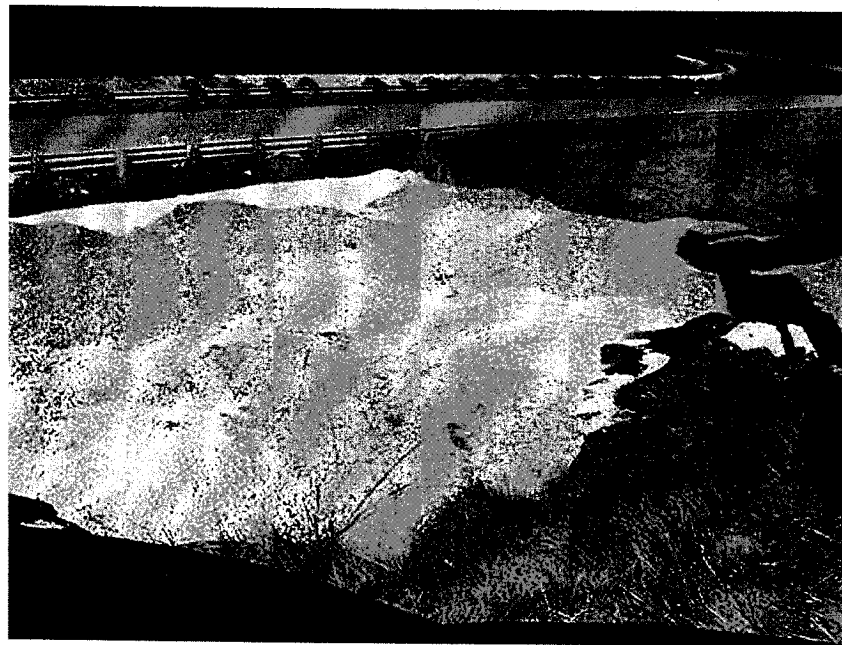
Photo 4. Current dike leak temporary repair.

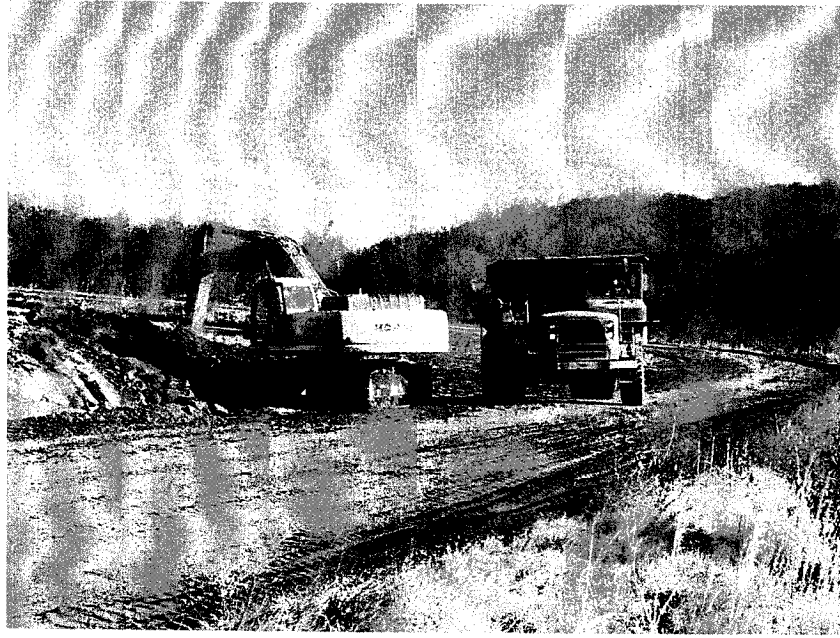
Photo 5 Ash is transported via truck to the top of Dredge Cell 1

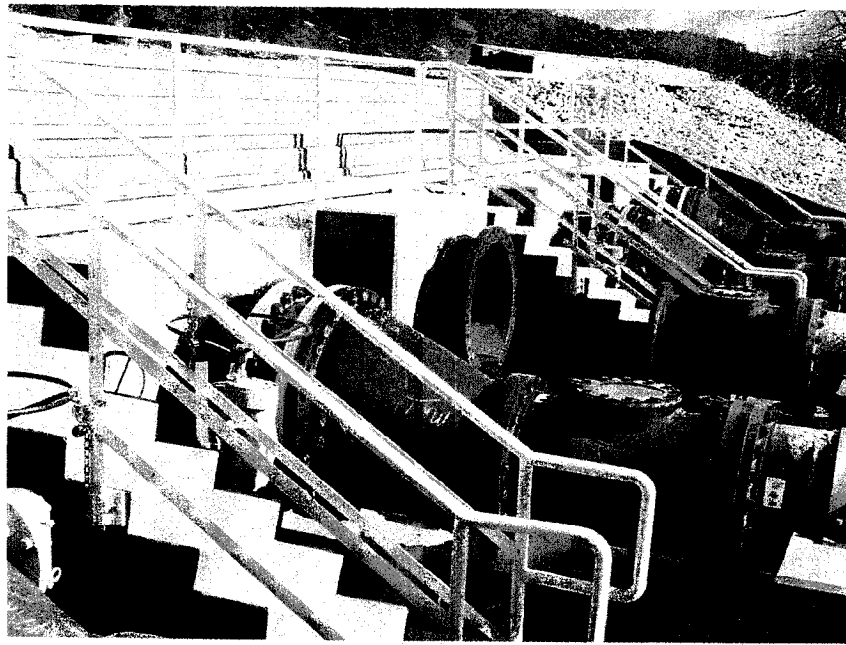
The sluice water flows into the stilling pool through two plant constructed spillways. From the stilling pool, the water discharges into the plant intake channel via six standard spillways. Construction on new discharge diffusers was completed November 2003. At the time of the inspection, five of the six discharge diffusers were operating (Photos 6 and 7).

Picture 6. Ash Pond Discharge Diffusers

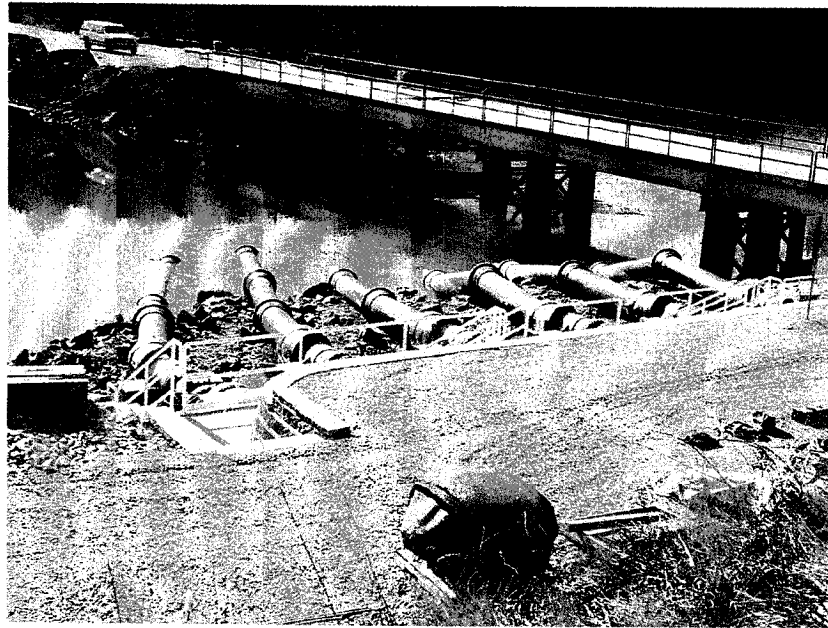
Photo 7. Ash Pond Discharge Diffusers

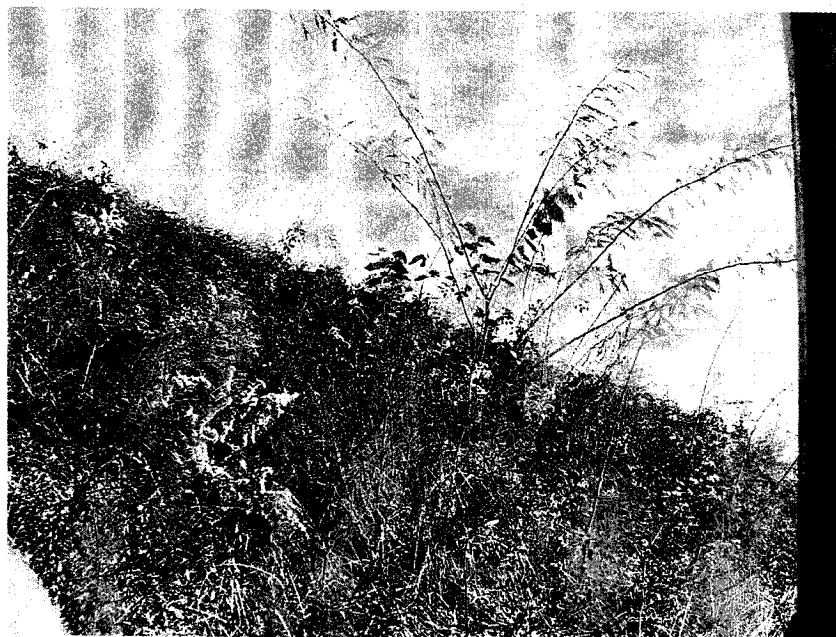
All exterior dike slopes (except dredge cells 2/3) around this area appeared to be in sound condition with excellent vegetative cover. The dikes were in need of mowing. Small trees grown to a height of 3 to 5 feet (Photo 8) in some places. These trees should be pulled up and the area reseeded. Presently the dikes are mowed only once a year.

Photo 8. Heavy vegetation and small trees growing on the slope.

- Dredge cell drainage ditches should be kept free of cattails. The existing cattails should be cut.
- Remove trees from the slope of the stilling pool dike. At this point, the trees are small enough to be mowed. Mowing at least twice a year is recommended to control the size of the trees. Preventing the trees from getting larger than 1" in diameter at the ground is preferred. Any trees larger than 3" in diameter at the base must be pulled from the dikes, roots and all. Repair and reseed the area the tree was removed from.

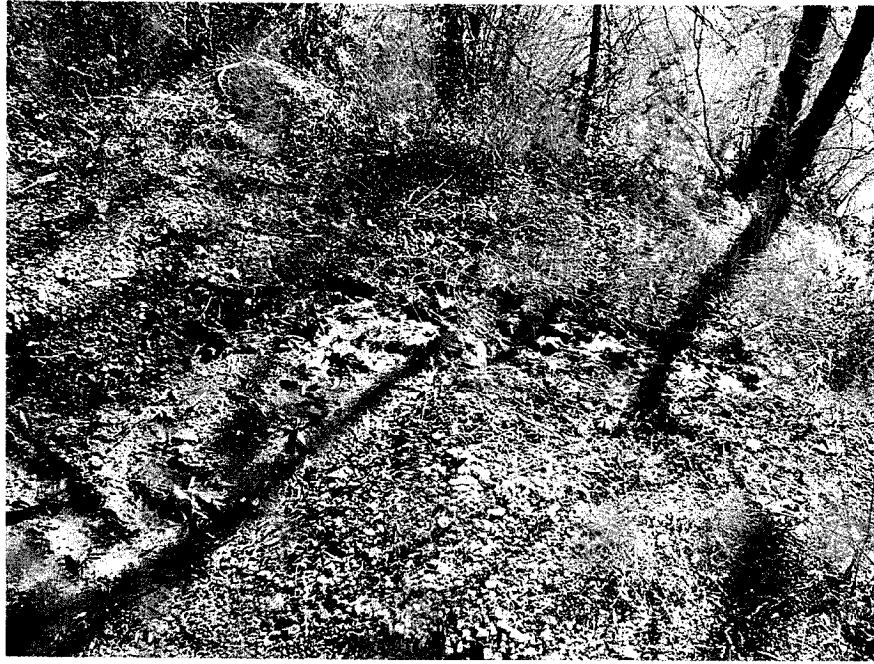
All dike roads were in good condition with a good ash or crushed stone surface except the lower dike road along the East side of the pond (Dike C) and the South Stilling Pond lower dike. Several areas of the roads were rutted and held water (over 12 inches deep in some places) making vehicle passage impossible (Photos 10 and 11). These areas should be repaired as soon as possible. The dike slope near one of the road ruts showed signs of erosion (Photo 9). This area should be repaired as soon as possible.

Photo 9. Dike slope erosion.

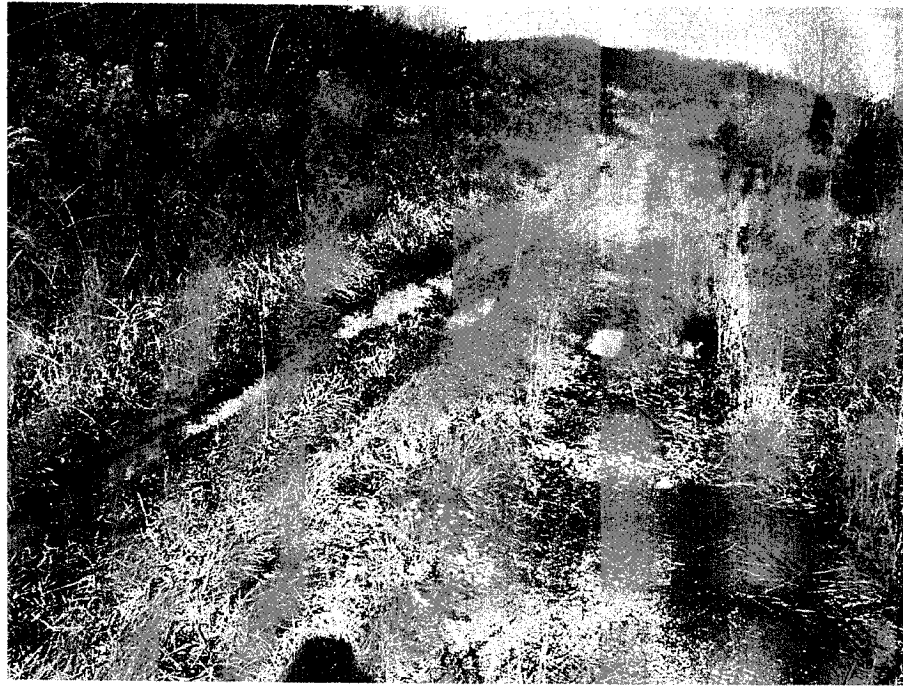
Photo 10. Road ruts. Note slopes needs mowing.

- Repair the ruts in the road along the stilling pool and Dike C by filling with soil, compacting it, grading the road to turn water to the outside and covering the repairs with ¾" crushed stone. It is estimated the repairs will require approximately 20 yards of soil to fill the ruts and 70 tons of stone for cover.

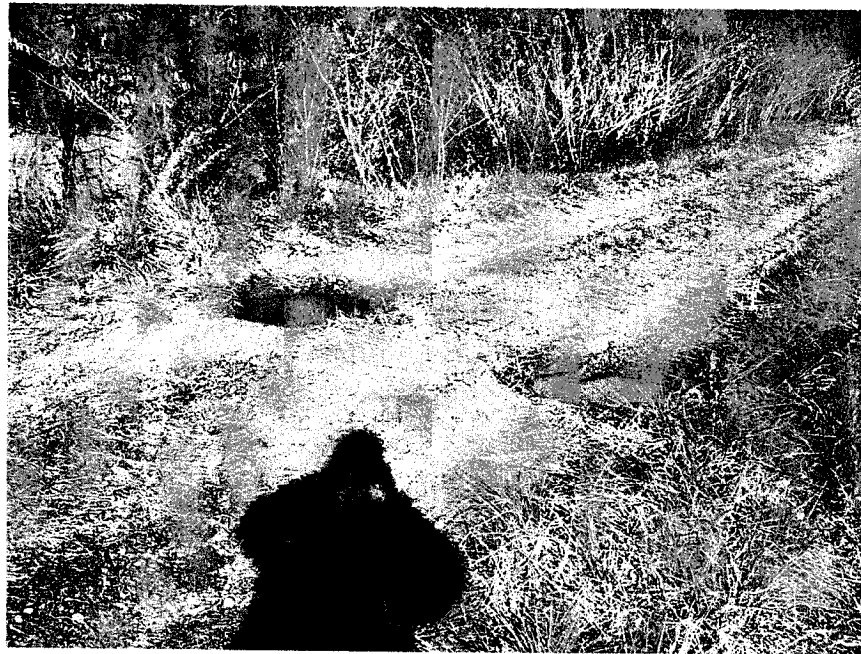
Photo 11. Road ruts

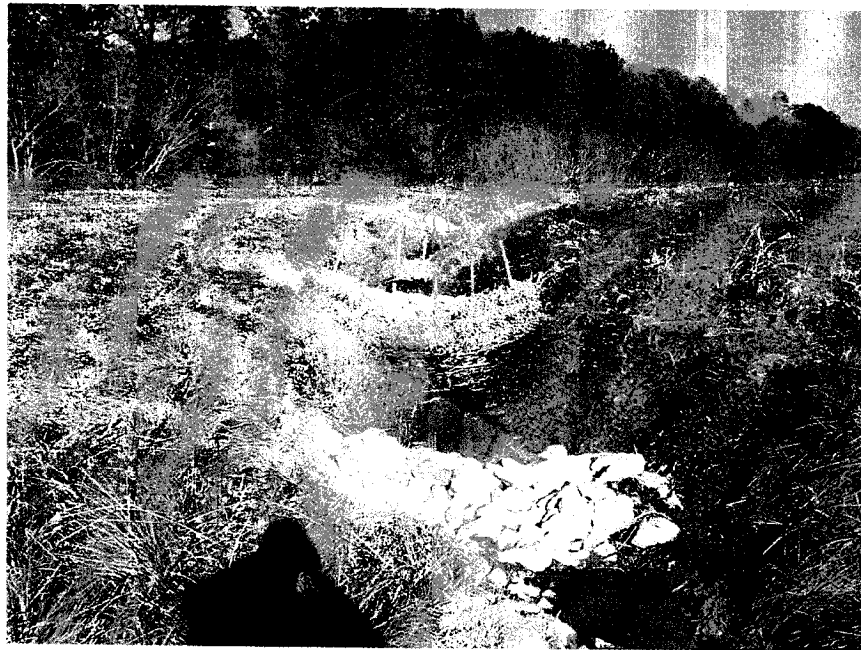
A berm was constructed in the drainage ditch at the toe of the dike slope for dredge cells 2/3 to prevent ash leaking from the dredge cell from getting into the river. Water is pumped from the ditch into the Ash Pond. Several check dams were constructed in the drainage ditch beyond the berm to catch sediment. Sediment fences and bales of hay were also placed in the drainage ditch (Photo 12). Water observed in the drainage ditch adjacent to the bales of hay on the day of the dike inspection appeared to be clear. None of the cells were being dredged into at the time of inspection. Dike slopes with sparse vegetation should continue to be reseeded and mulched until a good vegetative cover is apparent (Photo 13). Add top soil to the slope of the upper lift so a vegetative cover can be established to help control erosion.

Photo 12. Sediment check dams and hay bales paced in drainage ditch to prevent ash from getting into the river.

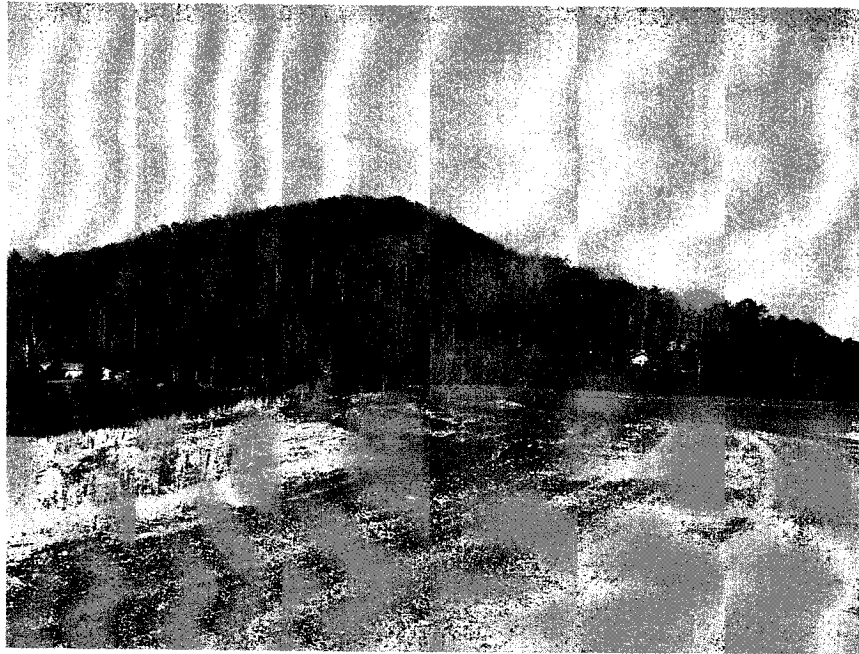
Photo 13. Dike slopes with sparse vegetation shall be reseeded.

- Areas on the dike slopes with sparse vegetation should continue to be reseeded and mulched until a good vegetative cover is present.
- Dredge cell slopes with exposed ash should receive a layer of top soil and be seeded as soon as possible.

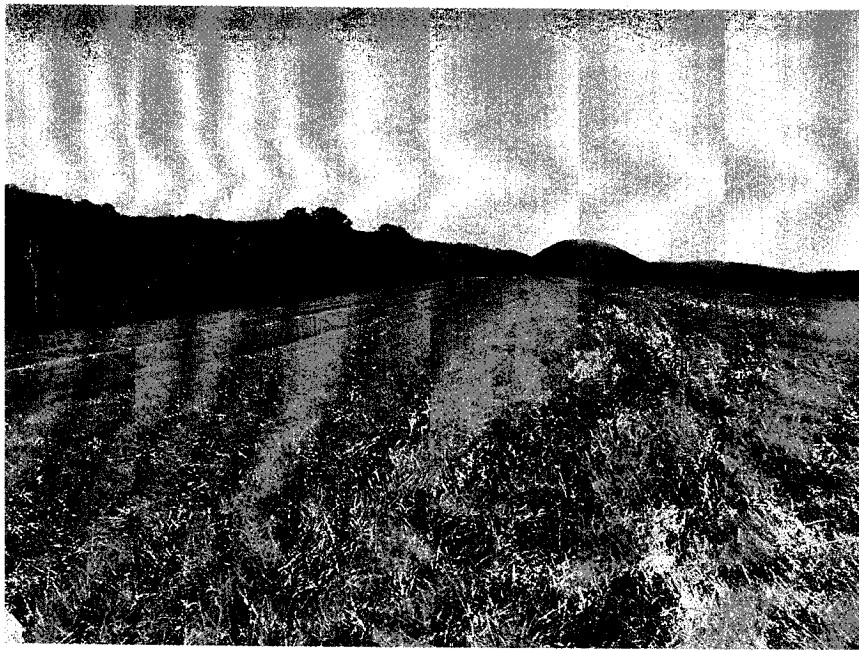
Plant operations continue to do a commendable job of mowing the dredge cell slopes (Photo 14). A few small trees are growing on the slopes. They should be pulled or kept mowed to prevent further growth.

Photo 14. Grassy dike slope.

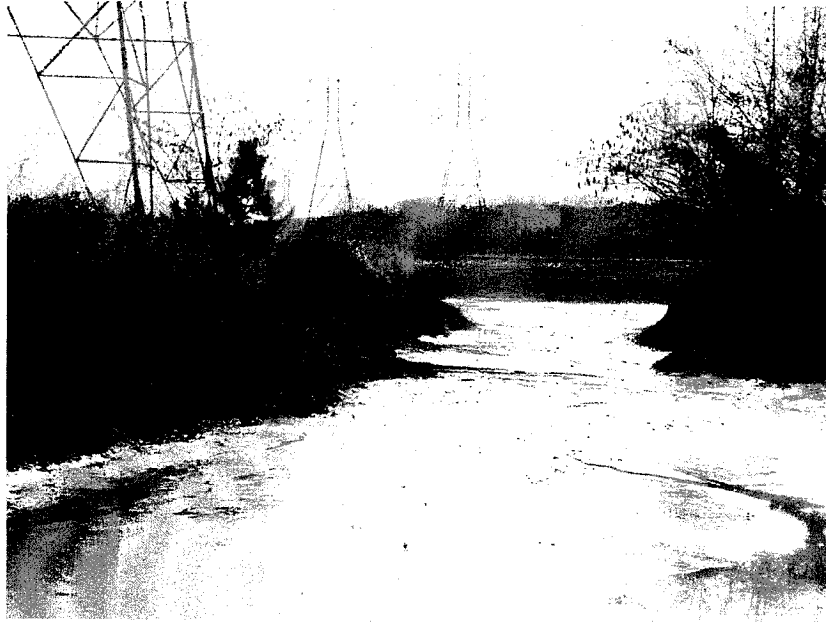
The coal yard drainage basin is located at the southwest corner of the coal pile. This basin was excavated below grade; therefore, there are no exterior dikes (Photo15). The interior slopes appeared to be in satisfactory condition. Normal discharge from this basin is pumped into the fly ash discharge ditch and flows to the active ash disposal area. At the time of inspection, water in the pond was at a low level, about 6" below the first pump start switch and the platform was grounded. The basin was sounded at 4 places and found to have a depth of 1.08 feet average when the water was at elevation 751. This indicates the sediment in the bottom occupies 4.92 feet of the basin's storage capacity. This represents a 1.67 feet increase in sediment depth since the last inspection. The basin was dredged just over two year ago, we recommend dredging the basin annually. The bottom of the pond should be no higher than elevation 745. Elevation 745 allows 2 feet of clearance below the pump intakes to prevent the pumps from pumping solids; the elevations indicate the pumps have been pumping solids for some time. In addition, the "V-shaped" pond extensions added during the summer of 2001 to increase the pond storage volume contained coal yard sediment (Photo16). TVA drawing 10W225-1 shows the pond and its intended bottom contours.

Photo 15. Coal Yard Drainage Basin

- Dredge the Coal Yard Drainage Basin to restore its design contours and protect the pumps from further damage. There is an estimated 2,800 cubic yards of sediment in the original pond and an extra 3,400 cubic yards in the "V" section that needs to be removed as soon as reasonable. See the attached copy of 10W225-1.

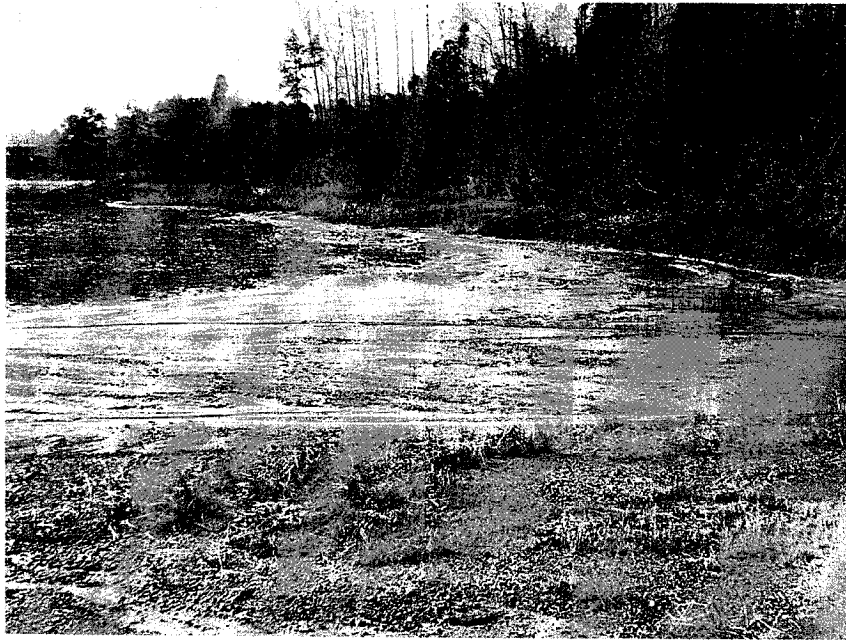
Photo 16. Coal Yard Drainage Basin Overflow

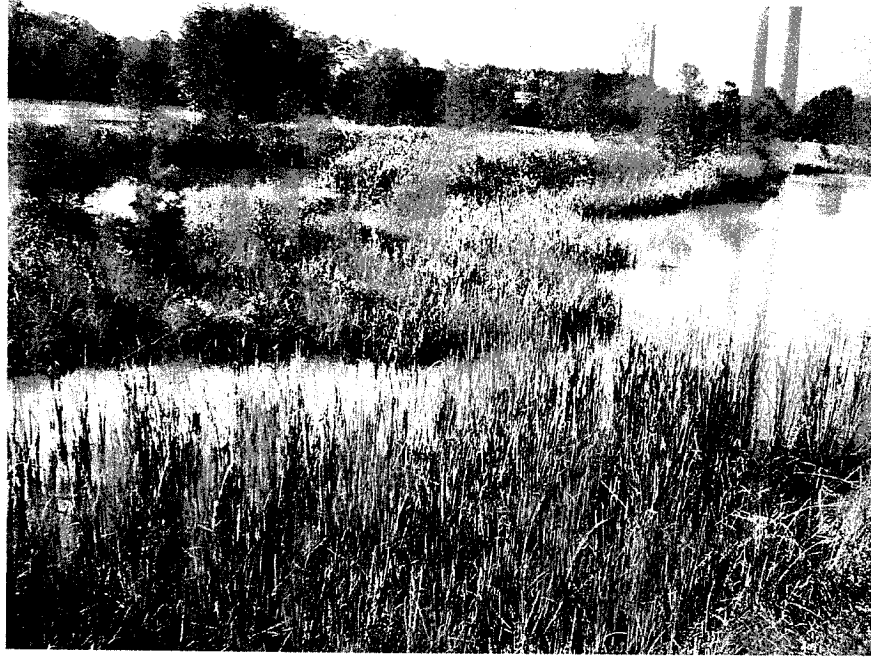
The engineered wetland along the southwest dike receives seepage that collects in the anoxic limestone drain below the bottom ash trench. The wetland appeared to be functioning, at least partially, though the discharged is still pumped to the ash pond (Photo 17).

Photo 17. Engineered Wetlands
