**KINGSTON FOSSIL PLANT (KIF) - ANNUAL STABILITY INSPECTION OF
WASTE DISPOSAL AREA DIKES**

TENNESSEE VALLEY AUTHORITY
KINGSTON FOSSIL PLANT
ANNUAL ASH POND DIKE
STABILITY INSPECTION

Prepared by: Sherman G. Garrett
Date: December 13, 2004

**KINGSTON FOSSIL PLANT
ANNUAL ASH POND DIKE STABILITY INSPECTION
2005**

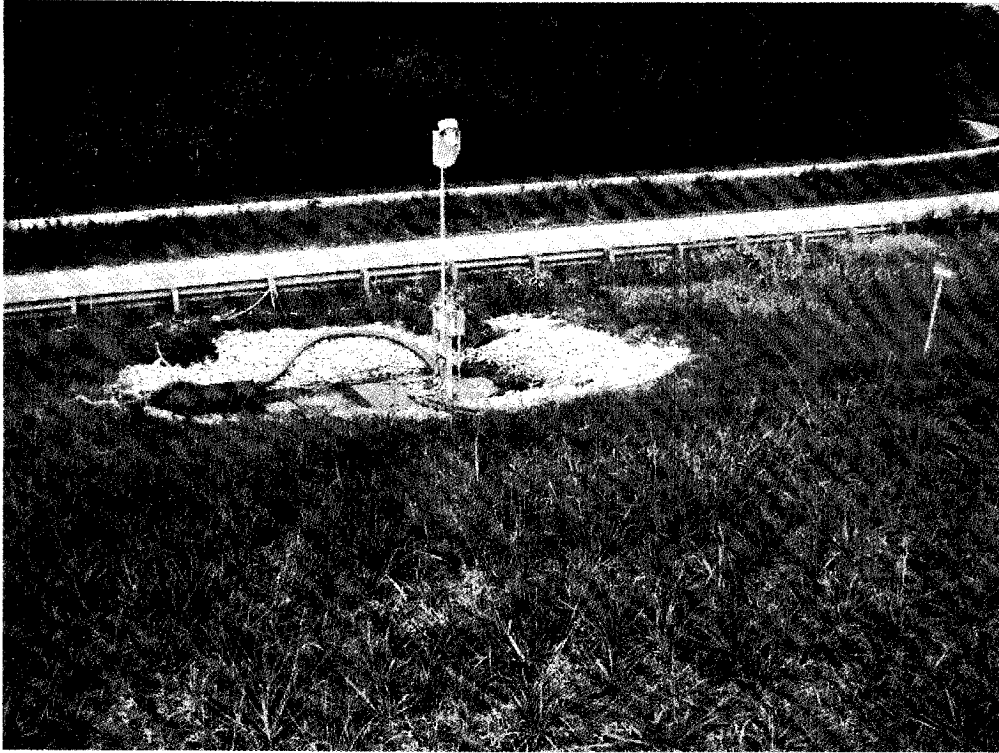
After November 2003, dredging operations to this area ceased due to a leak in the toe of the dike slope for dredge cells 2 & 3. The leak has not been stopped, but corrective action to prevent runoff into the river was undertaken by providing slope stabilization and adding a collector sump and pump to redirect the runoff (photo 1) into a bench drainage ditch running between dredge cell 2 and the road along Dike C.

Photo 1—Looking north toward collector sump and pump for dredge cell seepage

A project is planned for the summer of 2005 to permanently correct the seepage condition and allow dredging to resume. In the future, operations may be resumed in these cells with lifts up to elevation 840.0.

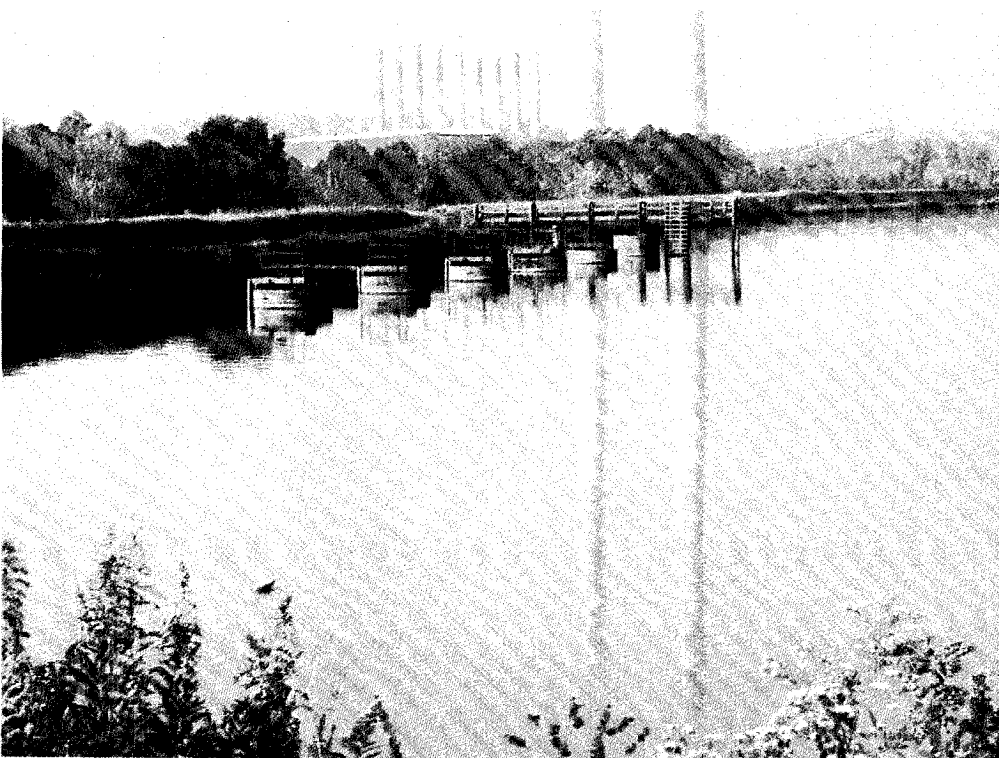
The sluice water flows into the stilling pool through one of two plant constructed spillways. From the stilling pool the water discharges into the plant intake channel via six standard spillways (photo 2). At the time of the inspection, five of the six spillways were operating. The western spillway was raised above the level of the other five and was not discharging. In 2003, new discharge diffusers were constructed (photo 3). Cenospheres were present in both the stilling pool and the active ash pond.

Photo 2—Looking southwest toward stilling pool spillways

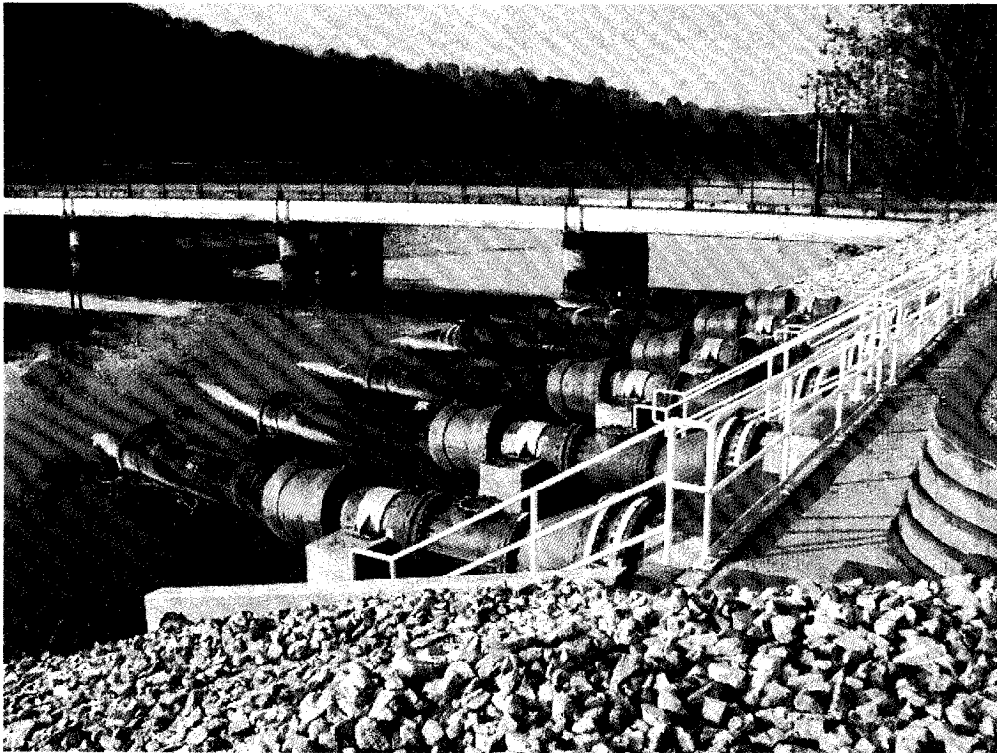
Photo 3—Looking southwest at stilling pool spillway discharge diffuser piping

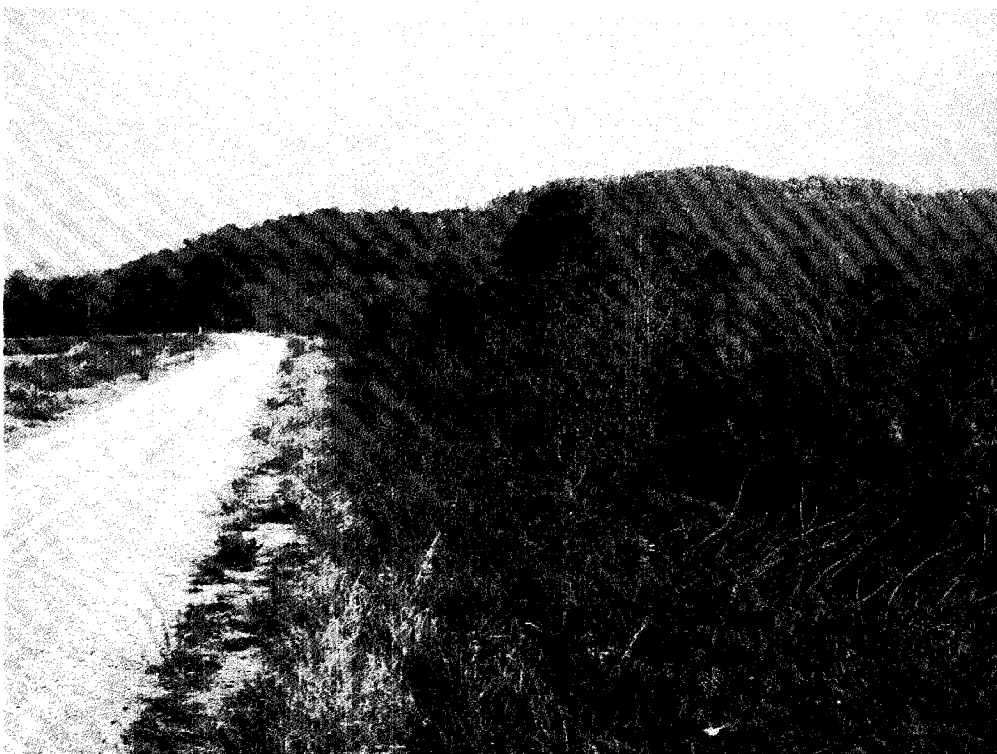
All exterior dike slopes around this area were in sound condition with excellent vegetative cover. On the eastern side of the dikes extending to the area of Swan Pond Road, the vegetation along both the upper and lower portions of the slope was in good condition, but the central portion had some small trees present and needed mowing (photos 4 & 5). No sloughs or seepages were detected. The divider dike between the active pond and the stilling pool had some areas of rill erosion and gullies, but otherwise was in good condition. The dike roads were in good condition generally with a good ash or crushed stone surface. There were a couple of areas along the lower dike road (Dike C) at the northeast side of the dredge cells where deep ruts or ditches across the road made vehicle passage difficult.

Photo 4—Looking east along stilling pool outer dike slope with trees and vegetation

- Dredge cell drainage ditches should be kept free of cattails. The existing cattails should be removed.
- Remove trees from the slope of the stilling pool dike. At this point, the trees are small enough to be mowed. Mowing at least twice a year is recommended to control the size of the trees. Preventing the trees from getting larger than 1" in diameter at the ground is preferred. Any trees larger than 1" in diameter at the base must be pulled from the dikes, roots and all. Repair and reseed any areas where trees are removed.

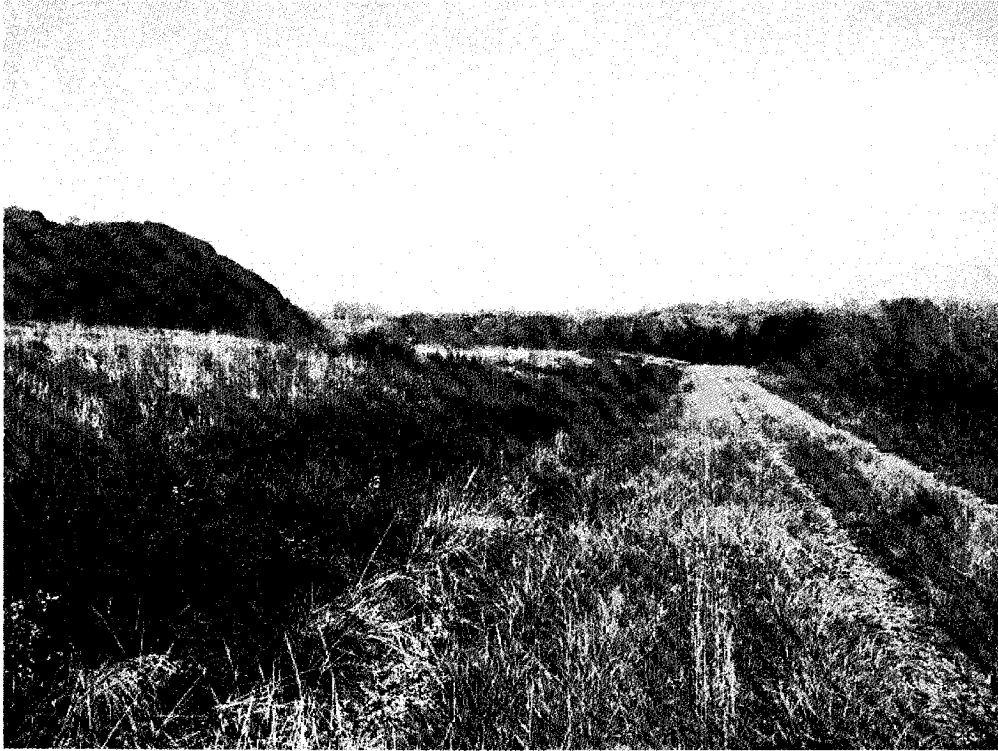
Photo 5—Looking northwest along Dike C roadway

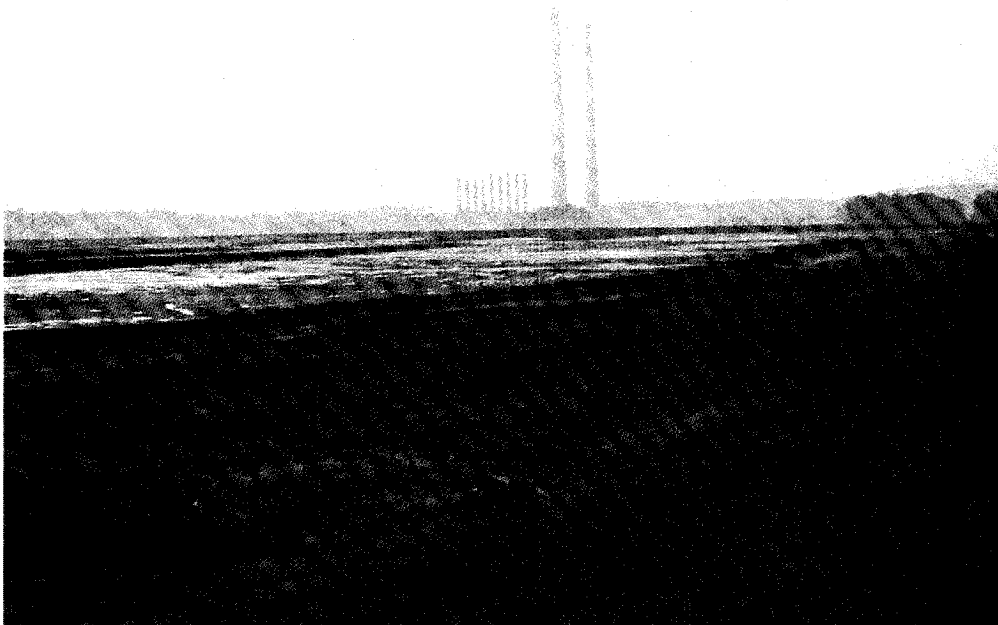
Dredge cells 2 & 3 are inactive at the current time with the present elevation at 811.0 (photo 6). In the future, this may be increased to elev. 840.0. Cells 2 and 3 have been combined by no longer raising the dike separating the two cells. The dike for Cell No. 1 is currently at elevation 811. All three cells are inactive at this time, although eventually, the cells may be raised to elev. 840.

Photo 6—Looking south-southwest across top of dredge cells

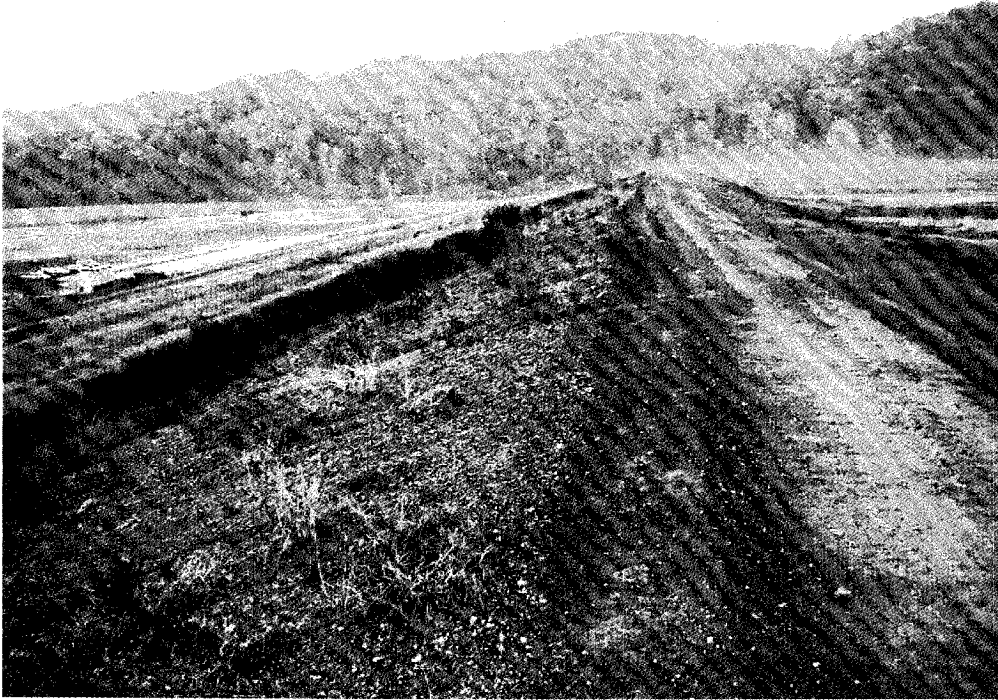
The dike slopes around this area were all stable with some rill erosion in places. The upper slopes need to be seeded and mulched to prevent further erosion (photos 7 & 8). Dike slopes with sparse vegetation should continue to be reseeded and mulched until a good vegetative cover is apparent. Operations personnel continue to do a commendable job of mowing the slopes.

Photo 7—Looking northwest along top of dredge cell no. 1 showing bare areas

- Dredge cell outer slopes with exposed ash should receive a layer of top soil and be seeded as soon as possible.
- Earth fill should be added and riprap placed to prevent further erosion at a few french drain outlets on the eastern slope of the stage A dike.

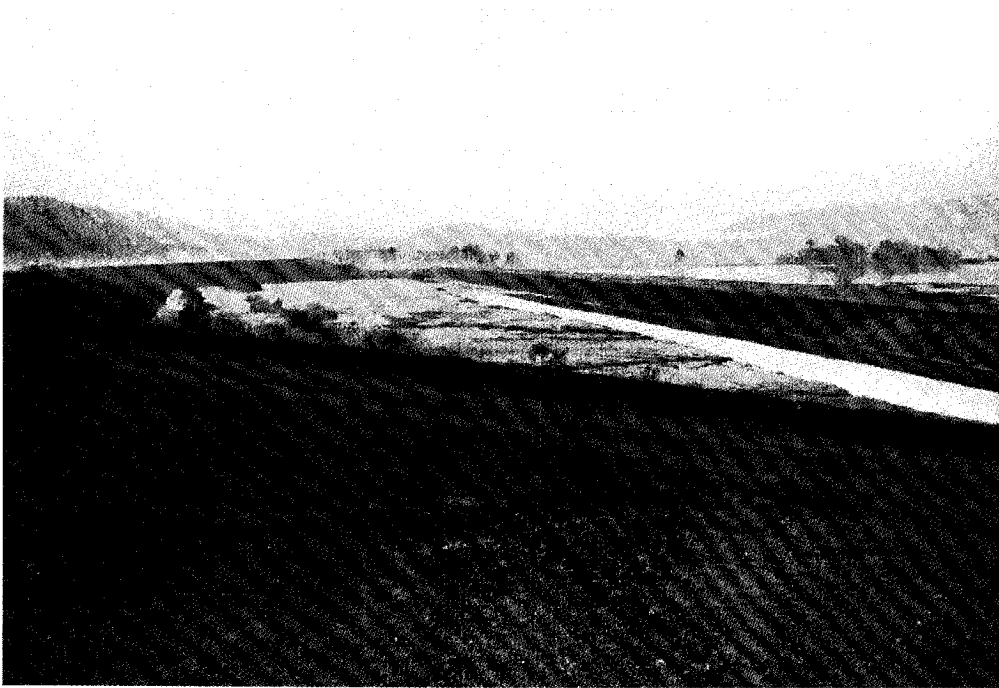
An intermediate dredge cell has been constructed with a current elevation of 787.0 with current operations raising the elevation to 795.0 (photos 9 & 10).

Photo 9—Looking northeast at intermediate dredge cell

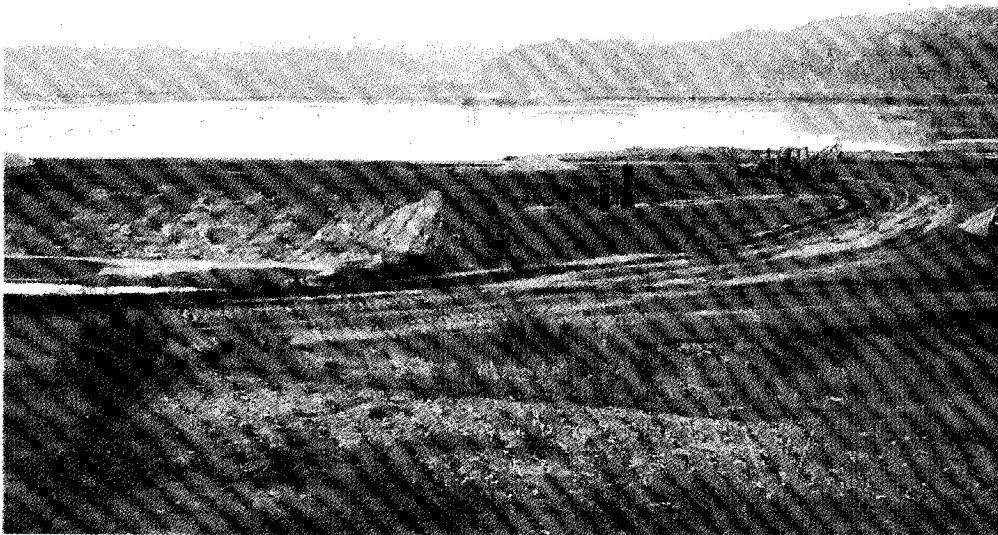
Photo 10—Looking east at intermediate dredge cell and active ash disposal area

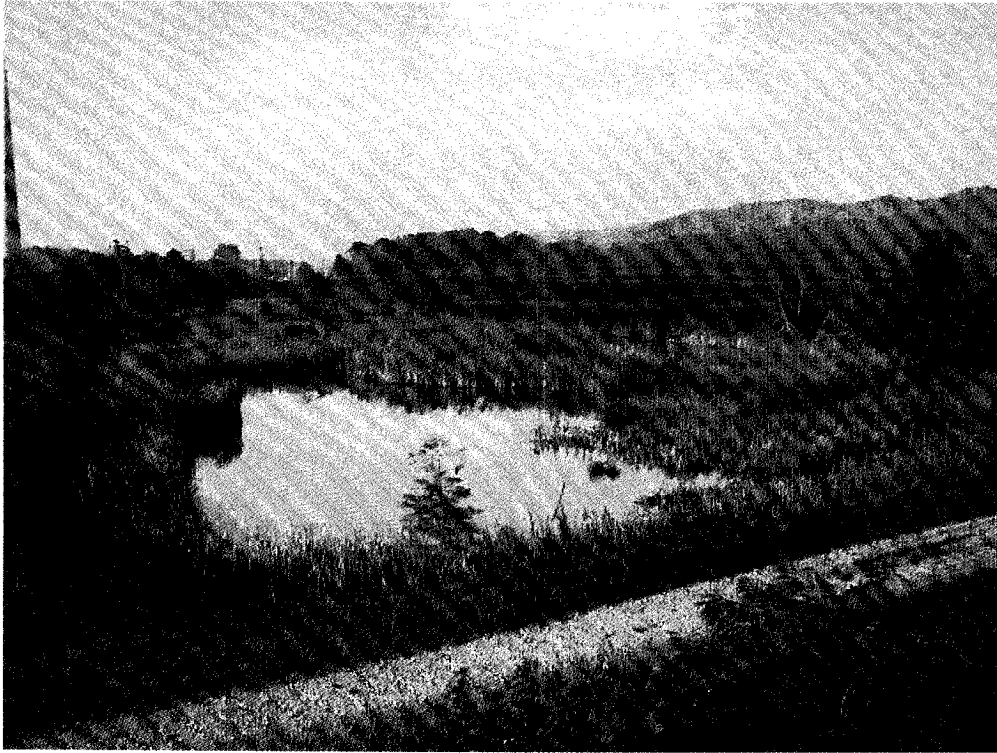
The engineered wetlands along the southwest dike of the active ash pond receive seepage that collects in the anoxic limestone drain at the toe of the slope. The wetlands appeared to be saturated, but functioning properly (photo 11).

Photo 11—Looking southwest at engineered wetlands

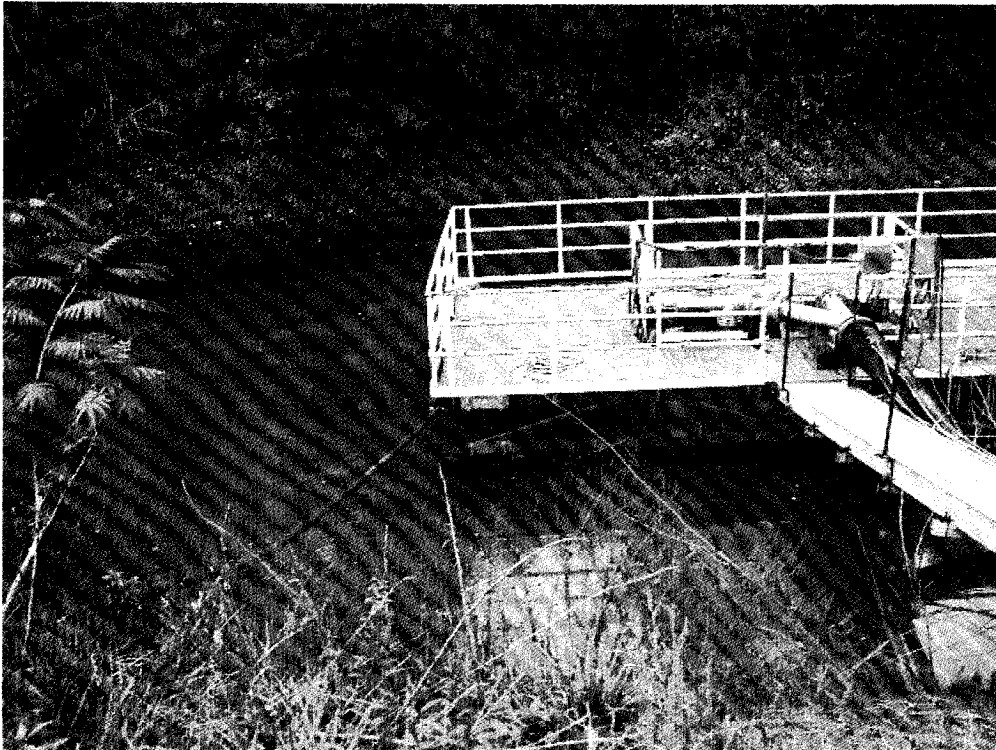
The interior slopes appeared to be in satisfactory condition (photos 12 & 13). Normal discharge from this basin is pumped into the fly ash discharge ditch which flows to the active ash disposal area. At the time of inspection, water in the pond was at a low level, about 6" below the first pump start switch—approximate elev. 751.0. The basin was sounded at several places along the perimeter of the platform, and the water was found to have an average depth of 15 inches with the top of sediment being approximate elev. 749.75. The grade elevation in the area of the pump platform is 745.0. This indicates the sediment in the area of the pump platform occupies approximately 4.75 feet of the basin's 6-foot storage capacity. With allowance of a 2-foot clearance below the pump intakes to prevent the pumps from pumping solids, the maximum sediment elevation should be no greater than 749.5. This indicates that the pumps are probably pumping solids. The basin should be dredged annually to maintain optimum pumping performance. The pond extensions for overflow appeared to have built up with sediment limiting the storage capacity of the pond (photo 14). Kingston drawing 10W225-1 shows the pond and its intended bottom contours.

Photo 12—Looking southwest at pump platform and coal yard drainage basin

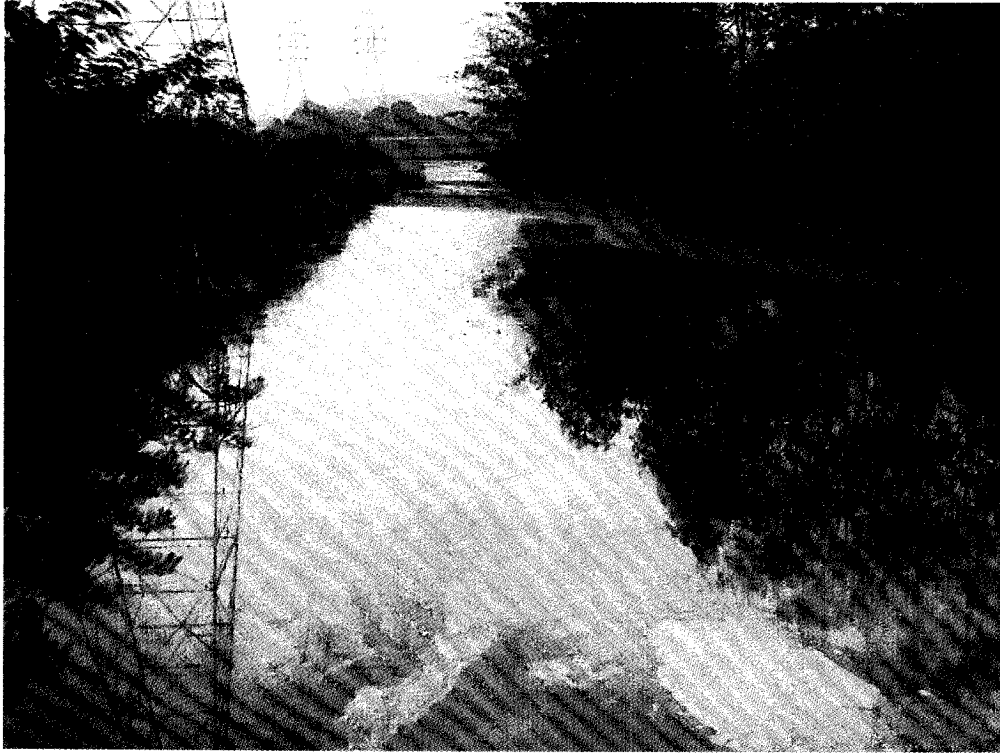
Photo 13—Looking southeast at coal yard drainage basin toward “wye” extensions past gap

- Dredge the Coal Yard Drainage Basin to restore its design contours and protect the pumps from damage by removing approximately 3,300 cy of sediment from the original section and the south and east "wye" extensions. See Kingston drawing 10W225-1.

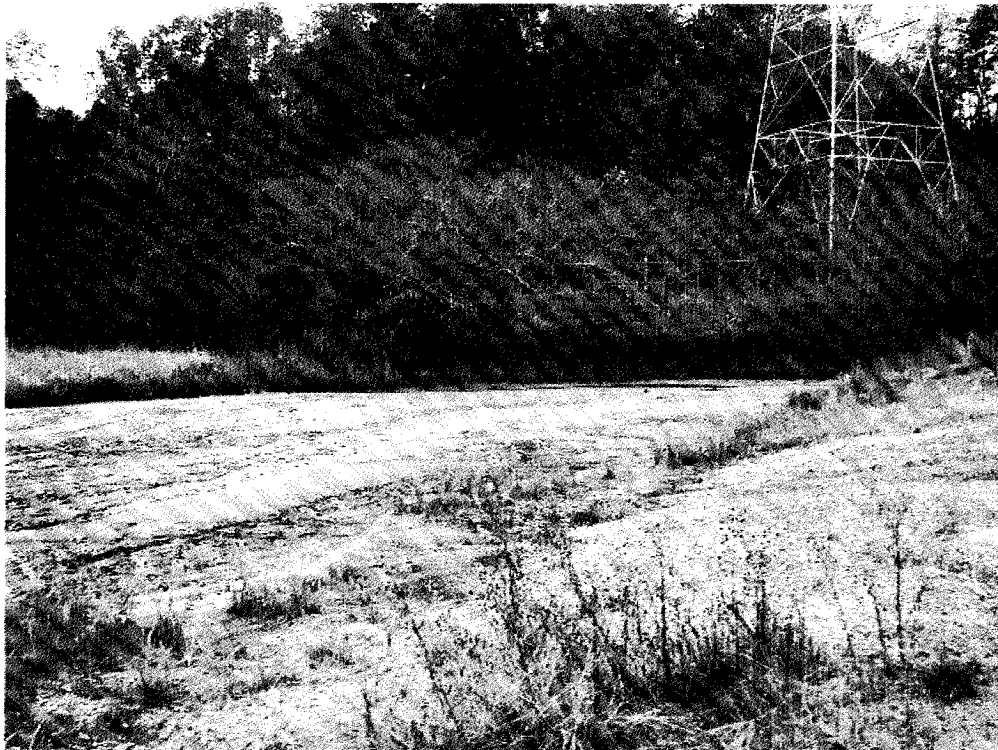
Photo 14—Looking southwest toward “wye” intersection with coal yard drainage basin
