KINGSTON FOSSIL PLANT - ANNUAL ASH POND DIKE STABILITY INSPECTION

ANNUAL ASH POND DIKE
STABILITY INSPECTION

KINGSTON FOSSIL PLANT
ANNUAL ASH POND DIKE STABILITY INSPECTION --2006

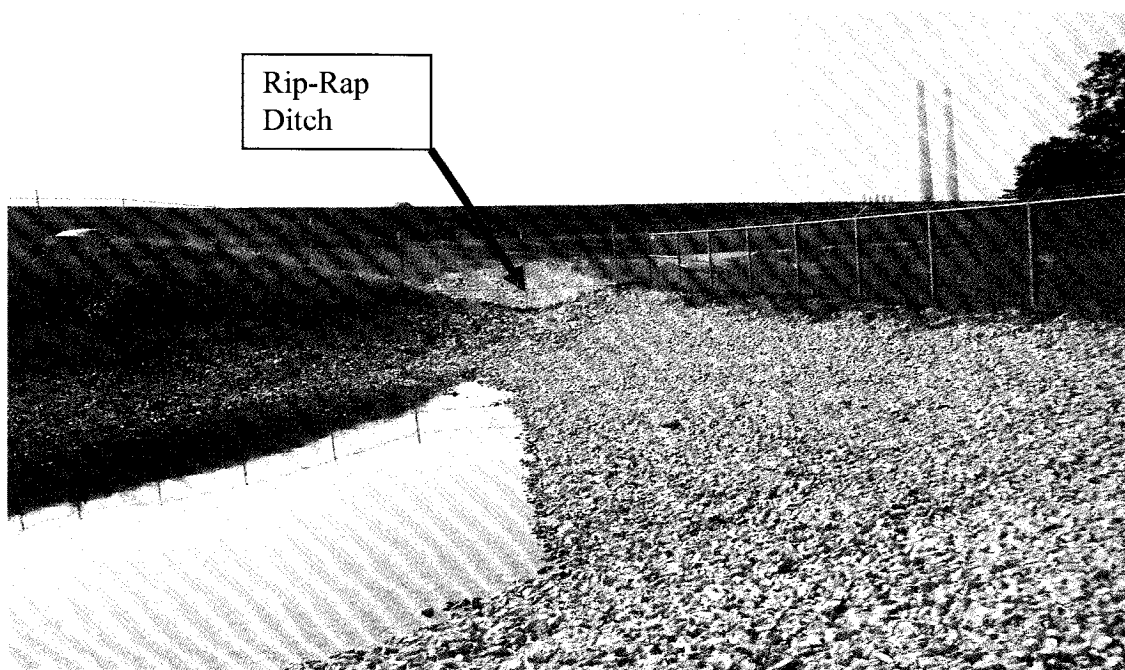
The rip-rap channel along Swan Pond Road and the toe of the dike has a high point approximately 400 feet north of the intersection with the plant access road. North of the high point, the runoff and leachate drain into a new sump pond (see again Pictures 6 and 7). South of the high point, runoff and leachate runs south and east to the ash pond. The sump pond leachate is pumped to the ash pond. The pumps were relocated from the ditch along Swan Pond Road to the new location in the pond. The pumps are electric powered with high water level alarm indicators at the control panel. The pond is sized to contain a 25 year storm event, and emergency overflow is to Swan Pond Embayment.

Picture 6: Rip-rap ditch along Swan Pond Road, sump pond in foreground

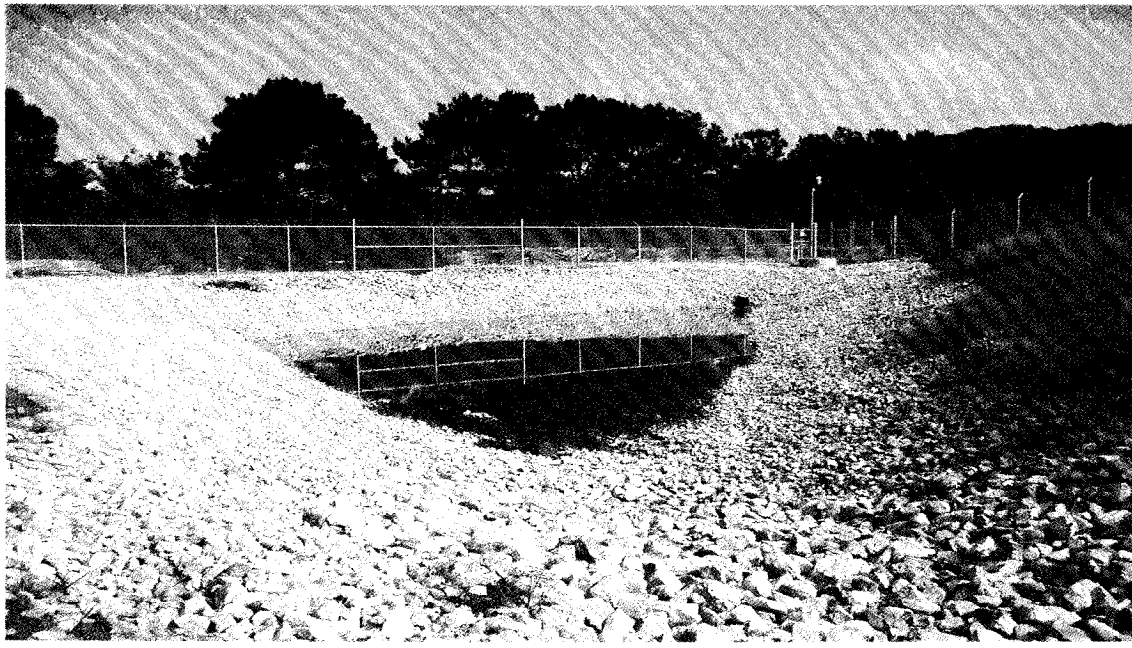
The top-of-dikes elevation is 811 feet. In order to repair the previously reported leakage, the Dredge Cell Restoration Project was undertaken. In late 2004, design was started on the Dredge Cell Restoration Project. Construction started during the summer of 2005 and was accomplished in the manner cited below. This Project involved placing underdrains at the lower two bench levels to relieve pressure caused by the phreatic water surface in the slopes and installing rip-rap ditches and a pump station to send the water to the ash pond (see Pictures 6 and 7).

Picture 7: New pump station and detention pond

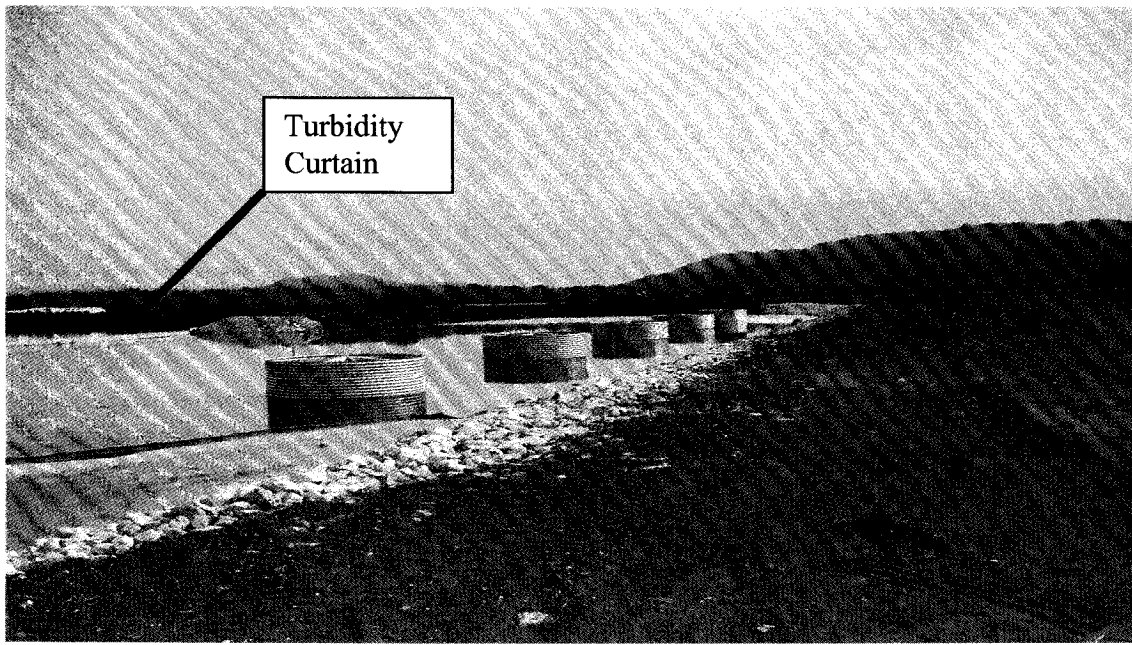
The sluice water flows from the active ash pond into the stilling pool through the five (5) new spillways constructed in 2005 (see Picture 8). The old plant constructed spillways (Kennedy weir and spillway, see Picture 9) were taken out of operation in 2005 as part a project to replace the Kennedy weir and allow more accurate accounting of free water volume. From the stilling pool, the water discharges into the plant intake channel via six standard spillways. Construction of new discharge diffusers was completed in November 2003. At the time of the inspection, five of the six discharge diffusers were operating (Photos 10 and 11).

Picture 8: New spillways, note turbidity curtain at opening to the left

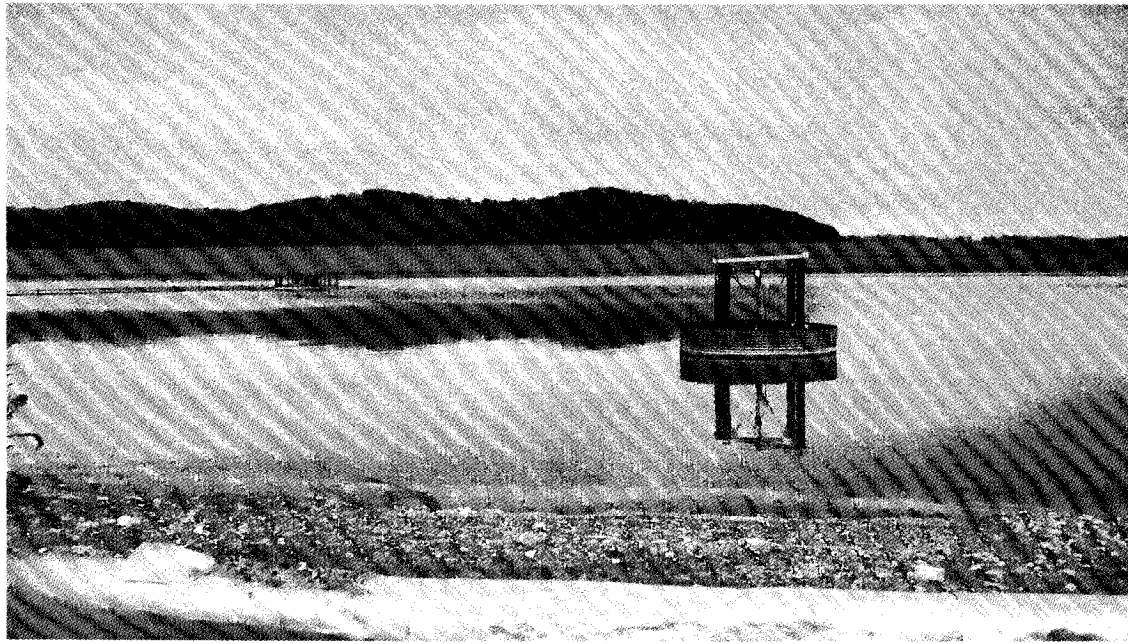
Picture 9: Old Kennedy Weir in background, old spillway in foreground
(Both now removed, out of Service)

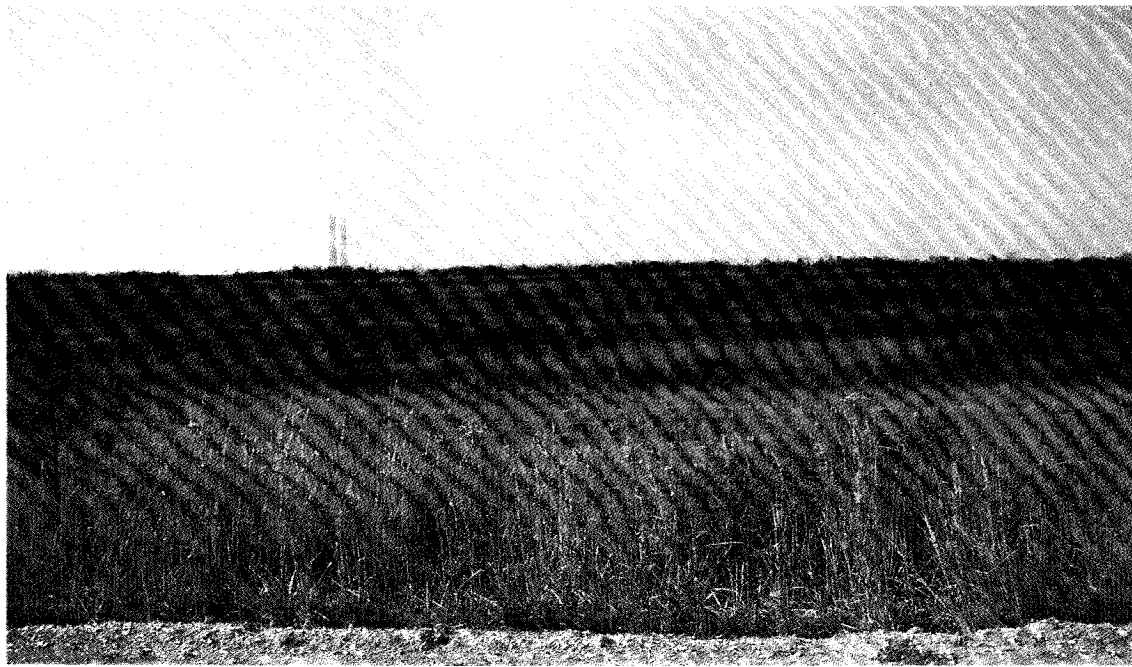
All exterior dike slopes around this area appeared to be in sound condition with excellent vegetative cover (see Picture 12). The dikes were in need of mowing. Small trees had grown to a height of 3 to 5 feet in some places. These trees should be pulled up and the area reseeded. Presently the dikes are mowed only once a year.

Picture 12: Typical vegetated banks outside dredge cells

- Remove trees from the slope of the stilling pool dike. At this point, the trees are small enough to be mowed. Mowing at least twice a year is recommended to control the size of the trees. Preventing the trees from getting larger than 1" in diameter at the ground is preferred. Any trees larger than 3" in diameter at the base must be pulled from the dikes, roots and all. Repair and reseed the area the tree was removed from.

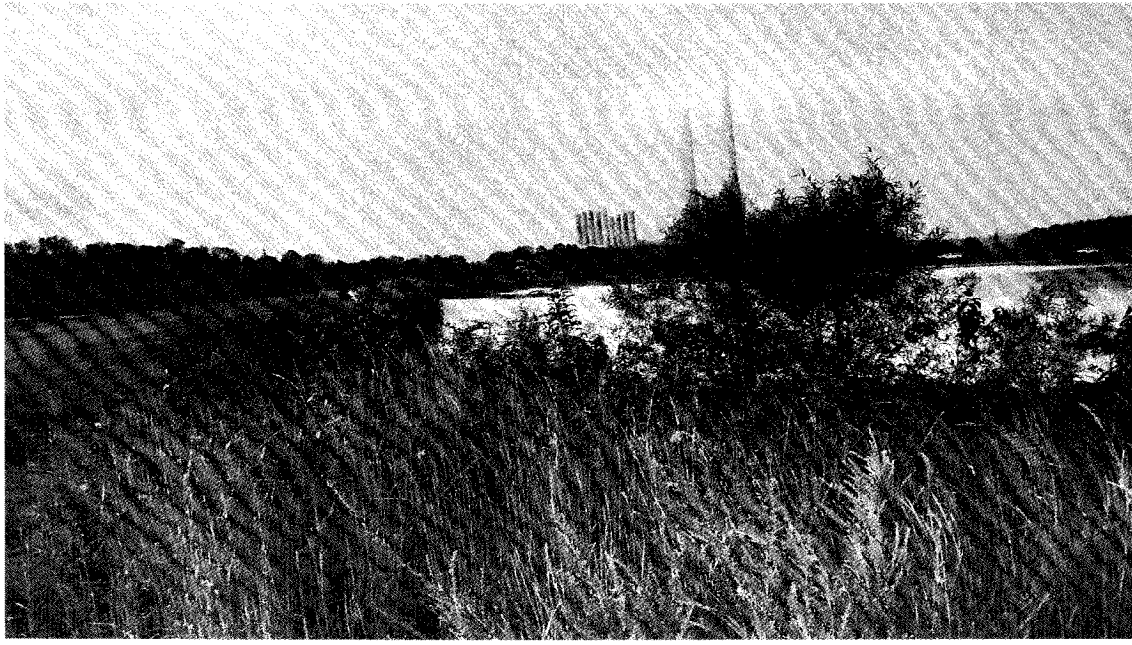
The divider dike between the active pond and the stilling pool had some areas of erosion and gullies, but appeared stable otherwise. The divider dike on the ash pond side needs mowing and some small trees pulled up (see Pictures 13 and 14). These areas of the dikes at the new spillway construction should have rip-rap placed to minimize erosion from potential wave action.

Picture 13: Vegetation in divider dike (ash pond side), note small trees in dike

- The divider dike between the ash pond and the stilling pool shows signs of erosion on the ash pond side. These slopes should be rip-rapped to stabilize.
- Trees on the divider dike on the ash pond side and the stilling pool side should be mowed or pulled up and the area repaired and reseeded.
- Dredge cell drainage ditches should be kept free of cattails. Any existing cattails should be cut.

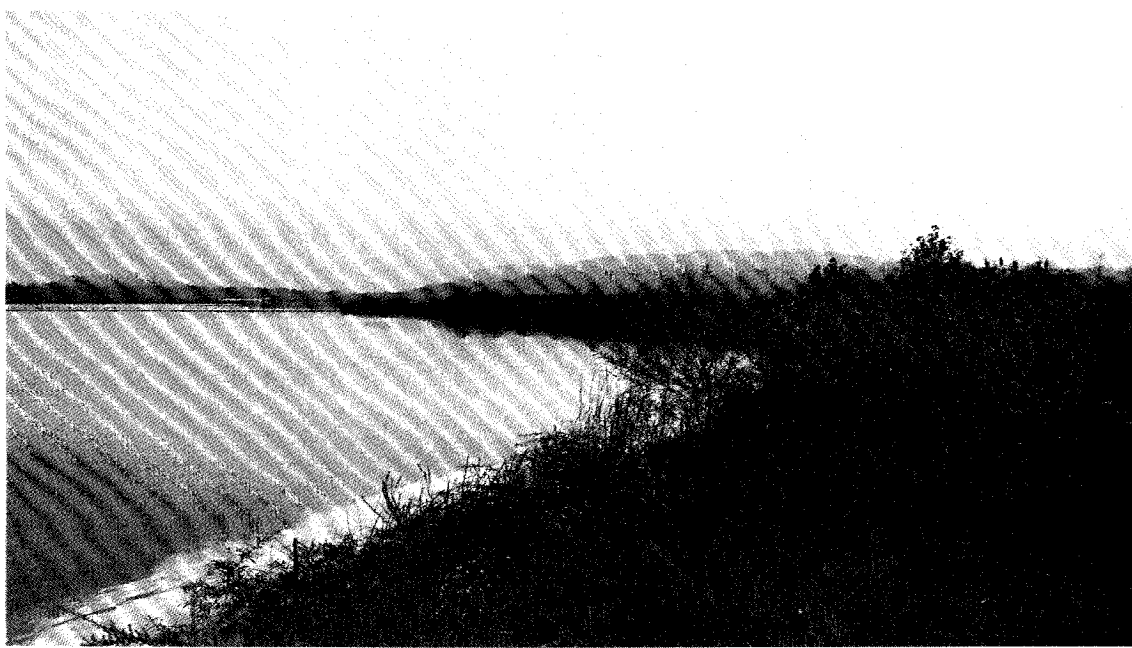
Picture 14: More vegetation in divider dike (looking east)

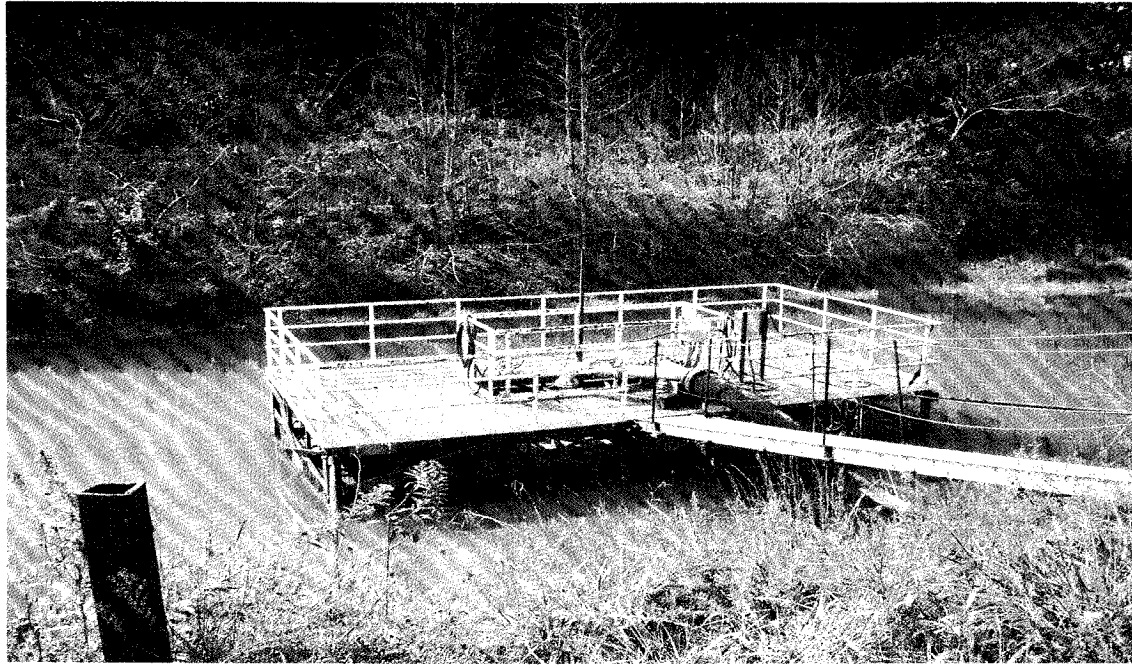
Picture 15: Floating Pump platform at coal yard drainage basin (grounded)

- Dredge the Coal Yard Drainage Basin to restore its design contours and protect the pumps from further damage. There is an estimated 2,800 cubic yards of sediment in the original pond and an extra 3,400 cubic yards in the "V" section that needs to be removed as soon as reasonable. See the attached copy of 10W225-2.

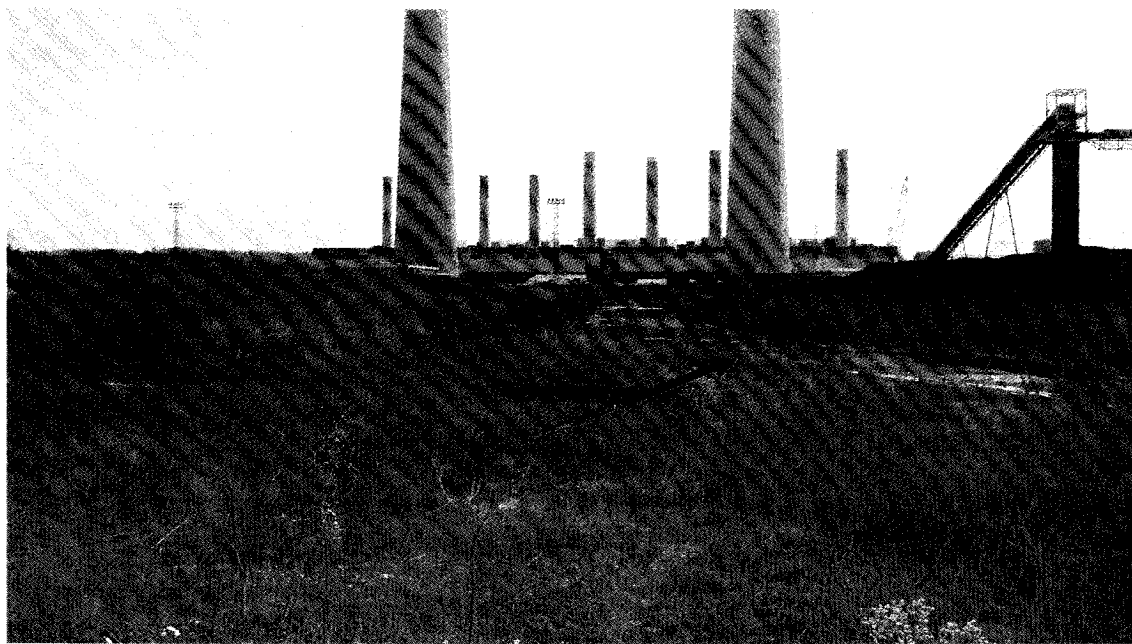
The coal yard drainage basin is located at the southwest corner of the coal pile. This basin was excavated below grade; therefore, there are no exterior dikes. The interior slopes appeared to be in satisfactory condition. Normal discharge from this basin is pumped into the fly ash discharge ditch and flows to the active ash disposal area. At the time of inspection, water in the pond was at a low level, about 6" below the first pump start switch and the platform was grounded (see Picture 15). The basin was sounded at 5 places and the depths are indicated on the attachment API 2006-2. This indicates the sediment in the bottom is taking more than 50 percent of the basin's storage capacity. This represents a 1.67 feet increase in sediment depth since the last inspection. The basin was dredged just over three years ago, but it is recommended that dredging the basin occur annually. The bottom of the pond should be no higher than elevation 745 at the pump platform. Elevation 745 allows 2 feet of clearance below the pump intakes to prevent the pumps from pumping solids; the elevations indicate the pumps have been pumping solids for some time. In addition, the "V-shaped" pond extensions added during the summer of 2001 to increase the pond storage volume contained coal yard sediment (see Picture 16). TVA drawing 10W225-2 (attached as API 2006-2) shows the pond and its intended bottom contours.

We understand that others are taking a more precise survey of the Coal Yard Drainage Basin to more accurately assess the situation. these spot elevations indicate a need for dredging.

Picture 16: Coal yard runoff channel, note the sediment

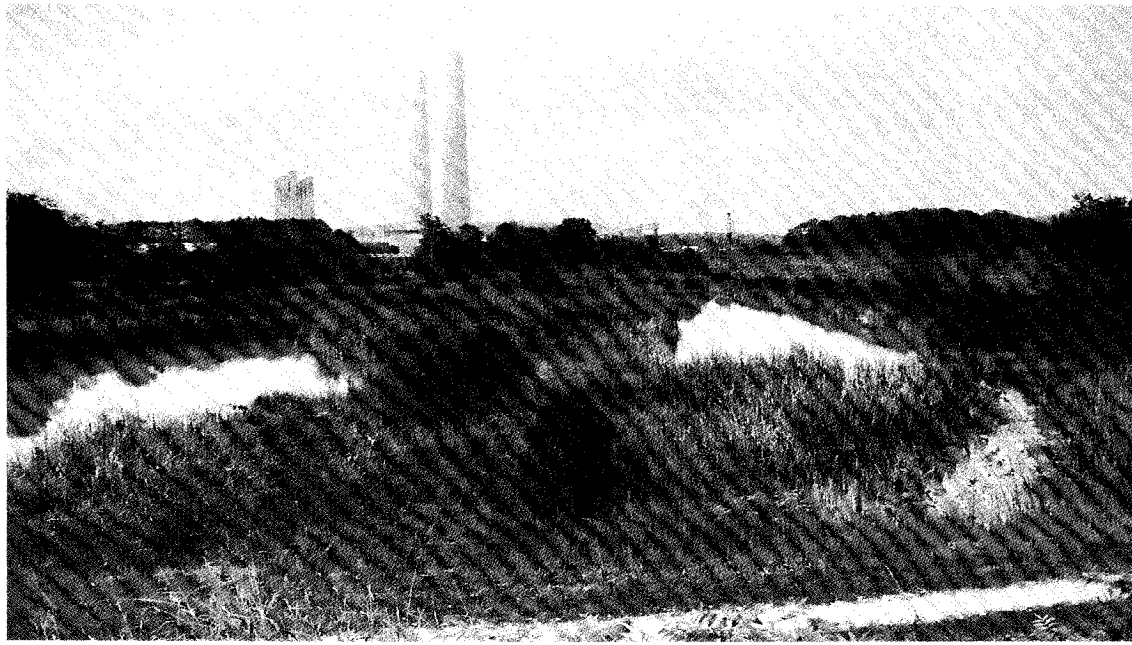
The engineered wetland along the southwest dike receives seepage that collects in the anoxic limestone drain below the bottom ash trench. The wetland appeared to be functioning, at least partially, though the discharged is still pumped to the ash pond (see Picture 17).

Picture 17: Engineered Redwater Wetland
