KINGSTON FOSSIL PLANT - ANNUAL ASH POND DIKE STABILITY INSPECTION

ANNUAL ASH POND DIKE
STABILITY INSPECTION
2007

Prepared by: John Albright and Jeff Gray
Date: January 31, 2007

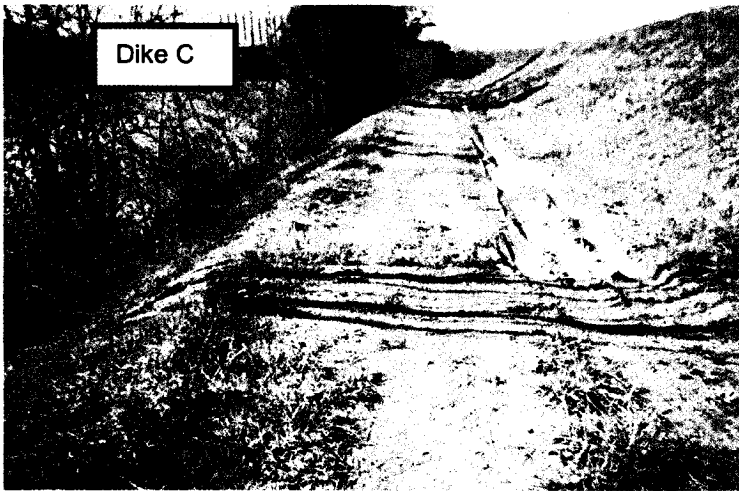
All exterior dike slopes around this area appeared to be in sound condition with excellent vegetative cover. The dikes had been mowed recently and were in very good condition. As shown to the left, some of the benches don't drain well. As much as practical, these ditches should be graded so they will drain, even if slowly. Wheel ruts that hold water should be filled with soil and covered with stone if they are in a road.

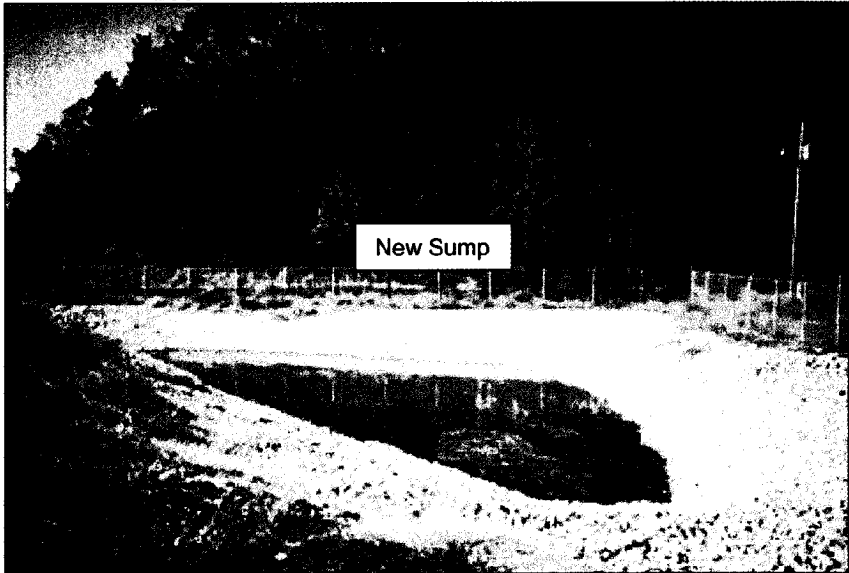
North of the high point, the runoff and leachate drain into a new sump pond. South of the high point, runoff and leachate runs south and east to the ash pond. The sump pond is pumped to the ash pond. The pumps are electric powered with high water level alarm indicators at the control panel. The pond is sized to contain a 25 year storm event, and emergency overflow is to Swan Pond Embayment.

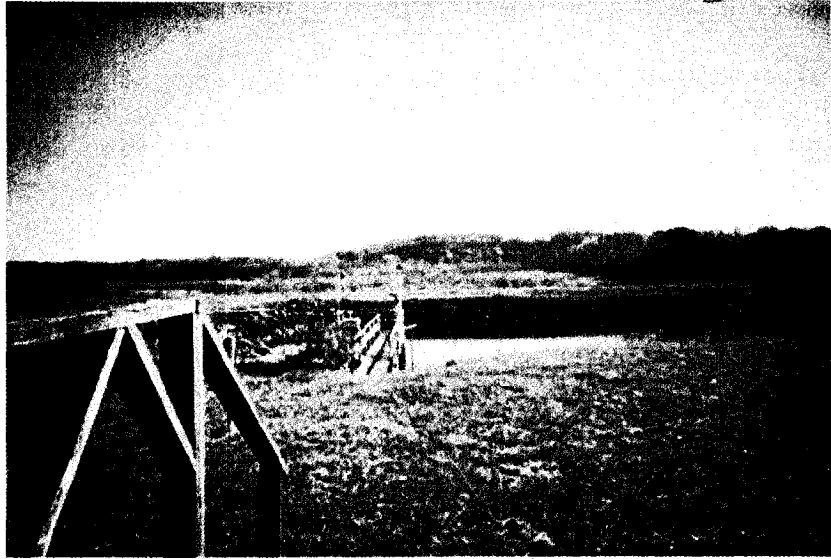
The chemical treatment ponds are located southwest of the active ash pond. Both ponds were excavated and have no exterior slopes. The internal dike slopes are covered with riprap. These slopes were in good condition. Sediment in the ponds was tested in FY 2004 and found to be non-hazardous.

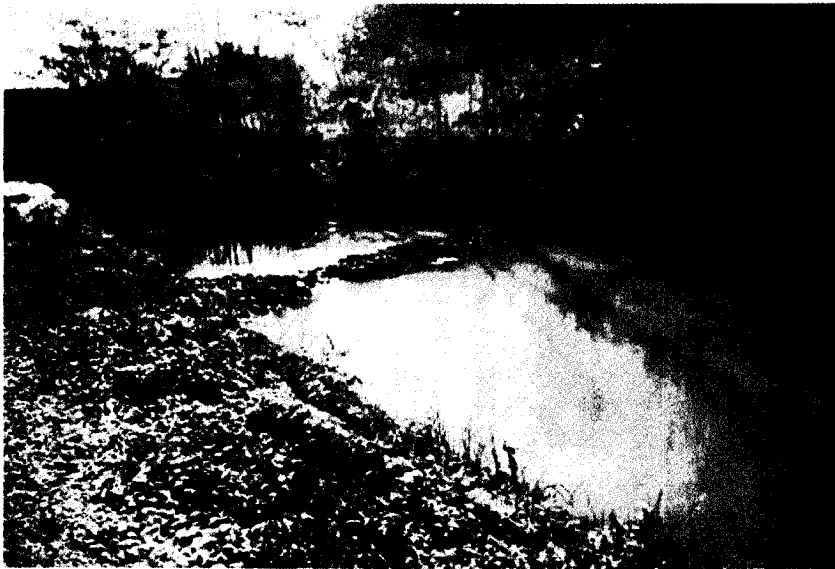
The coal yard drainage basin is located at the southwest corner of the coal pile. This basin was excavated below grade; therefore, there are no exterior dikes. The interior slopes appeared to be in satisfactory condition. Normal discharge from this basin is pumped into the fly ash discharge ditch and flows to the active ash disposal area. The picture to the left shows one of two rock check dams built to keep the coal fines away from the pumps. The basin was dredged just over four years ago, but is in need of clean out, again. The bottom of the pond should be no higher than elevation 745 at the pump platform. Elevation 745 allows 2 feet of clearance below the pump intakes to prevent pumping solids. The pumps seem to have been pumping solids for some time. In addition, the "V-shaped" pond extensions added during the summer of 2001 to increase the pond storage volume

contained coal yard sediment. TVA drawing 10W225-2 (attached as API 2006-2) shows the pond and its intended bottom contours.

- Dredge the Coal Yard Drainage Basin to restore its design contours and protect the pumps from further damage. There is an estimated 2,800+ cubic yards of sediment in the original pond and an extra 3,400+ cubic yards in the "V" section that needs to be removed as soon as reasonable. See the attached copy of 10W225-2. We estimate \$50,000 will be needed, depending on haul distance.

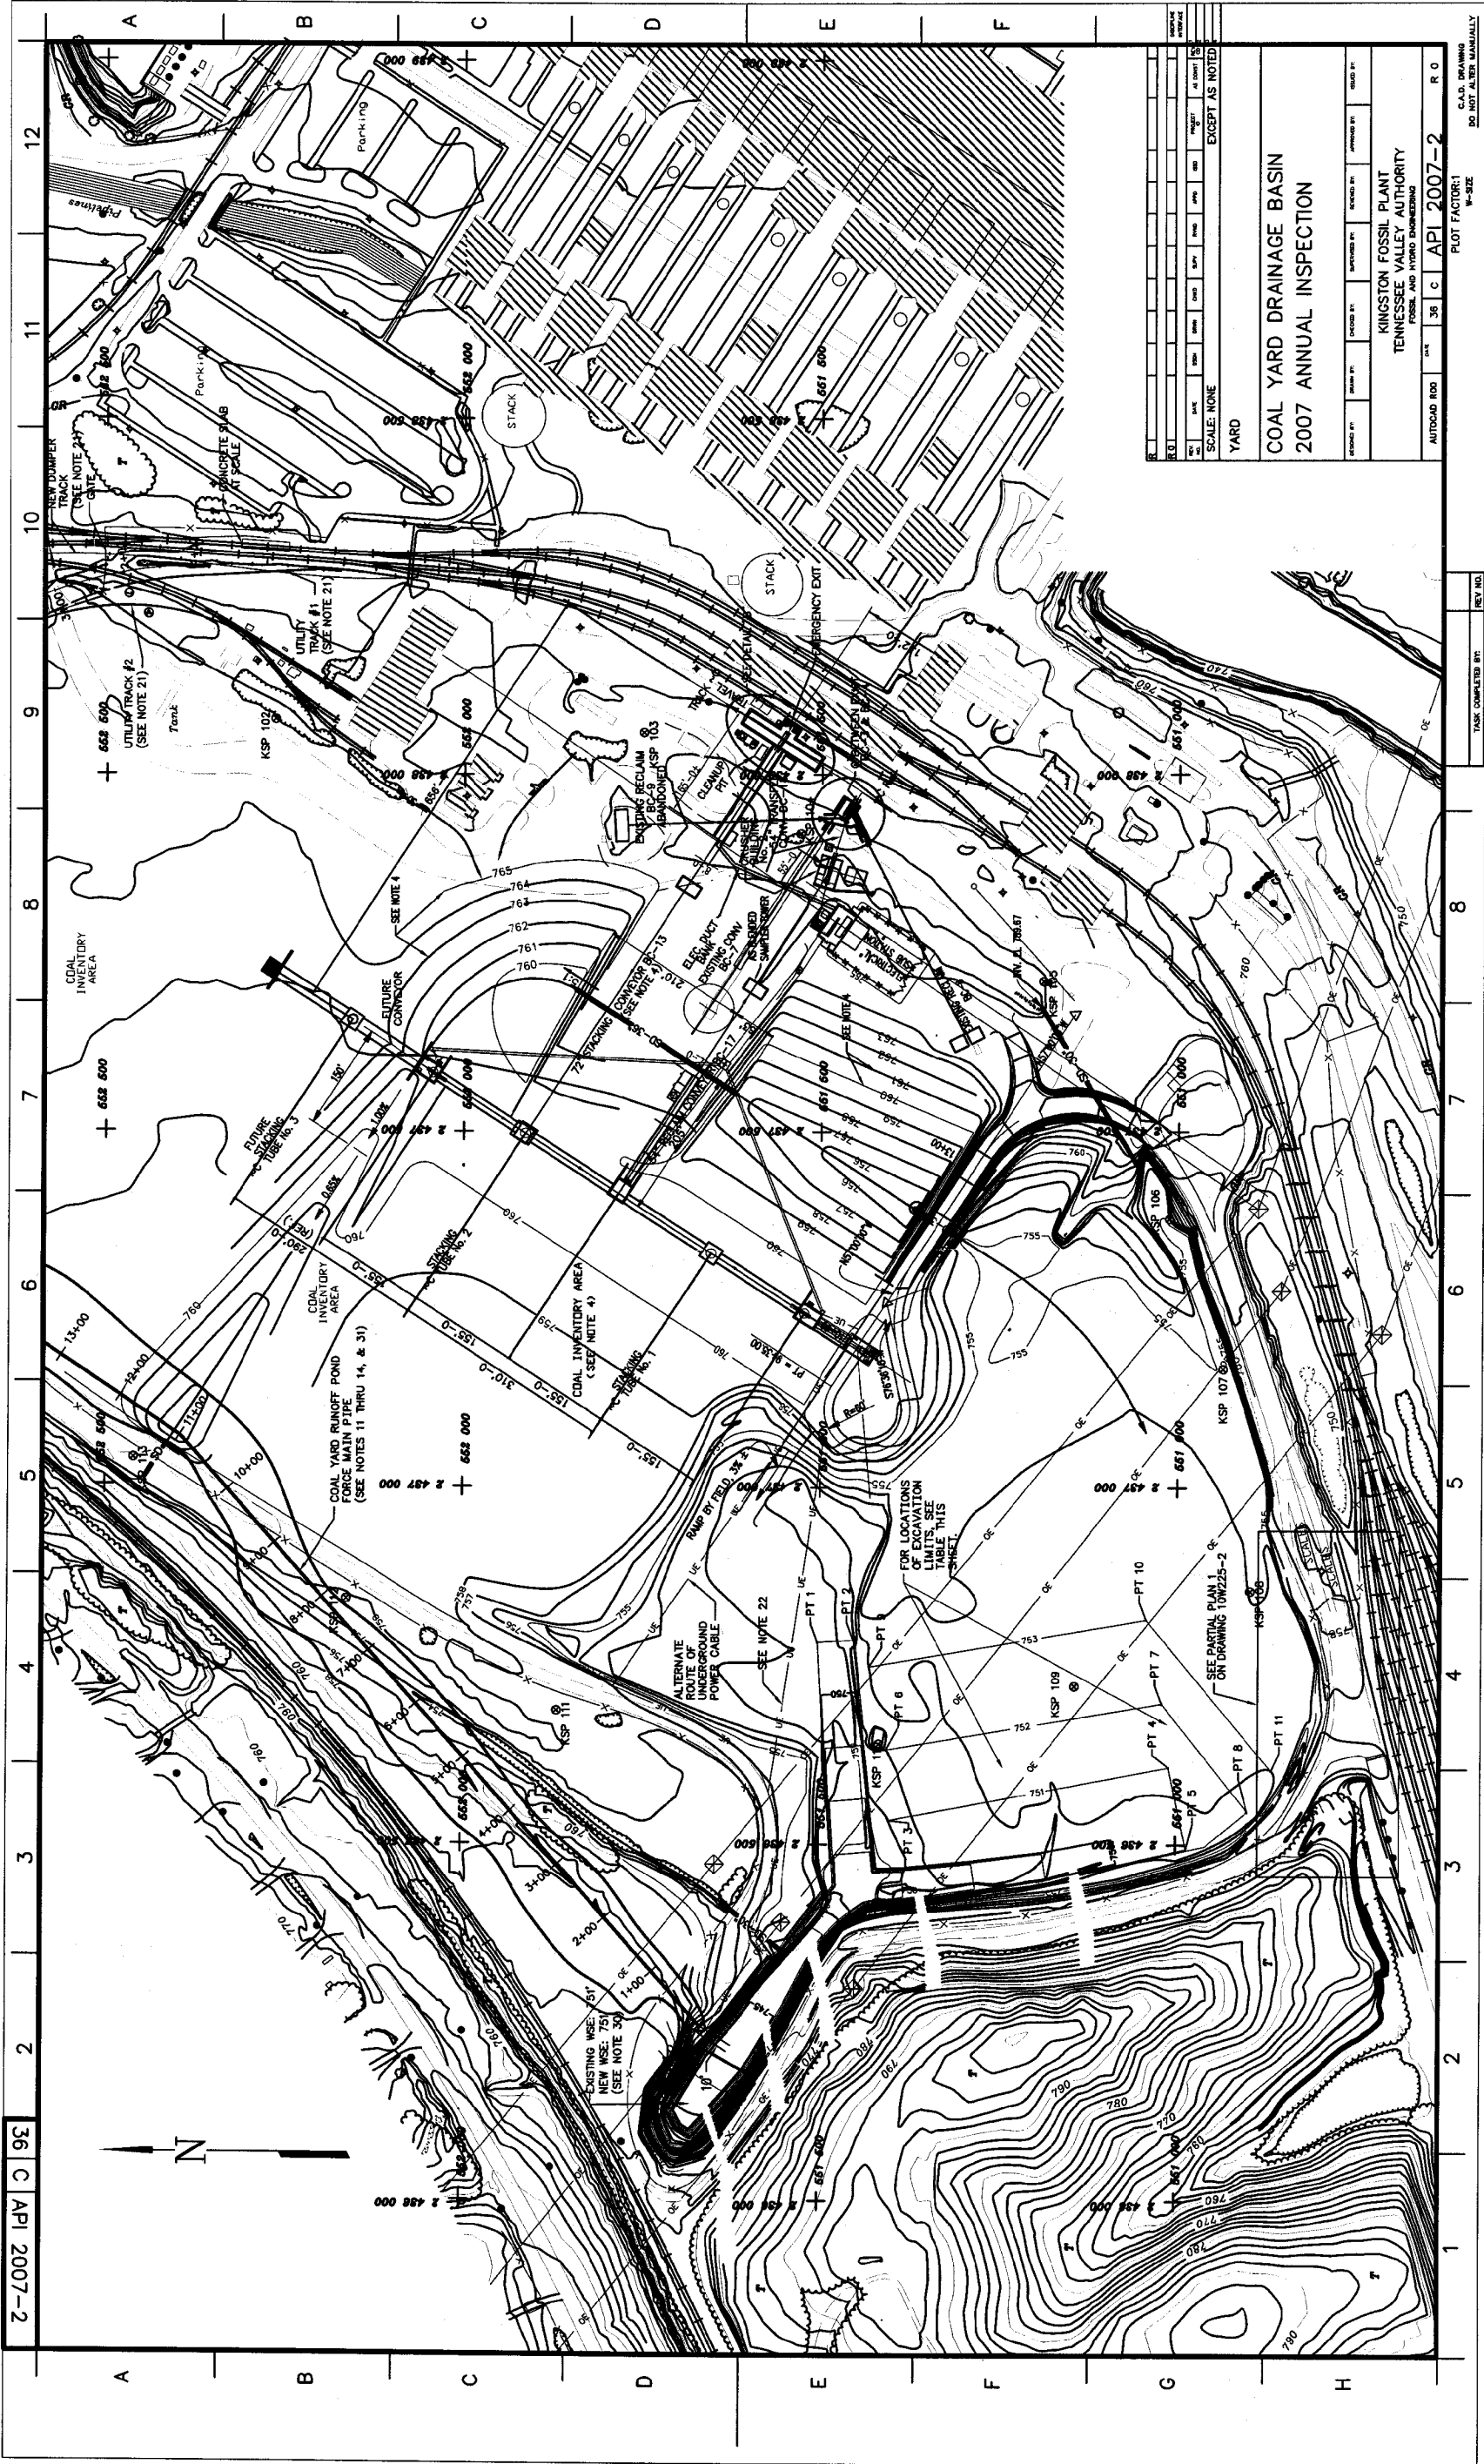
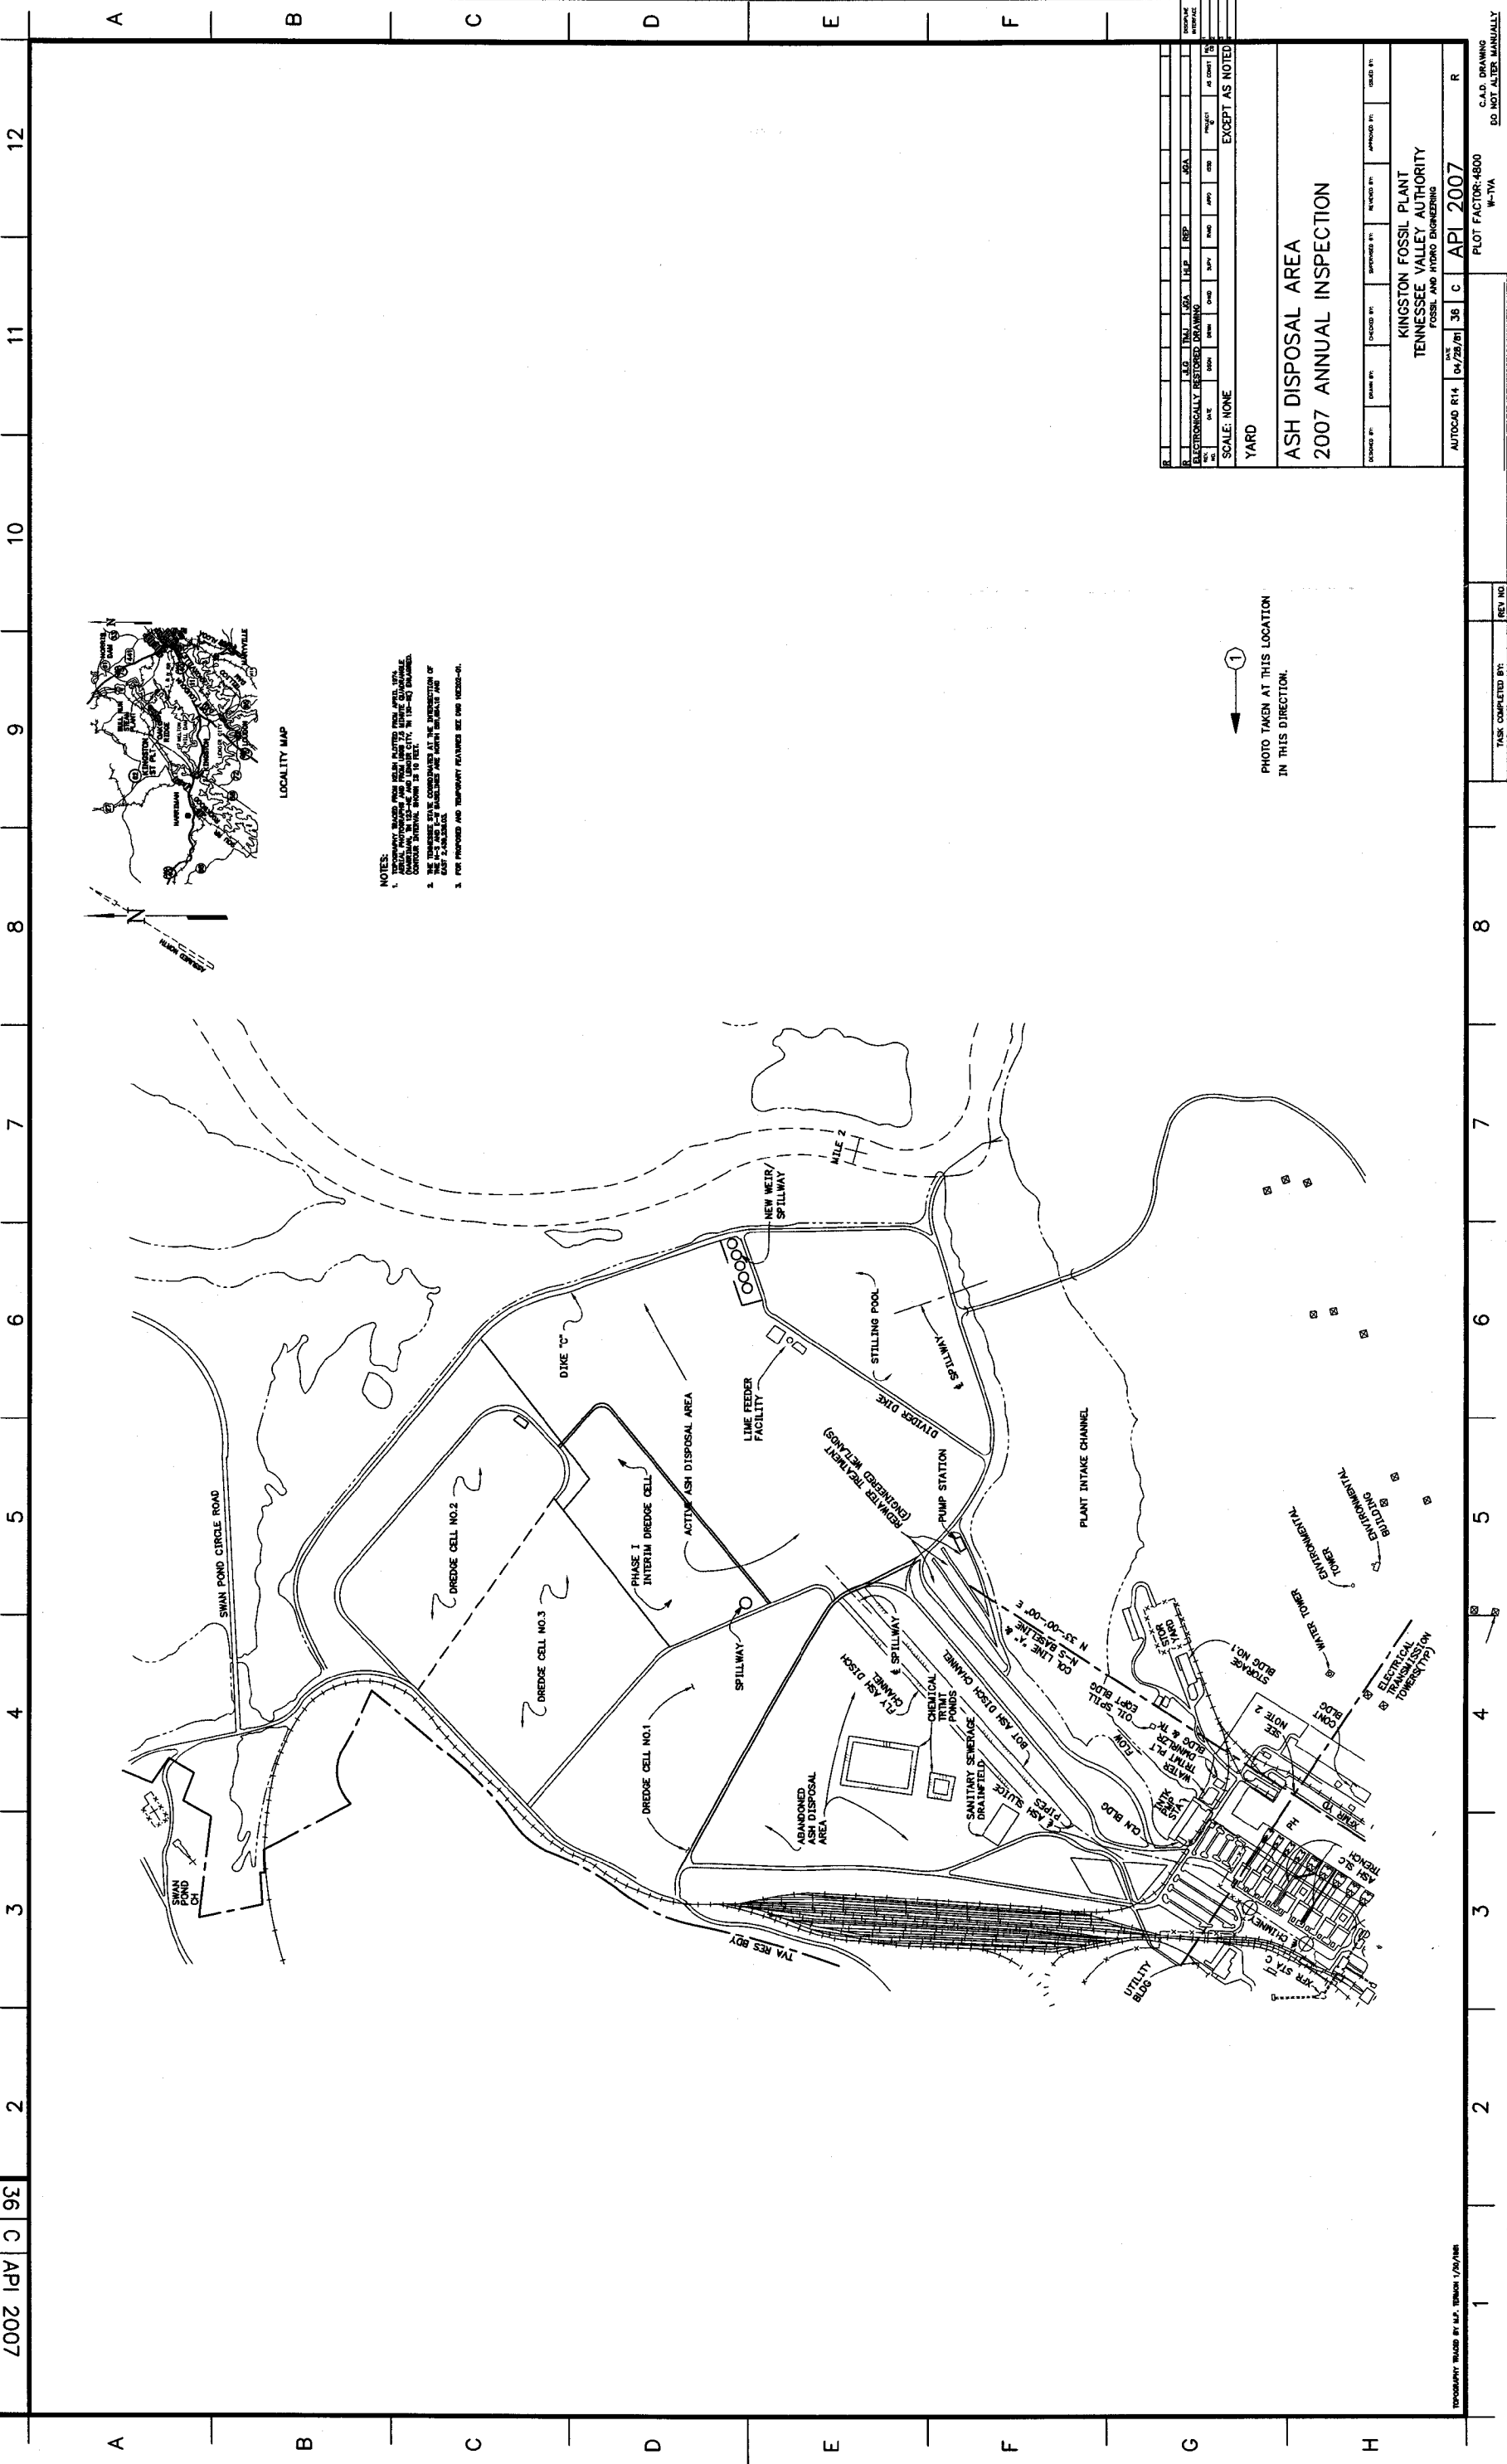
36 C API 2007

Bottom ash is sluiced into a channel southwest of the disposal area where it settles out and is removed by drag line, approximately once a week, to be used for dike construction. Fly ash is sluiced into a channel northwest of the bottom ash channel. Both channels flow northeast into the active ash pond where the fly ash settles out and accumulates. Please see drawing API 2007.
