MEMORANDUM TO THE DIRECTOR - ALLEN DIVISION

REVIEW OF SPILLWAY AND DRAINAGE

PROJECT EIGHT
SURVEYED 1
ECONOMIC 1
DIVISION OF DESIGN
TENNESSEE VALLEY AUTHORITY
KINSEYON ST CLAM PLANT

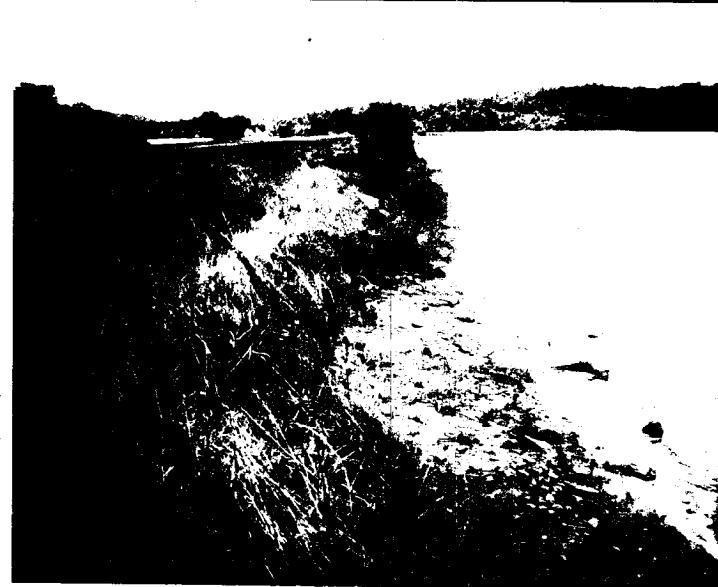
All dikes look to be in good shape. There is very little erosion by wave action on the outside slopes which are about 6:1. Slight wave action erosion has occurred on the inside but is not serious. All the dikes, with the exception of 200 to 300 feet on the south end of the west dike, are made of earth with a roadway surface of sand. The south end of the west dike for about 200 to 300 feet is composed entirely of sand, but has flat slopes and has withstand the wave action as good, if not better, than the earth dikes. Vegetation has been established on the dikes except where the dikes are made of sand.

Kingston
Wave action inside dike cuts back into fill.
7-3-67

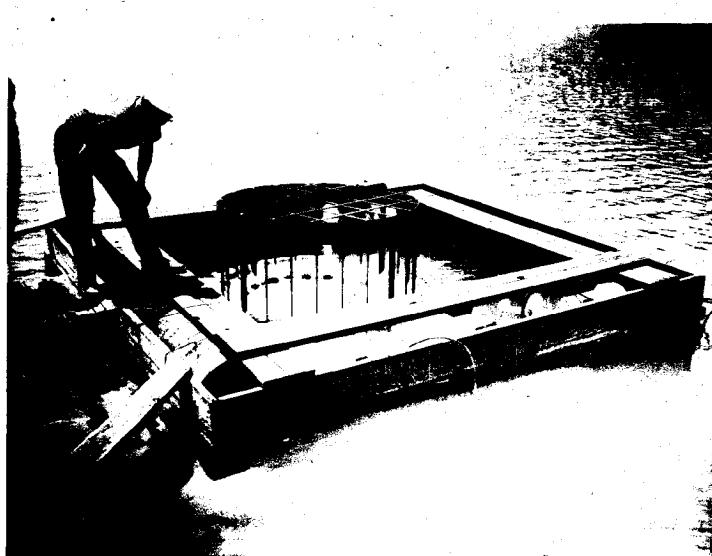
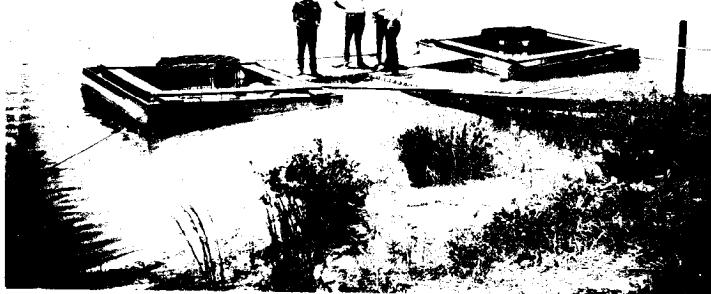
On July 2, 1967, there was approximately one foot of the dam at Spillway and from 3-1/2 to 4 feet above. The bottom outlet with the rest, but usually in this partially open at the top. A square wooden timber floating on sand bags (see photo) is used here instead of the circular metal type we have designed. We see no objection to the wood type except this one does not extend far enough below and above the water level to hold back floating debris.

Pictures showing Spillway inside Reservoir.
Structure is too short to extend far enough across the reservoir to skim off all ash and to prevent debris from going over. 7-3-67

In summary, the filters show no signs of being in any danger of failure provided proper cross section is used in raising them to higher elevations. The shrimps at the spillways should be made more effective.
