KINGMAN CREEK PLANT - ANNUAL AND DUNE INSPECTION

KINGMAN STEAM PLANT - ANNUAL ASH DIKE INSPECTION

On October 13, 1969, J. L. Hall of BFW; A. G. Spencer, Plant Superintendent; L. E. Kennedy, Assistant Plant Superintendent; B. J. Hunt, Operating Supervisor; and H. G. Bantala and I of BFD inspected the ash dikes at Kingman Steam Plant.

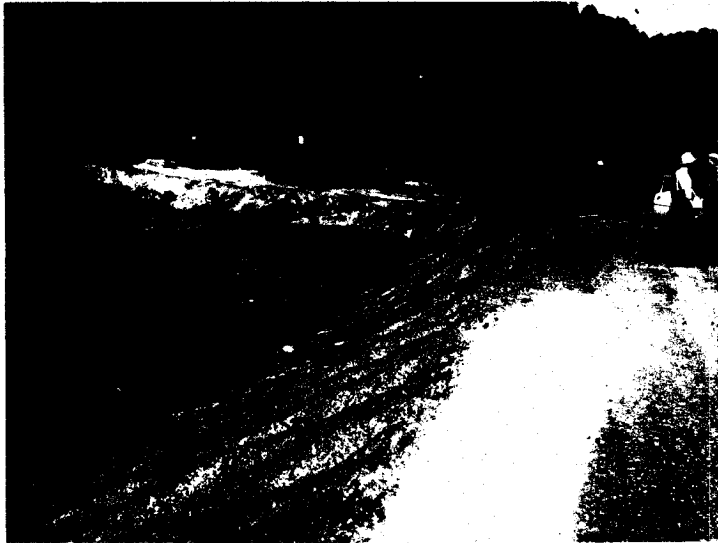
①

Plant personnel have completed raising the dikes around the initial ash area with heavy ash to approximately elevation 768. The outside slope of the east dike is approximately 6:1 and is in very good condition. The outside slopes of the north and west dikes are approximately 2:1 with the outside slope of the west dike developing some erosion gullies (picture 1). The top width of the dikes is approximately 30 feet. The north dike is having ash deposited against it. The outside slope of the west dike will be flattened. The dikes are named on the attached print of drawing 10N400.

*Slope of Dike parallel to R.R.
built by plant. Note steep slope.*

1. Dress up the outside slope of the west dike and slope to 3:1, maintaining a top width of at least 16 feet.
2. On the outside slopes of the east and west dikes of the initial area, establish two experimental plots, on each slope, about 50 feet long. One plot shall be covered with 6+ inches of soil fertilized and seeded; the other plot shall be lined to neutralize the ash, then fertilized and seeded. We recommend type 7 grass mixture for seeding. Seeding and fertilizing shall be in accordance with section 100 of the T-1 Specifications. Design shall be notified of the results of these experiments.

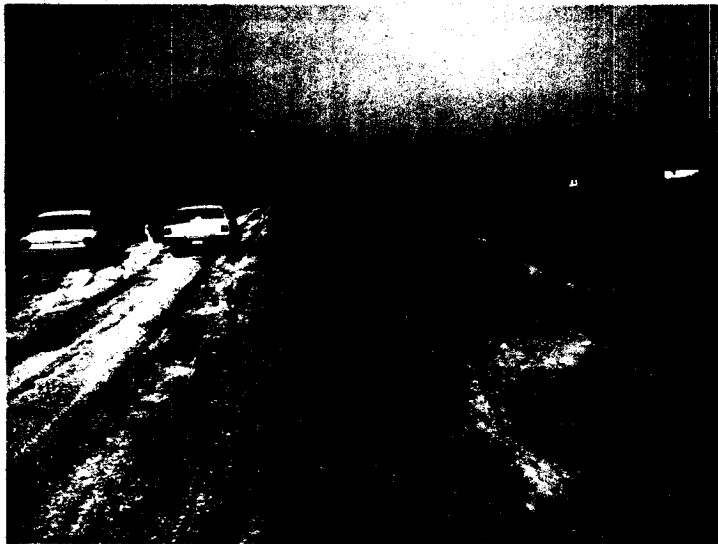
②

No raising has been done on dike C. The plant personnel have attempted to establish vegetation on the outside earth slope of dike C, with type 7 mixture as recommended; but at the time of our inspection, very little growth could be seen. Several logs and other trash were seen on the outside slope of dike C (picture 3). The top portion of the outside slope of dike C is too steep for wave protection of high flood and should be flattened (picture 2). Picture 4 shows the inside slope of dike C which has eroded vertically. This has occurred in several places along the inside slope. At the present time, the

*Dike along Emory River: Arrow
points to mulch where an attempt
has been made to establish grass.
Not certain why seed has not
sprouted.*

5. Reseed, with type 7 mixture, the outside earth slopes of dike C, where necessary.
6. Flatten the upper portion of the outside slope of dike C (picture 2) to 3:1 or flatter, being sure to leave a top width of at least 16 feet.
