KINGSTON STEAM PLANT - ANNUAL ASH DISPOSAL AREA INSPECTION

On the attached marked print of drawing 10N400, the different ash disposal areas and dikes are designated.

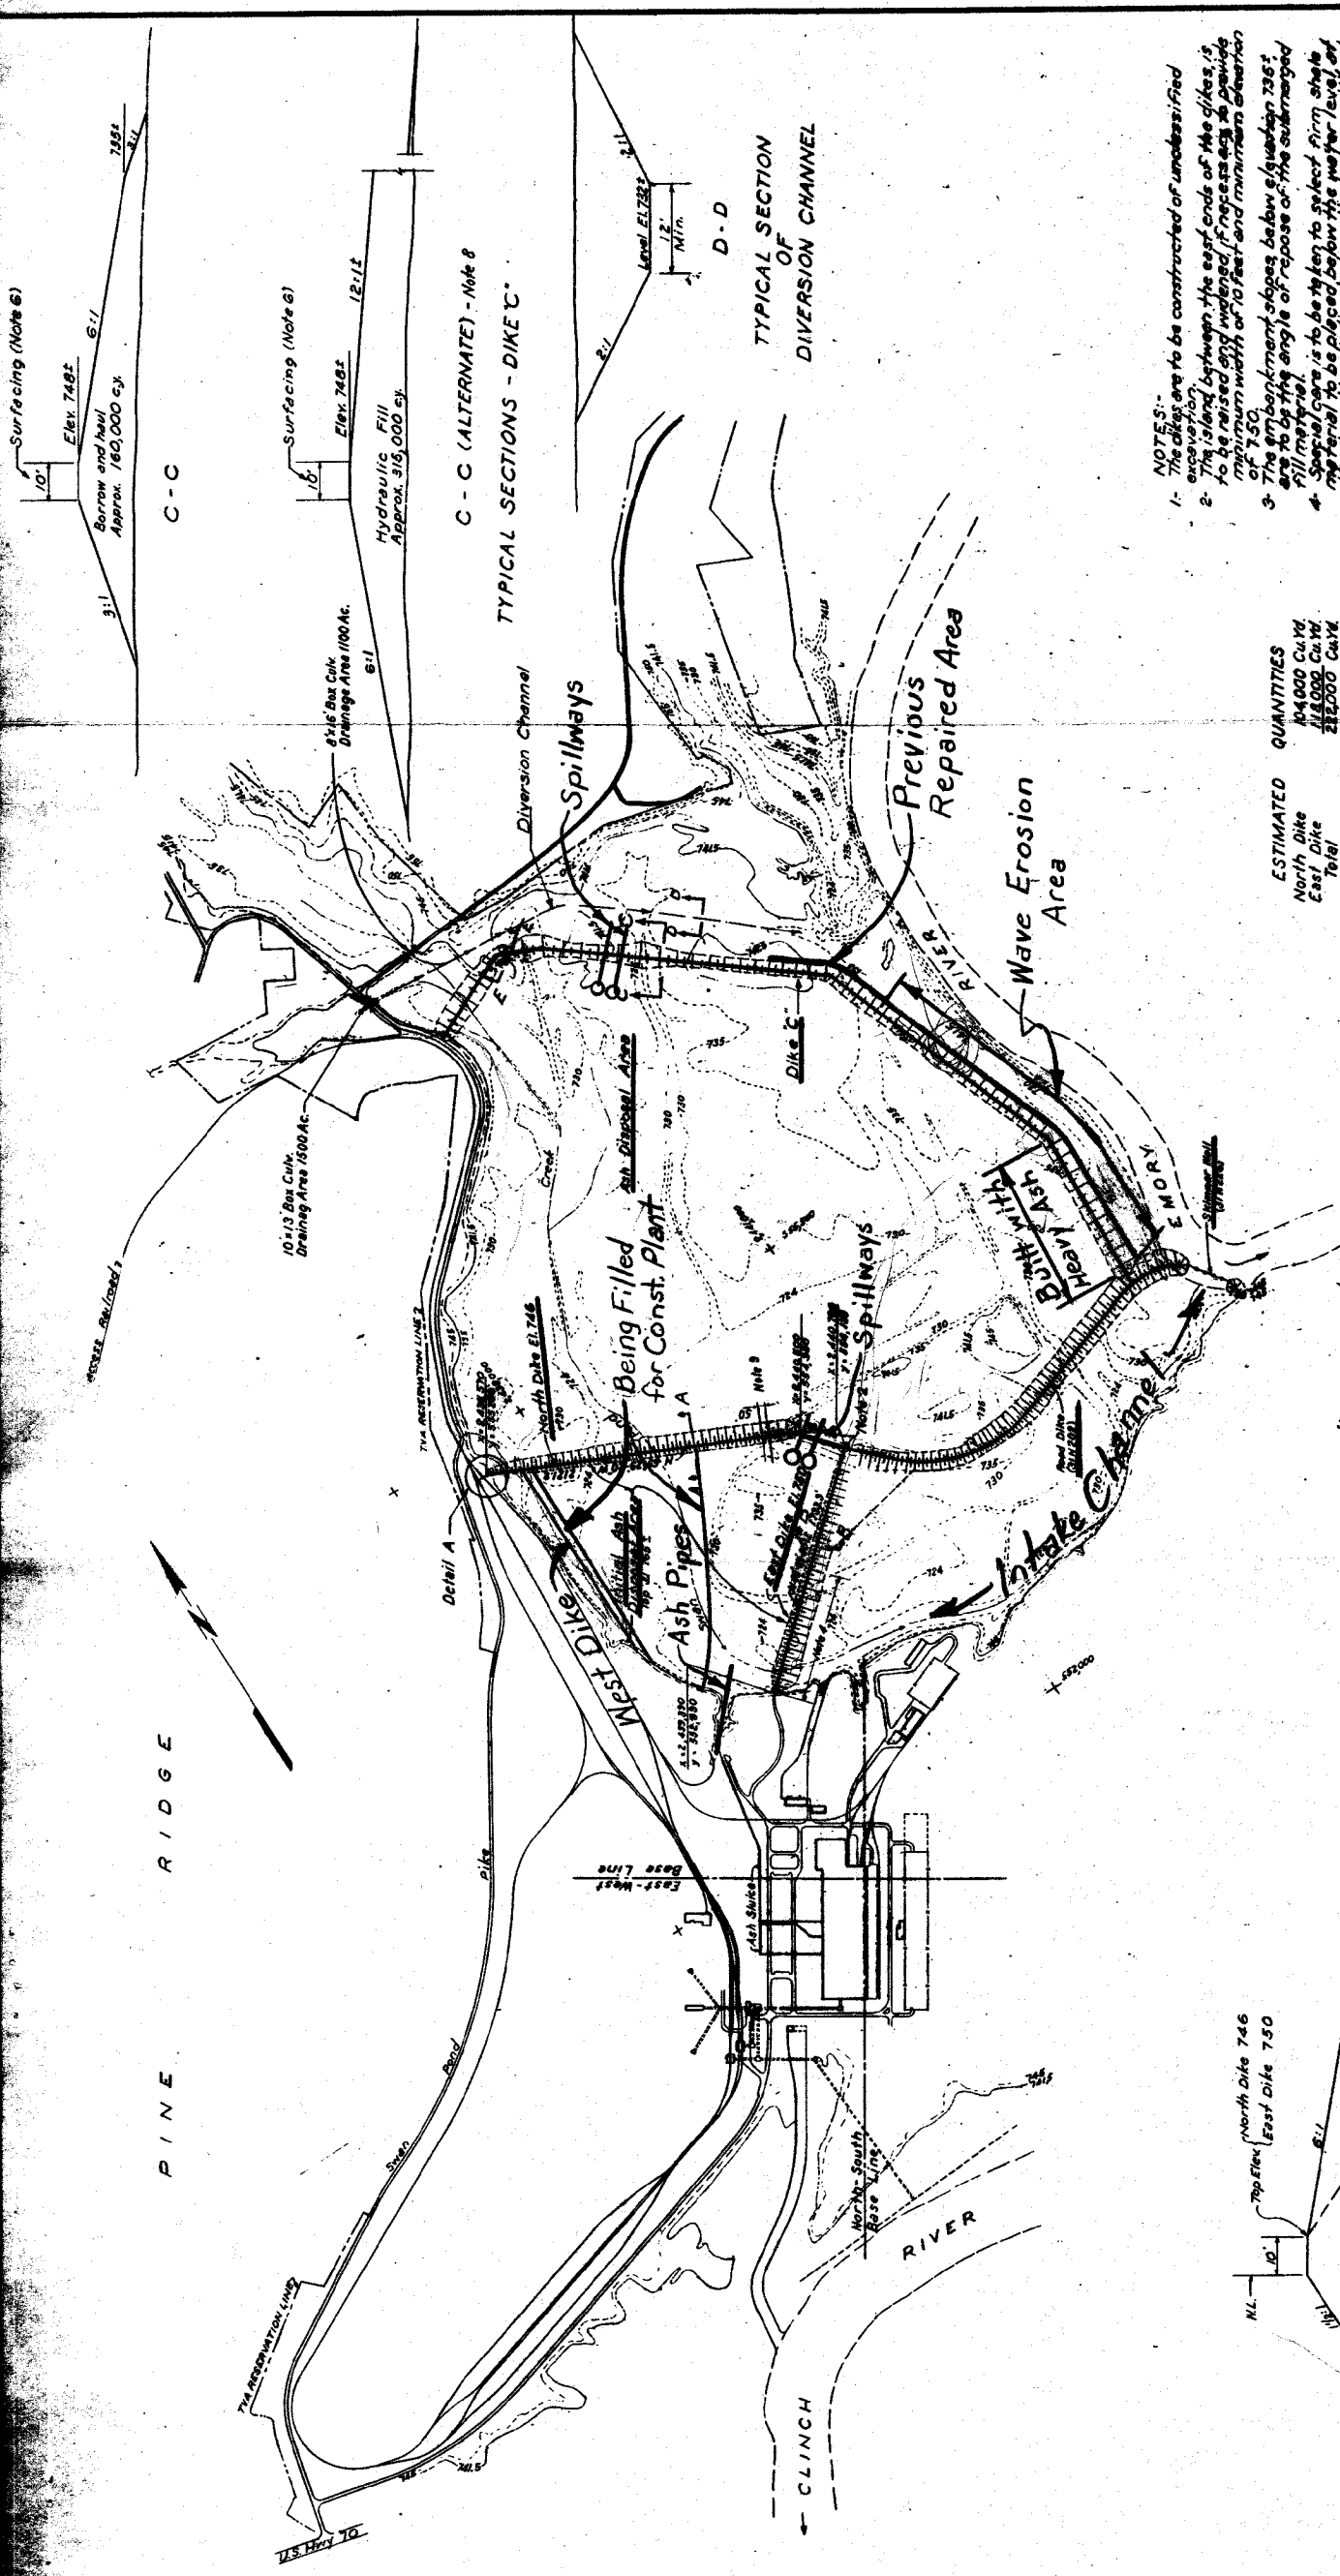
GENERAL	
ASH DISPOSAL AREA	
KINGSTON STEAM PLANT TENNESSEE VALLEY AUTHORITY	
DIVISION OF DESIGN	APPROVED
SUBMITTED	RECOMMENDED
J. B. [Signature]	C. C. [Signature]

During the 1969 inspection, an area which eroded due to wave erosion was found on the outside toe of dike C, as shown on the print of drawing 10N400. This area was repaired in 1970 by rebuilding the toe with rockfill, and no further erosion of this area has taken place. Since 1970 the toe of dike C south of the original erosion has shown some small amounts of wave erosion, but none of any consequence until this inspection. The high flood waters and heavy rainfall of the past year have increased the erosion of the outside toe of dike C. The toe of the outside slope has eroded away leaving vertical slopes varying in height from one foot to approximately four feet. This area extends from the original (1969) erosion south to the junction of dike C with the road dikes. The new erosion will have to be repaired. Although the erosion is now not serious enough to be an immediate danger to the dike, further erosion can become so; and a long delay will only add to the expense of the repair. When Watts Bar Lake is drawn to coming winter elevation, another inspection of the erosion should be made to determine the full extent of repair needed. The plant personnel will coordinate the time of inspection with the Divisions of Power Production and Engineering Design.

With the above exception, all the dikes are in good condition with the tops smooth and sloped to the inside. The vegetation on the outside slopes is good with few exceptions. The main exception is the portion of dike C that was built with heavy ash, noted on the print of drawing 10N400. Seeding of this area is not planned at this time. The other exceptions are small isolated areas that are being worked on by plant personnel.

1. Rebuild, with rockfill, the toe of the outside slope of dike C where the erosion has taken place. The rebuilding is to be deferred until another joint inspection of the area can be made. This inspection is to be done at the earliest time when the elevation of Watts Bar Lake is such that a more detailed inspection can be made, approximately the middle of October. Plant personnel is to coordinate the time of inspection.
2. Remove the trash from the outside slopes of the dikes, especially the road dike.
