KINGSTON STEAM PLANT - ANNUAL ASH DISPOSAL AREA INSPECTION

September 27, 1974

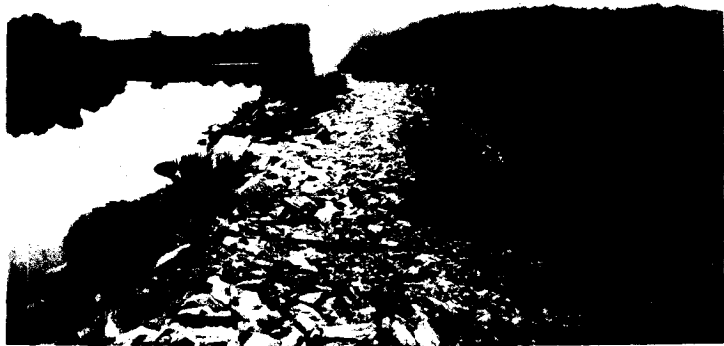
The area of erosion on the outside toe of dike C has been repaired with rockfill; and the slope above the rockfill that was disturbed during the repair operations has been smoothed, and an excellent cover of vegetation established (pictures 1 and 2).

2. DIKE "C" SHOWING NORTH END
OF EROSION AREA REPAIRED
WITH ROCK FILL. AGAIN NOTE
THE GOOD VEGETATION ON SLOPE.

1. The toe of the outside slope of dike C where the erosion had taken place has been rebuilt with rockfill as recommended. This should eliminate any further erosion in this area. The dike slope above the rockfill which was disturbed during repair of the toe has been graded smooth, covered with earth where needed, and seeded. An excellent cover of vegetation has been established on the slope including that part of the dike originally built with ash.
2. The trash has been removed from the outside slopes of all dikes.

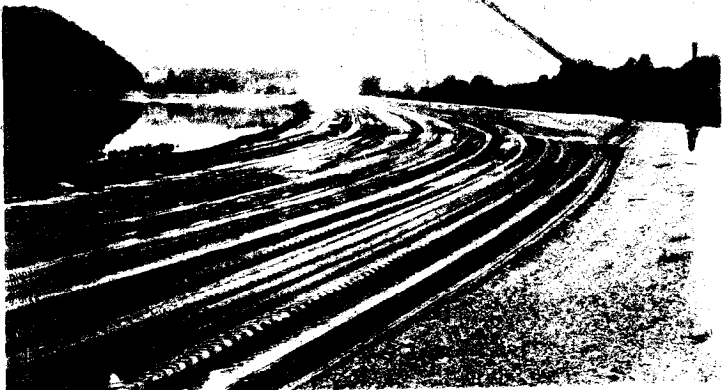
The outside 15 feet of the top of dike C has been raised approximately 1.5 feet with material that was excavated from the foundation area of the new stacks. The material was hauled to the dike in trucks, and dumped, spread with dozers and patrol graders, and equipment compacted. The raising of the outside 15 feet of the top of dike C was done to insure adequate freeboard when the water level inside the disposal area was raised. This material is used for freeboard purposes only and will be only the top of a berm when the dike is raised for additional storage capacity. The raising was agreed to in telephone conversations between DED and the plant.

3. DIKE "C" SHOWING OUTSIDE 15'±
RAISED TO INSURE ADEQUATE
FREEBOARD. (ARROW) AND INSIDE
WIDENED WITH ASH.
