SUBJECT: KINGSTON STEAM PLANT - ANNUAL ASH DISPOSAL AREA INSPECTION

On September 18, 1980, Terry Pratt of F&H PR and Jerry Glover, Don Galloway, and I of EN DES inspected the ash disposal areas at Kingston Steam Plant. The findings were discussed with Ford Clayton, Assistant Plant Superintendent.

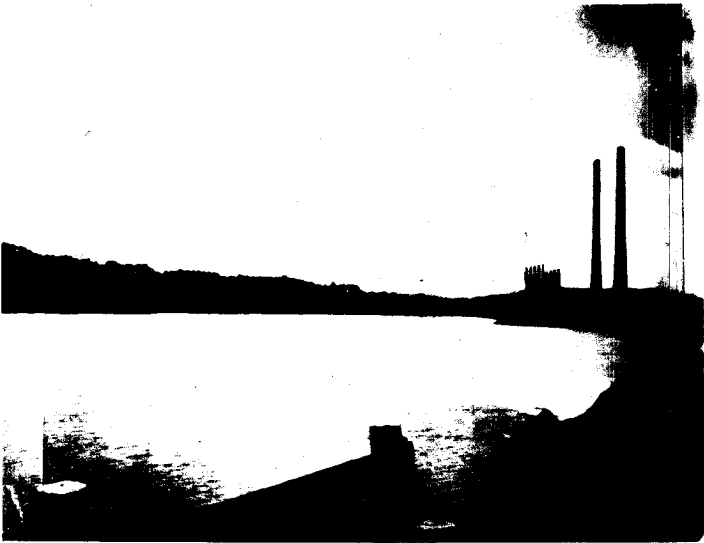
⑤
NOTE FLY ASH SLURRY ON
STILLING POOL

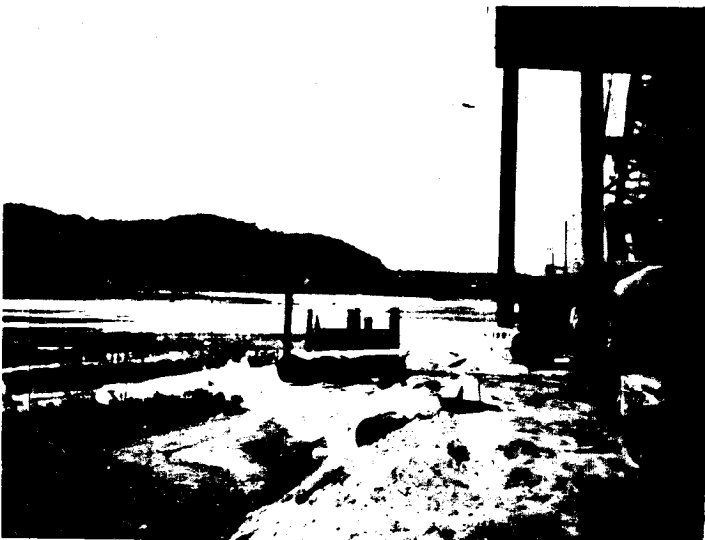
⑨

The buoyant skimmer in the divider dike flow-through spillway is not adequate to prevent ash from passing into the stilling pool area. This is due mainly to the unusually high quantity of fly ash slurry present at Kingston Steam Plant. This high quantity causes a large buildup of slurry on the upstream side of the skimmer (pictures 6 and 7) which causes an unacceptable amount of fly ash to pass into the stilling pool area. In an attempt to alleviate this situation, plant personnel have designed and fabricated and were installing on the day of the inspection a sheet metal spillway and skimmer (pictures 9 through 15).

This spillway has dimensions of 5 feet by 10 feet and the skimmer has a dimension of 10 feet by 20 feet. There are two 36-inch corrugated metal pipes which extend from the spillway through the divider dike into the stilling pool. EN DES had no input into the design or location of this structure and, subsequently, do not feel responsible for its adequacy. We feel the ash finger dike, which the plant constructed to facilitate the placement of the new structure, should be left in place. This would provide access to the structure for routine maintenance and to raise it as the pond level rises. We understand the spillway through the divider dike will be plugged and the floating skimmer removed after the field-constructed skimmer is in place.

INSIDE OF SKIMMER
DESIGNED AND BUILT BY
PLANT PERSONNEL

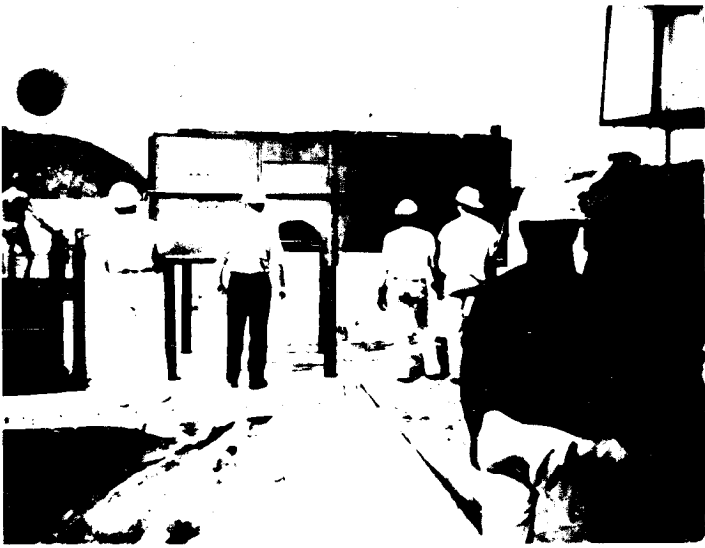
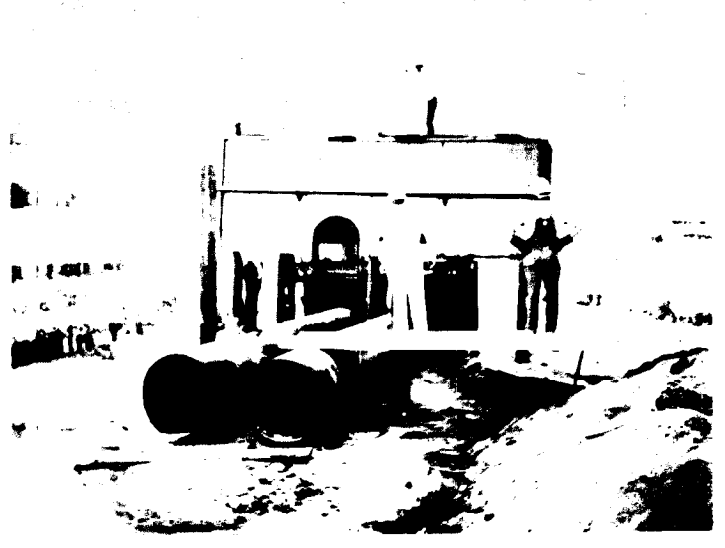
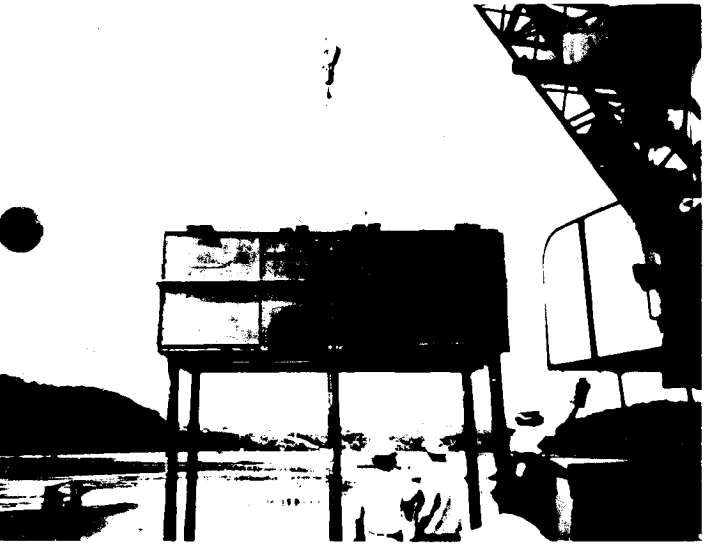
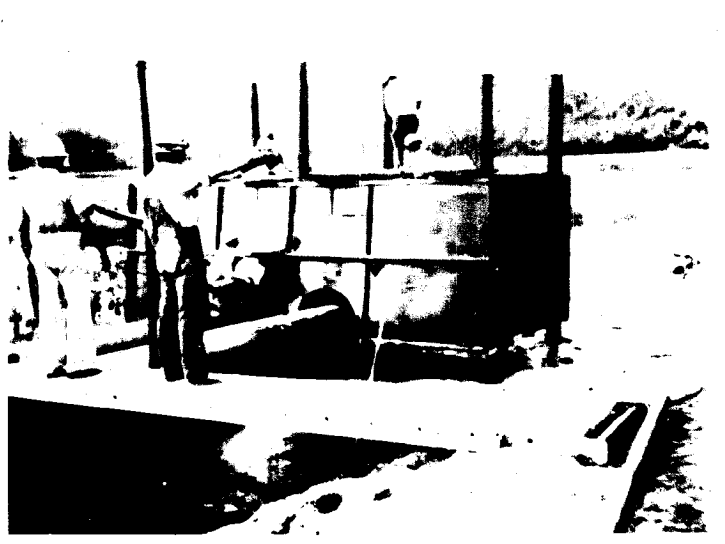
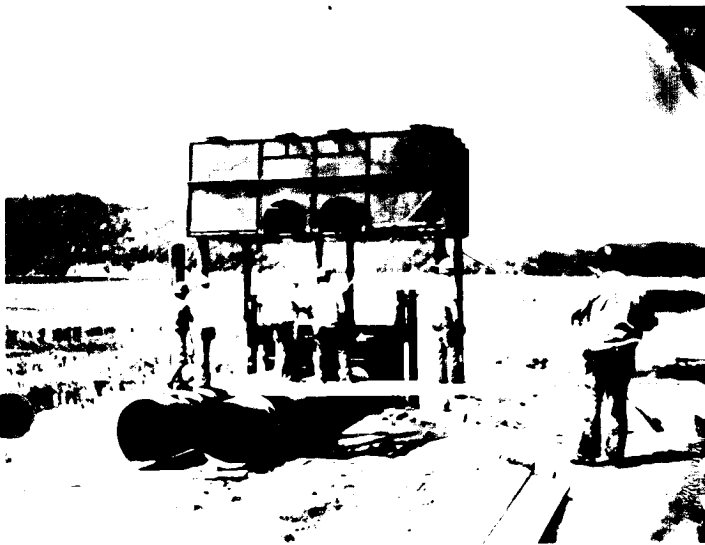
PLANT PERSONNEL ASSEMBLING
THEIR SKIMMER

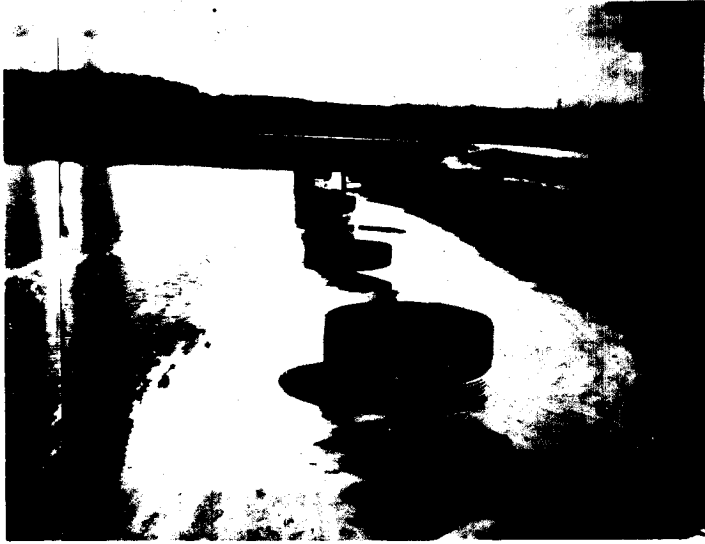
The standard spillways and skimmer in the stilling pool area appear to be in good condition and functioning properly (picture 1). The spillway outlets are discharging equally (picture 4), and the concrete end wall is in good condition. The riprap outfall to the intake channel appears to be in good condition with no sign of erosion. There was no sign of loss of ash into the intake channel. The weep holes in the concrete end wall of the spillway outlet pipes were seeping; however, the dike slope behind the end wall appeared to be dry and well compacted.

NOTE SKIMMERS, FLY ASH
SLURRY & VEGETATION
ON DIKE SLOPES

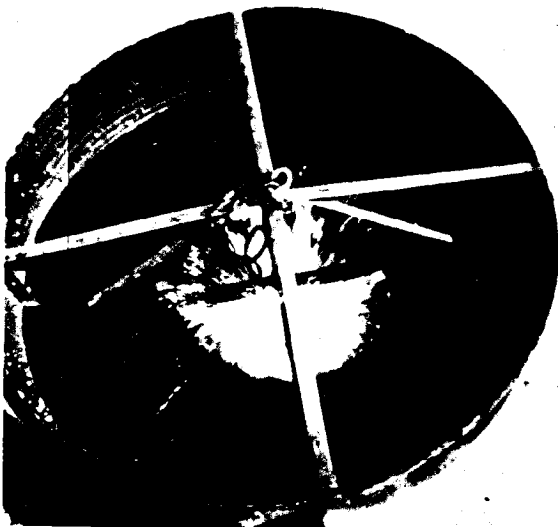
NOTE AMOUNT OF SLURRY
OUTSIDE SKIMMER AND
CLEAR WATER INSIDE
SKIMMER

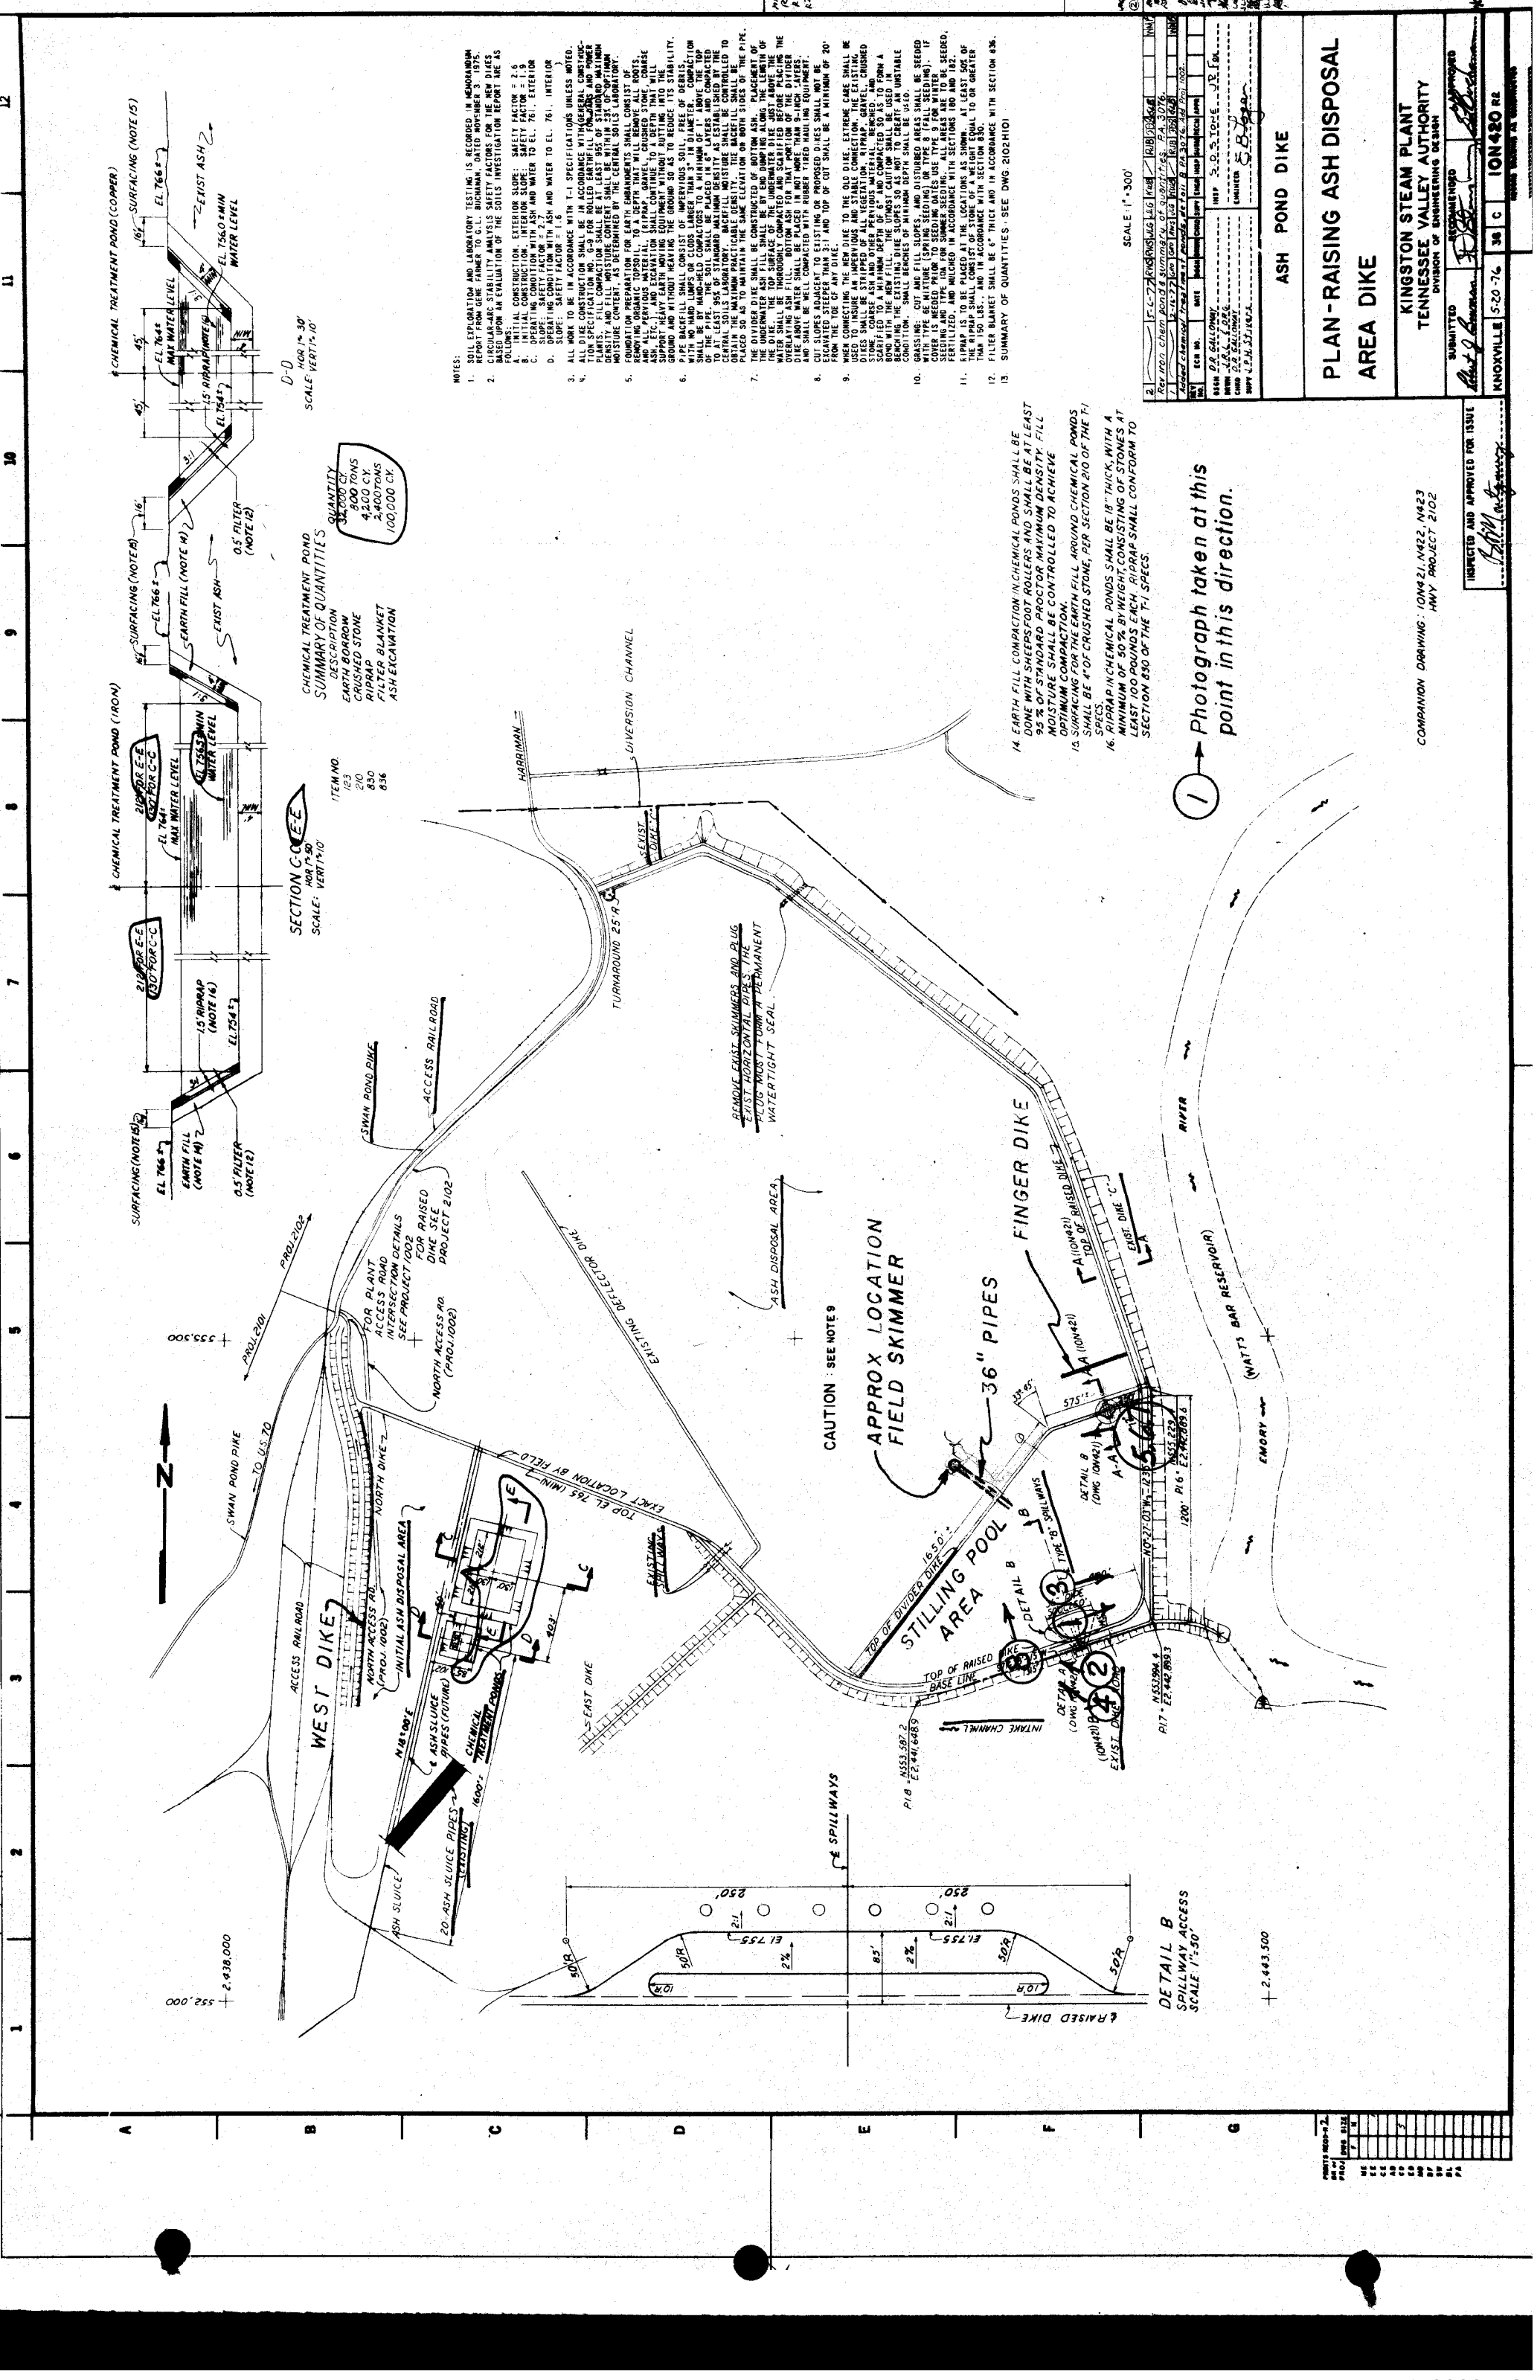
PLAN-RAISING ASH DISPOSAL AREA DIKE

On the attached print of drawing 10N⁴²⁰₂₄₀, the different areas are designated.
