TENNESSEE VALLEY AUTHORITY

SUBJECT: KINGSTON STEAM PLANT - ANNUAL ASH DISPOSAL AREA INSPECTION

DATE : August 25, 1982

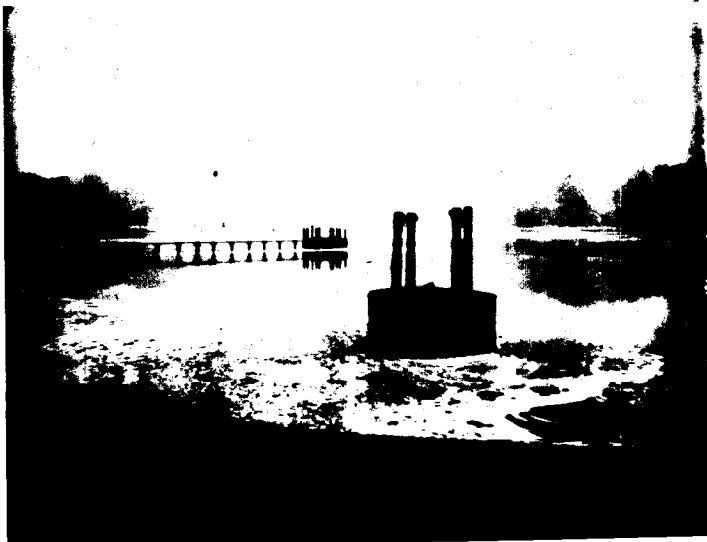
①

The plant-designed and plant-constructed spillways and skimmers from the ash disposal area to the stilling pool area appear to be in good condition and functioning properly (picture 1). There has been no noticeable settlement of these structures, although it was reported to us during our subsequent discussion with Mr. Kennedy that plant personnel had encountered a seam of very soft material while driving the piles for the foundations of these structures. This seam of soft material was reported to be 10 to 12 feet beneath the earth surface and approximately 10± feet thick. The outlets of these spillways were in good condition (pictures 2 and 3). Some algae was present in the stilling pool area around the outlet for the circular spillway.

*Looking west at ash disposal area. Spillways & skimmers
Plant designed and constructed*

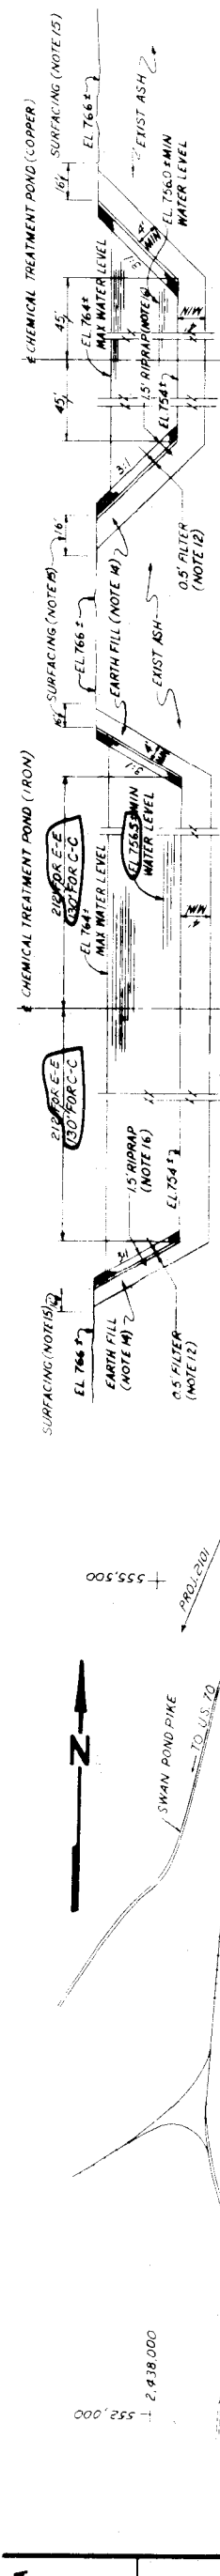
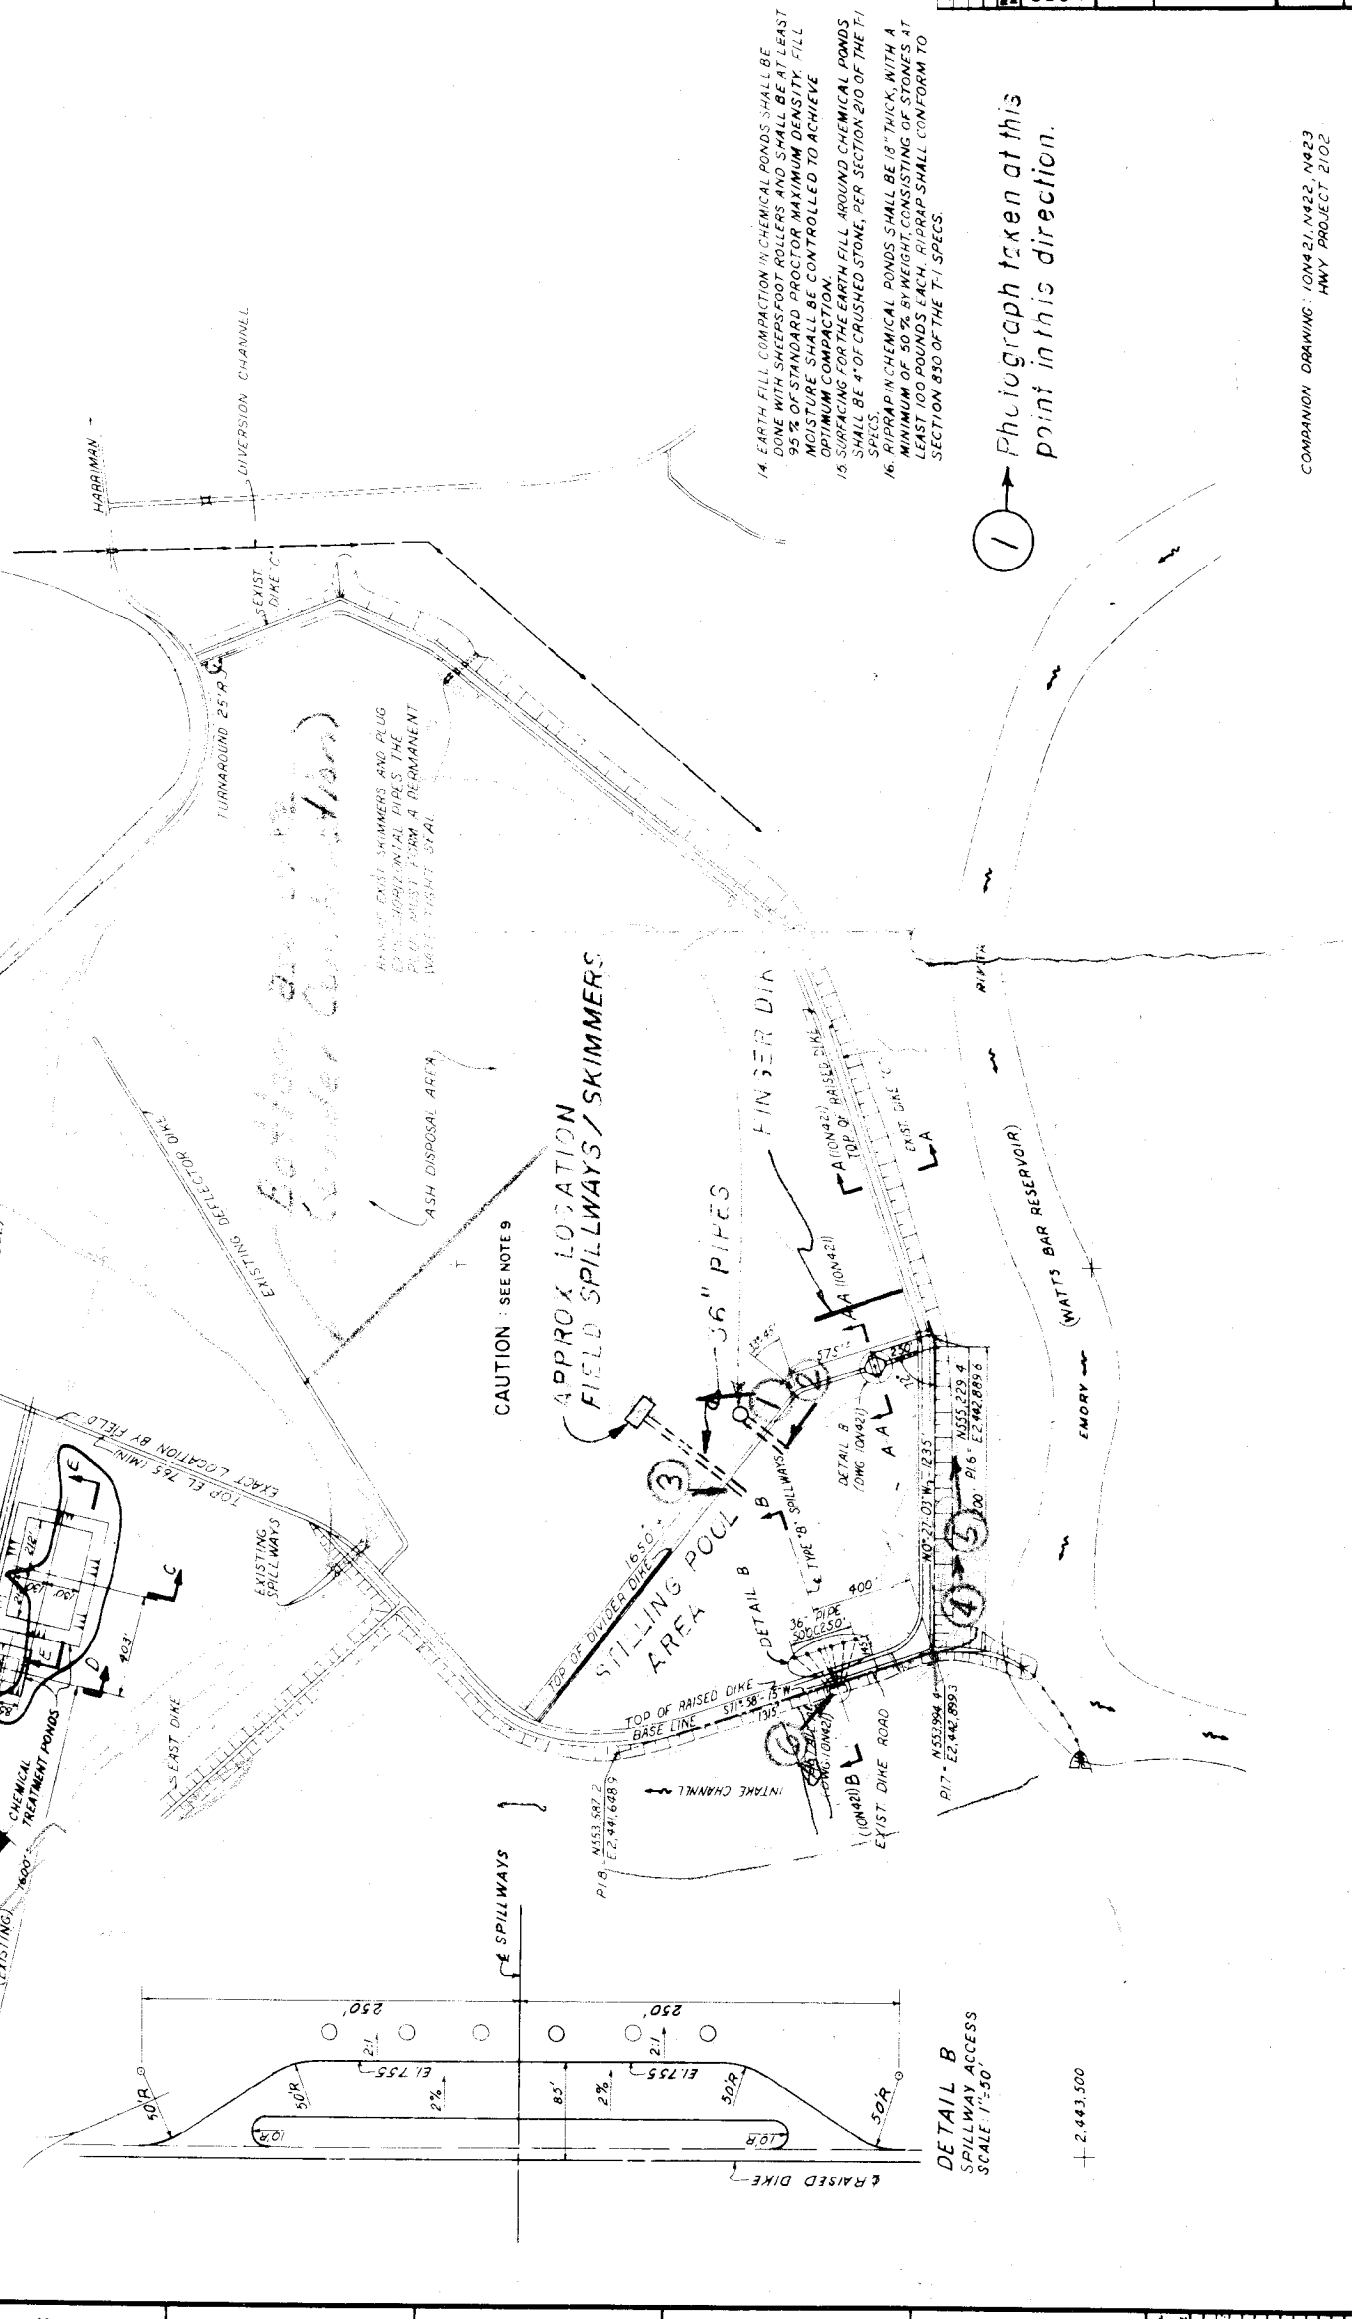
PLAN-RAISING ASH DISPOSAL AREA DIKE

On the attached print of drawing 10N420, the different areas are designated.

An interior dike of bottom ash, extending northeast from the existing deflector dike in the approximate location shown on the attached print of drawing 10N420, is presently under construction.
