TENNESSEE VALLEY AUTHORITY

SUBJECT: KINGSTON STEAM PLANT - ANNUAL ASH DISPOSAL AREA INSPECTION

FDP '83 0920 012

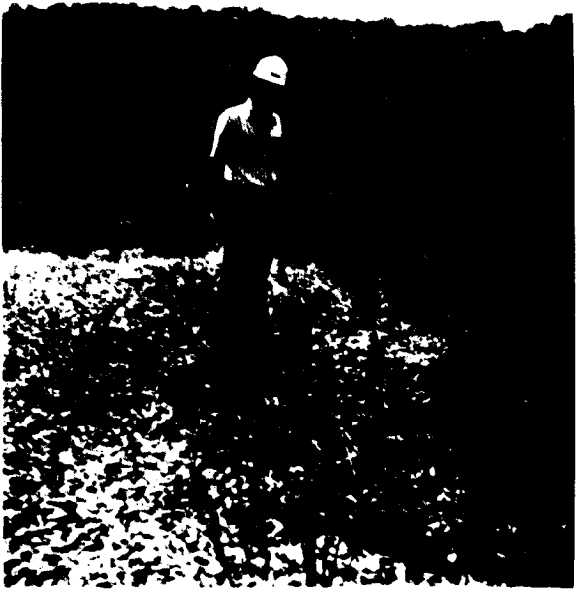
The dikes appear to be stable and generally in good condition. Wetness is still evident at the toe of exterior slope of the south end of dike "C" (see picture number 1 and recommendation number 1). Several small trees were observed along the slope of this dike (see recommendation number 2).

① *SEEPAGE AT TOE OF DIKE "C".*

1. Plant personnel should continue to monitor the seepage at the toe of the exterior slope of the sound end of dike "C". Should contact F&H PR, Chattanooga, and EN DES immediately if any changing conditions are observed.
2. Should remove all small trees and brush from exterior slope of dike "C".
3. Should remove any vegetation within the spillway/skimers.
4. Should remove the weeping willow trees and vegetation at and around the base of the discharge end wall.

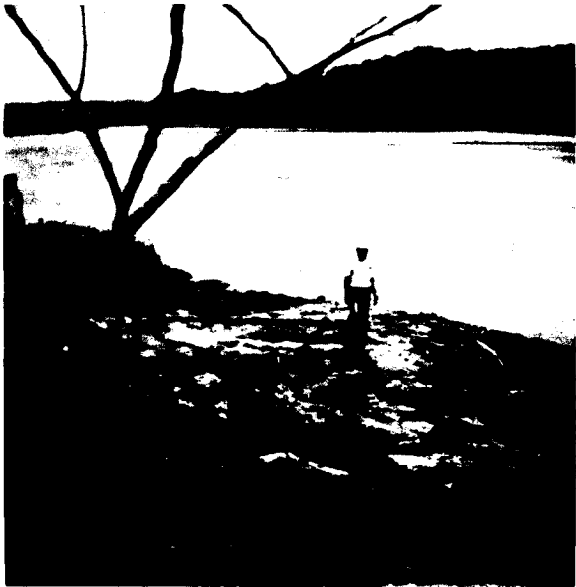
The seepage repair along the east dike adjacent to the condenser intake channel (see pictures numbers 2 and 3) will begin by late September. CSB will construct a clay key and slope cover in accordance with EN DES plans.

② *SEEPAGE AT EAST DIKE.*

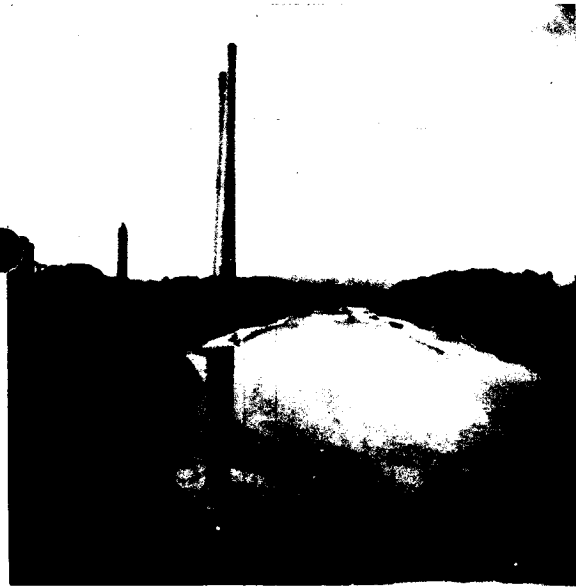
The vegetation at the base of the discharge end wall appeared to be excessive (see picture number 4 and recommendation number 4).

- ④ **DISCHARGE /OUTLET NOTE:
VEGETATION.**
