TENNESSEE VALLEY AUTHORITY

SUBJECT: KINGSTON STEAM PLANT - ANNUAL ASH DISPOSAL AREA INSPECTION

FEP '840912 003

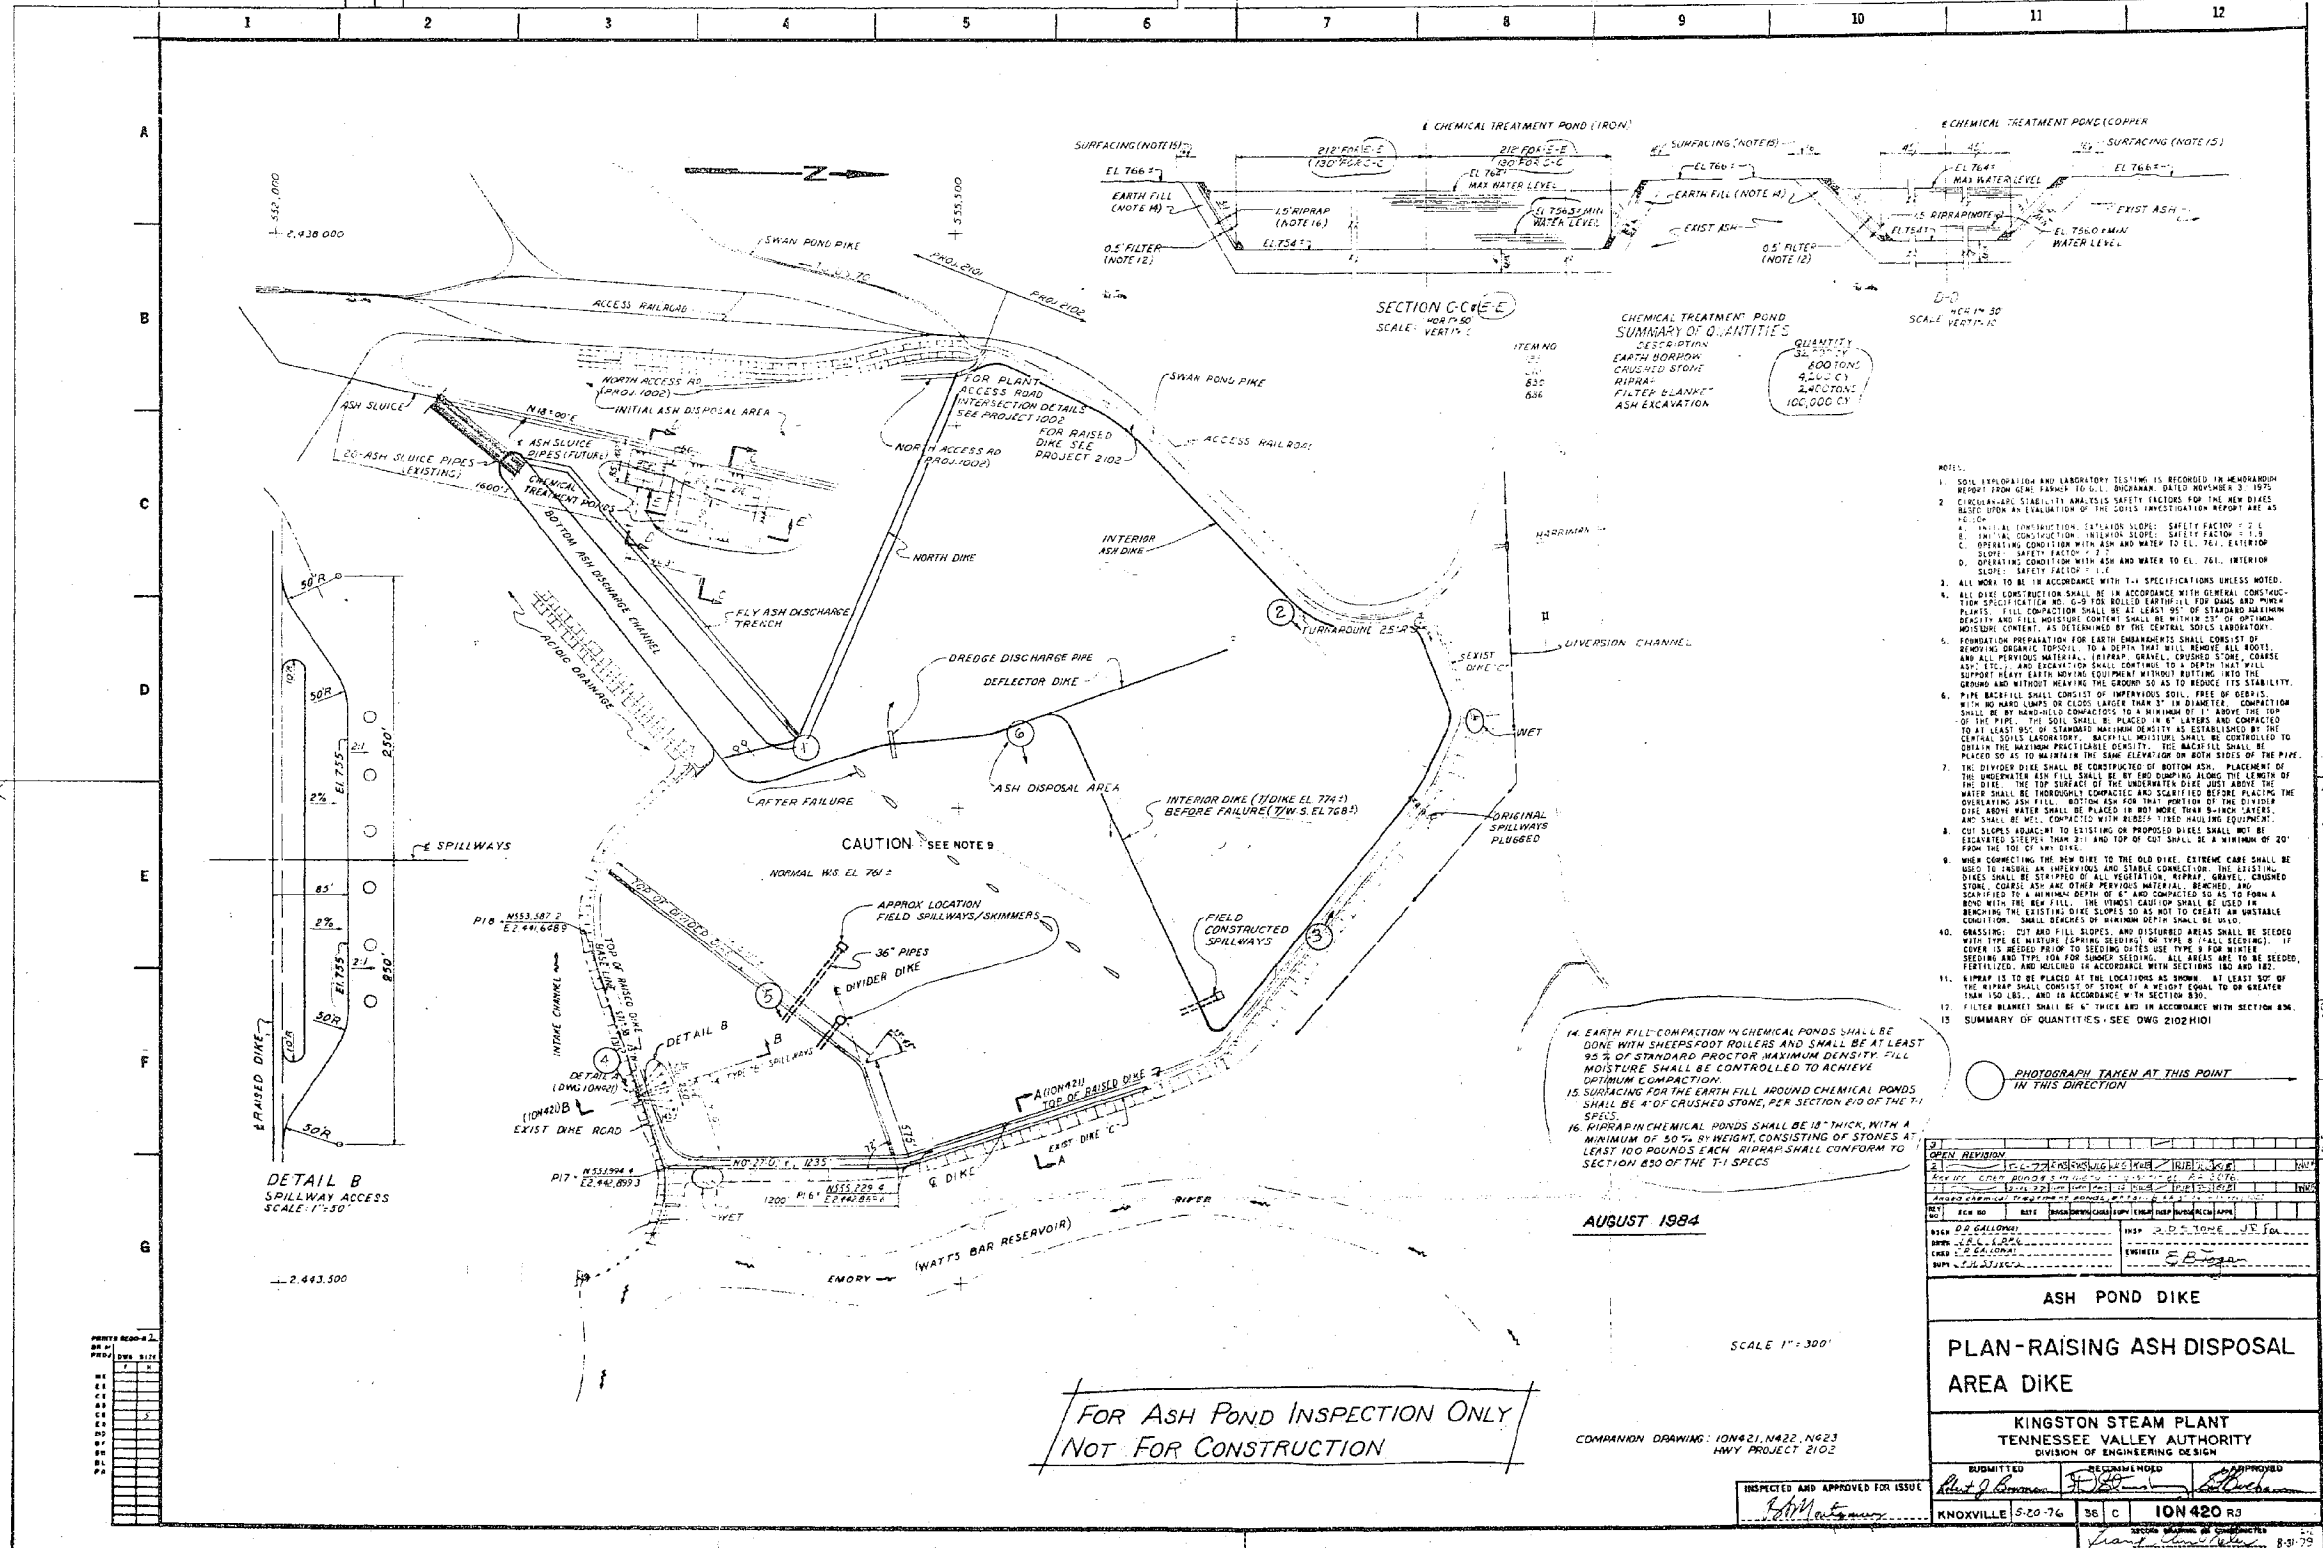
INSPECTED AND APPROVED FOR ISSUE	DATE	PROJECT NO.
[Signature]	5-20-76	36 C ION 420 R3

On the attached print of drawing 10N420, the different areas are designated.

Pooled water at the base of the raised dike was also observed at the north end of dike "C." This area is indicated on the attached drawing 10N420 (see recommendation No. 1).

F&H PR constructed an interior ash dike for the containment of material dredged by a private contractor. On the morning of August 8, a failure of this dike resulted in the loss of much of the dredged material to the previously dredged area (see attached print of 10N420). With the sudden rise in the water/ash elevation, the plant constructed spillways and skimmers were inundated, thus discharging floating ash into the stilling pool.

1. Plant personnel should continue to monitor the seepage at the indicated locations and contact F&H PR, Chattanooga, and EN DES immediately if any apparent changes are observed.
2. Should remove all small trees and brush from exterior slopes.
3. Slope stability analyses of the exterior dikes should be performed to ensure their stability before any additional loads (dredging or stacking) are incurred. Engineered interior dikes could reduce the risks of their failure also.
