SUBJECT: KINGSTON STEAM PLANT - ANNUAL JOINT INSPECTION OF THE ASH DISPOSAL AREAS BY
OE AND F&H PR

KINGSTON STEAM PLANT

ASH DISPOSAL AREAS

TITLE KINGSTON STEAM PLANT - ANNUAL JOINT INSPECTION OF THE ASH DISPOSAL AREAS BY OE AND F&H PR		REPORT NO. 85-20	
		PLANT/UNIT	
		SAR SECTIONS	
VENDOR	CONTRACT NO.	KEY NOUNS	
	REV	(FOR MEDS USE)	MEDS ACCESSION NUMBER
APPLICABLE DESIGN DOCUMENTS	R0		B41 85 0 709 004
	R1		
	R2		
REFERENCES	R3		
	R4

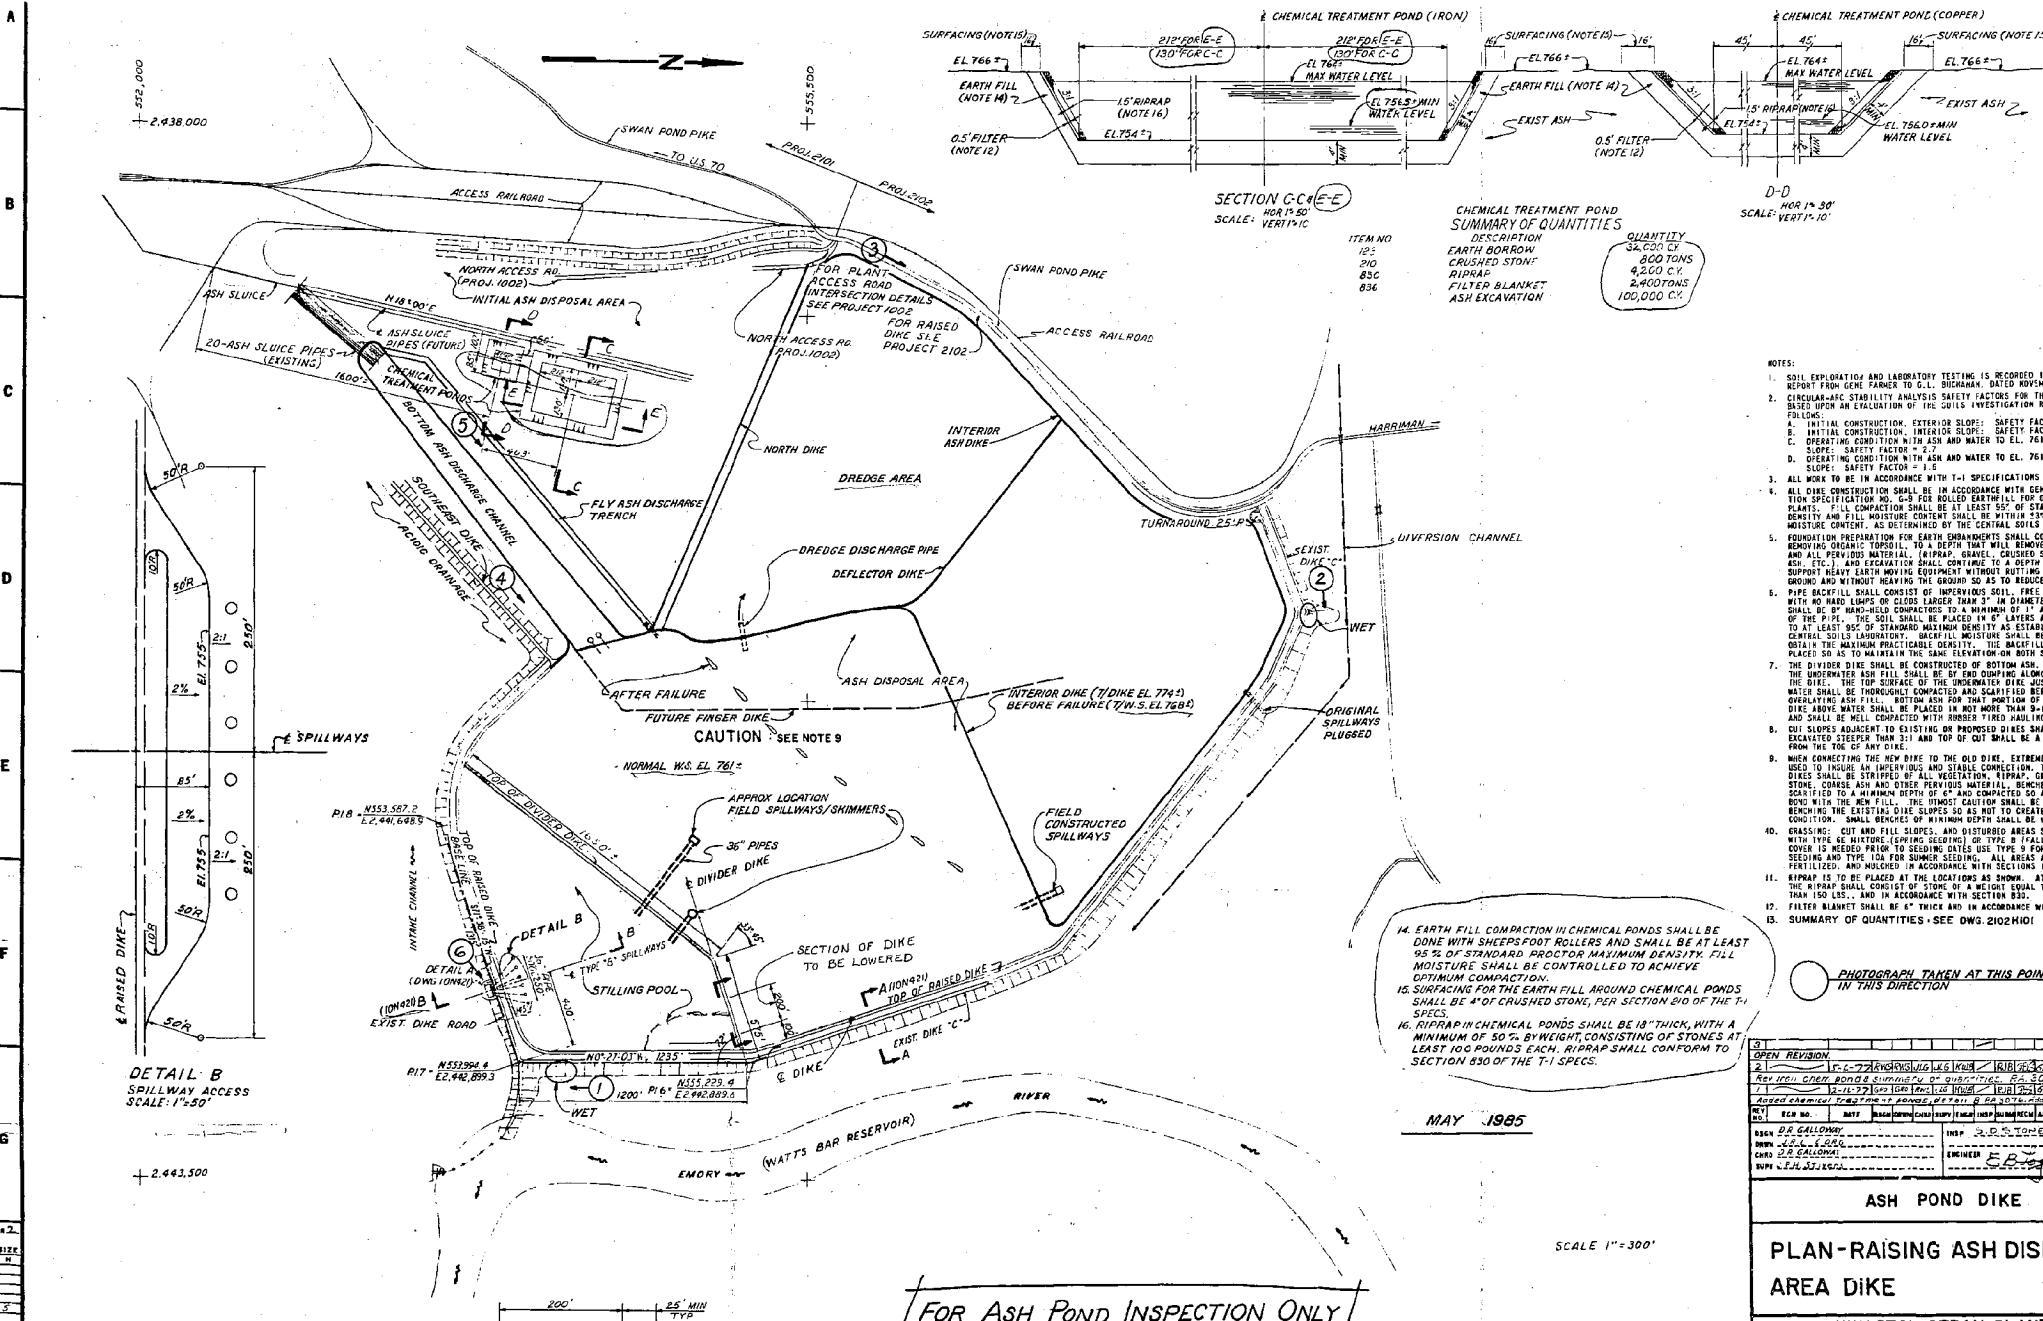
ASH POND DIKE
PLAN-RAISING ASH DISPOSAL
AREA DIKE

- 2.2 *The two previously noted areas of wetness along the toe of dike "C" are still very evident (pictures 1 and 2). These areas are indicated on the attached drawing 10N420 (see recommendations No. 6.2 and No. 6.3). A repair scheme for the area at the south end of dike "C" has been proposed by OE and a cost estimate prepared. This cost estimate has been transmitted to F&H PR (B65 850524 001).

- 2.6 After the failure of the internal dredge dike, plant personnel raised the top of the divider dike approximately two feet to elevation 765 \pm . This is the same elevation as the top of the earth perimeter dikes (see recommendation No. 6.6).

- 6.6 In order to reduce the potential for ash pond water to overflow the perimeter dikes, plant personnel should lower the top of the divider dike by two feet to elevation 763 for a length of 200 feet along the dike. The recommended location of and a section taken through the portion of the dike to be lowered is shown on the attached print of drawing 10N420.
