SUBJECT: KINGSTON STEAM PLANT - ANNUAL JOINT POWER ENGINEERING AND FOSSIL AND HYDRO POWER INSPECTION OF THE ASH DISPOSAL AREA

ASH DISPOSAL AREAS

INSPECTED: MAY 6, 1987

SUBJECT: KINGSTON STEAM PLANT - ANNUAL ASH DISPOSAL AREA INSPECTION

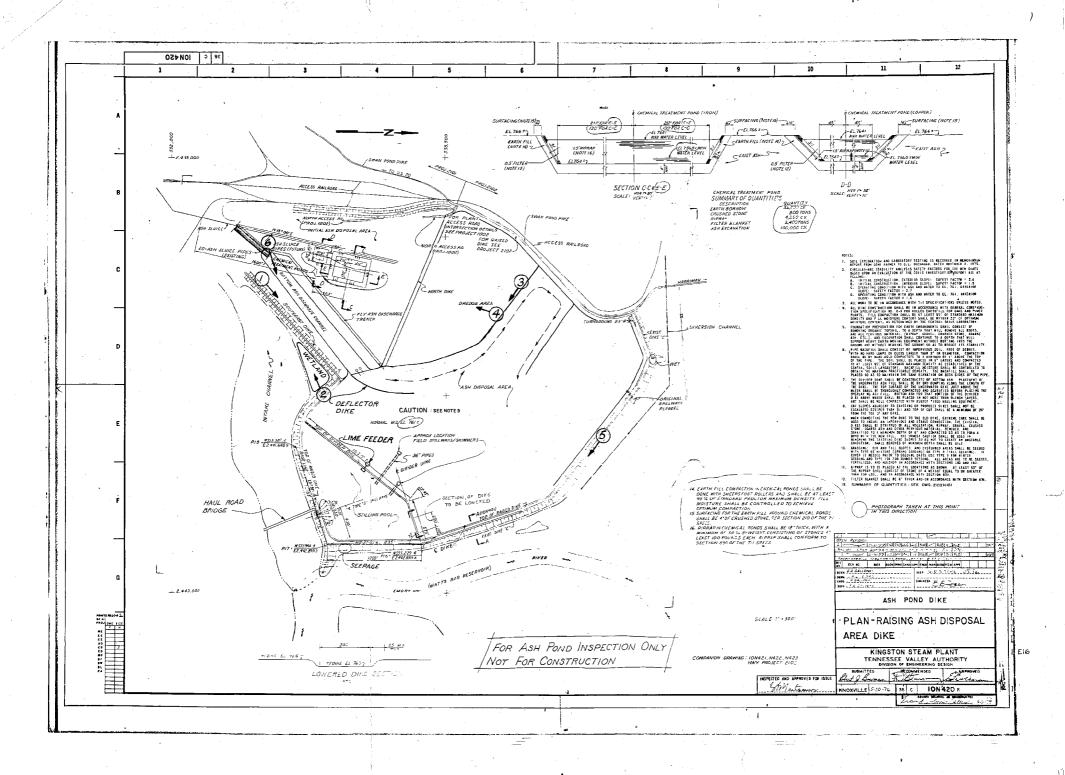
- 2.1.1 The exterior slopes have a good vegetative cover, however, small trees are again sprouting, especially at the north end (see recommendation No. 1). The top of the dikes have a good crushed stone surfacing.

EXTERIOR SLOPE DIKE C.

6.1 All small trees and brush should be removed from the dike's slopes. It is recommended that this undesirable vegetation be removed by chain or cable as to remove the root system from the earth.
