SUBJECT: KINGSTON STEAM PLANT - ANNUAL POWER ENGINEERING AND CONSTRUCTION AND FOSSIL AND HYDRO POWER JOINT INSPECTION OF THE ASH DISPOSAL AREA

INSPECTION OF

KINGSTON STEAM PLANT

ASH DISPOSAL AREAS

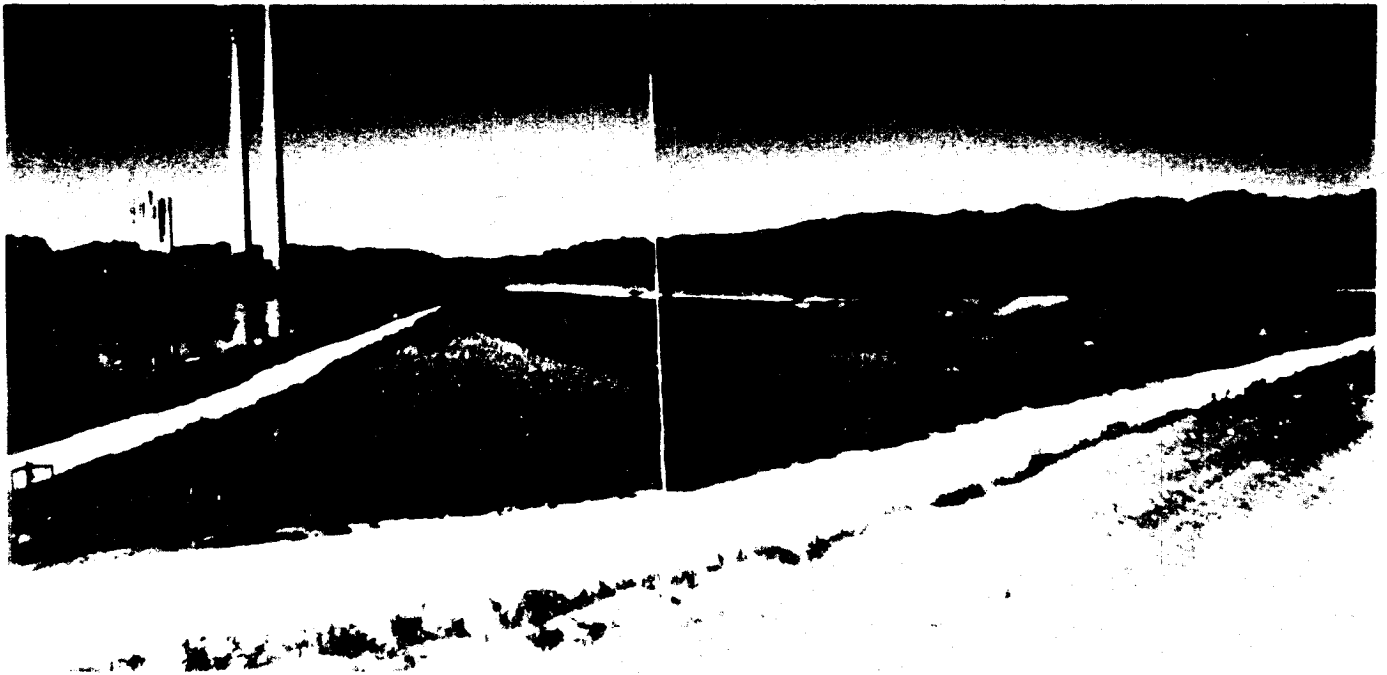
- 2.2 Seepage of redwater still persists along the exterior slope of the southeast dike near its southern end. The majority of the redwater drainage in this area of the disposal area is collected in an interceptor ditch and routed to an engineered wetland for treatment before discharging into the intake channel. At the present time, the discharge to the intake channel has been cut off and is being pumped to the ash pond. The wetland consists of several shallow ponds with cattails and is located as shown on the attached drawing 10W420.

① REDWATER COLLECTION DITCH.

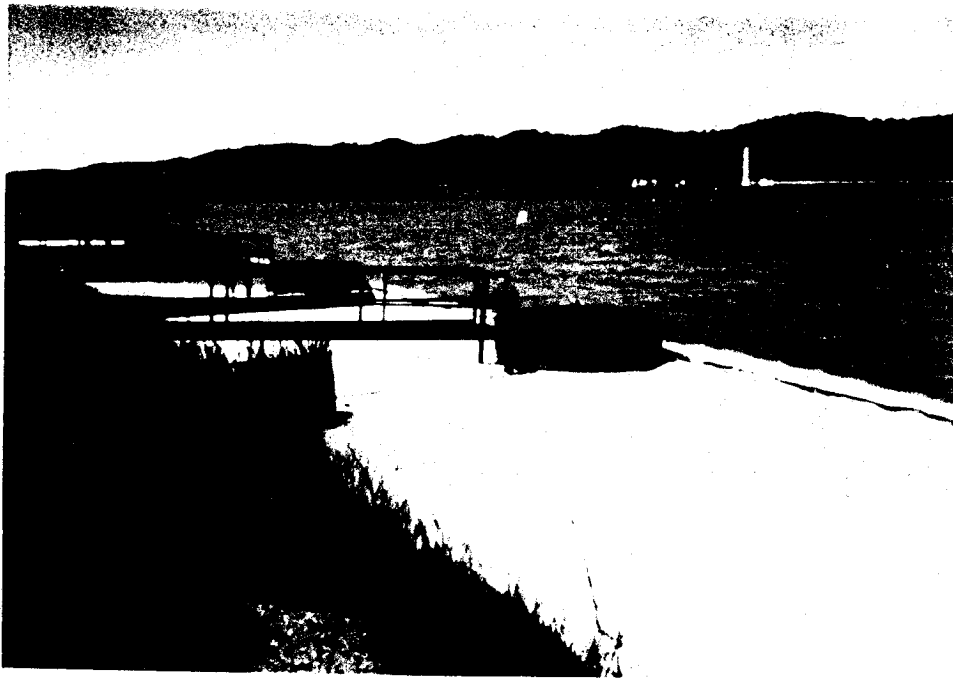
- 4.4 The outlet area for these spillways has a good rip rap cover, and the concrete head wall appears to be in good condition. There was noticeable loss of ash into the plant intake channel. The plant has a floating skimmer in front of the intake structure to skim off the floating ash lost to the intake channel. (See recommendation No. 6.2).

3 DISCHARGE TO INTAKE CHANNEL.

- 6.1 All small trees and brush should be removed from the dike's slopes as needed. It is recommended that this undesirable vegetation be removed by chain or cable as to remove the root system from the earth.
- 6.2 The floating ash within the stilling pool needs to be removed to prevent loss through the spillways.
- 6.3 All limbs and algae need to be removed from the spillway skimmers.

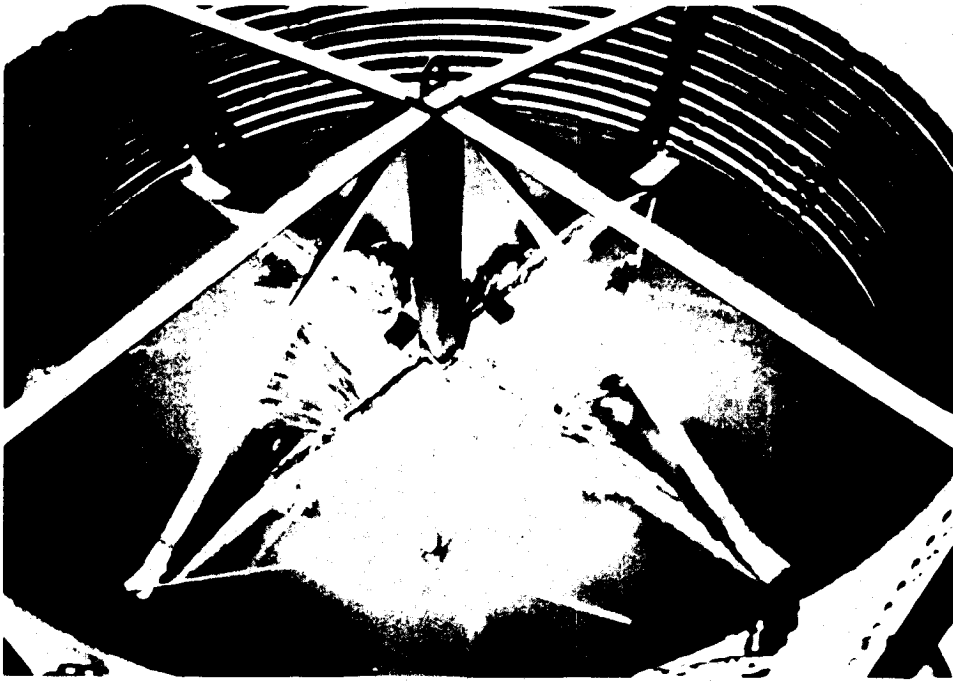
- 4.2 There was a considerable amount of floating ash trapped behind the floating skimmer around the standard spillways and skimmers. Due to this build up of ash, there was a noticeable loss of ash into the spillways (see recommendation No. 6.2).

4 FLOATING ASH AND SPILLWAY SKIMMERS.

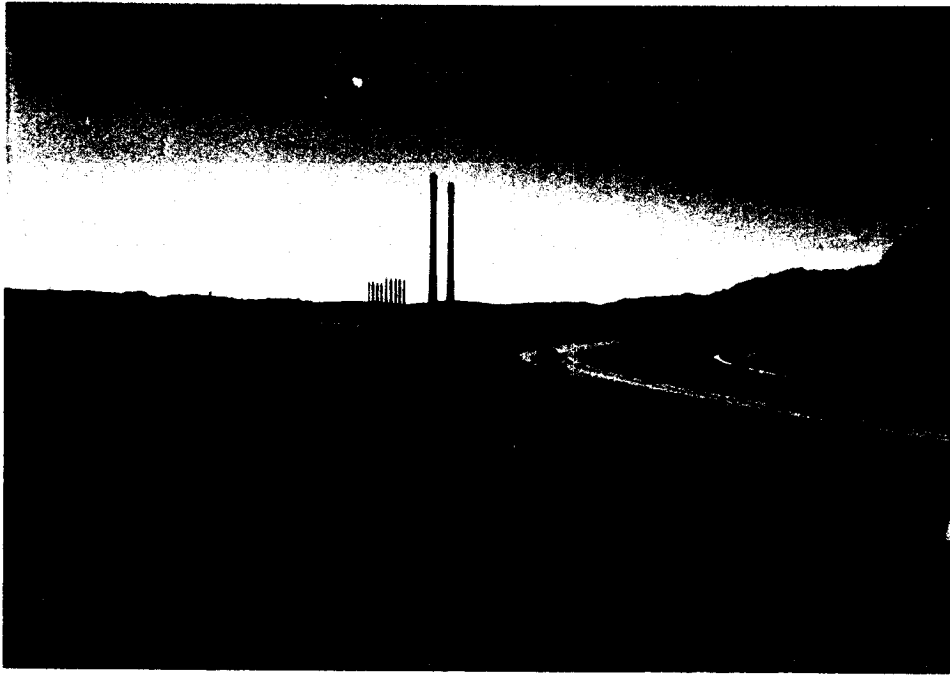
- 2.1 In general dike "C" appears to be stable although the wet area along the berm in the southeastern corner has not abated since the last inspection. Two moist areas were noted along the berm on the north end of this dike, but there was no sign of dike instability in these areas.

6 SEEPAGE AREA

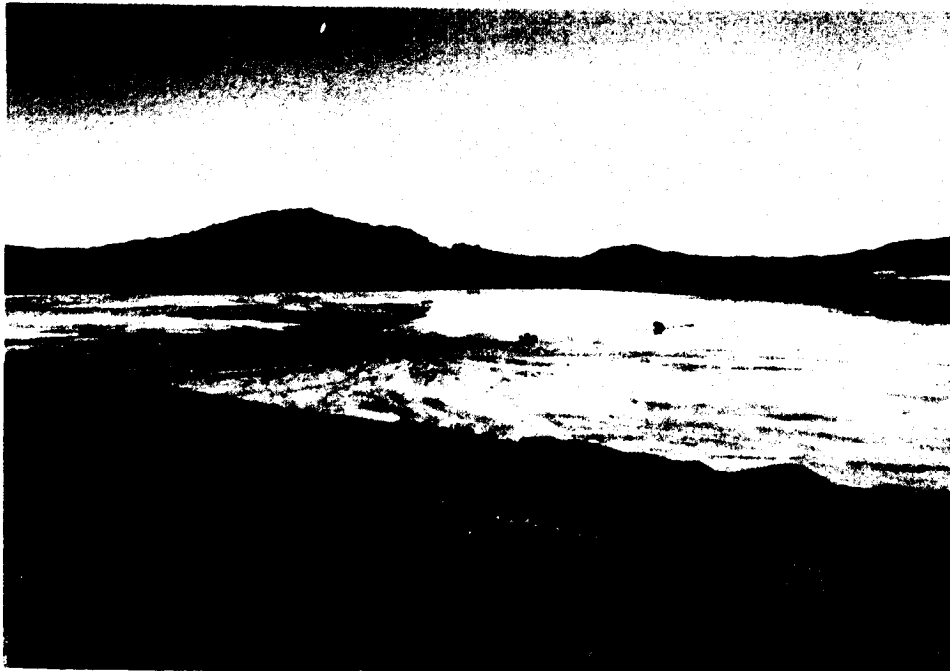
2.1.1 The exterior slopes have a good vegetative cover, and the top of the dikes has a good crushed stone surfacing.

7) GOOD VEGETATION ON EXTERIOR DIKE.
