TENNESSEE VALLEY AUTHORITY

TO : J. E. Varner, Manager, Inspections and Small Projects, BR 4N 83A-C
FROM : Joel D. Paris, Civil Engineer, Site Development, MR 3S 131D-C
DATE : SEP 28 1990
SUBJECT: KINGSTON FOSSIL PLANT - ANNUAL FOSSIL AND HYDRO ENGINEERING (FHE)
INSPECTION OF ASH DISPOSAL AREAS

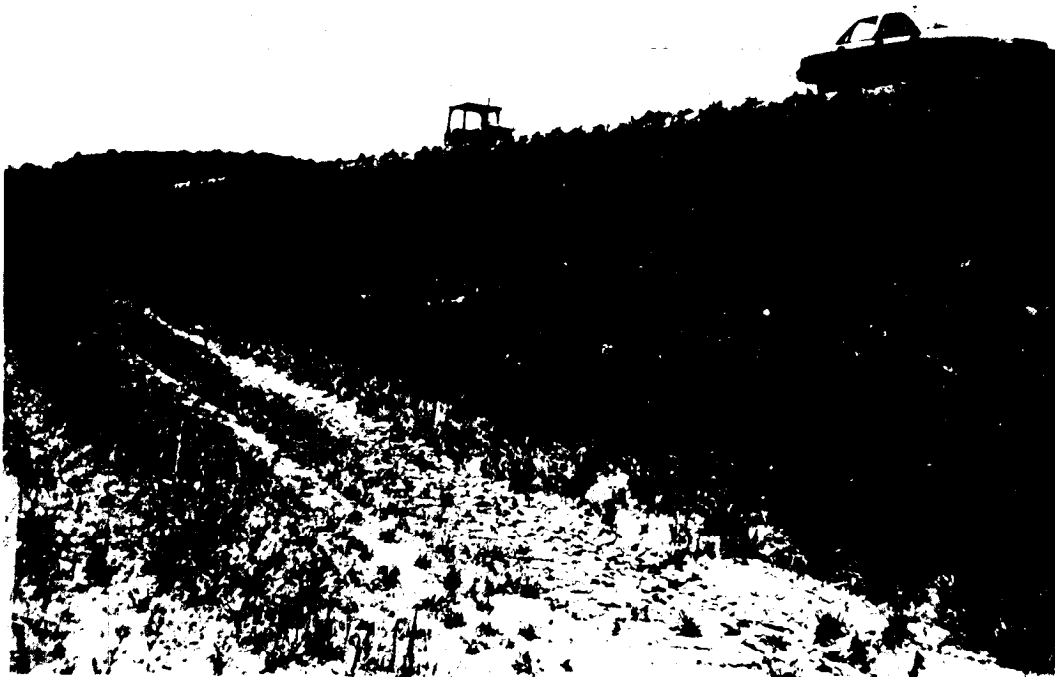
- 2.1 Dike "C" appears to be stable although there are three wet areas on the berm.
 - 2.1.1 The exterior slopes have a good vegetative cover. The dikes have not been mowed recently. Due to the extreme dry weather, the ground is cracking (picture 1 and 2).
 - 2.1.2 Wet area number 2 identified during a 1988 inspection at the time was not wet but was dark green with everything around it dry.
 - 2.1.3 The third wet area observed during the 1988 inspection was also dry. This area should be watched closely because at the time of this inspection, dredging has been in operation for 12 days. "Water boils" and "water piping" occurred in this area in 1987 that caused the original dredging operation to shut down.

② DIKE "C" DRY GRASS WITH GROUND CRACKS.

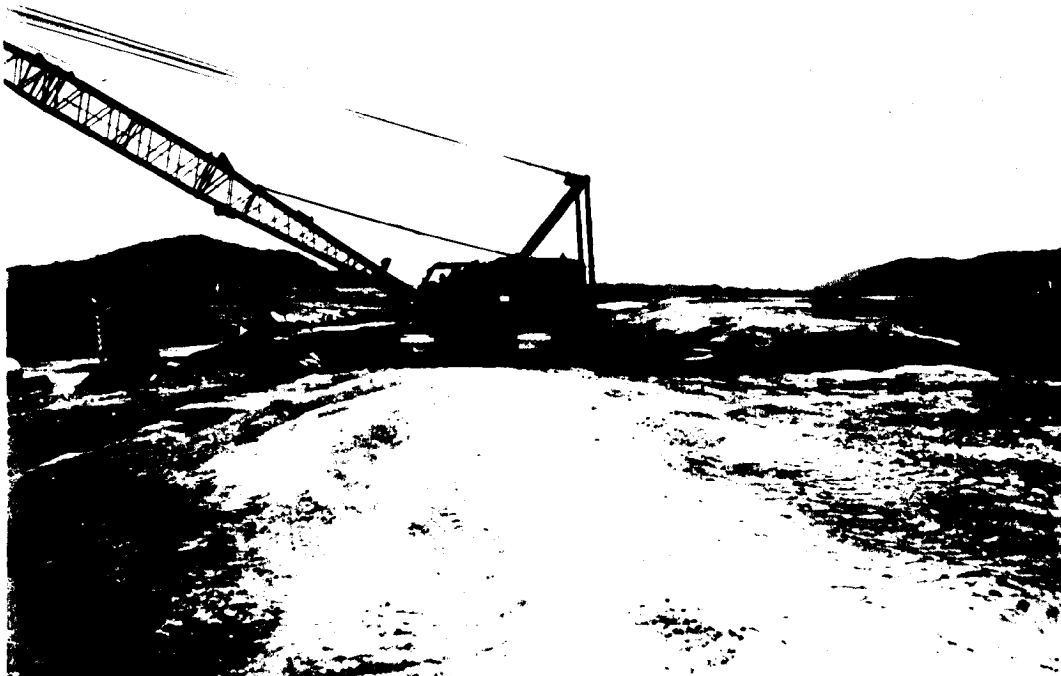
3.1 The bottom ash continues to be sluiced into a channel at the south end of the initial ash pond and removed by dragline (picture 4). The bottom ash continues to be sluiced faster than it is being used for dike building.

④ RECLAIMING ASH FROM DISCHARGE.

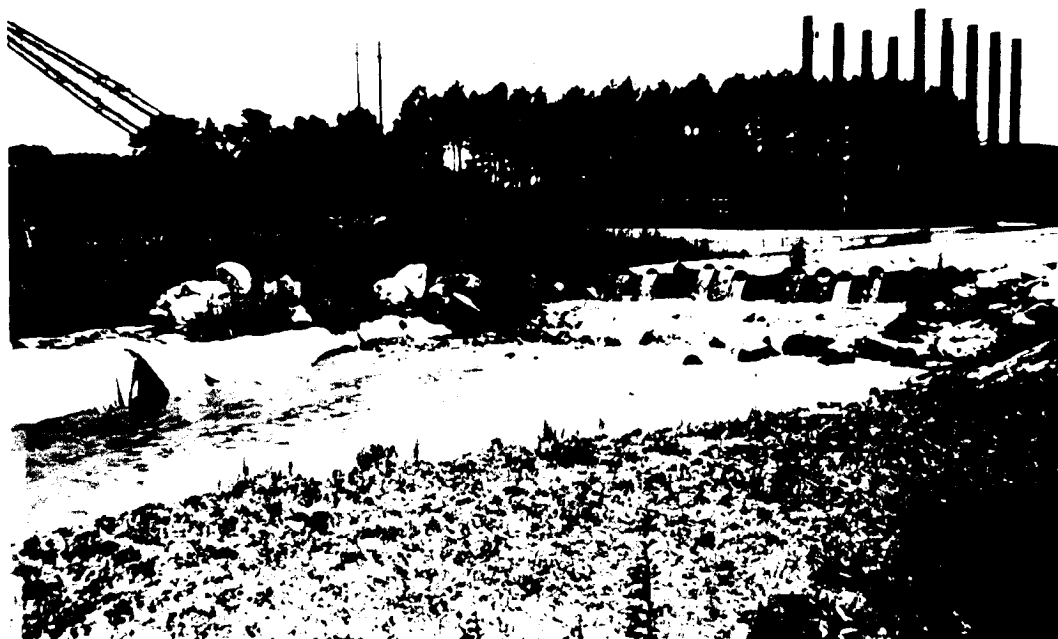
3.2 The fly ash continues to be sluiced into a rubber-lined ditch that is showing signs of deterioration. This should be watched and replaced if necessary (pictures 5 through 8).

⑤ FLY ASH DISCHARGE - NOTE LINER DAMAGE.

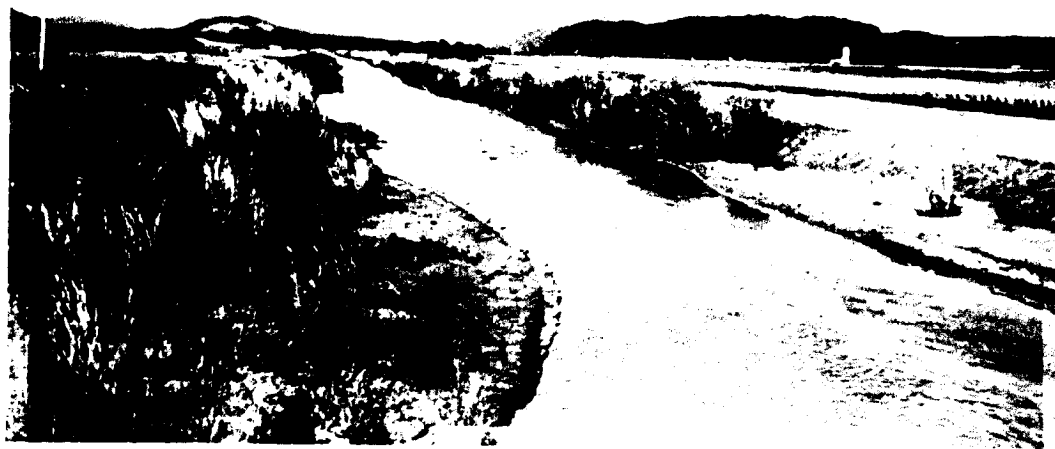
⑥ FLY ASH TRENCH

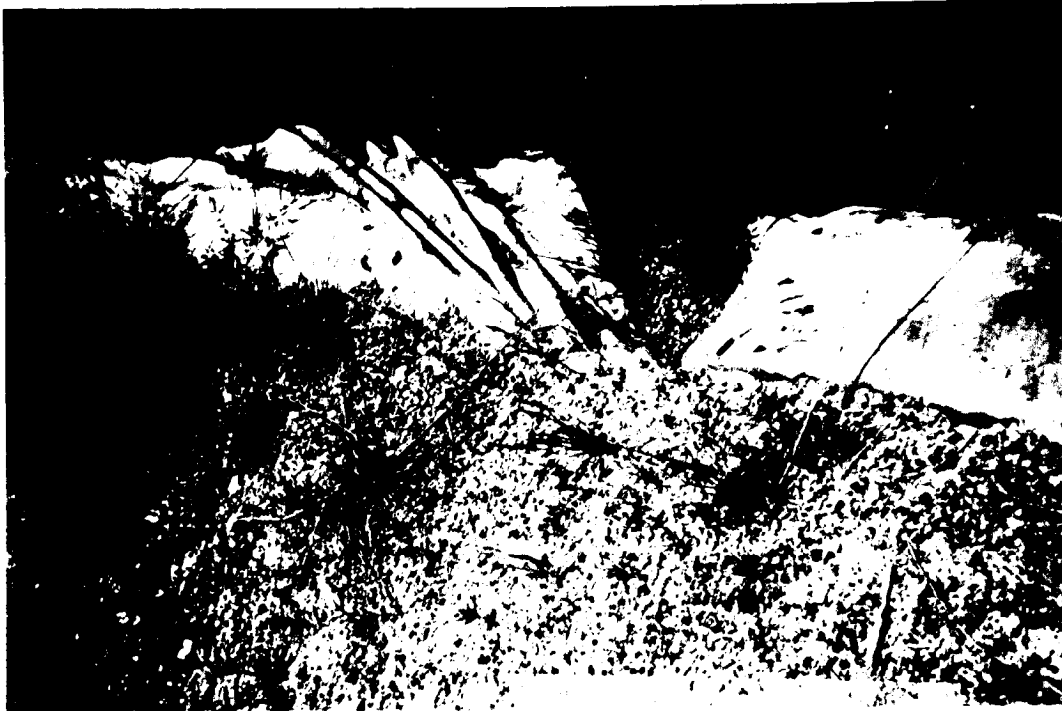
⑦ LINER DAMAGE

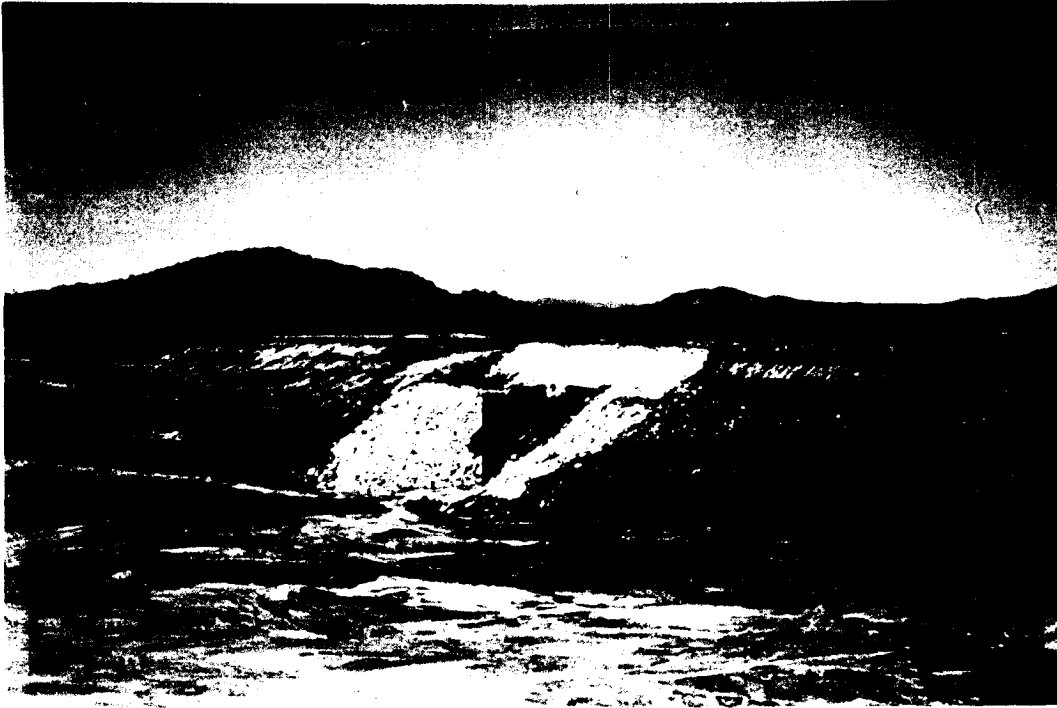
3.4 Cell No. 1 has been raised to elevation 795 and a new return spillway constructed in the east end (picture 9). The cell is almost cleaned out and ready for dredging.

⑨ ONE OF THREE DISCHARGES FROM THE THREE
DREDGE CELLS.

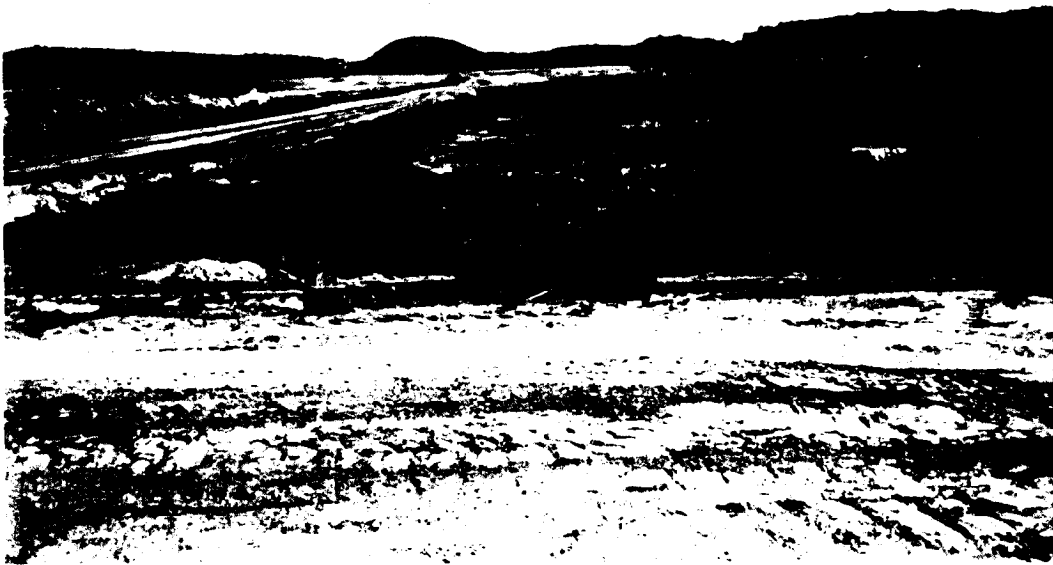
3.5 Cell No. 3, center cell, is being cleaned out but the ash is wet and hard to remove (picture 10). The discharge spillway has been removed from the northwest corner and reconstructed in the dike running northeast and now discharges back into the original pond without going to Cell No. 2.

⑩ ASH RECOVERY FROM CELL NO. 3 THE ASH IS DOUBLE
HANDLED BECAUSE OF MOISTURE.

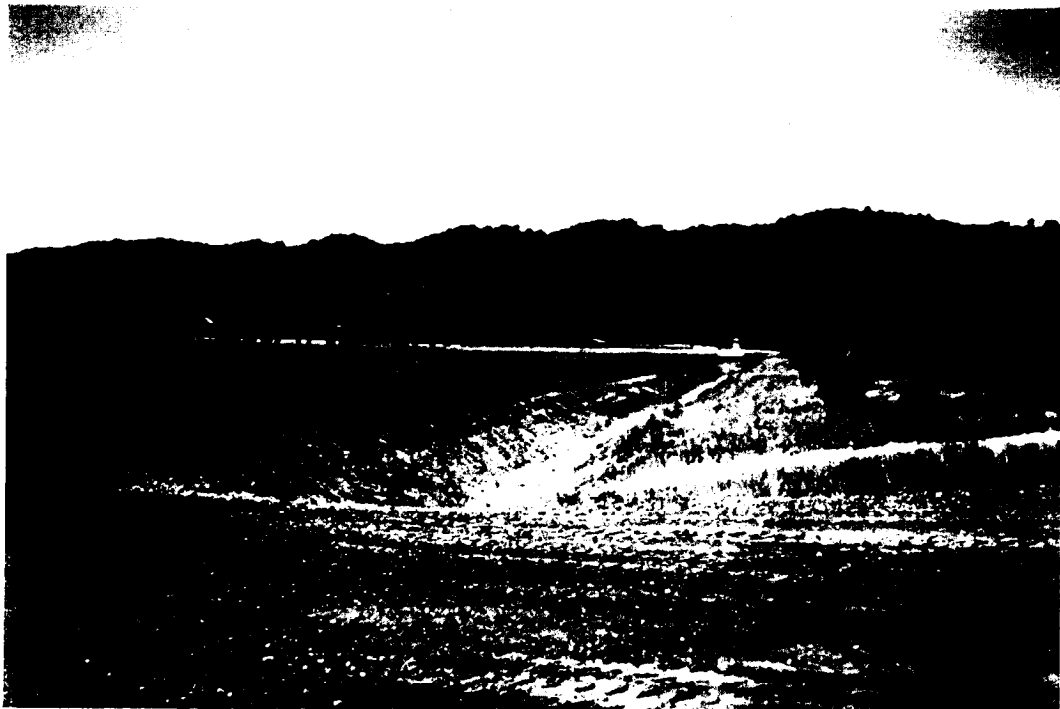
11

3.7 The original north dike drainage (now south toe of cell 1) has been lowered to remove the ponding. The road crossing at the east end of the ditch was reworked and the pipe lowered four feet. An additional section at pipe was also added (picture 12). This allows an extra four foot fall in the 1800-foot ditch (picture 11).

LOWERING OF DRAINAGE
DITCH TO STOP STANDING
WATER.

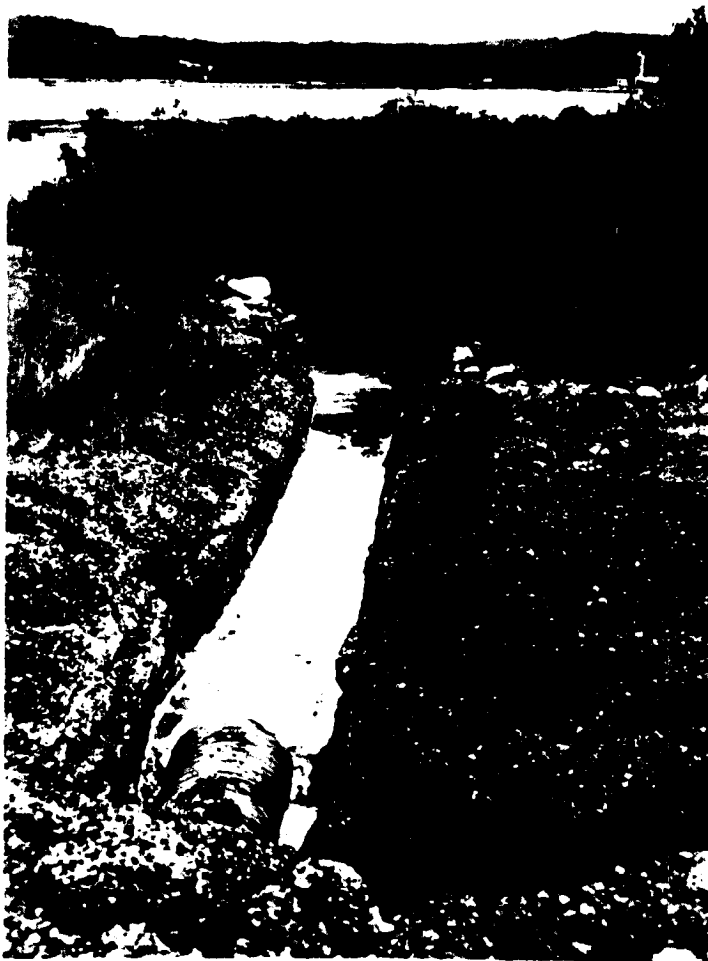
12

DISCHARGE END AT LOWERED
DRAINAGE DITCH.

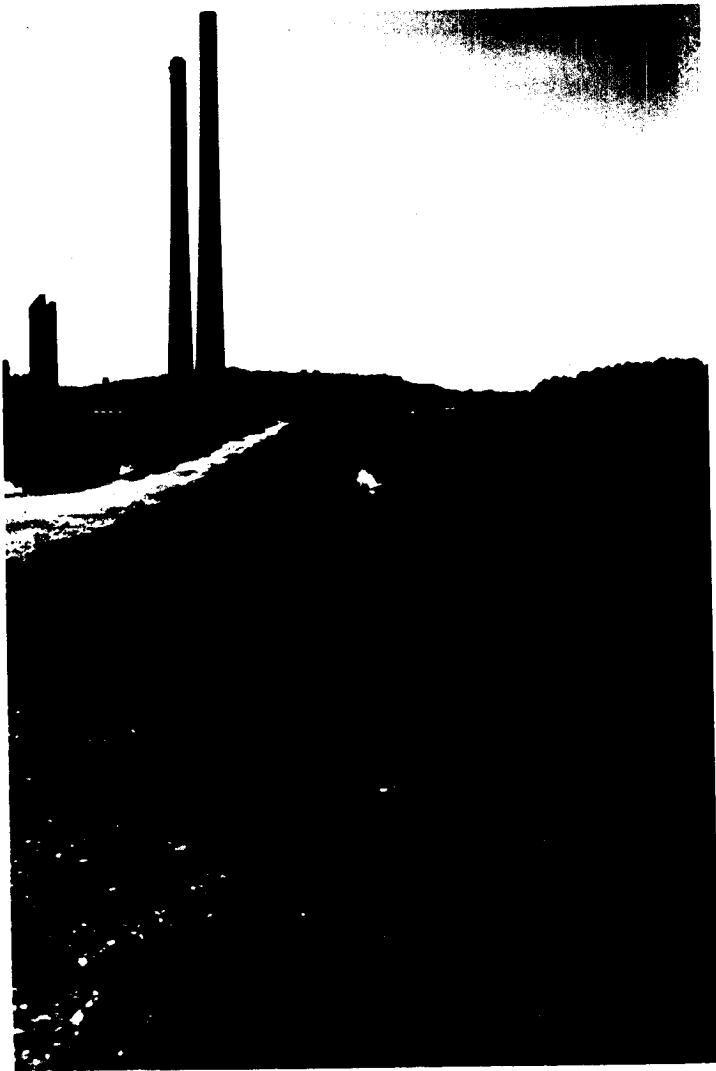
2.2 Seepage of redwater still persists along the exterior slope of the southeast dike. The redwater is collected in an interception ditch (picture 13) and routed to an engineered wetland (picture 14). The water is pumped to the ash pond (picture 15). Cattail and other aquatic growth continues to increase in the wetland and removal and replacement will not be necessary for several years.

(13) INTERCEPTOR DITCH
FOR RED WATER.

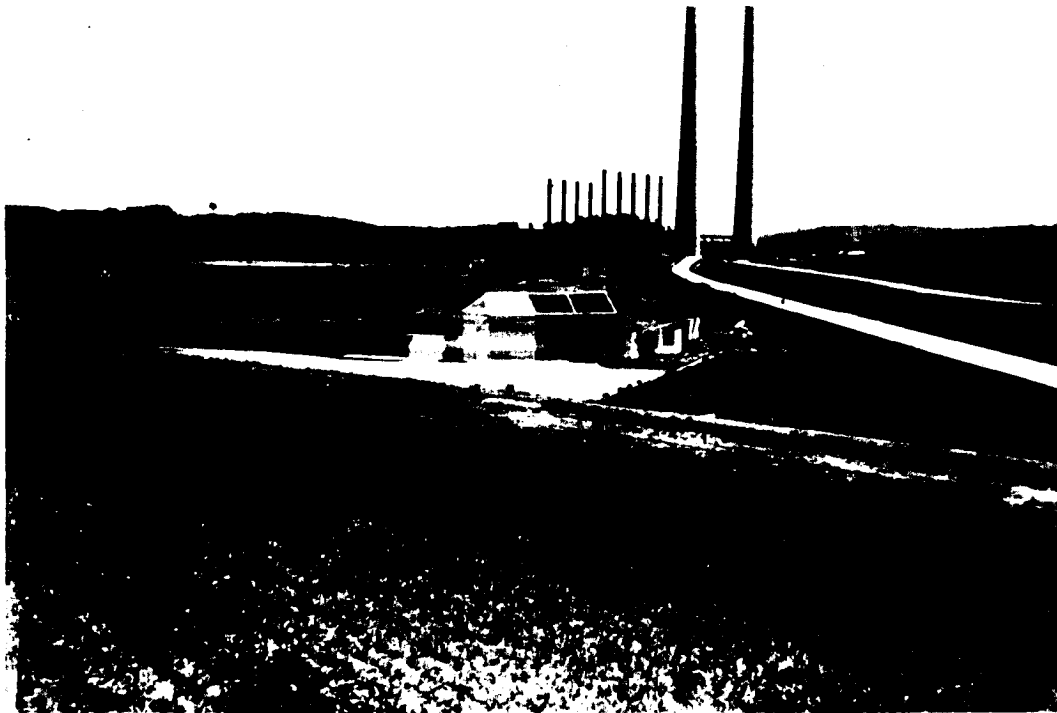
3.8 A baseball diamond has been constructed on the southwest corner of the "north dike" (picture 16).

16) NEW BALL FIELD.

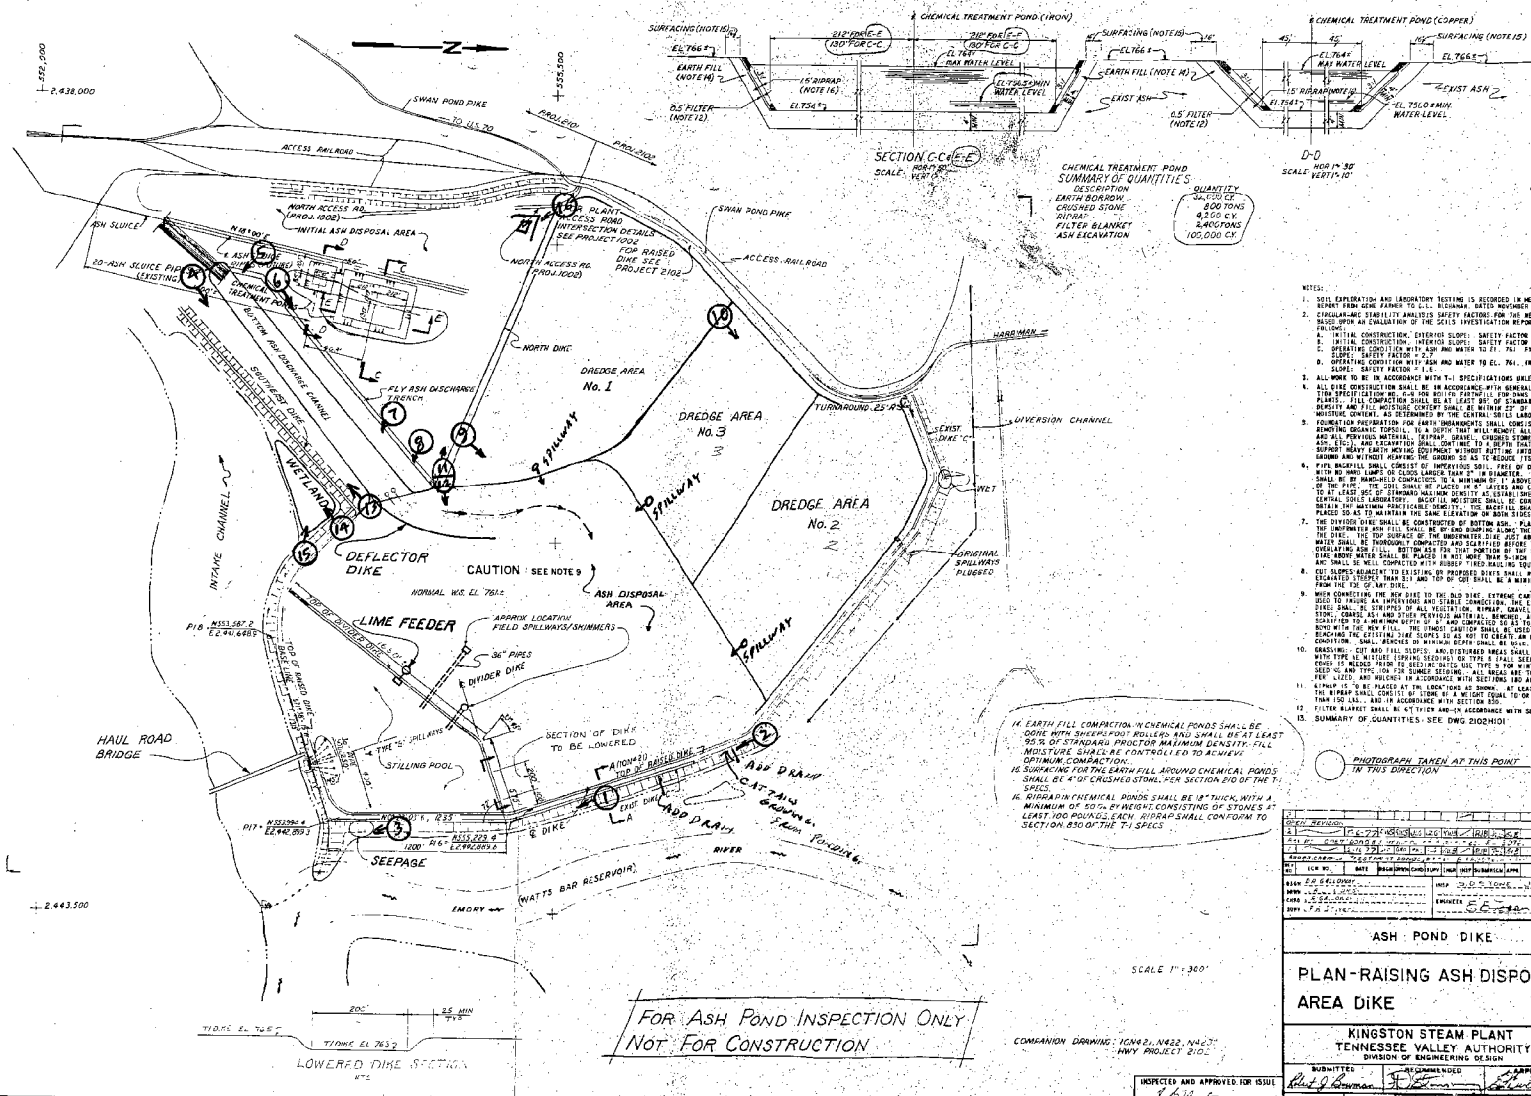
ASH POND DIKE
PLAN-RAISING ASH DISPOSAL AREA DIKE
KINGSTON STEAM PLANT
TENNESSEE VALLEY AUTHORITY
DIVISION OF ENGINEERING DESIGN
SUBMITTED: [Signature] RECOMMENDED: [Signature] APPROVED: [Signature]
DATE: 5-20-76
KNOXVILLE 5-20-76 36 C ION 420 R

2.1.4 There is a good gravel surface on the dike "C" roads. Additional drainage pipes should be added to add drainage from the berm (see 10N420).

6.2.1 Add two drains under the road (berm) on the north original dike to improve storm drainage.

6.2.1.1 Add one drain at the east end of the island and another one drain at the middle of the island.
