B65 931006 201

KINGSTON FOSSIL PLANT - INSPECTION OF THE WASTE DISPOSAL AREA

KINGSTON FOSSIL PLANT - INSPECTION OF ASH DISPOSAL AREAS

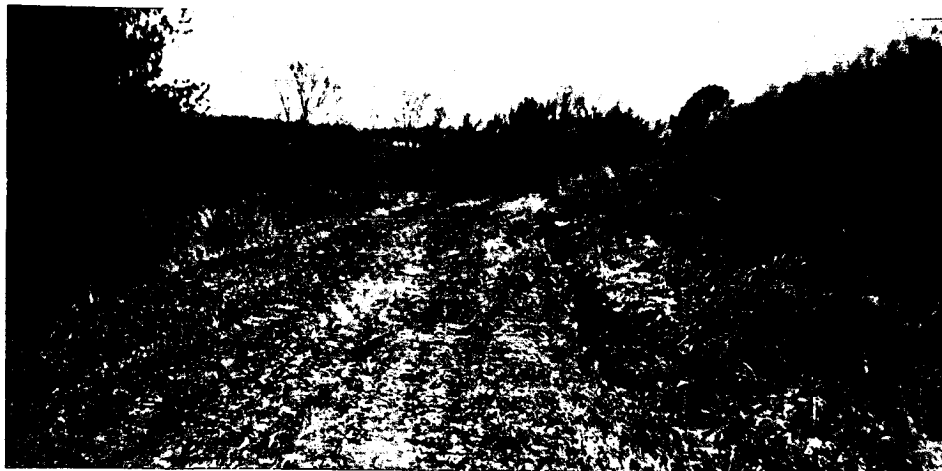
- 2.1 Dike "C" appears to be stable although there are three wet surface areas and one slope failure on the berm.
  - 2.1.1 The exterior slopes have a good vegetative cover (picture 1). Wet area No. 1 continues to be monitored by the plant.
  - 2.1.2 Wet area number 2 identified during a 1988 inspection was not wet but was dark green with everything around it dry.
  - 2.1.3 The third wet area observed during the 1988 inspection was also dry.
  - 2.1.4 There is a good gravel surface on the dike "C" roads. Additional drainage from the berm is needed (see 6.1.4).
  - 2.1.5 There is a sluff about 150 feet from Swan Pond Road on the outside of dike "C" (picture 4). This 50 foot sluff has been checked three additional times by me between the original inspection and June 4, 1993.

Picture 1-Grass Cover (2.1.1)

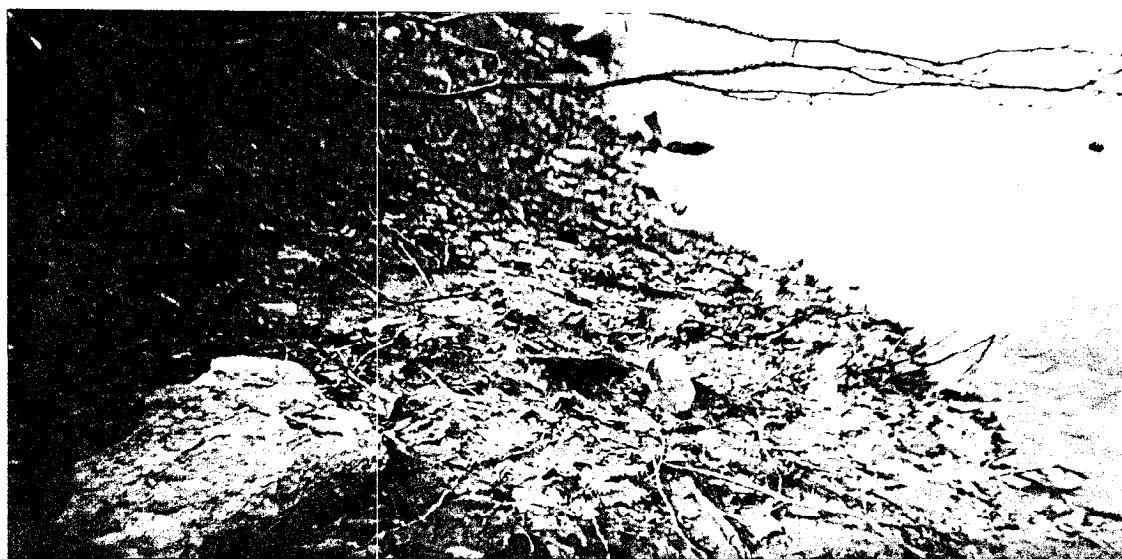
2.3 The lake was at winter pool and there were red water seeps all along Dike C in the draw down area. There is a stream discharging out of the Swan Pond Road fill at the Dike C intercept (Pictures 2 and 3) and below the summer pool.

This is an old area of seepage and does not appear to be increasing.

Picture 3-Red water flow.

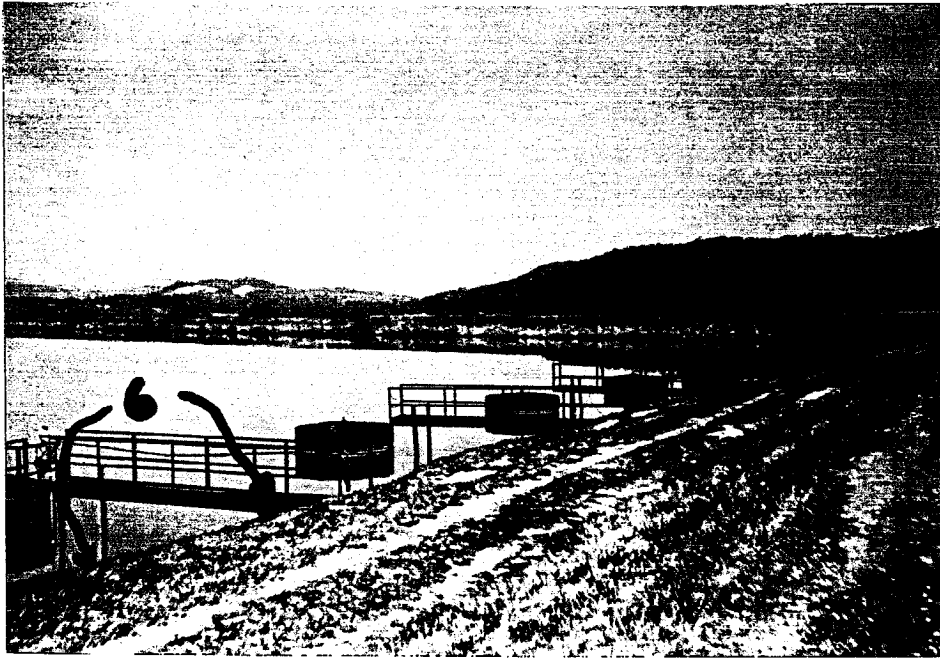
- 4.1 The plant constructed spillway and skimmer discharging water from the pond area into the stilling pool area appear to be in good condition as there is very little floating ash on the stilling basin.
- 4.2 Five of the six standard spillways and skimmers in the stilling pool area appear to be in good condition and functioning properly. The spillway on the west end has been raised one section higher than the other five and is not discharging. The algae should be periodically removed for accurate discharge readings. (See Recommendation 6.1.1.)
- 4.3 The interior dike bank is washing into the pond due to wave action (picture 6). (See Recommendation 6.1.2.)
- 4.4 The riprap looks good at the spillway discharge outlets.

Picture 5-Skimmers in the stilling pond and location of the wave damage.

- 6.1.1 The algae needs to be removed from the skimmer of the western most spillway on a continuous basis.
- 6.1.2 Riprap needs to be placed on the inside slope of the stilling pool dike, average 100 lbs., to stop the wave erosion.
- 6.1.3 Add riprap at the outlet end of the existing dike storm drains to correct the existing erosion and prevent additional erosion. The stones should be in the range of 40 to 80 lbs.
- 6.1.4 Additional drain pipes should be added to Dike C across the berms, see 10N420 for locations, (reference 2.1.4).
