May 19, 1994

KINGSTON FOSSIL PLANT (KIF) - INSPECTION OF THE ASH DISPOSAL AREAS

KINGSTON FOSSIL PLANT- ANNUAL FOSSIL ENGINEERING INSPECTION OF ASH
DISPOSAL AREAS

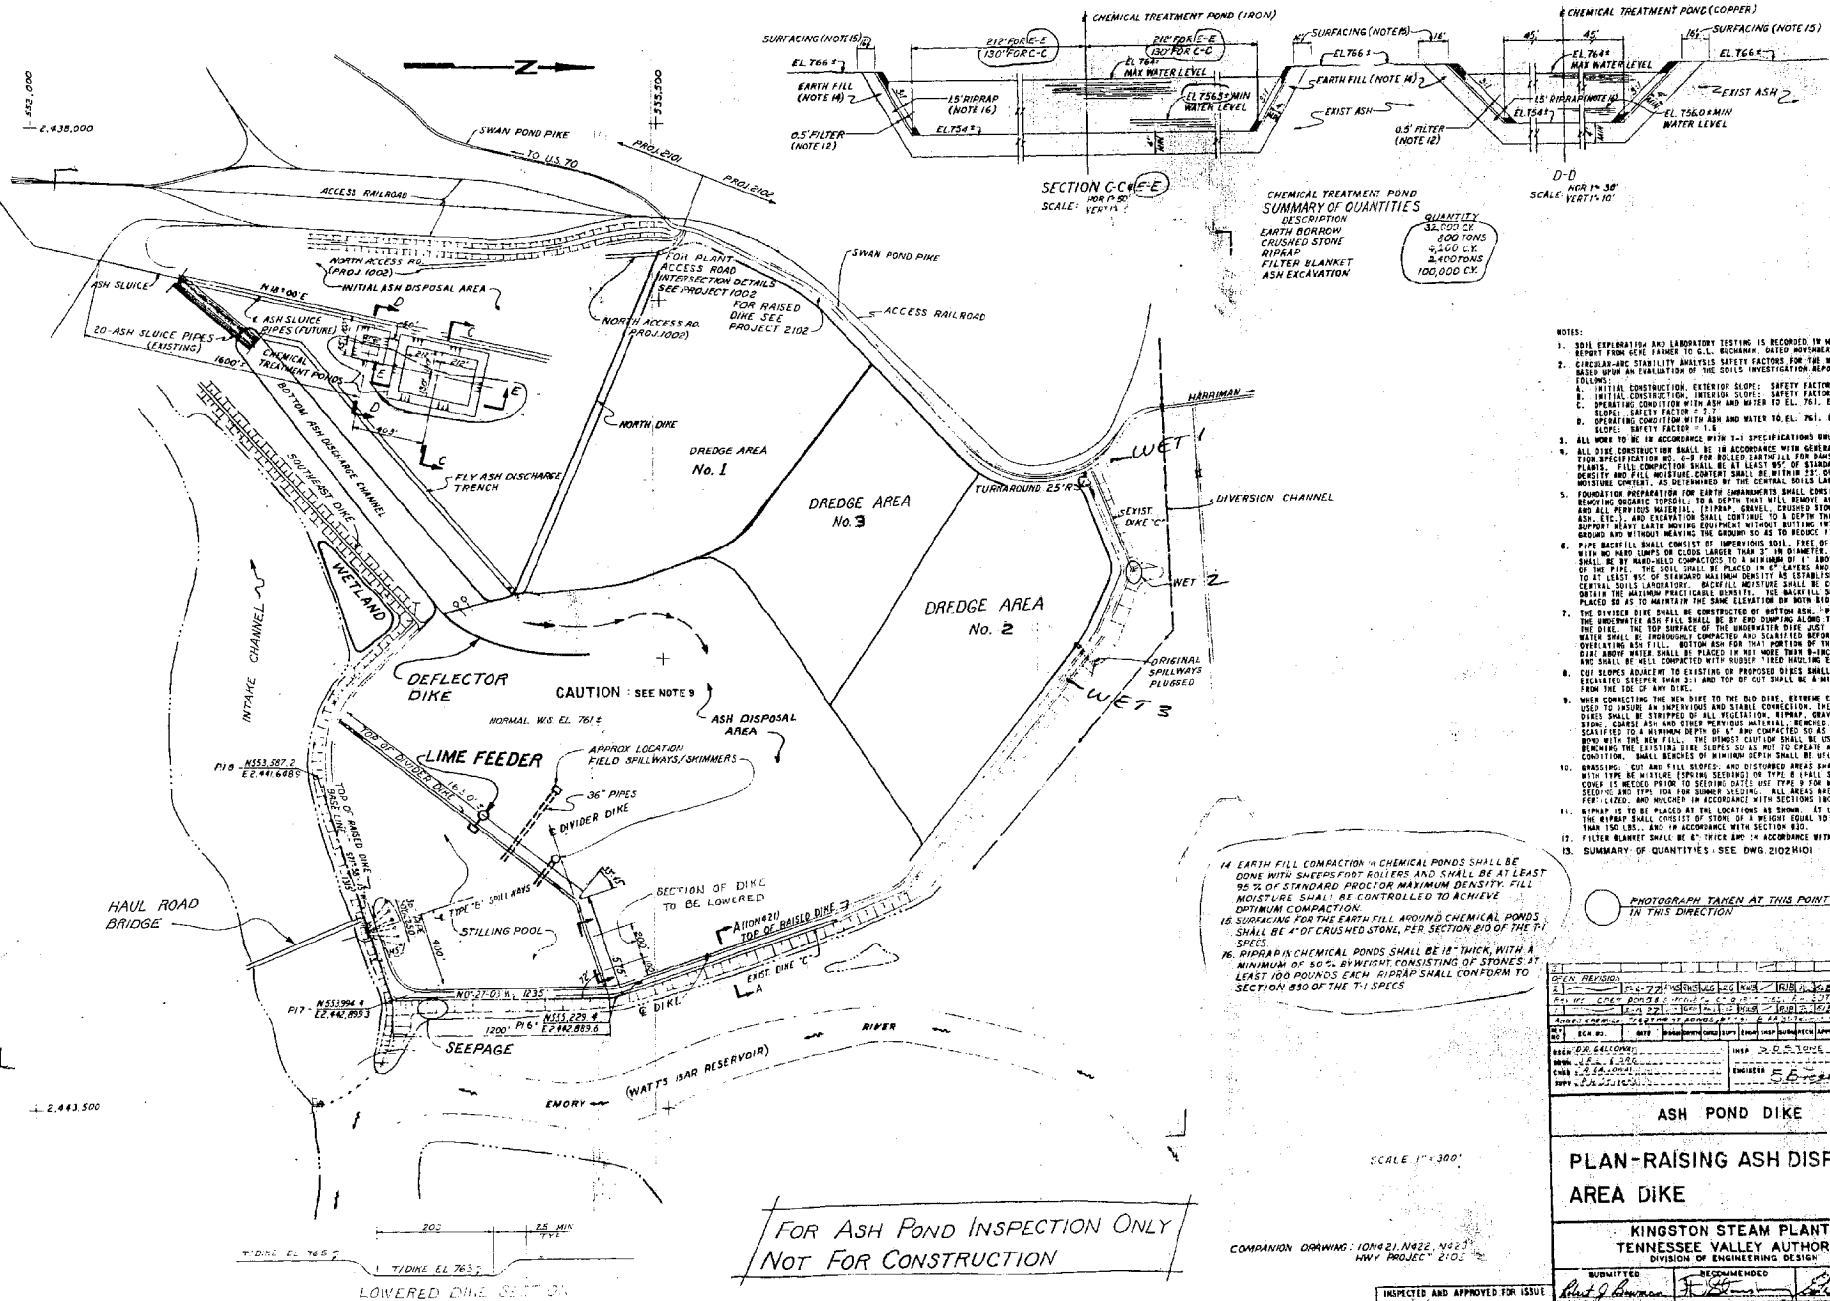
ASH POND DIKE
PLAN-RAISING ASH DISPOSAL
AREA DIKE

1.3 The different areas referenced in this report are designated on the attached print of drawing 10N420.
