**KINGSTON FOSSIL PLANT (KIF) - ANNUAL FOSSIL ENGINEERING INSPECTION  
OF ASH DISPOSAL AREAS**

April 28, 1995

KINGSTON FOSSIL PLANT- ANNUAL FOSSIL ENGINEERING INSPECTION OF ASH DISPOSAL AREAS

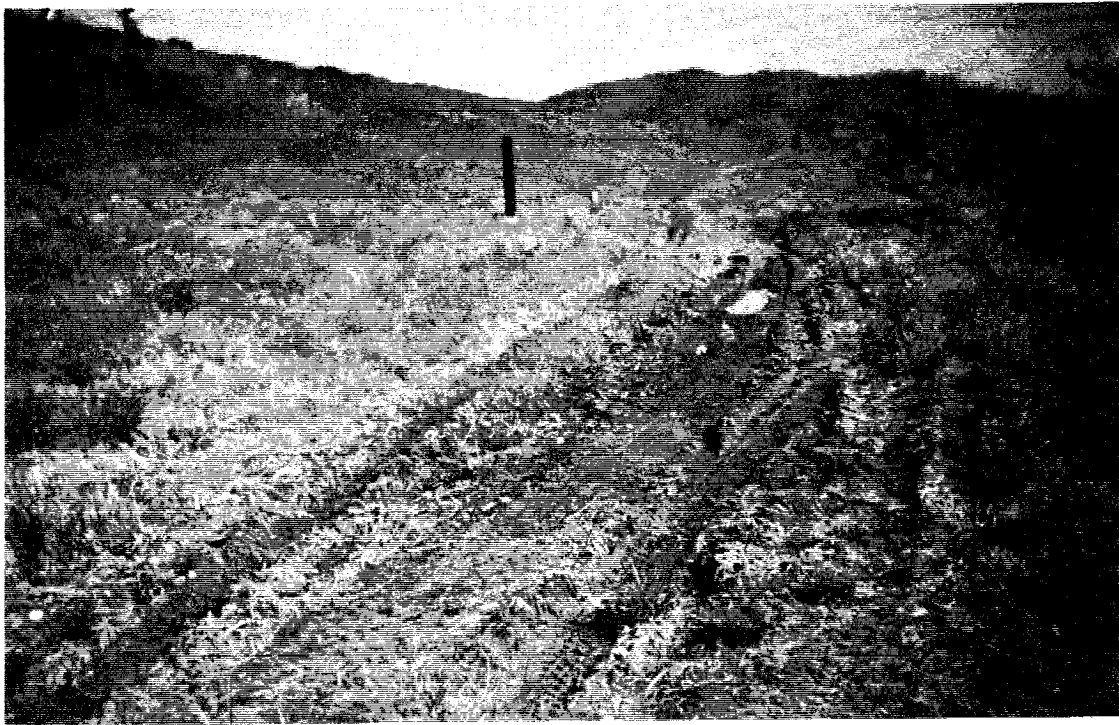
2.1.3 There is a 150' long area of rutting and standing water on the east side of the stilling pond dike. The ruts are up to 12" deep. (see 8.1) (picture 1)

PICTURE 1- Wet, rutted area along Dike "C" should be repaired.

- 8.1 Plant personnel should repair ruts and continue to monitor the exterior dike slopes for seepage, soft wet spots, animal burrowing, etc. and report any change to Fossil Engineering.

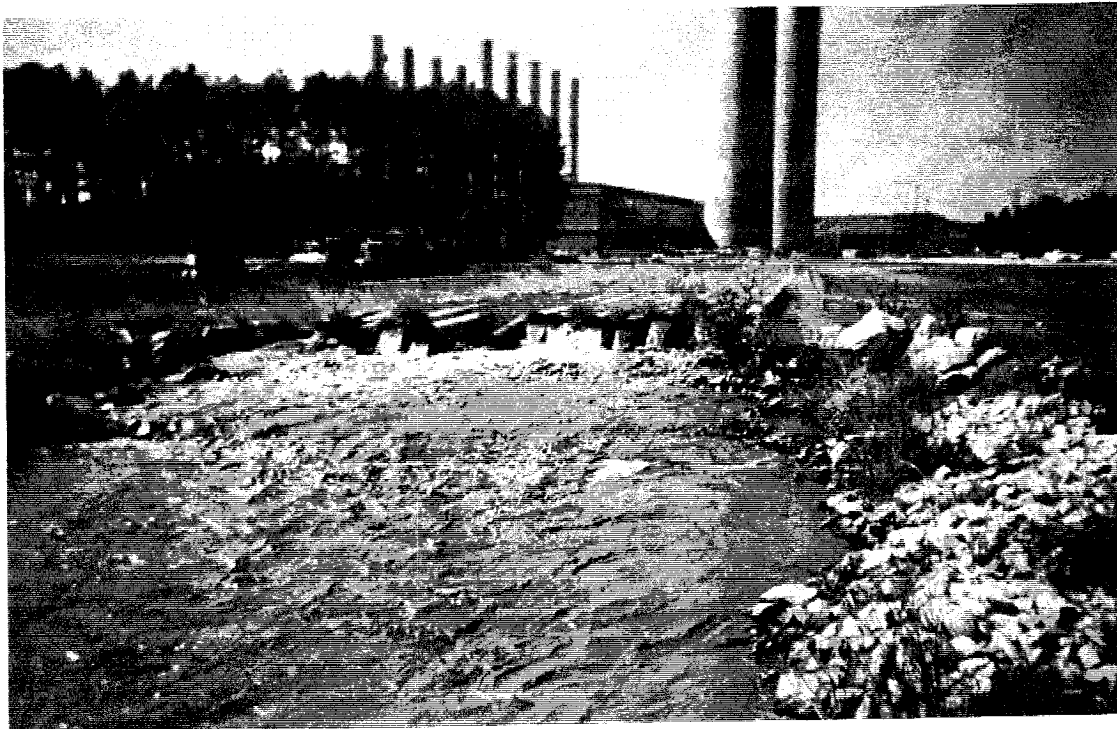
- 3.2 The fly ash continues to be sluiced into a rubber-lined ditch. The lining has deteriorated. Plant personnel have cleaned out the ditch and placed earth fill and riprap on the slopes for approximately 150 feet of the ash sluice ditch. (see 8.5) (picture 2)

- 7.4 Plant personnel have not replaced the rubber liner; only the first 150' of the fly ash discharge ditch has been replaced with rip rap. (see 8.5)
- 7.5 Plant personnel have added and monitored riprap at the outlet end of the existing dike storm drains. They have also added riprap to the inside of the stilling pool dike; however, waves continue to undercut the inside of the dike. (see 8.8)

PICTURE 2- The ash sluice ditch should continue to be cleaned out and filled with earth liner and riprap or the rubber liner should be replaced.

- 8.4 Earthfill should be placed in gullies and eroded areas. The area should be graded and the disturbed areas shall be seeded and mulched.
- 8.5 Plant personnel should replace the rubber liner in the fly ash sluice ditch or continue to clean out the ditch and fill with earth liner and riprap as required.

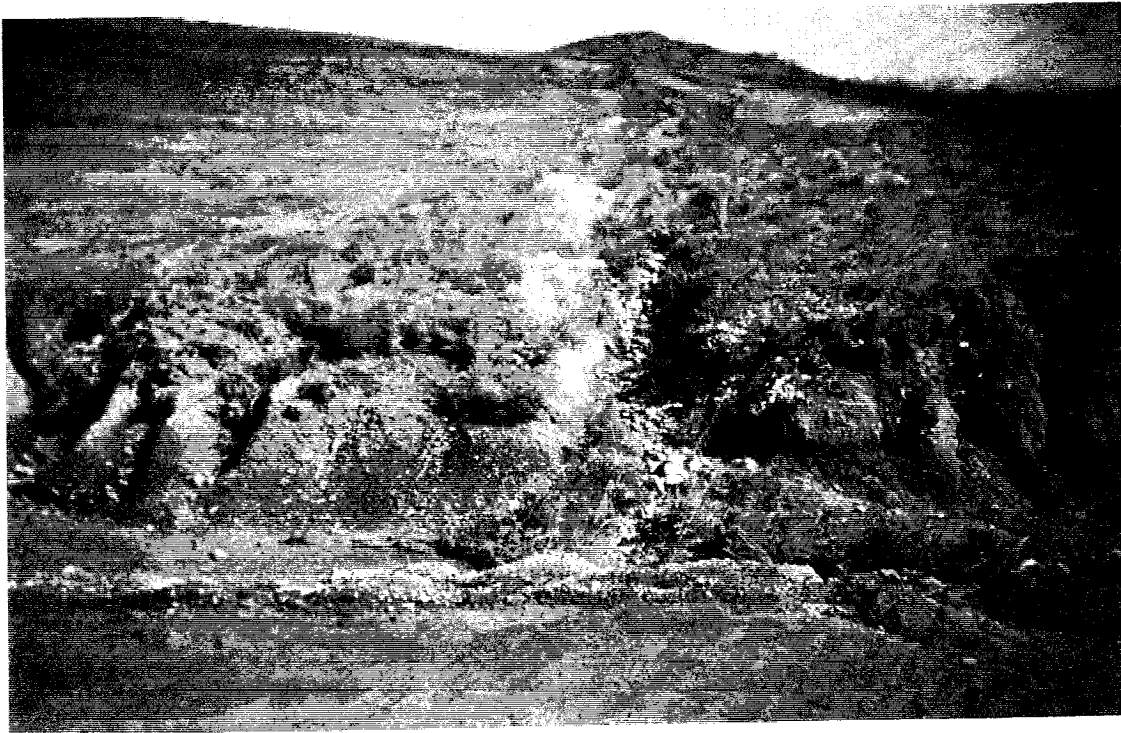
- 2.3 The divider dike at the stilling pool appears to be stable; however, there is some erosion due to wave action evident on the north side of the stilling pond.
- 2.4 The original north dike drainage (now south toe of cell 1) has been lowered to remove the ponding. The road crossing at the east end of the ditch was reworked and the pipe lowered four feet. An additional section of pipe was also added. This allows an extra four foot drop in the 1800-foot ditch.
- 2.5 Runoff water from the top of dredge cell no. 1 dike is forming gullies down to the eastern end of the north dike drainage ditch. The drainage ditch along the north dike is eroding. (see 8.4) (picture 3)

PICTURE 3- Gullies and eroded areas along North Dike and drainage ditch should be repaired.

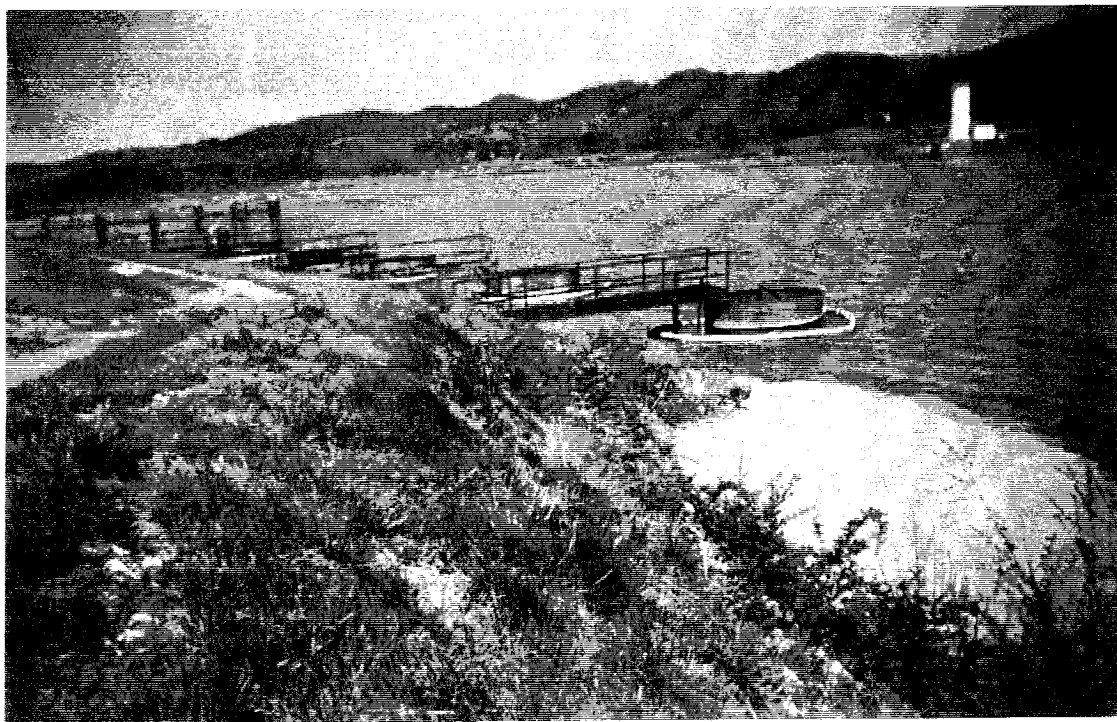
- 4.1 The plant constructed spillway and skimmer discharging water from the pond area into the stilling pool area appear to be in good condition.
- 4.2 There is some minor accumulation of floating ash in the southeast corner of the stilling pool. (see 8.6) (picture 4)

4.3 Five of the six standard spillways and skimmers in the stilling pool area appear to be in good condition and functioning properly. The spillway on the west end has been raised one section higher than the other five and is not discharging. (picture 4)

PICTURE 4- Spillways and skimmers appear to be in good condition. There is some floating ash in the stilling pool.

- 8.6 Plant personnel should periodically skim floating ash out of the stilling pond.
- 8.7 Plant personnel should rework the ditch in the coal yard to allow the ponded water to drain into the coal yard runoff pond.

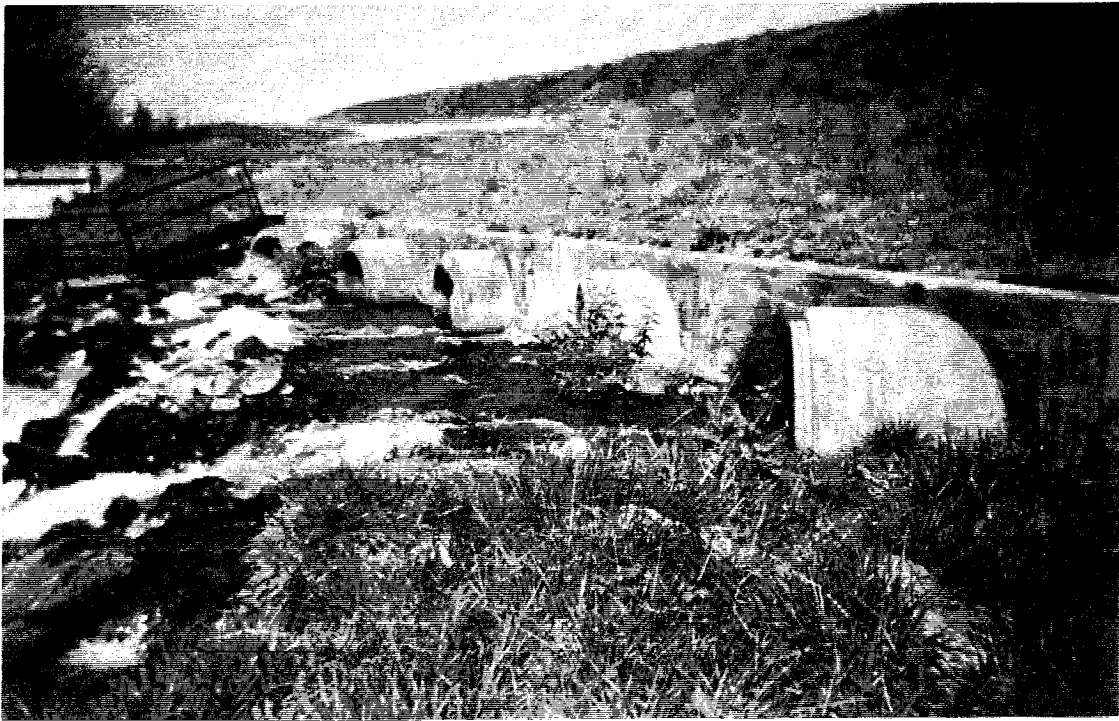
4.4 Five of the six outlet pipes were discharging at the time of this inspection and there was no visible loss of ash. The riprap appears to be in good condition at the spillway discharge outlets. (picture 5)

PICTURE 5- Riprap looks good at the spillway discharge outlets.

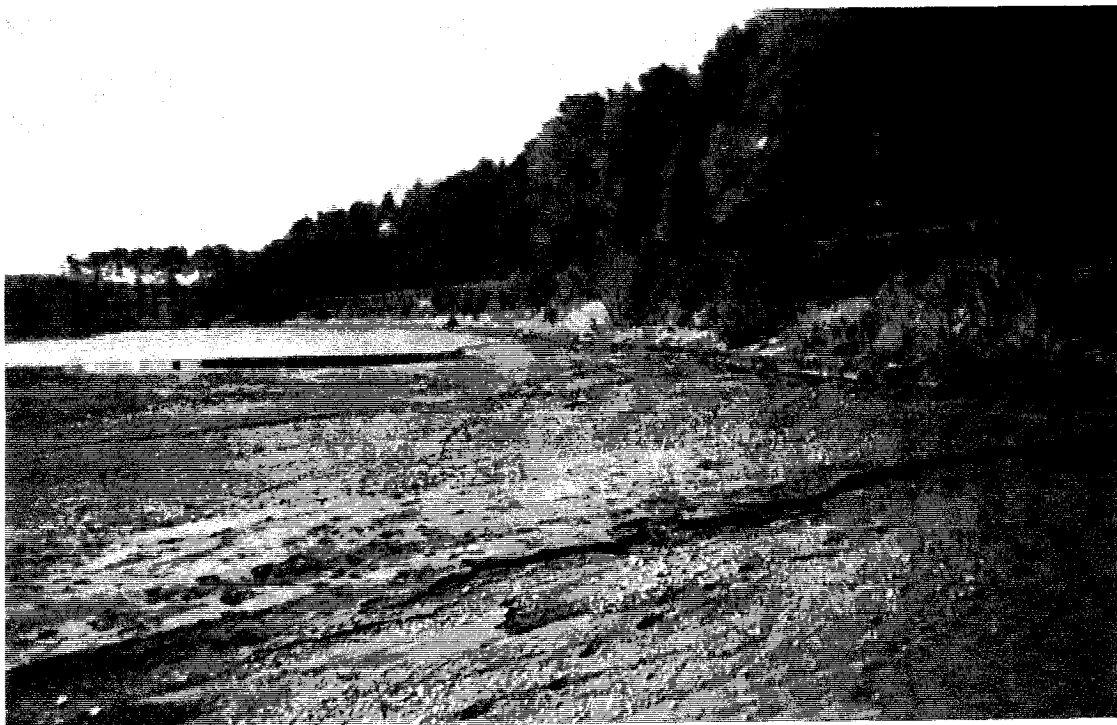
6.3 During the ash pond inspection, runoff was pooled up in the southeast corner of the coal yard. (see 8.7) (picture 6)

PICTURE 6- Runoff is pooled up in the southeast corner of the coal yard.
