KINGSTON FOSSIL PLANT (KIF) - ANNUAL INSPECTION OF WASTE DISPOSAL
AREAS

KINGSTON FOSSIL PLANT- ANNUAL INSPECTION OF WASTE DISPOSAL AREAS

An annual inspection of the ash pond dikes and toe areas at KIF to ensure structural stability was conducted April 2, 1996. The inspection was conducted by Cherie Minghini of Fossil Engineering and Jim Huber of Fossil Fuels. The previous stability inspection was conducted on April 13, 1995.

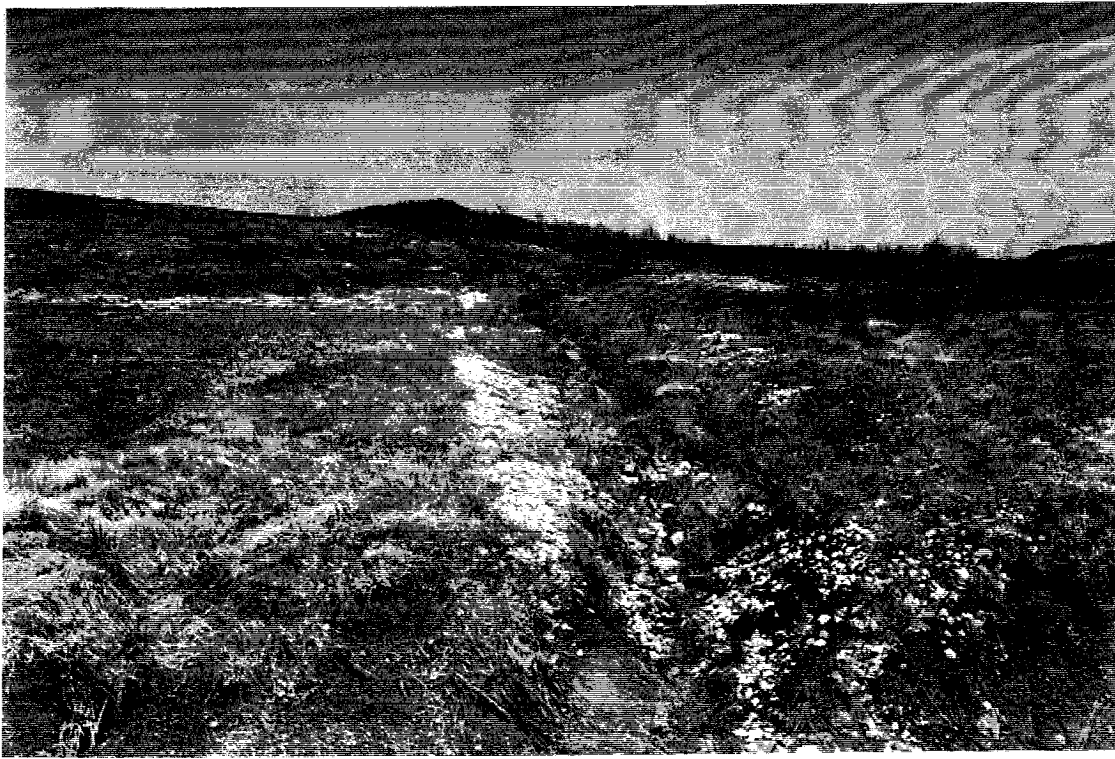
PICTURE 1- GULLIES AND ERODED AREAS ALONG NORTH DIKE

Riprap should be placed in erosion gullies along the north dike. Earthfill should be placed and compacted along the north dike drainage ditch in eroded areas. These areas should be seeded and mulched to help prevent additional erosion.

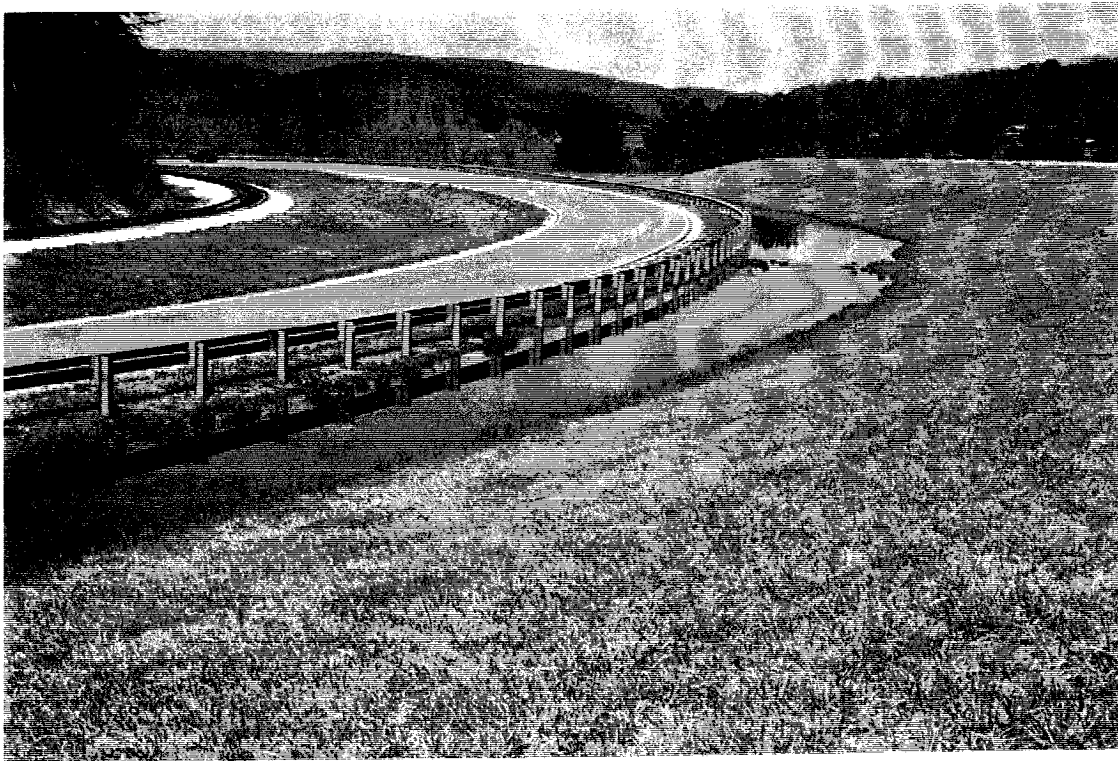
The dikes appear to be stable and did not exhibit any notable changes in the exterior dikes since the last inspection. A good vegetative cover was present on all exterior slopes. There is a good crushed stone surface on the dike roads. There are several areas of standing water along Dike "C" where the ditch is not draining. There is a 150' long area of rutting and standing water on the east side of the active ash pond. There is an erosion gully caused by discharge from a dike storm drain about 150 feet north of the stilling pool. The concrete around the monitoring wells 5B and 5C along Dike "C" is cracked up and in poor condition. The inside of Dike "C" has a few areas of minor erosion on the east side of the stilling dike caused by wave erosion. The ditch on the south dike is not draining in areas. This is partially due to one of the drains in the toe ditch that is clogged and not draining. There is a 25' long minor surface sluff on the south dike of the active ash pond. This sluff does not appear to be a threat to the stability of the dike. The divider dike at the stilling pool appears to be stable; however, there is some erosion due to wave action evident on the north side of the stilling pond. Some of this area has been filled and covered with earth; however, erosion still persists in this area. When earth is placed, the area should be seeded and mulched so that a good vegetative cover is established to prevent additional erosion. There is some minor accumulation of floating ash in the southeast corner of the stilling pool.

PICTURE 2- STANDING WATER- DIKE ADJACENT TO SWAN POND PIKE

Plant personnel should clean out and regrade the drainage ditches in areas with standing water. Establish vegetation in any disturbed areas.

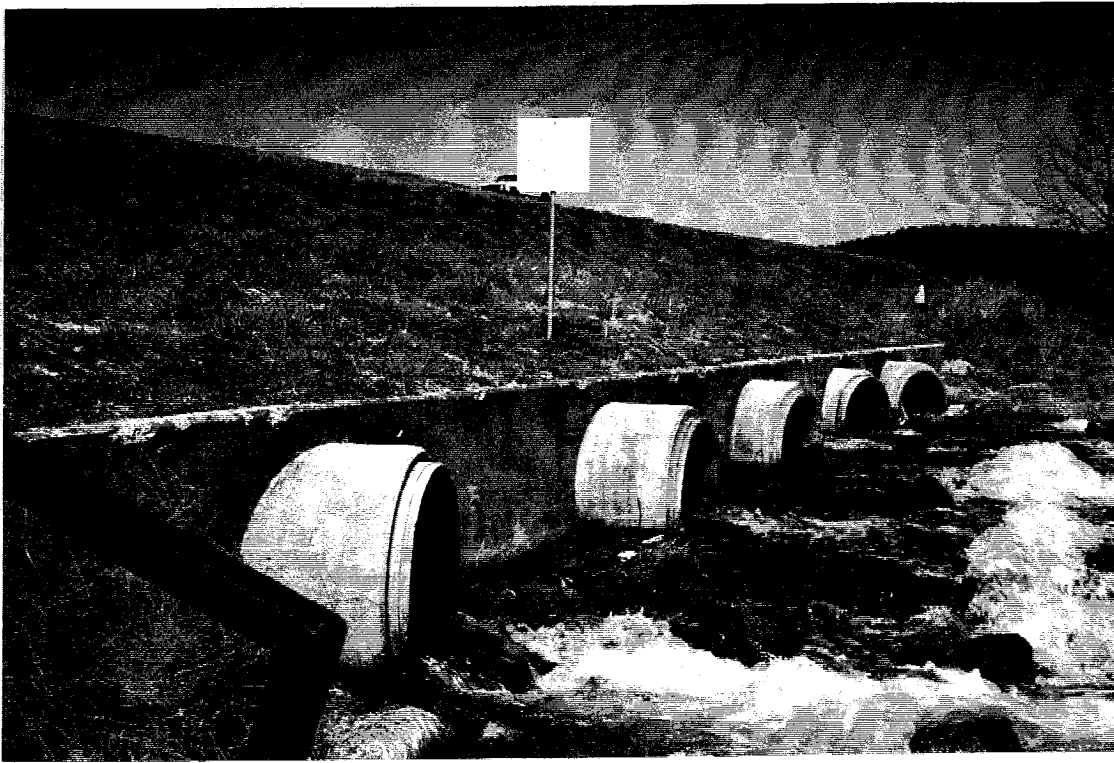
There has been no change in operation of the active ash pond since last inspection. Bottom ash continues to be sluiced into a channel at the southwest end of the pond. Bottom ash falls out and is removed by dragline. Fly ash is sluiced into a trench parallel and to the west of the bottom ash channel. The bottom ash and fly ash waters flow through the ash pond and through two field spillway/skimmers to the stilling pool. The plant constructed spillways/skimmers were discharging at the time of inspection and appear to be in good condition. Discharge to the intake channel is through five of six standard spillways and skimmers. At the time of the inspection, five outlet pipes were discharging with no visible loss of ash. The spillway on the west end has been raised and is not discharging. The riprap at the spillway outlets appeared to be in good condition with no signs of erosion.

PICTURE 3- SPILLWAY DISCHARGE OUTLETS

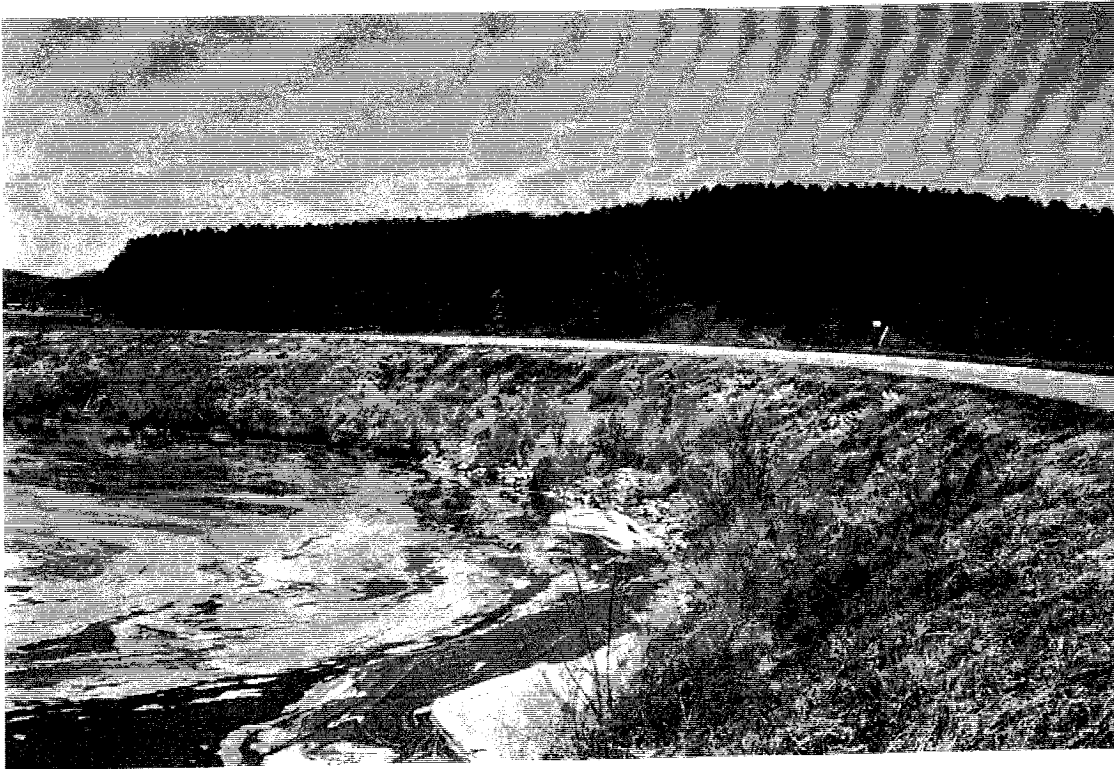
PICTURE 4- EROSION IN SOUTHEAST CORNER OF STILLING POOL. NOTE THAT SOME RIPRAP HAS BEEN PLACED.

Riprap should be placed in areas where wave erosion has undercut the inside of the stilling pool dike.

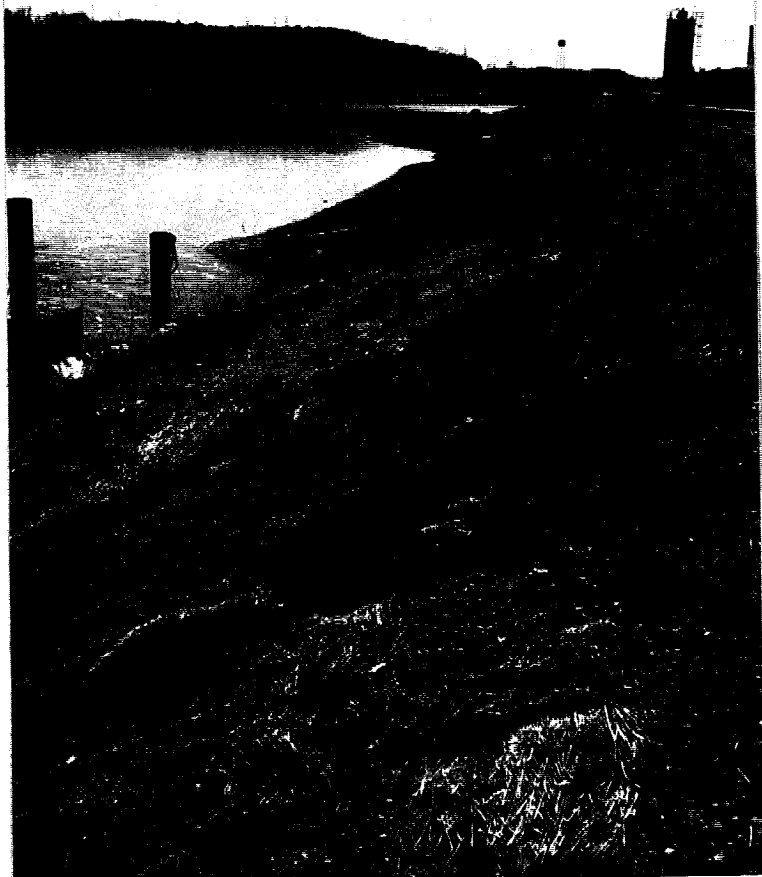
PICTURE 5- EROSION
ON DIVIDER
DIKE

Plant personnel should repair the erosion on the divider dike by placing bottom ash or earthfill in eroded areas. If earthfill is placed in eroded areas, personnel should seed and mulch to establish vegetative cover.

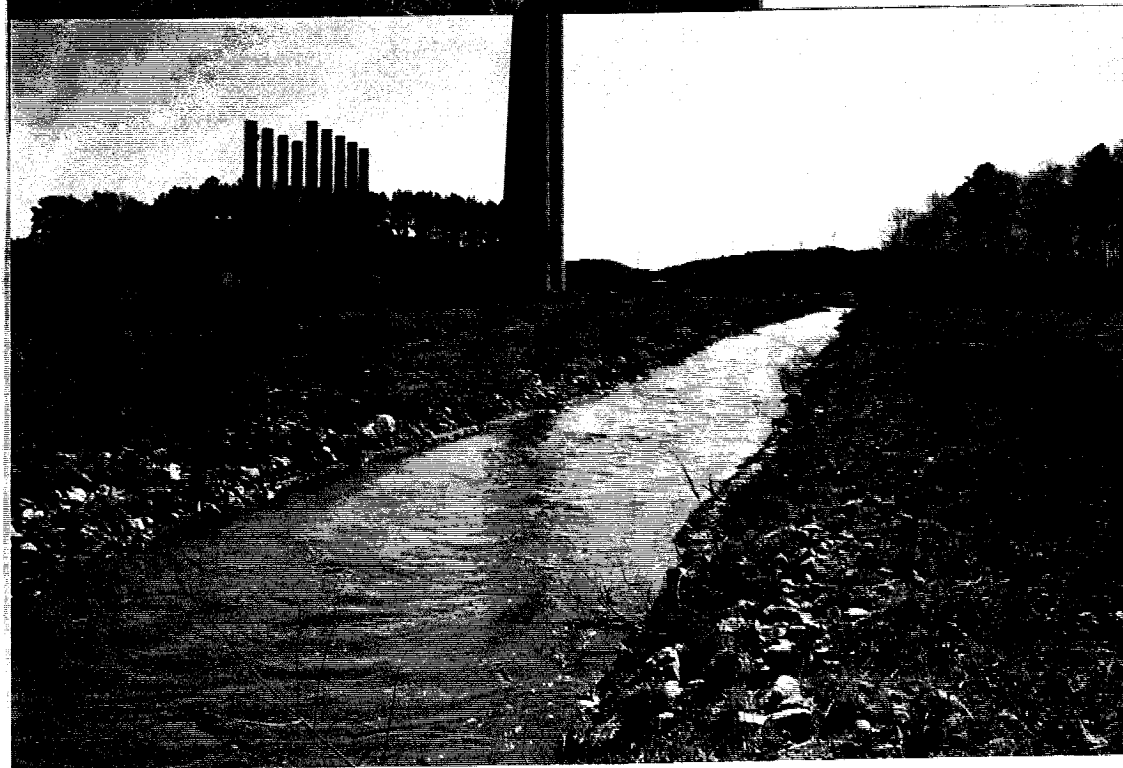
The fly ash continues to be sluiced into a rubber-lined ditch. The lining has deteriorated. Plant personnel have cleaned out the ditch and placed earth fill and riprap on the slopes for approximately 150 feet of the ash sluice ditch.

PICTURE 6- FLY ASH DISCHARGE TRENCH- RIPRAP SHALL CONTINUE TO BE
REPLACED WHEN NECESSARY

Plant personnel should replace the rubber liner in the fly ash sluice ditch or continue to clean out the ditch and fill with earth liner and riprap as required.
