KINGSTON FOSSIL PLANT (KIF) - ANNUAL INSPECTION OF WASTE DISPOSAL AREAS

**TENNESSEE VALLEY AUTHORITY  
KINGSTON FOSSIL PLANT**

***ANNUAL INSPECTION OF  
WASTE DISPOSAL AREAS***

KINGSTON FOSSIL PLANT  
NPDES PERMIT NO. TN0005452  
ANNUAL ASH POND DIKE INSPECTION  
1997

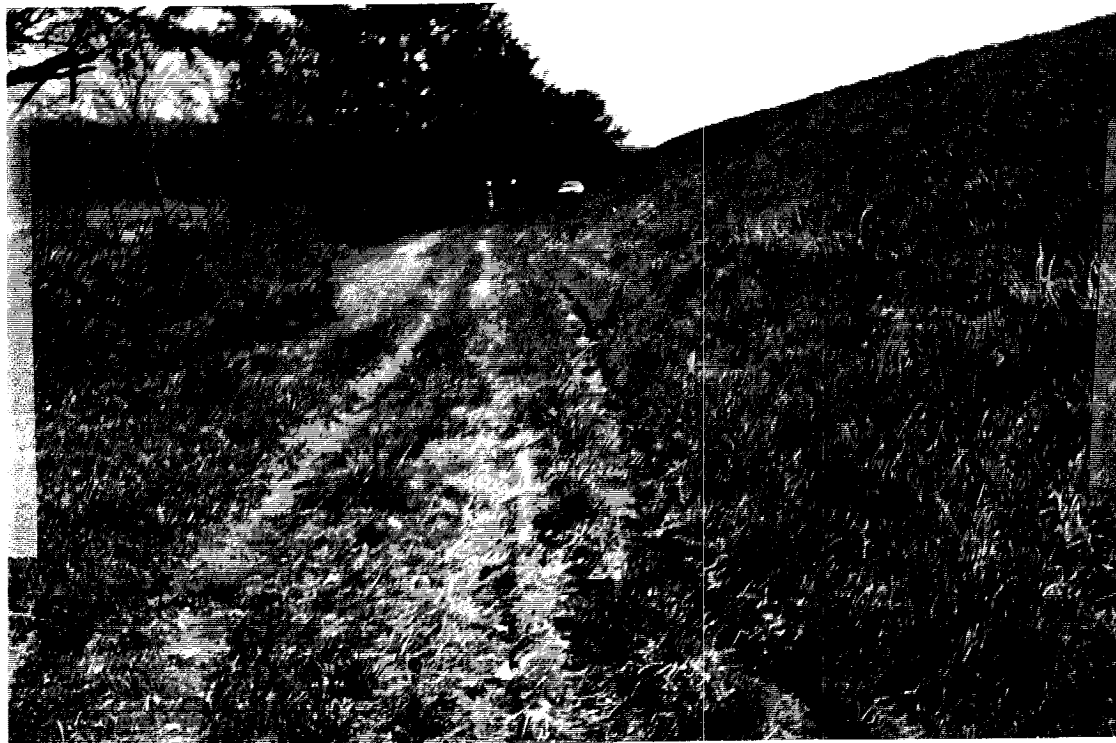
RUTTED AREAS - WEST END OF DIKE "C"

Plant personnel should repair any ruts and continue to monitor the exterior dike slopes for seepage, soft wet spots, animal burrowing, etc. and report any change to Fossil Engineering.
