KINGSTON FOSSIL PLANT (KIF) - ANNUAL INSPECTION OF WASTE DISPOSAL AREAS

**TENNESSEE VALLEY AUTHORITY
KINGSTON FOSSIL PLANT**

***ANNUAL INSPECTION OF
WASTE DISPOSAL AREAS***

**KINGSTON FOSSIL PLANT
NPDES PERMIT NO. TN0005452
ANNUAL ASH POND DIKE INSPECTION
1998**

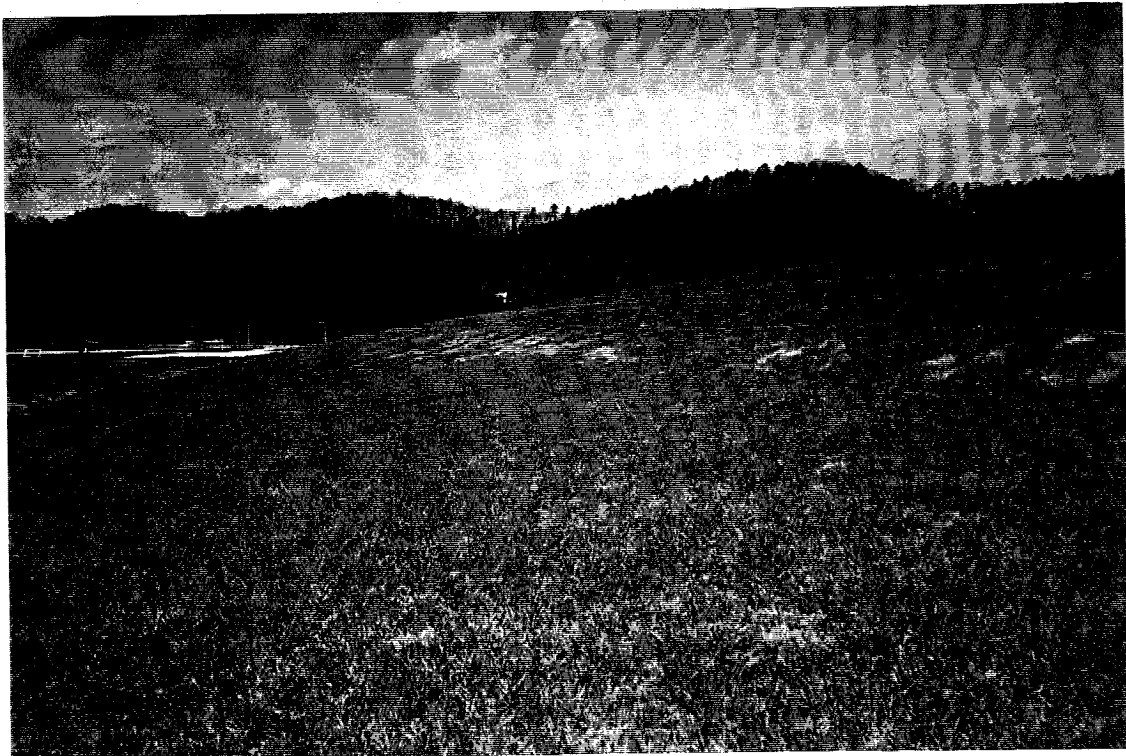
The dike slopes around this area were all stable and had excellent vegetative cover. Plant operations continue to do a commendable job of mowing the slopes. The previously identified minor slough on the west end of dike "C" had not changed in size or appearance. An area of ponded water was along the toe of the northwest dike in the ditch between the road and the dredge cells. Two erosion gullies were noted adjacent to the perimeter ditch along the northwest corner of Dredge Cell 2.

Figure 1. Southern dredge cell dike exterior slope looking westward. Note excellent cover and manicure.

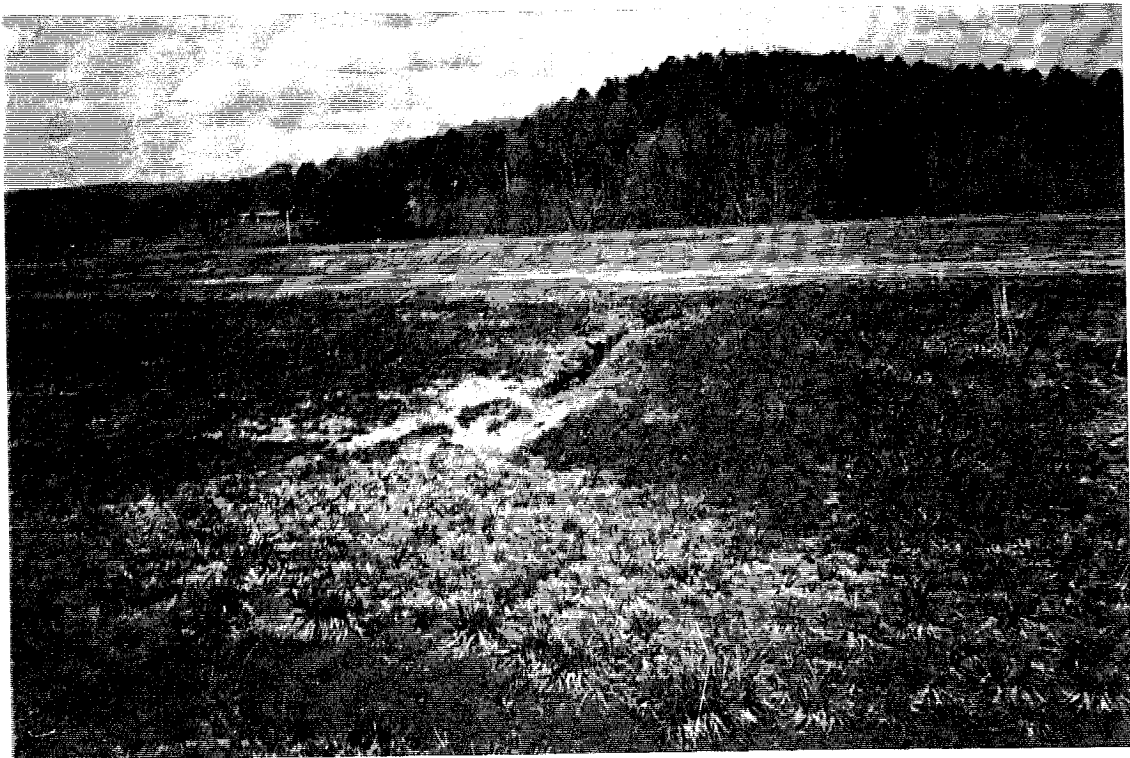
Figure 2. Area of erosion in perimeter ditch in northern corner of Dredge Cell 2.

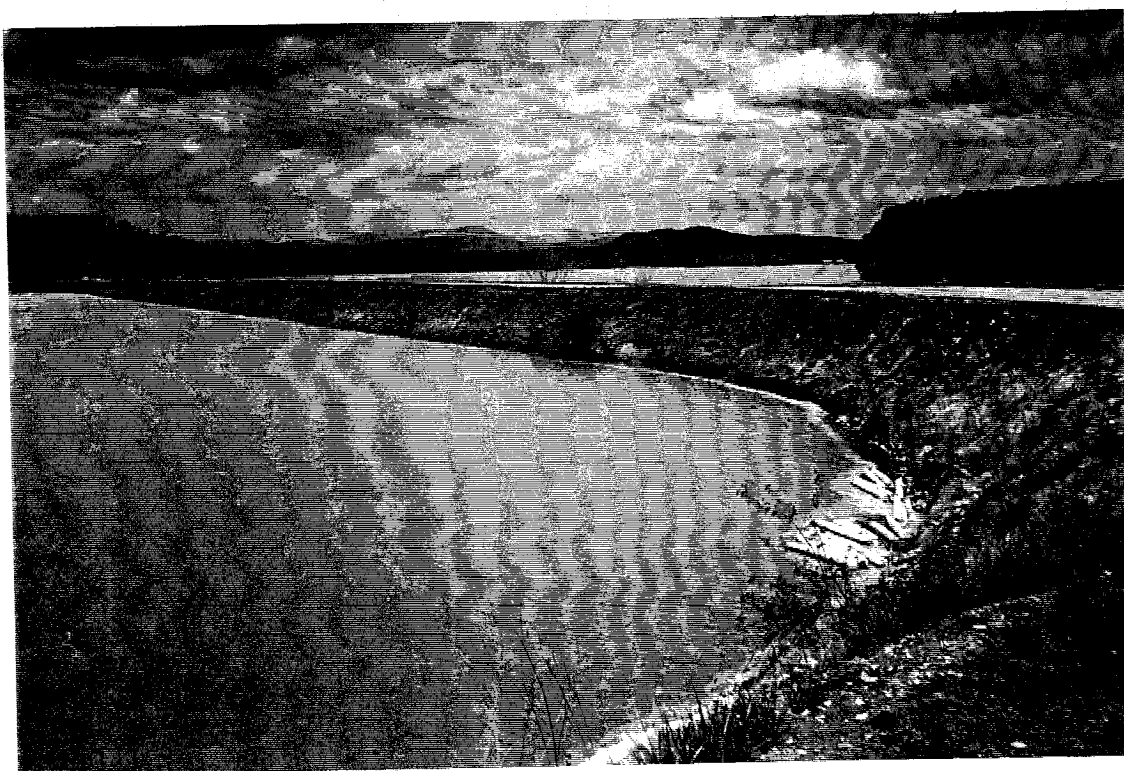
All exterior dike slopes around this area were in sound condition with excellent vegetative cover. The vegetation had been mowed and no signs of trees were present on any dike slopes. No new sloughs were detected, and the previously identified ones had not changed. There was evidence of wave erosion on the interior dike slopes of the stilling pond. The divider dike between the active pond and the stilling pool was in good condition with minor erosion on its slopes. Two areas of note were found--along the eastern dike and along the southern dike west of the bridge. Otherwise, these slopes had good vegetative cover. The dike roads were in good condition with the exception of two segments that were rutted along the southeastern dike--one west of the bridge over the intake channel and one adjacent to the anoxic limestone drain southwest of the engineered wetlands.

Figure 3. Wave erosion on northern interior slope of the stilling pond.

- Plant personnel should repair the areas of wave erosion on the interior dikes of the stilling pool by placing riprap in the problem areas where the slope has a visible vertical face of 1 foot or more.
- The ruts along the southeastern roads should be repaired by scraping away the soft material, replacing with firm clay material, and compacting. The drainage culvert under the road west of the bridge should either be replaced or cleaned out so that the area will drain and prevent future rutting.
- The drainage ditch at the toe of the northwest corner of the area should be graded to drain. Any disturbed areas resulting from this work should be seeded and mulched.

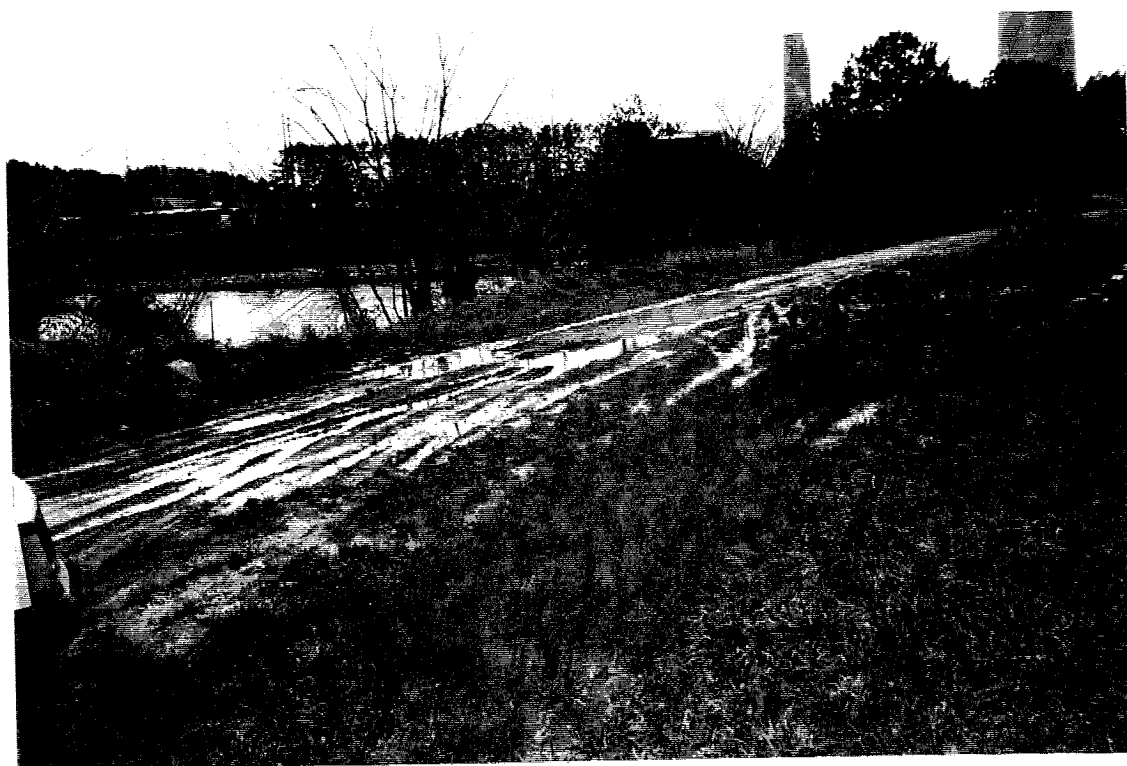
The engineered wetland along the southeast dike was functioning normally, receiving the seepage that collects in the anoxic limestone drain from the toe of the slope. A portion of the limestone drain appeared to be clogged, and the ground was saturated for approximately 100 feet.

Figure 4. Rutting on access road south of the engineered wetlands due to ALD clog.

- The seep from the anoxic limestone drain should be repaired. A plan for this work has been discussed with the plant, and a repair is scheduled for this summer.
- Plant personnel should continue to monitor any known seep and slough areas for material movement. Please notify Fossil Engineering immediately if any change is noted.
