**KINGSTON FOSSIL PLANT (KIF) - ANNUAL INSPECTION OF WASTE DISPOSAL
AREAS**

***ANNUAL INSPECTION OF
WASTE DISPOSAL AREAS***

Prepared By: Cherie Minghini
Date: April 16, 1999

**KINGSTON FOSSIL PLANT
NPDES PERMIT NO. TN0005452
ANNUAL ASH POND DIKE INSPECTION
1999**

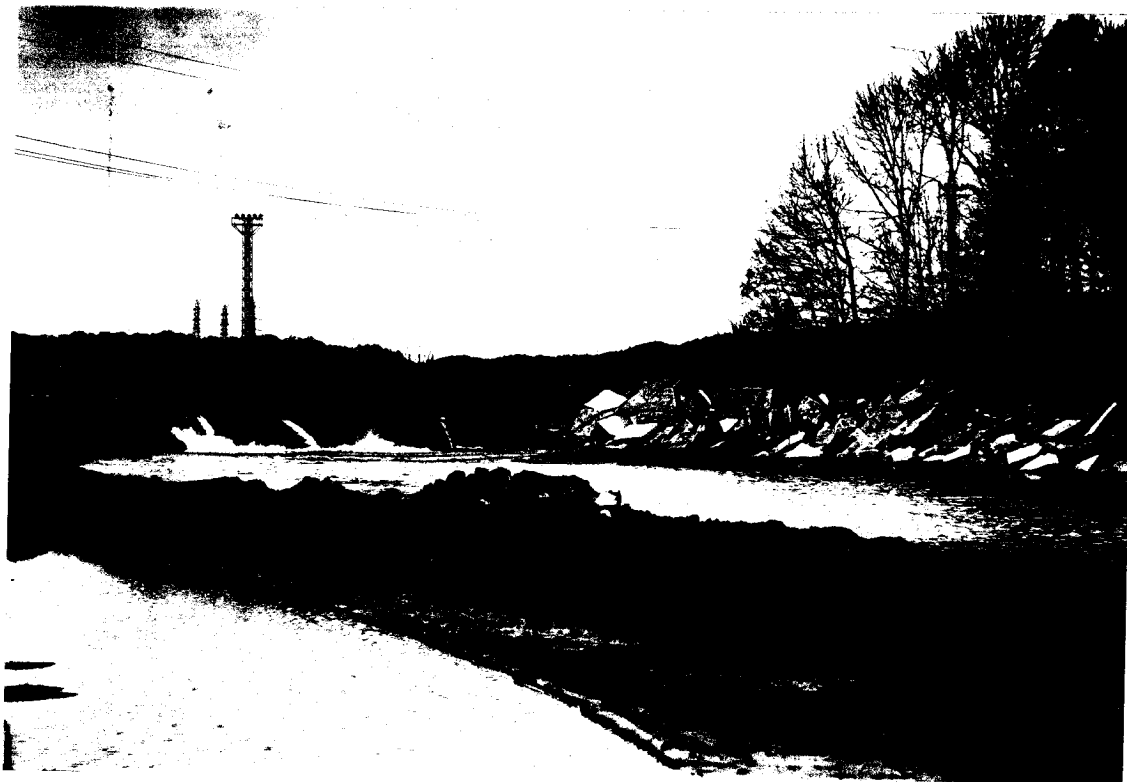
PICTURE 1 - NOTE: EROSION CONTROL ON SLOPES OF BOTTOM ASH DISCHARGE CHANNEL
