TVA – Kingston Fossil Plant and Bull Run Fossil Plant

Presentation to TDEC

December 5, 2007

Swan Pond Road Dike – Seepage Issues (2006)

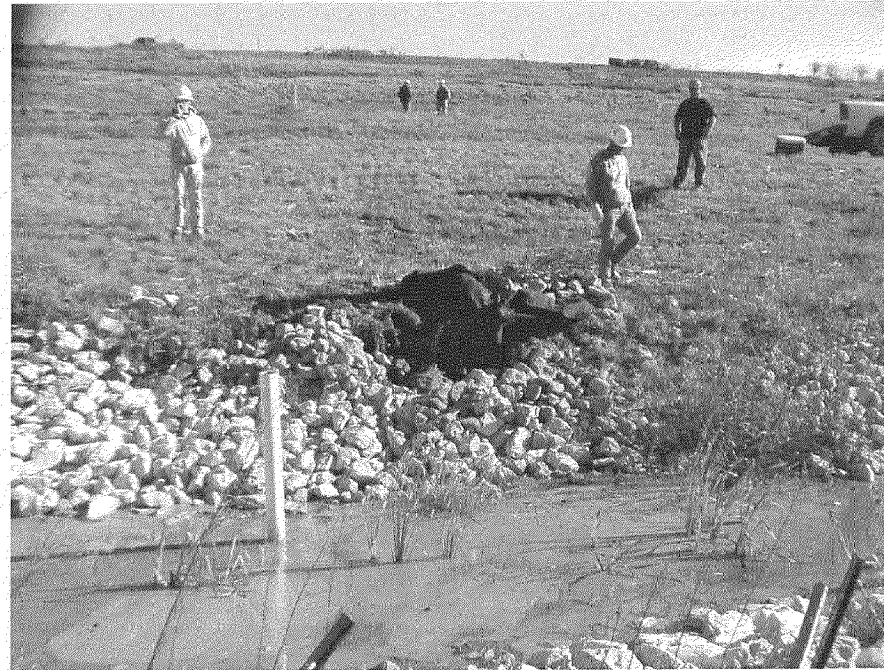
- Excessive seepage and piping observed near toe of dike on November 1, 2006 (two locations, similar location to 2005)
- Decision made to lower water levels in Ash Pond, conduct dye test, install “temporary patch”
- The patch coupled with weather improvements minimized the immediate threat
- Suspended Dredging Operations
- Lowered Water Table

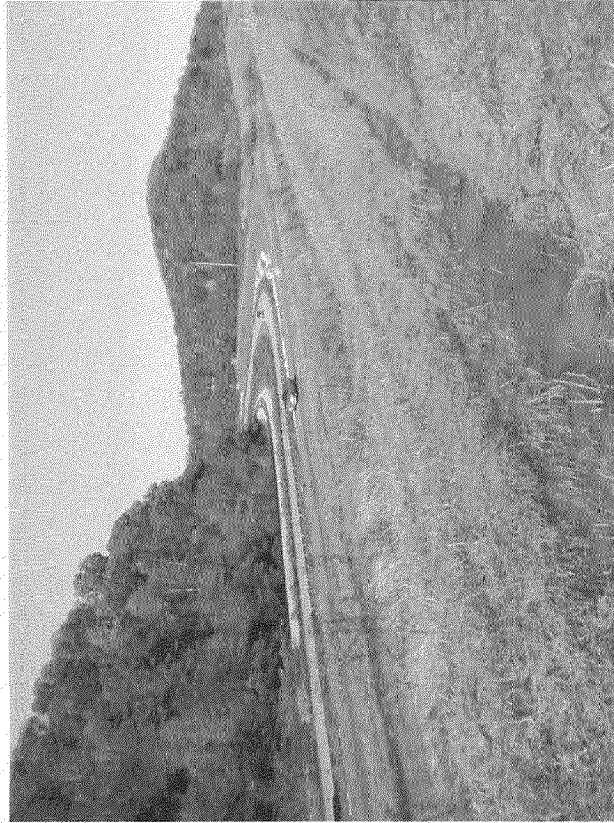
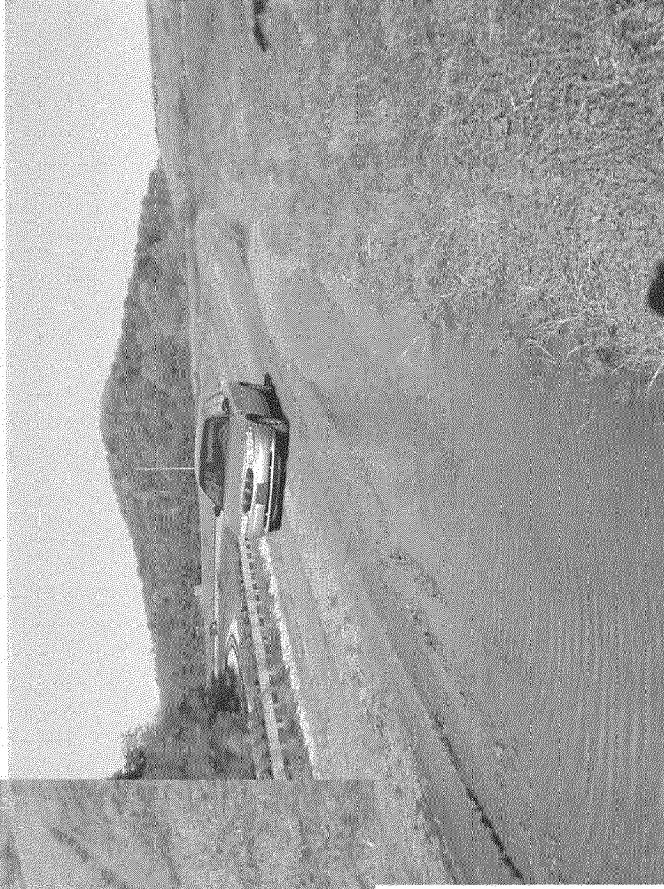
- Geosyntec performed an inspection on 2 November 2006 and concurred with the actions taken by TVA
- TVA initiated inspections every 2-hours to monitor the situation
- Geosyntec commenced planning for additional investigations and short-term repairs
- In the seep areas, water was observed to be flowing below the geonet drainage layer; water was also observed to be flowing through the geonet
- Surface water was observed on benches
- Underdrains currently discharge to benches

Photos taken November 2, 2006
(dry weather conditions)
Note water on benches in
general vicinity of seeps

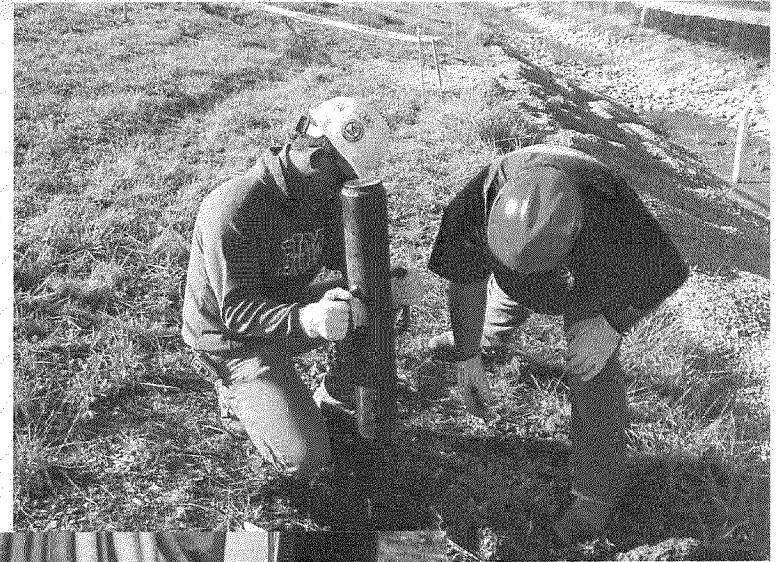
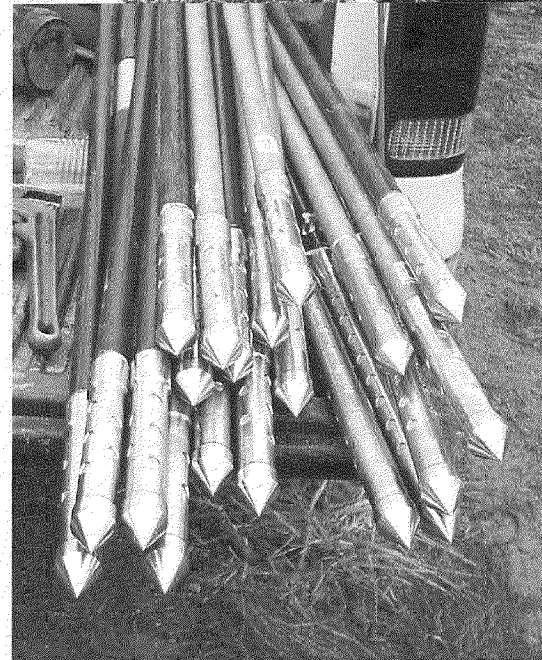
- Installed 33 drive-point piezometers along the toe of the slope
- Measured water levels and developed a water level profile
- Identified the area of concern based on the water levels that are within a foot or less of the ground surface
- In some instances water levels in piezometers were above the ground surface

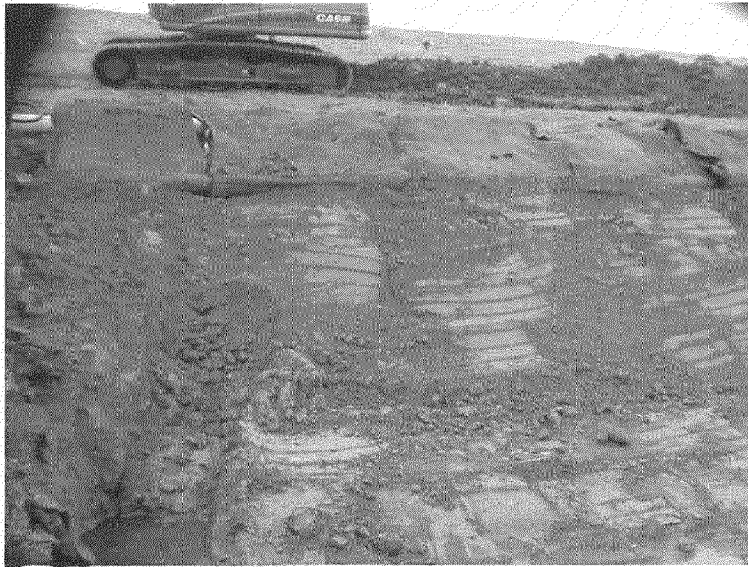
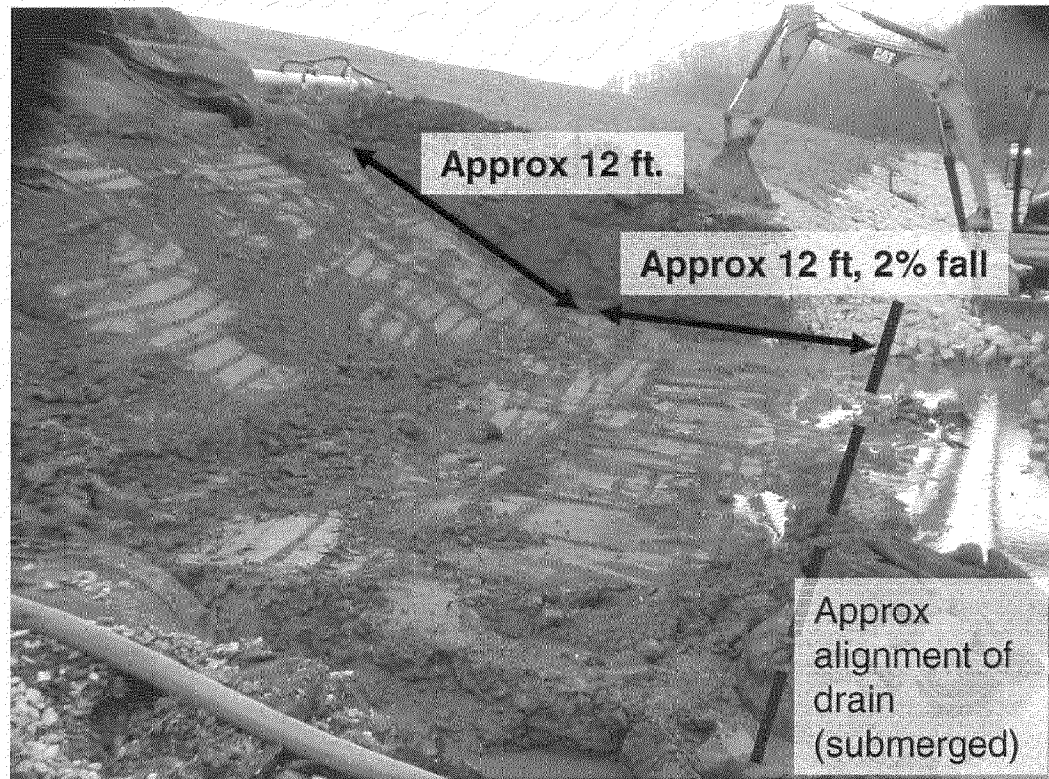
- Conditions immediately prior to repair/placement of new buttress drain

- Overall goal:
 - Improve toe drain
 - Contain ash to prevent piping

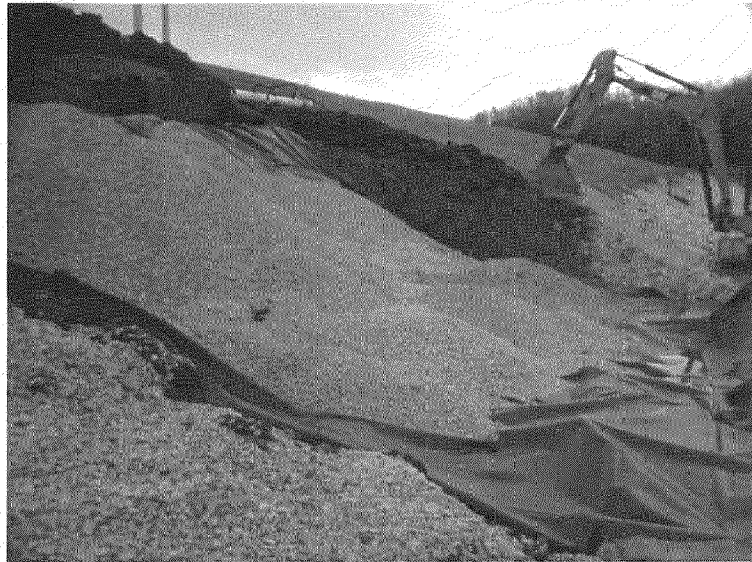
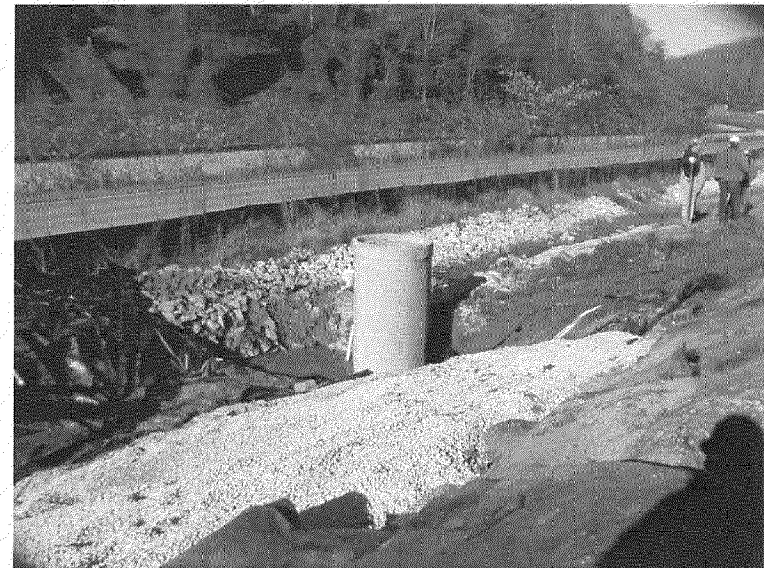
- Attempts to dewater and expose the toe drain pipe were not successful due to pump capacity and excess water.
- Placed gravel over the pipe and a layer of geotextile over gravel.
- Groundwater level was at about 1 ft below ditch invert.

- Placed the spring box (36-in concrete pipe) over the geotextile (see next slide).
- Backfilled the area surrounding the concrete pipe with gravel.
- Placed gravel inside the concrete pipe (~1 to 2 ft)
- Completed the placement of gravel blanket layer.

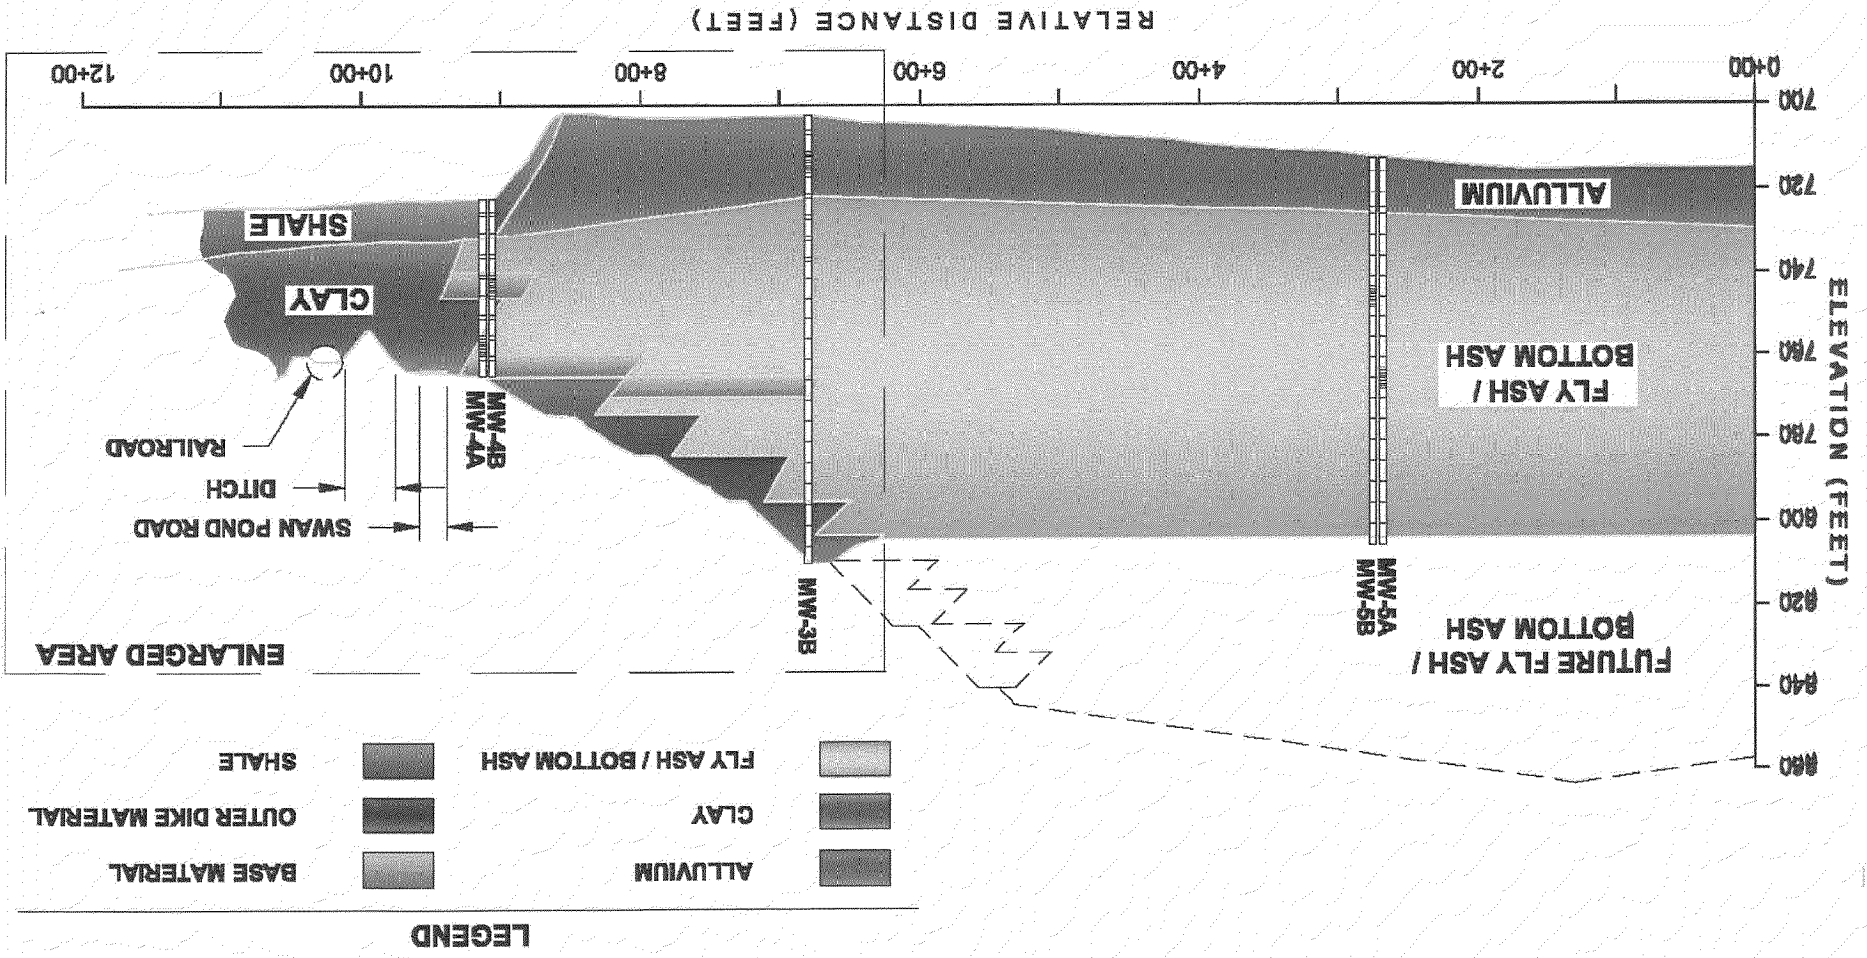
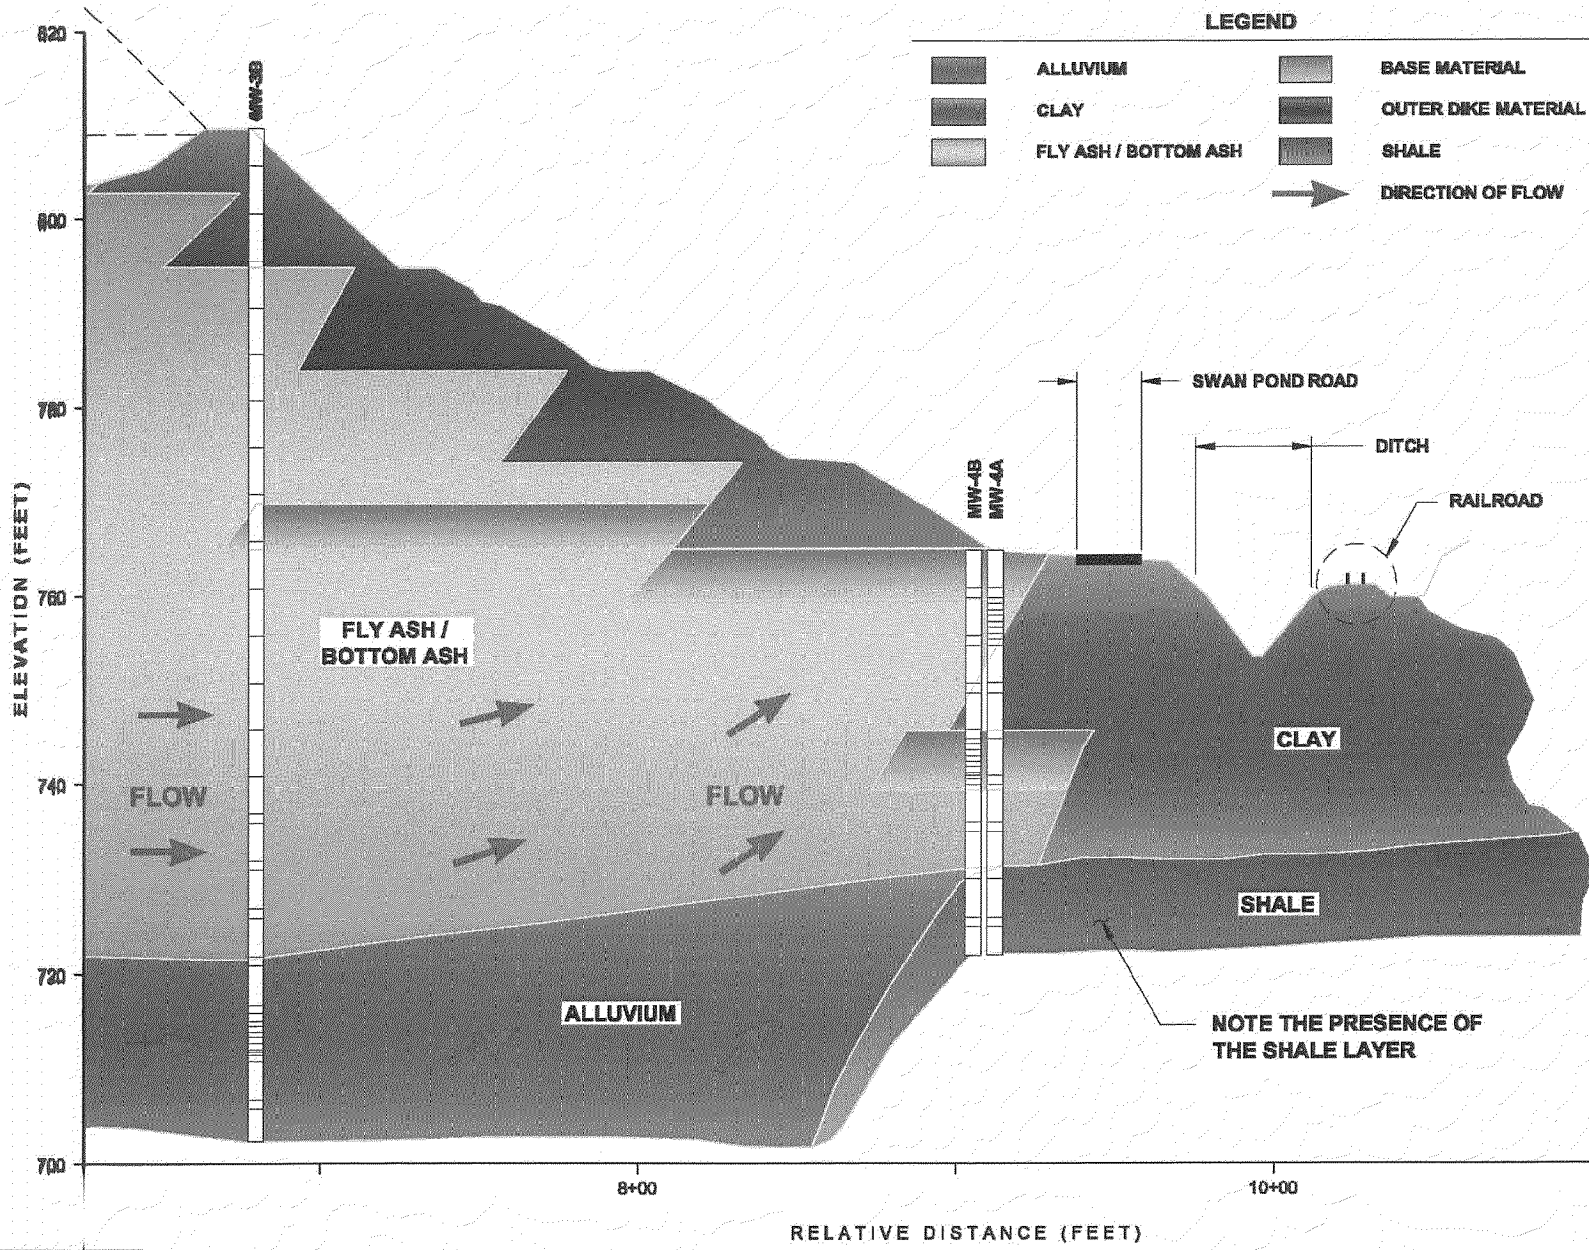
Cell 3 Cross Section (Seepage Area)

- Localized anomalies found in seepage area during intrusive investigation
- Presence of shale layer identified at seepage area during 2005 geotechnical investigation
- Seepage model constructed using Cell 3 geometry and properties

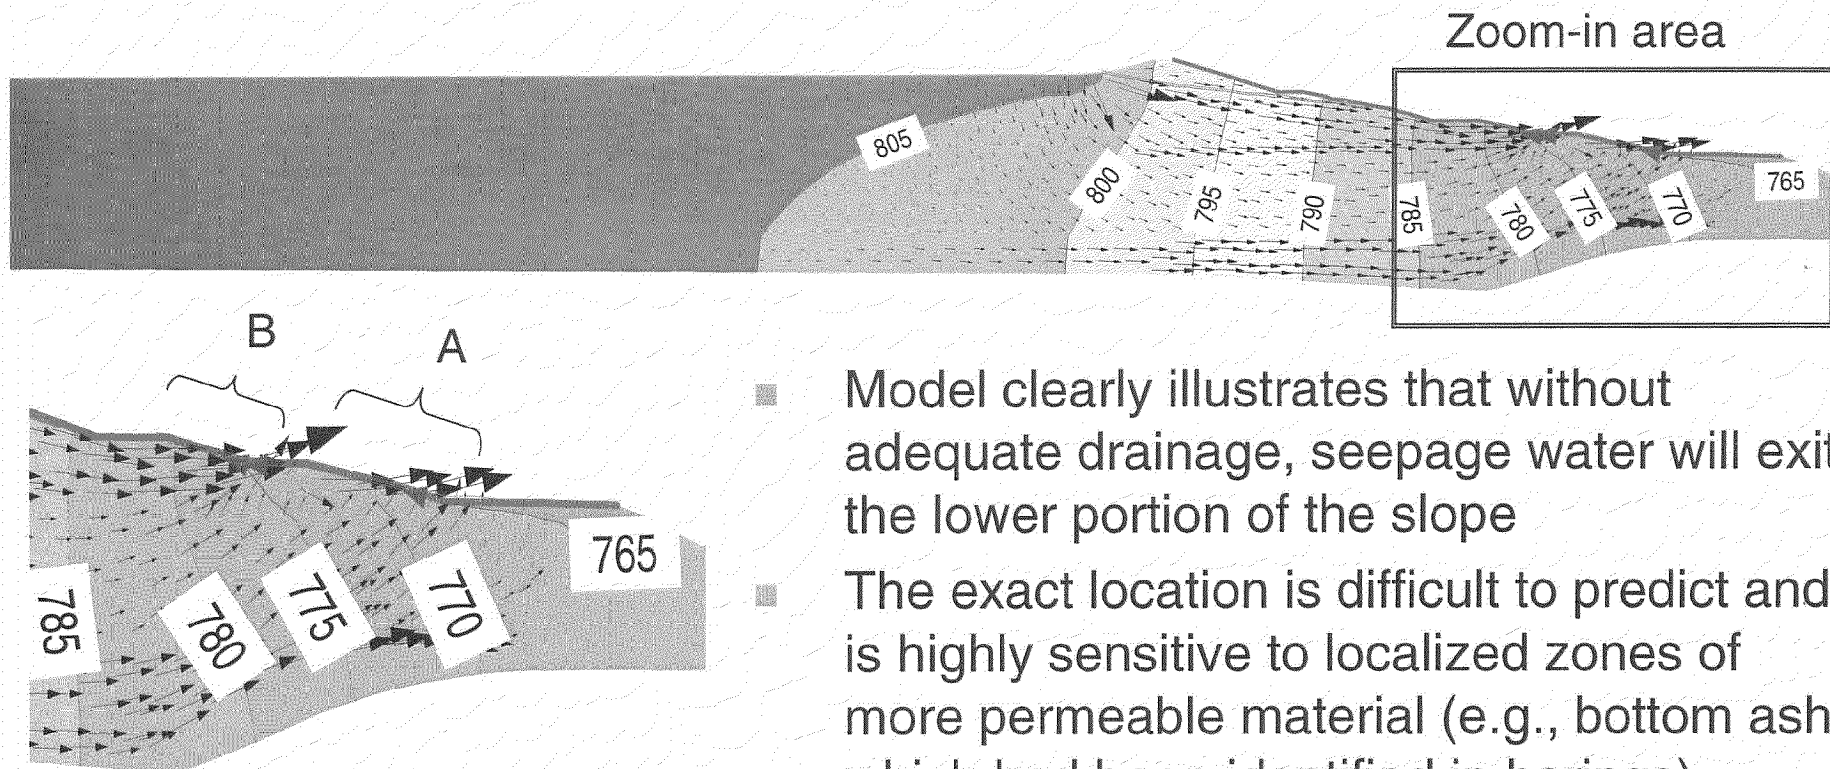
Model-predicted Total Head Distribution (equipotential lines)

- Model clearly illustrates that without adequate drainage, seepage water will exit the lower portion of the slope
- The exact location is difficult to predict and is highly sensitive to localized zones of more permeable material (e.g., bottom ash which had been identified in borings)
