KINGSTON FOSSIL PLANT - ANNUAL ASH POND DIKE STABILITY INSPECTION - FY 2008

TENNESSEE VALLEY AUTHORITY

## **KINGSTON FOSSIL PLANT**

**ANNUAL ASH POND DIKE  
STABILITY INSPECTION  
2008**

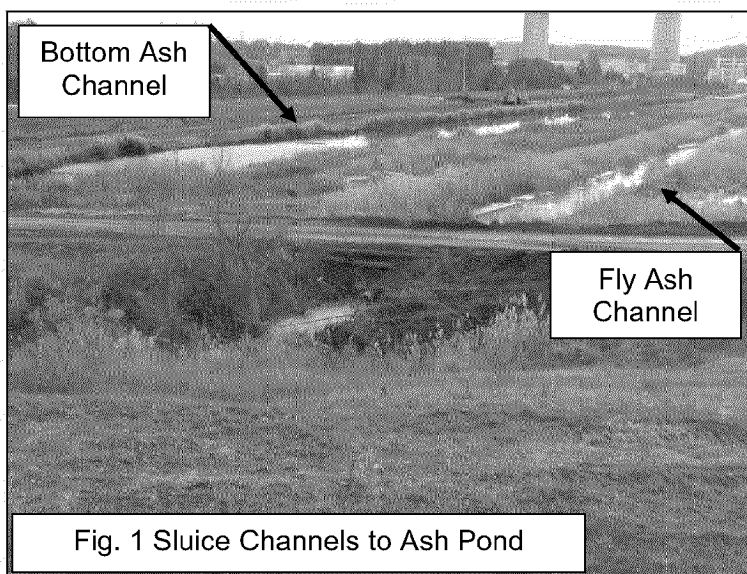
Fig. 1 Sluice Channels to Ash Pond

Fly ash is sluiced into an adjacent channel to the bottom ash channel where it flows into the main ash pond. The fly ash channel was cleared of vegetation last year. Both channels flow northeast into the active ash pond. See Figure 1 and drawing API 2008.

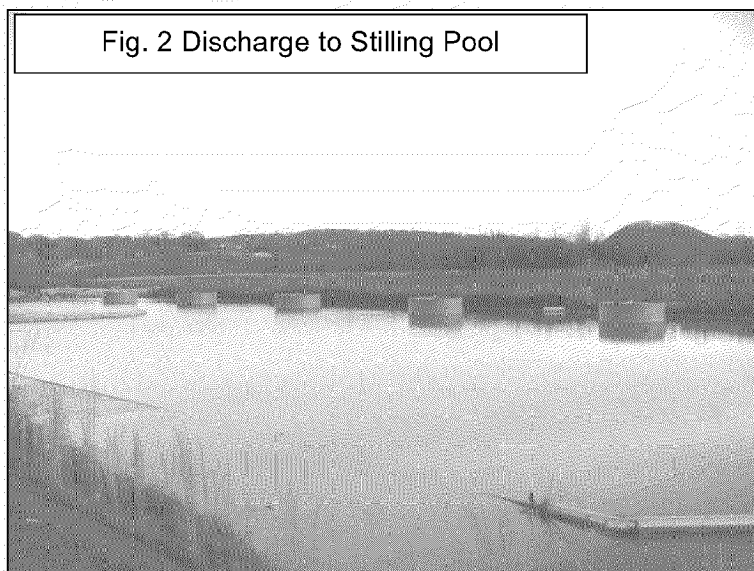
Fig. 2 Discharge to Stilling Pool

Sluice water flows from the active ash pond into the stilling pond through the five spillways constructed in 2005 (see Figure 2), as part of a project to allow more accurate accounting of free water volume. The old plant constructed spillway (Kennedy Weir) was taken out of operation at the same time. From the stilling pool, the water discharges into the plant intake channel via six standard spillways equipped with discharge diffusers constructed in November 2003. Many of these structures have vegetation and brush growing inside them, which needs to be removed.

- Remove vegetation growing inside spillway structures.
- Investigate the use of spraying to inhibit vegetation growth on the interior dikes of the stilling pond.

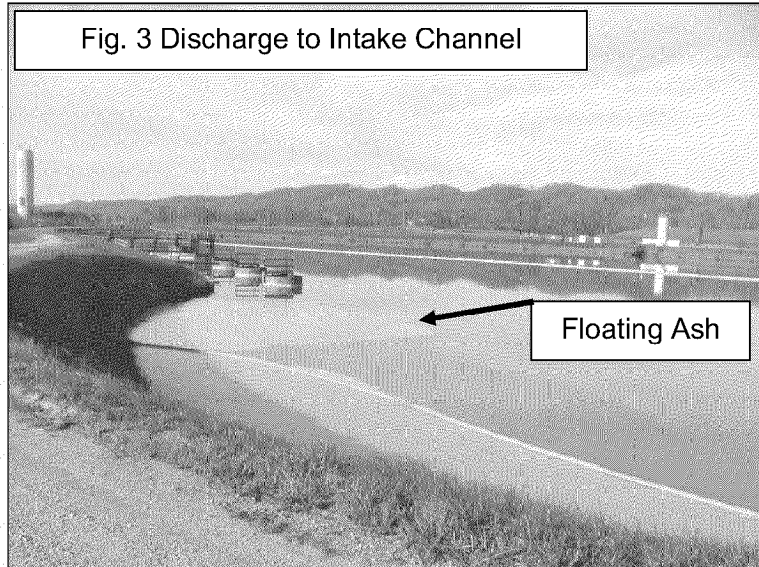
Large amounts of floating ash have been contained within floating skimmer booms (two inside both the active ash pond and the stilling pool). This ash should be removed in order to prevent an accidental release. Some of this ash has breached the booms and is near the discharge structures. See Figure 3. The seeps along the toe of Dike C and below the toe of the dike along the intake channel, known since the early 1980s were not visible during this inspection.

- Remove ash floating on the surface of the ash and stilling ponds.
- Repair rutting in the access and dike roadways. Fill with bottom ash and regrade as required to promote drainage.

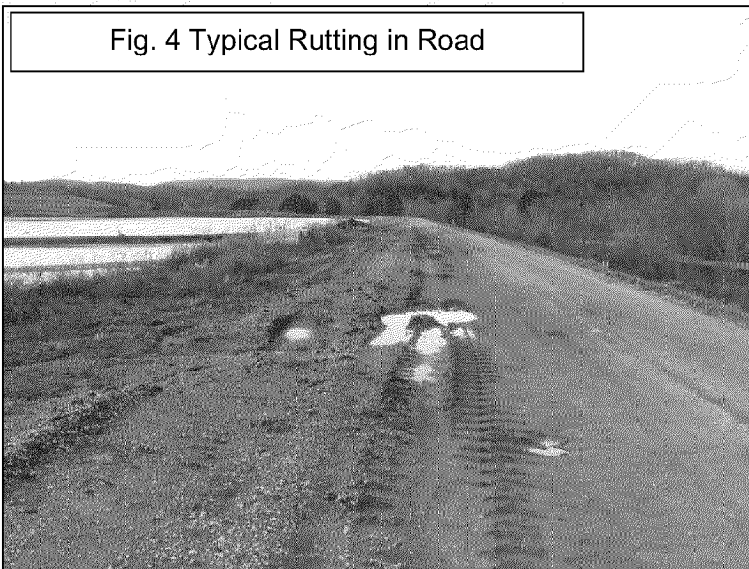
Some of the dike roads exhibit areas of rutting, see Figure 4. This photo is typical of the conditions of the roads, although it does not appear to be a significant problem

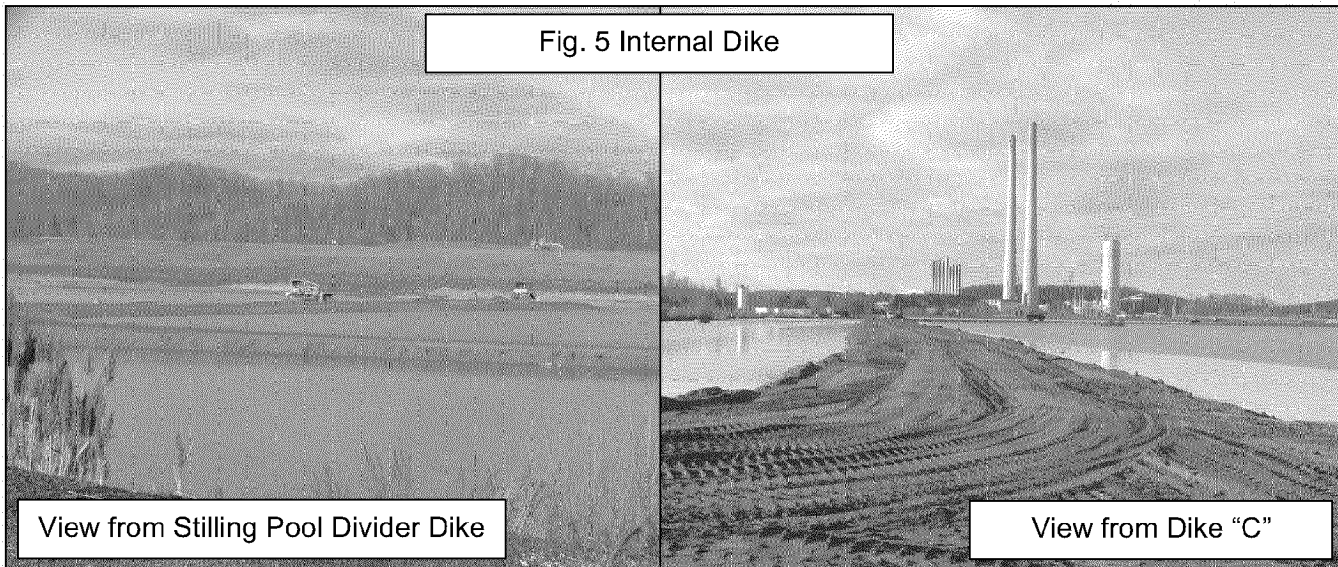
Construction of an internal divider dike inside the active ash disposal area is currently underway. The divider dikes will be constructed to build a base of fly ash for a dredge cell expansion, which will eventually cover approximately half of the existing main ash pond. See Figure 5.

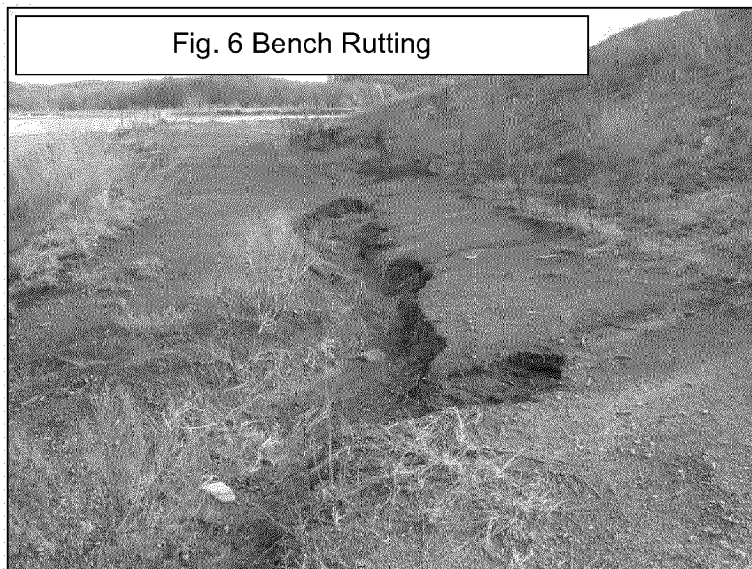
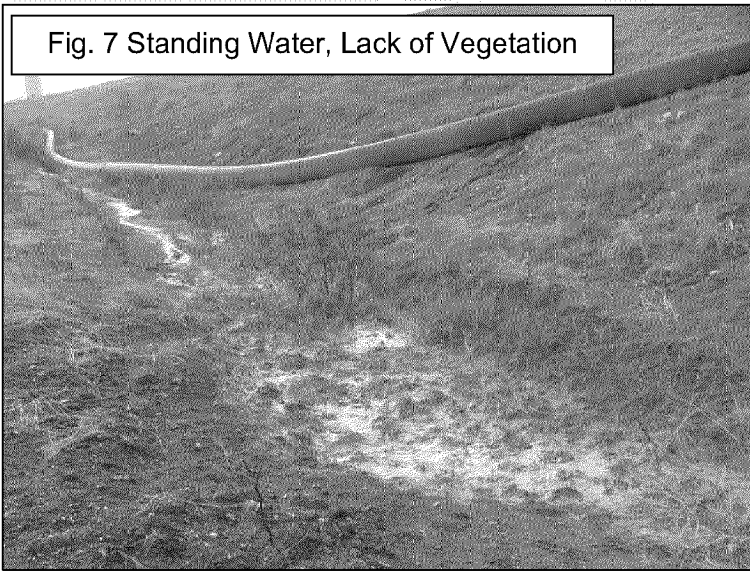
interim cell to the main ash pond. Water flow into the interim cell is essential for dust control. The divider dike between this cell and the active pond appeared to be in stable condition with some bench rutting and poor vegetation. There was one section of standing water approximately 100 feet in length. As much as practical, these areas should be graded so they will drain, even if slowly. Wheel ruts that hold water should be filled with bottom ash and covered with stone if they are in a road. See Figures 6 and 7 (next page).

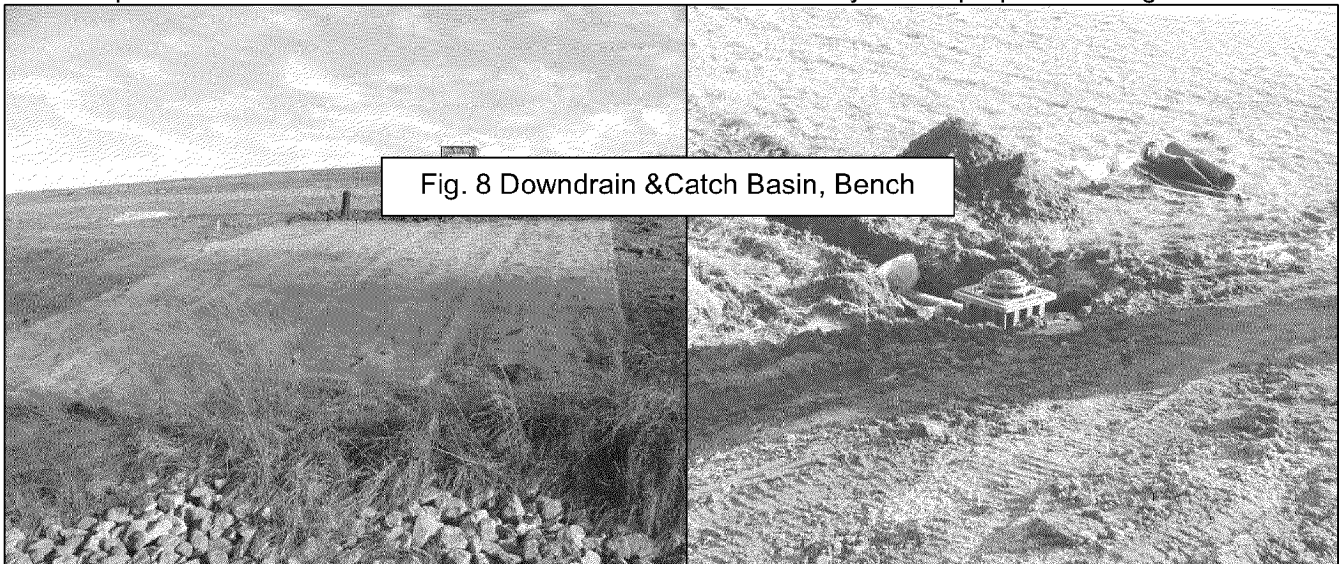
Since last year's inspection, ash was dredged into Cells 1, 2, and 3 to such levels that the divider dikes for Cell 3 were buried and now there are only two large cells (1 and 2). Dredging was stopped in mid-November 2007 based on recommendations from EDS and Geosyntec Consultants, Inc. This preventative measure was taken to reduce water levels in the dredge cell through the winter months in an attempt to avoid another blow out. EDS collaborated with Geosyntec to prepare a design to address

the poor bench drainage. The lower benches will be re-graded to provide positive drainage to a series of catch basins which will divert the water collected to the lower drainage ditch. Construction is currently underway to install surface drainage repairs, (See Figure 8, Figure 9 (next page), and Drawings 10WXXX-1 through -10 for details). In addition to these repairs, outlets are being installed on the old dewatering wells to allow personnel to relieve some of the water in these wells. The water drained will flow to the riprap channel along Swan Pond Road.

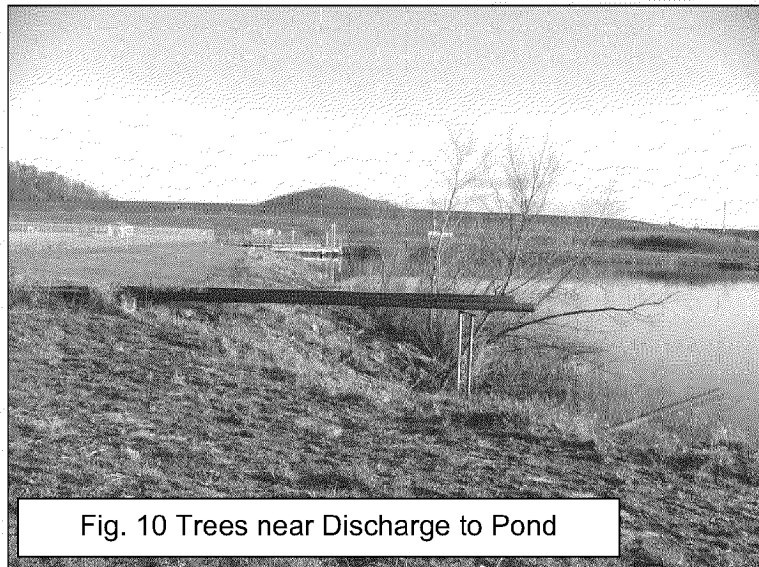
Fig. 10 Trees near Discharge to Pond

The chemical treatment ponds (iron and copper) are located southwest of the active ash pond. Both ponds were excavated and have no exterior slopes. The internal dike slopes are covered with riprap. These slopes were in good condition with a few trees present. See Figure 10. Sediment in the ponds was tested in FY 2004 and found to be non-hazardous. It appeared that some maintenance had been recently performed at one of the pond platforms. Old gaskets were on the ground and there was a new pipe flange and hardware. The platform at the smaller pond was missing a pump.

- Remove trees from the slopes of the dikes. Mowing at least twice a year is recommended to control the size of the trees. Preventing the trees from getting larger than 1" in diameter at the ground is preferred. Any trees larger than 3" in diameter at the base must be pulled from the dikes, roots and all. Repair and reseed the damaged area.

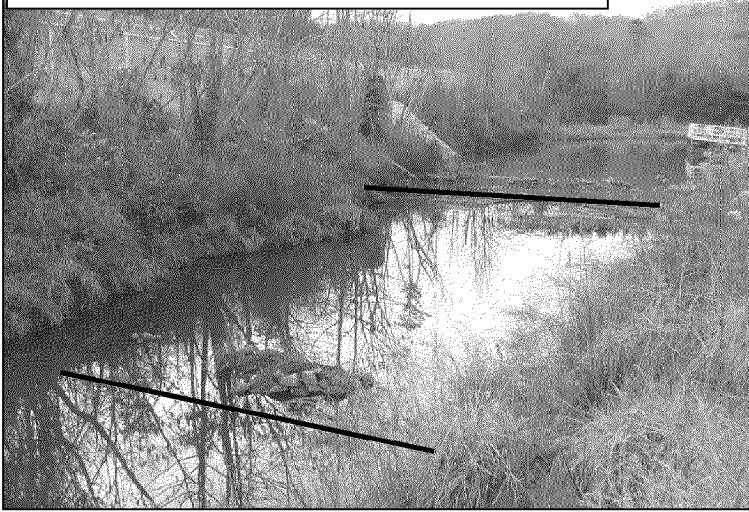
Fig. 11 Breached Check Dams

The coal yard drainage basin is located at the southwest corner of the coal pile. This basin was excavated below grade; therefore, there are no exterior dikes. The interior slopes appeared to be in satisfactory condition. Normal discharge from this basin is pumped into the fly ash discharge ditch and flows to the active ash disposal area. The basin was cleaned out in 2006, but is in need of another clean out. The bottom of the pond should be no higher than elevation 745 at the pump platform. Elevation 745 allows 2-feet of clearance below the pump intakes to prevent pumping solids. In addition, the "V-shaped" pond extensions added during the summer of 2001 to increase the pond

storage volume contained coal yard sediment. The above figure shows rock check dams built to keep the coal fines away from the pumps. The check dams appear to have been breached, allowing suspended solids to reach the pumps. TVA drawing 10W225-2 (attached as API 2008-2) shows the pond and its intended bottom contours.

- Dredge the Coal Yard Drainage Basin to restore its design contours and protect the pumps from further damage. There is an estimated 2,800+ cubic yards of sediment in the original pond and an extra 3,400+ cubic yards in the "V" section that needs to be removed as soon as reasonable. See the attached copy of 10W225-2. Estimated at \$55,000, depending on haul distance.

- Continue intermittent dredging into the interim dredge cell to inhibit fugitive dusting.
- Re-establish riprap check dams in the coal yard drainage basin to prevent solids away from the pumps.

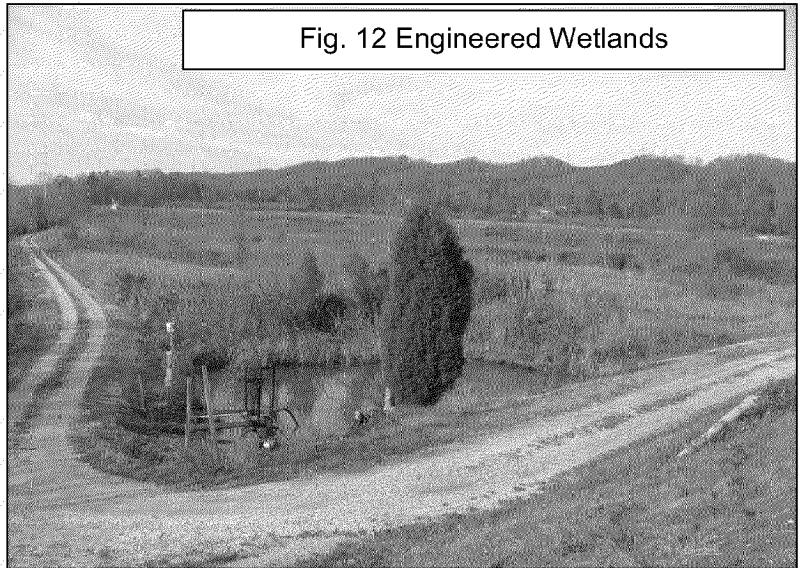
Fig. 12 Engineered Wetlands

The engineered wetlands along the southwest dike receive seepage that collects in the anoxic limestone drain below the bottom ash trench. The wetland appeared to be functioning, but the discharge is still pumped via two pumps to the ash pond, see Figure 12.

The water levels in the pump structures were at different levels at the time of inspection. There were several trees varying in size growing on the interior dikes of the ponds.

- Monitor the limestone drain area and all exterior dike slopes (along Swan Pond Road in particular) for seepages, soft wet spots, animal burrowing, sloughing, etc., and report any changes to Jamey Dotson of FPG Engineering Design Services, 423-751-6421.
