TENNESSEE VALLEY AUTHORITY

KINGSTON FOSSIL PLANT

ANNUAL ASH POND DIKE
STABILITY INSPECTION
2009

Prepared by: Chris Buttram
Date: January 12, 2009

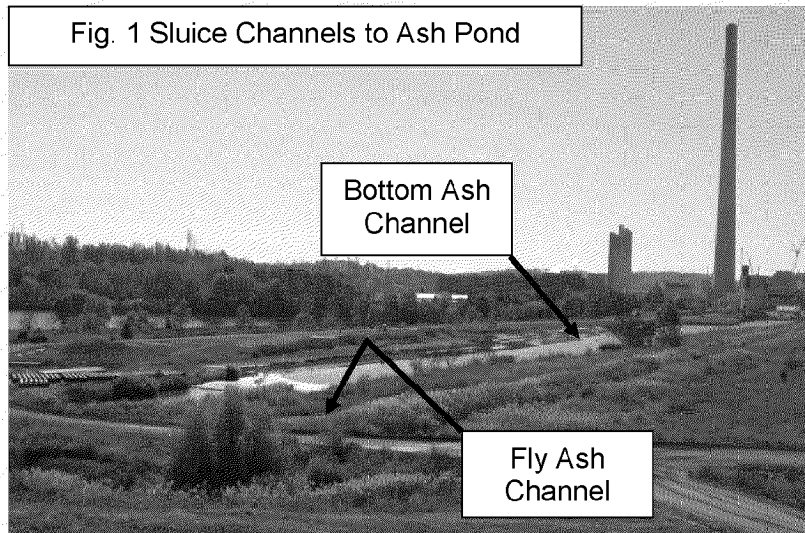
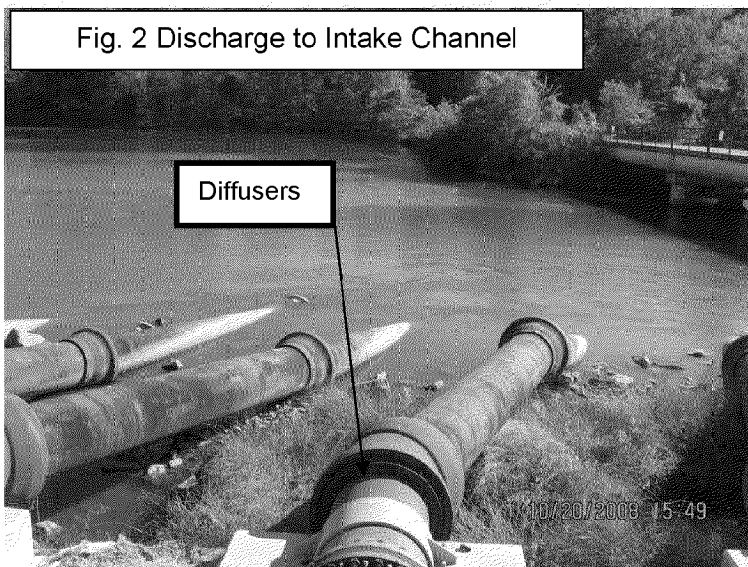
Fly ash is sluiced to a channel adjacent to the bottom ash channel and flows into the main ash pond. The fly ash channel was cleared of vegetation last year. Both channels flow northeast into the active ash pond. See Figure 1 and drawing API 2009.

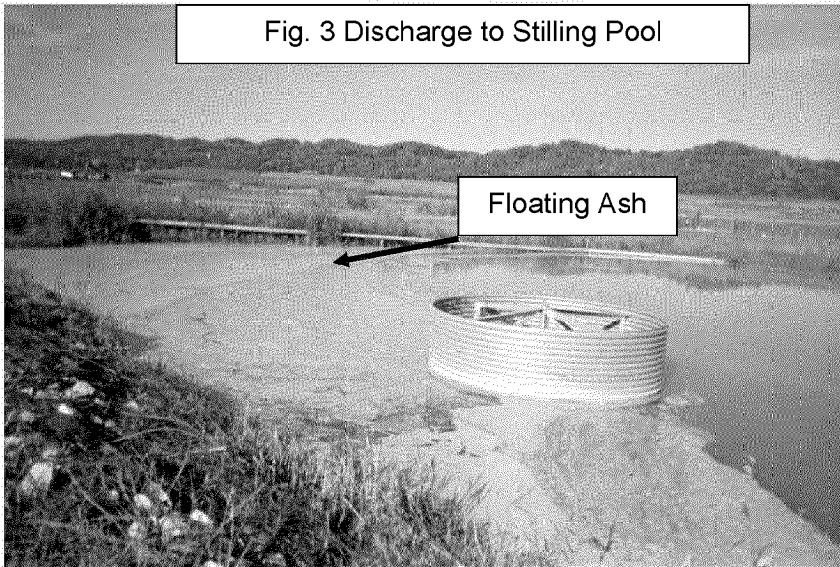
Fig. 3 Discharge to Stilling Pool

Floating ash near discharge structures, as seen in Figure 3 below, should be removed to prevent an accidental release. Check the floating skimmer booms and maintain them to keep floating ash away. The seeps on the bench of Dike "C" north of the intake skimmer, mentioned on previous reports, have not been observed since wheel ruts were repaired a few years ago. No seeps or wet spots were seen in this area during the inspection.

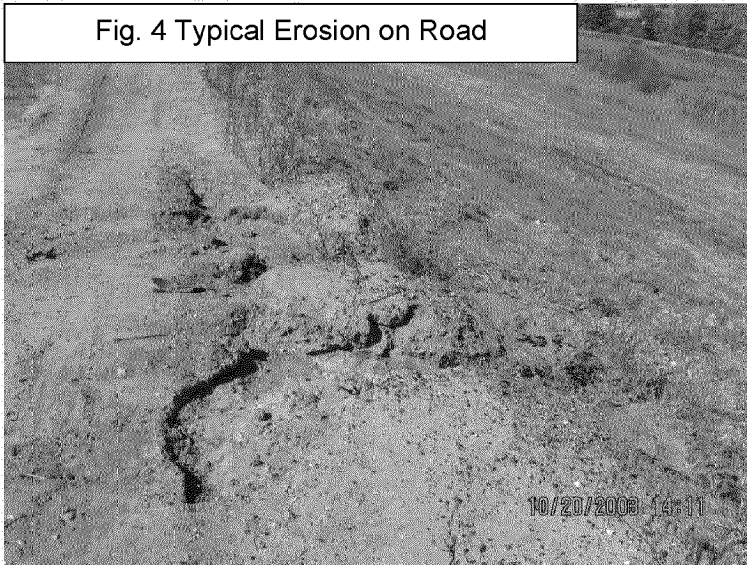
Fig. 4 Typical Erosion on Road

Some of the dike roads exhibit areas of erosion on the edges and some rutting, see Figure 4. This photo is typical of the eroded areas of the roads. Although it does not appear to be a significant problem, these eroded areas, as well as any ruts, should be graded out and the road covered with crushed stone to prevent larger erosion gullies.

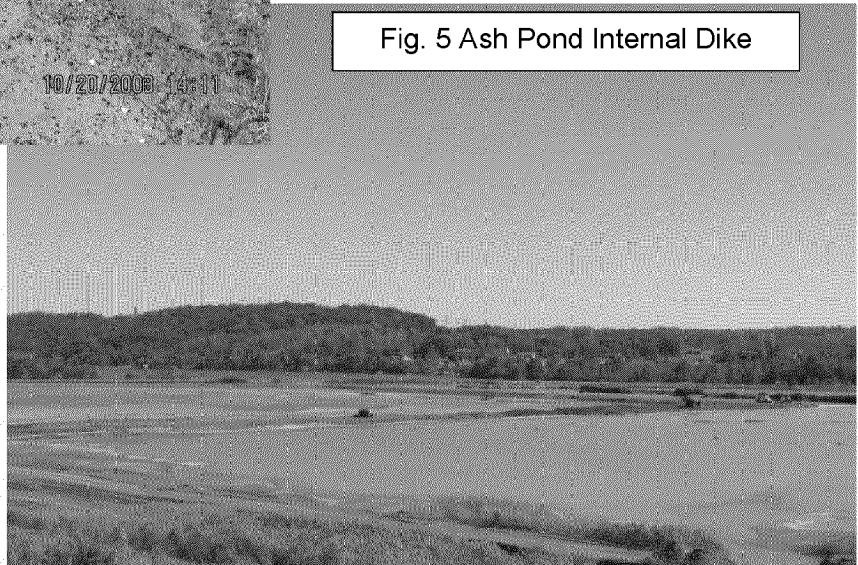
Fig. 5 Ash Pond Internal Dike

Construction of an internal divider dike inside the active ash disposal area is currently underway. The dike is one foot

to two feet above elevation 760, the elevation of the water in the pond. The divider dike will be constructed to build a base of fly ash for a dredge cell expansion, which will eventually cover approximately half of the existing main ash pond. See Figure 5.

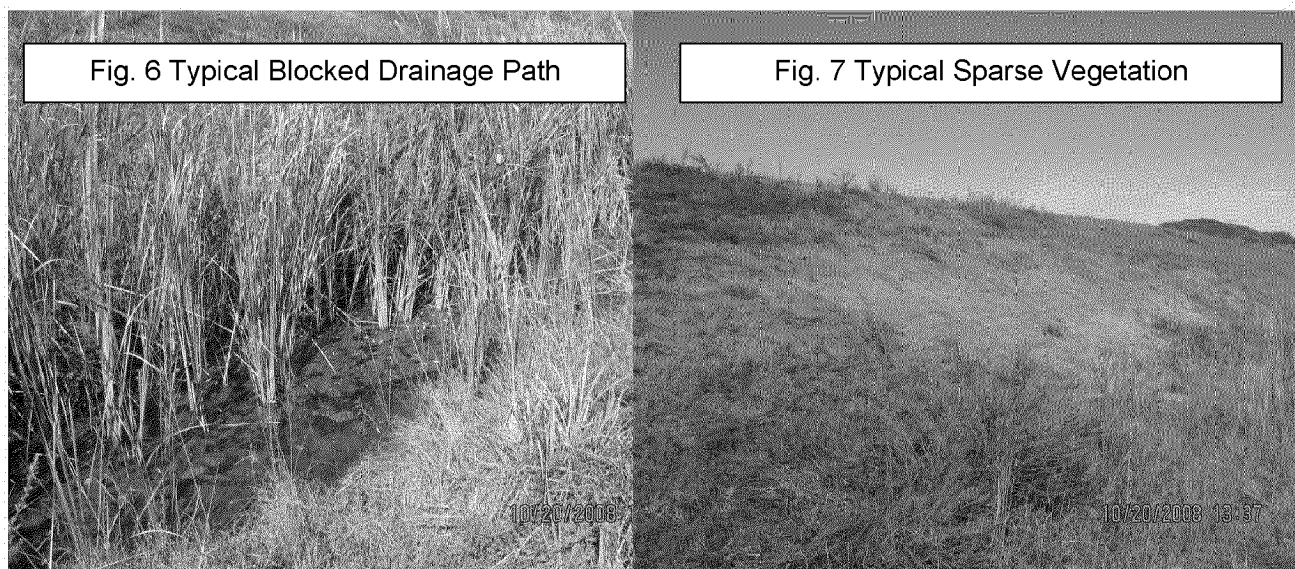
The interim dredge cell capacity has been depleted; however decant water from the raised dredge cells flows through the interim cell to the main ash pond. Water flow into the interim cell is essential for dust control. The divider dike between this cell and the active ash pond appeared to be in stable condition. Some areas of sparse vegetation (Fig. 7) and poor bench drainage were observed spotted on this dike. These areas should be reseeded and fertilized per T-1, section 580. Areas with poor

drainage should be graded so they will drain, even if slowly. Also, thick vegetation in drainage ditches (Fig. 6) should be thinned out or removed to keep from blocking the water flow. Wheel ruts on benches or in roads that are holding water should be filled with bottom ash and covered with stone.

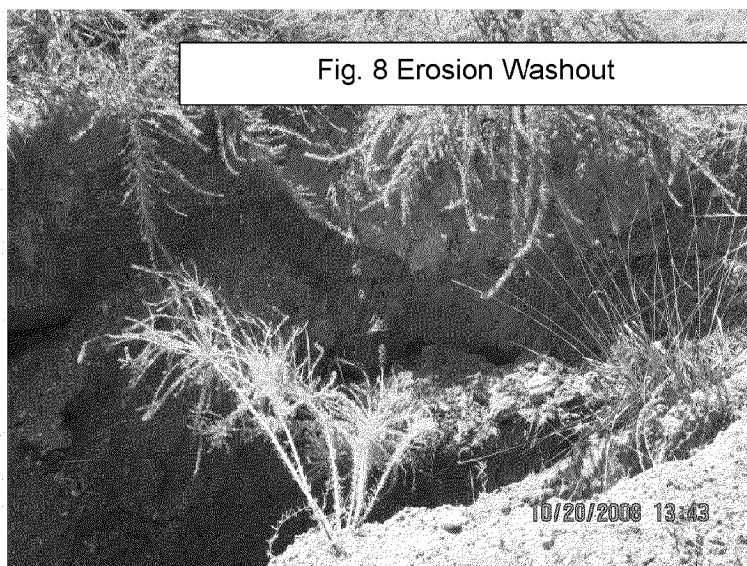
Due to extensive erosion in one area, a washout two feet wide by twenty feet long by two feet deep had formed (Fig. 8). This area should be repaired by filling bottom layer with six inch lifts of compacted bottom ash until clay area is reached. Cap with one foot of clay using six inch compacted lifts. It is recommended that an erosion control blanket be used in this area for quicker vegetation growth. Monitor this area, especially after rain events, to assure that no settling occurs.

- Repair broken dewatering well outlet pipes. These pipes should be draining directly into the lined ditch at the bottom of the cells.
- Repair the 2' x 20' area of erosion on the east slope of the interim dredge cell. Fill bottom layer with bottom ash in 6" lifts and compact. When the clay layer is reached, cap with 1' of clay via 6" compacted lifts. Lastly, cover with an erosion control blanket to help stabilize the damaged area. After repairs have been made, continue to monitor area until good vegetation has stabilized the area.
- Repair erosion washout on lower dike bench at North end of dredge cells. Repair eroded area by filling with clay in 6" lifts and compacting, then reseed and fertilize per T-1, section 580.
- Continue to monitor the wet spot at the toe of the Cell 2 dike.

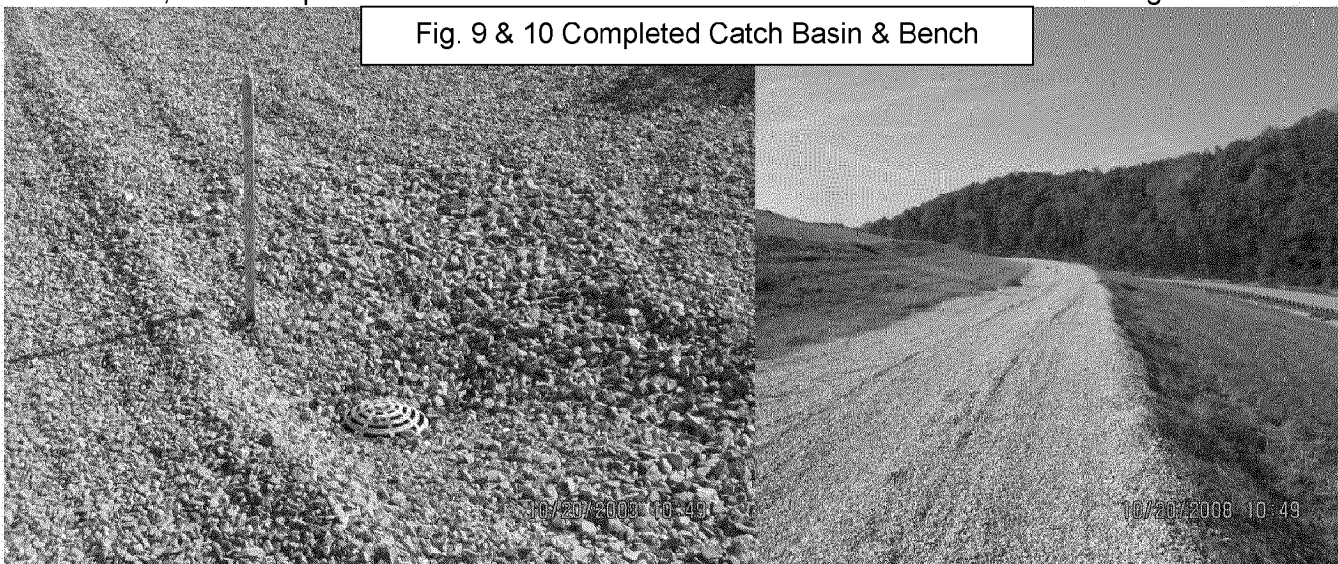
Previously, ash had been dredged into three separate cells, but in 2007, the ash reached levels that buried the divider dikes for Cell 3 and now there are only two large cells (1 and 2). Dredging to these cells was stopped in mid-November 2007 based on recommendations from EDS and Geosyntec Consultants, Inc. This preventative measure was taken to reduce water levels in the dredge cell

through the winter months. Dredging restarted in March 2008 and was still in operation at the time of this inspection. Since the last inspection, the lower benches have been re-graded to provide positive drainage to a series of catch basins which divert the water collected to the lower drainage ditch. In addition to the catch basins and down drains, the benches were covered with a geomembrane, geotextile and then crushed stone to further reduce infiltration into the benches. See Figures 9 and 10 above.

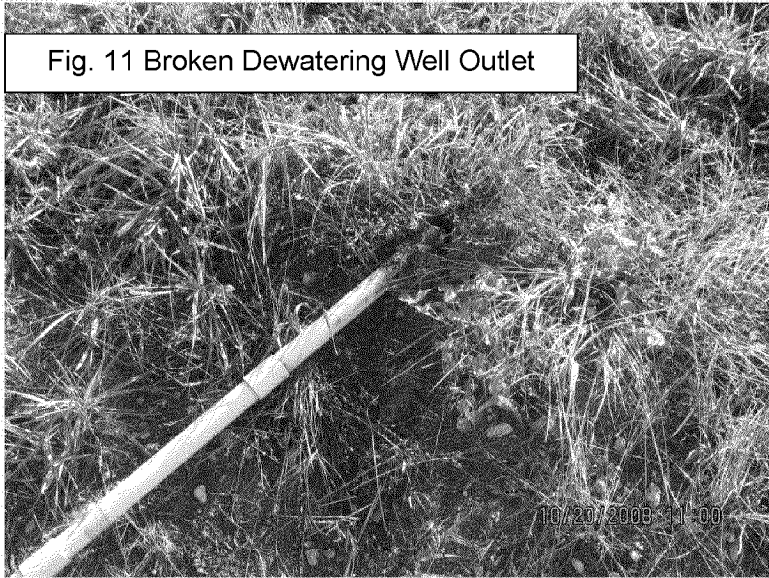
Fig. 11 Broken Dewatering Well Outlet

Drain lines with valves were installed on the old dewatering wells to allow personnel to relieve some of the water in these wells. These outlets empty directly into the riprap channel along Swan Pond Road. At the time of the inspection, the valves on some drains were closed in preparation for measurement of water levels and those wells showed water pressure above the dike slope. The valves of the other monitoring wells were open and were flowing clear water to the drainage ditch. Some of these drains had been broken (Figure 11), possibly while the slopes were being mowed.

These broken drains should be repaired so that the water is not draining freely down the slopes.

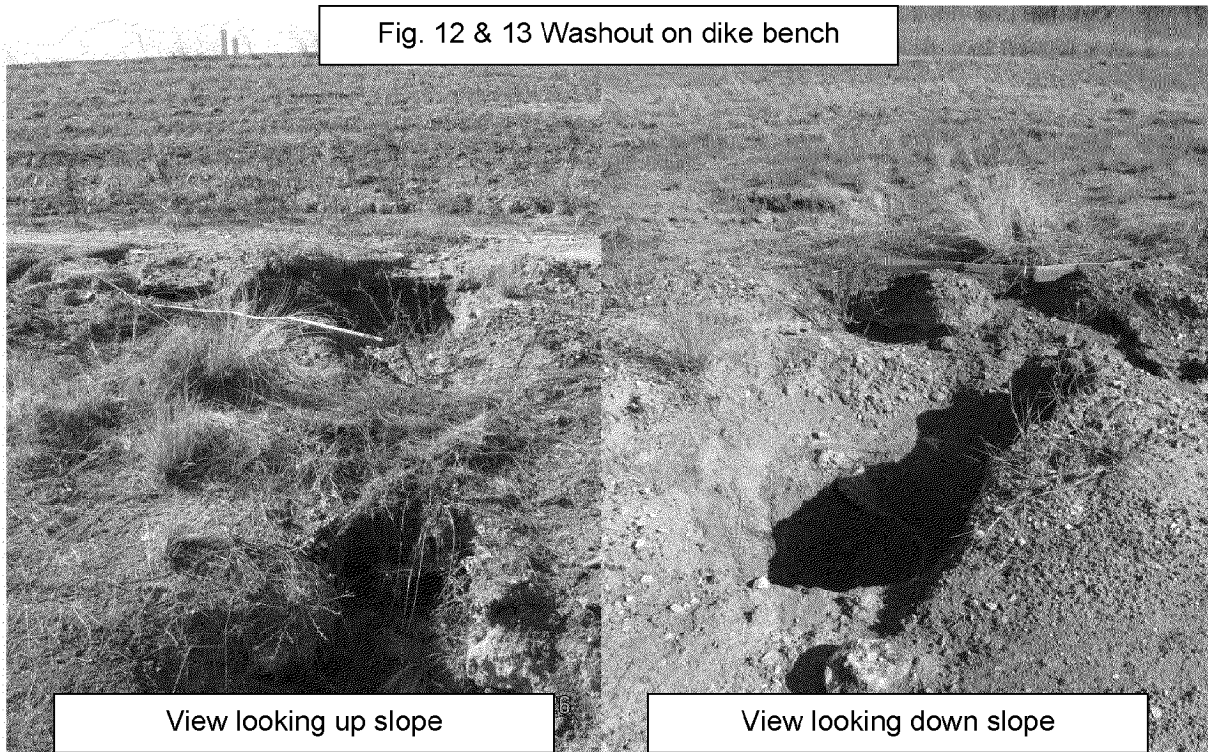
Fig. 12 & 13 Washout on dike bench

Plant operations has mowed the dredge cell slopes. Small trees growing on the slopes have been cut level with the ground. If trees are too large to be mowed, the trees should be cut, the stumps removed, and the area backfilled with soil, compacted and seeded and fertilized. Several areas around the dikes of the dredge cells are in need of seeding and fertilizing. It is recommended these areas should be reseeded and fertilized per T-1, section 580. At the north end of the dredge cells, one of the lower dike benches has an area that has eroded and washed out (See Figures 12 and 13 below). This area should be repaired by filling with clay in 6" lifts and compacting. After the area has been filled and compacted, reseed and fertilize per T-1, section 580. A small wet spot was noticed at

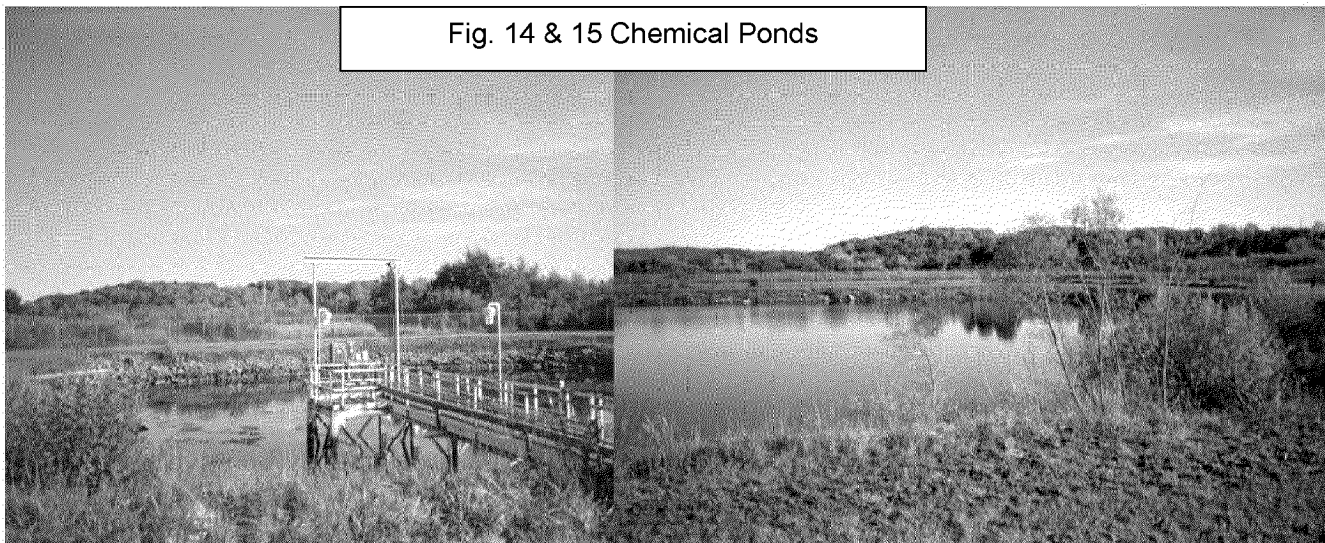
Fig. 14 & 15 Chemical Ponds

The chemical treatment ponds (iron and copper) are located southwest of the active ash pond. Both are excavated ponds and have no exterior slopes. The internal dike slopes are covered with riprap. These slopes were in good condition with some trees present. See Figures 14 and 15. Sediment in the ponds was tested in FY 2004 and found to be non-hazardous.

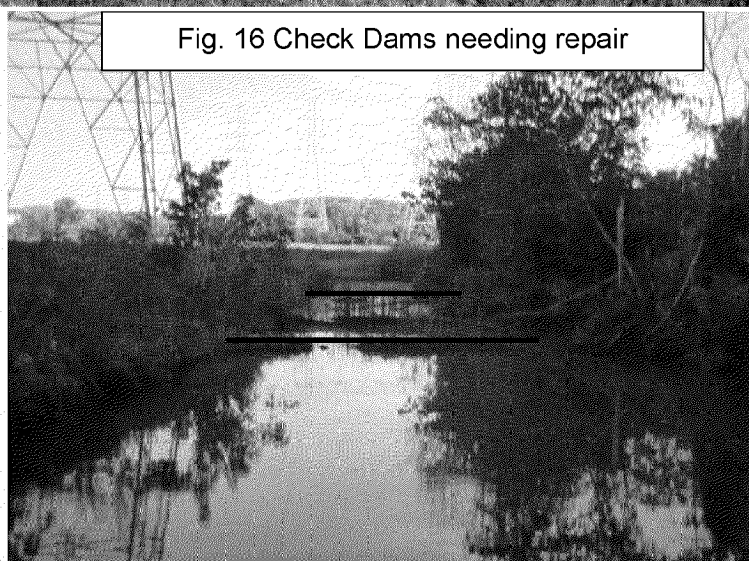
Fig. 16 Check Dams needing repair

contain coal yard sediment. Figure 16 shows rock check dams built to keep the coal fines away from the pumps. The check dams appear to be in need of repair and cleaning out. If maintained properly, the check dams will keep sediment from reaching the pumps. TVA drawing 10W225-1 (attached as API 2009-2) shows the pond and its intended bottom contours. The coal yard drainage basin should be cleaned out annually.

- Dredge the coal yard drainage basin to restore its design contours and protect the pumps from further damage. There is an estimated 2,800 cubic yards of sediment in the original pond and an extra 3,400 cubic yards in the "V" section that needs to be removed as soon as reasonable. See the attached copy of 10W225-2.
- Repair and clean out riprap check dams in the coal yard drainage basin to keep solids away from the pumps.

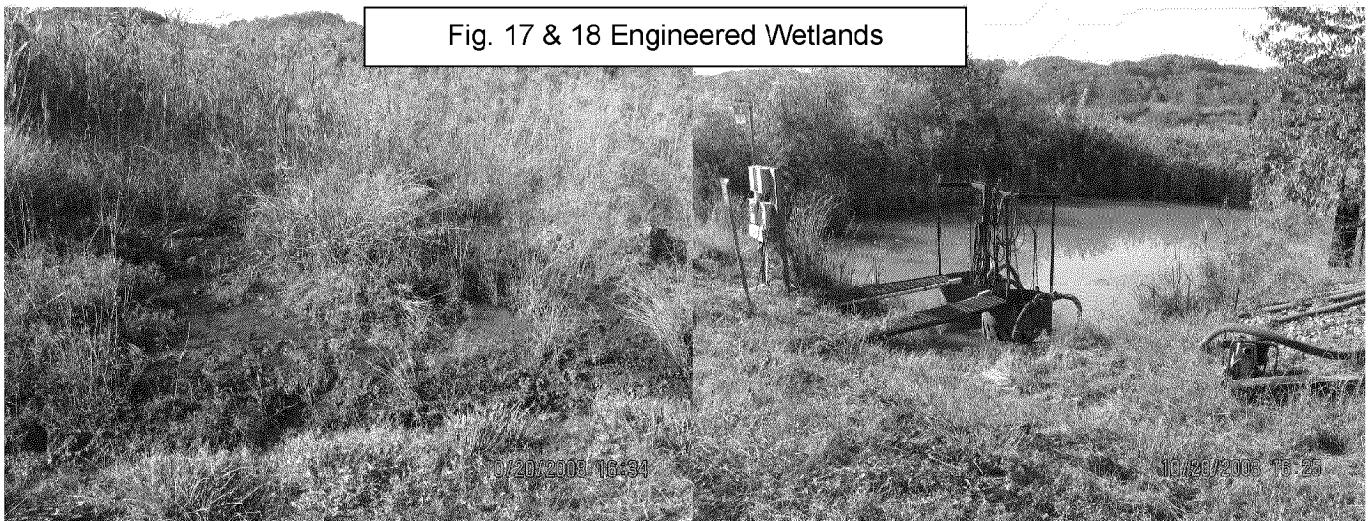
Fig. 17 & 18 Engineered Wetlands

The engineered wetlands along the southwest dike receive seepage that collects in the limestone drain below the bottom ash trench. The wetland helps naturally remove iron and raise the pH of the water before it is pumped to the ash pond. The wetland appeared to be functioning and the discharge is still pumped via two pumps to the ash pond, see Figures 17 and 18 below. Vegetation within the pump structures should be removed so that the pumps do not become clogged. Several trees were noticed along the interior slopes and should be removed by pulling up the roots. Repair the damage by compacting soil into the damaged areas.

- Remove all vegetation from within the pump structures

- Remove trees from the interior slopes. Preventing the trees from getting larger than 1" in diameter at the ground is preferred. Any trees larger than 3" in diameter at the base must be pulled from the dikes, roots and all. Repair and reseed the damaged area.

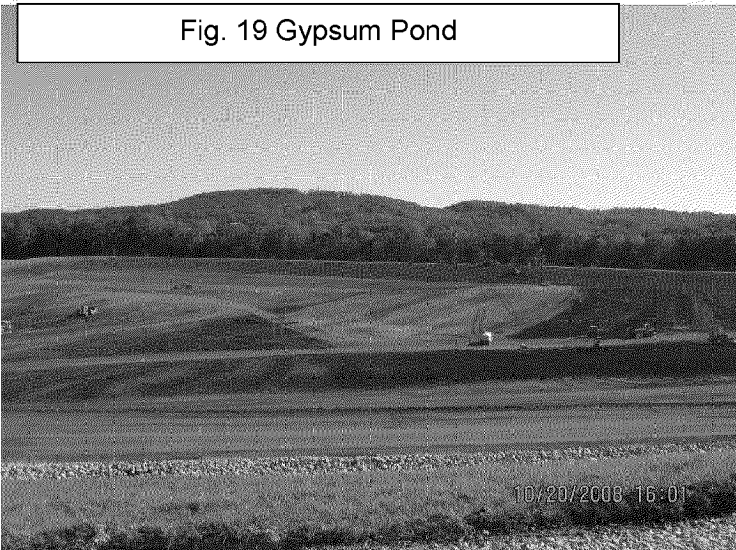
Fig. 19 Gypsum Pond

The gypsum pond is located on the peninsula, which is east of the plant. The pond was still being constructed at the time of this inspection, see Figure 19 below. Construction is scheduled to be finished on 6/01/09.

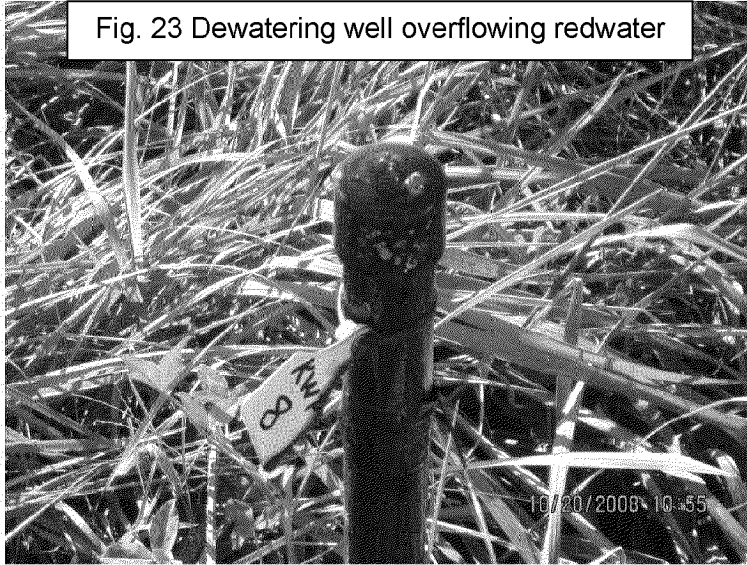
Fig. 23 Dewatering well overflowing redwater

Besides the wetlands, there was only one spot that showed flowing redwater. When dissolved iron from the ash and water mix, it tends to give the water a red appearance. This area was first thought to be a seep, but it was discovered that the redwater was flowing out of a dewatering well that had a closed valve. The water was flowing down the slope into the riprap ditch. The riprap ditch was also stained some at the outlet area for this dewatering well.
