July 12, 1967

KINGSTON STEAM PLANT - ASH DIKES

On July 3, 1967, J. P. Hillier Stivers and Robert J. Bowman met with Meigs Brewer, Jr., and Shelton Johnson of Power Production and Buford Cross, Assistant Superintendent, and Buford Street, Mechanical Supervisor, of the Kingston Steam Plant at Kingston Steam Plant for an inspection of the ash dikes.

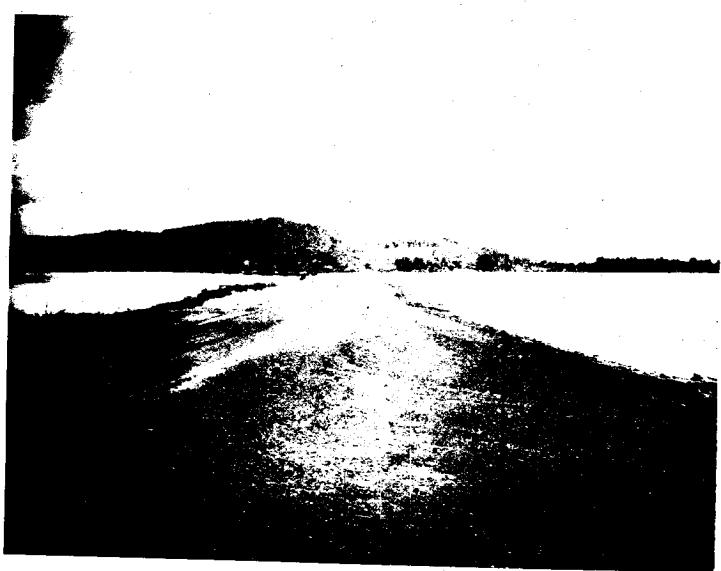
All dikes look to be in good shape. There is very little erosion by wave action on the outside slopes which are about 6:1. Noticeable wave action erosion has occurred on the inside but is not serious. All the dikes, with the exception of 200 to 300 feet on the south end of the east dike, are made of earth with a roadway surface of ash. The south end of the east dike for about 200 to 300 feet is composed entirely of ash, but has flat slopes and has withstood the wave action as good, if not better, than the earth dikes. Vegetation has been established on the dikes except where the dikes are made of ash.

Flat slopes inside and outside of dike
7-3-67

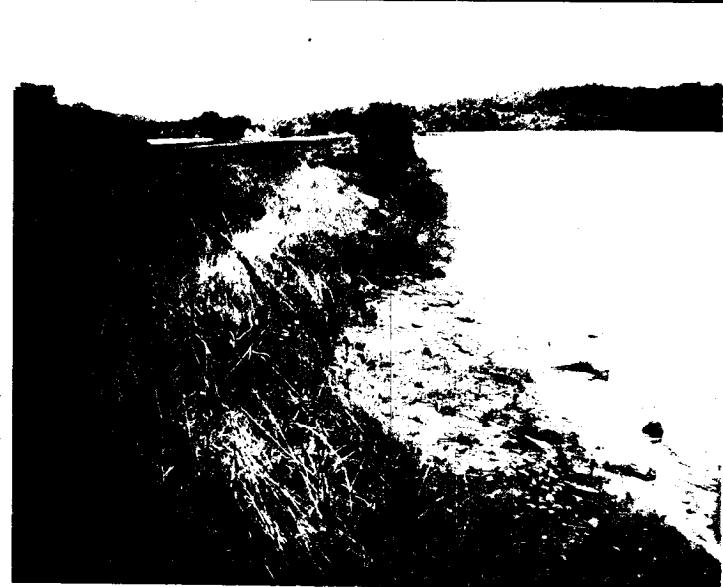
At the time of our visit the people at the plant were talking about a 3-foot increase in the elevation of the water on the inside of the dike. This would require raising of the dike to prevent the 4- to 6-foot waves that have been observed from overtopping the dike. Even a 2-foot increase in water elevation without raising the dike would reduce the freeboard below a safe minimum. The reason for raising the water level was understood to be to provide more dilution. Unless additional depth is proved to be required, the depth of water on the inside should be kept about as it now is, in order to minimize wave action and head against the dikes.

Kingston
Wave action inside dike cuts back into fill.
7-3-67

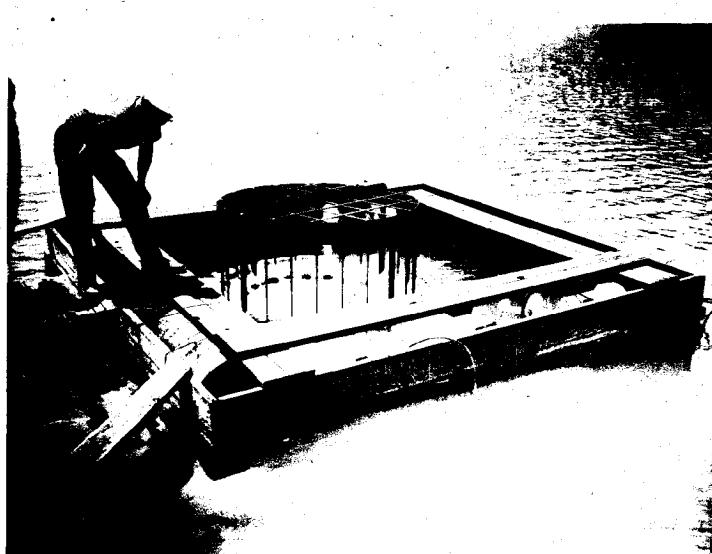
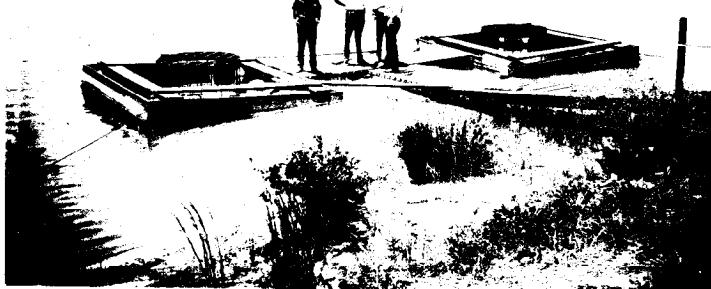
On July 3, 1967, there was approximately an area of two acres of floating ash from 1-1/2 to 2 inches thick. The location varies with the wind, but usually is diametrically opposite the spillways. A square wooden skimmer floating on metal drums (see photo) is used here instead of the circular metal type we have designed. We see no objection to the wood type except this one does not extend far enough below and above the water level to hold back floating ash.

Pictures showing Spillway inside Reservoir.
Structure is too short to extend far enough to allow water to skim off all ash and to prevent it from going over. 7-3-67

In summary, the dikes show no signs of being in any danger of failure provided proper cross section is used in raising them to higher elevations. The skimmer at the spillways should be made more effective.
