KINGSTON STEAM PLANT - ANNUAL ASH POND DIKE INSPECTION

KINGSTON STEAM PLANT - ANNUAL ASH FOND DIKE INSPECTION

On September 30, 1970, L. B. Cook of DPP; L. B. Kennedy, Assistant Plant Superintendent; and J. P. H. Stivers and I of DED inspected the ash ponds at the Kingston Steam Plant and discussed the findings with A. O. Spencer, Plant Superintendent.

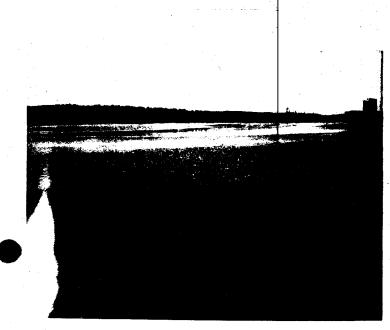
6 Standard skimmers that have been placed on spillways

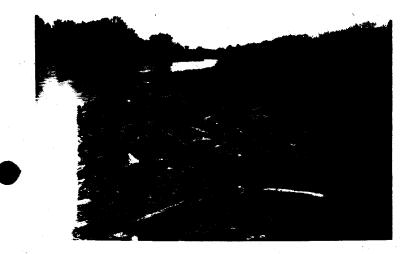
A section of dike C that had been eroded by wave action from Watts Bar Lake has been riprapped (picture 3). This should eliminate the erosion at this section of dike.

3 Area of Dike"C" riprapped to prevent erosian.
