TENNESSEE VALLEY AUTHORITY

KINGSTON FOSSIL PLANT

ANNUAL ASH POND DIKE
STABILITY INSPECTION
2009

Prepared by: Chris Buttram
Date: January 12, 2009

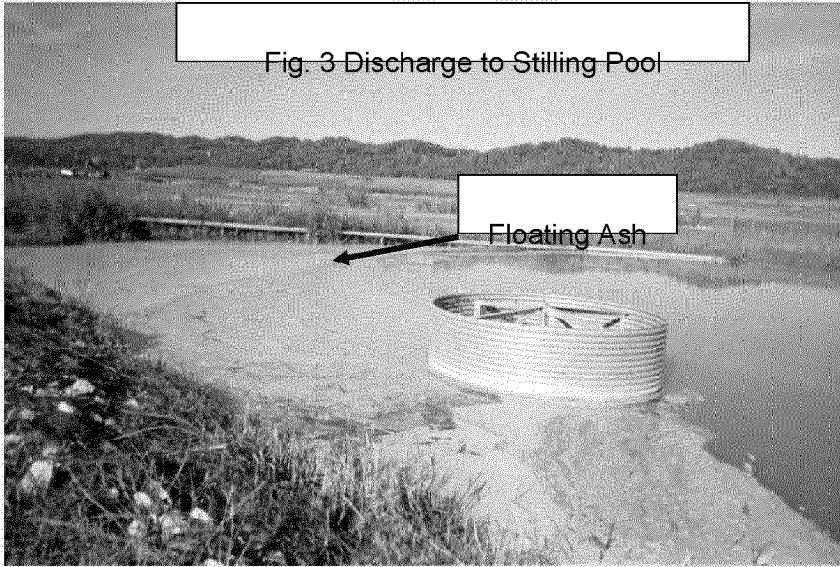
Fig. 3 Discharge to Stilling Pool

Floating ash near discharge structures, as seen in Figure 3 below, should be removed immediately to prevent an accidental release. Check the floating skimmer booms and maintain them to keep floating ash away. The seeps previously reported in 200X on the bench of Dike "C" north of the intake skimmer have not been observed since wheel ruts were repaired a few years ago. No seeps or wet spots were seen in this area during the inspection.

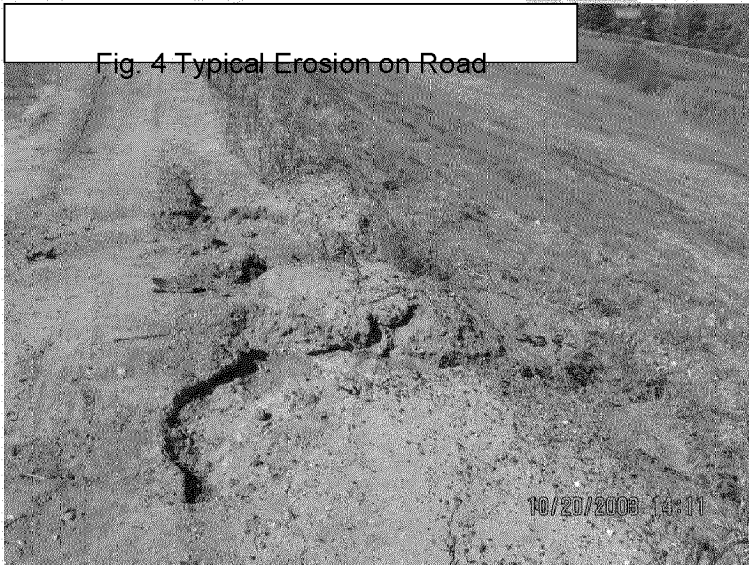
Fig. 4 Typical Erosion on Road

Some of the dike roads exhibit areas of erosion on the edges and some rutting, see Figure 4. This photo is typical of the eroded areas of the roads. Although it does not appear to be a significant problem, these eroded areas, as well as any ruts, should be graded out and the road covered with crushed stone to prevent larger erosion gullies.

- Repair rutting in the access and dike roadways, as well as benches. Fill with bottom ash and regrade as required to promote drainage.
- Repair broken dewatering well outlet pipes. These pipes should be draining directly into the lined ditch at the bottom of the cells.

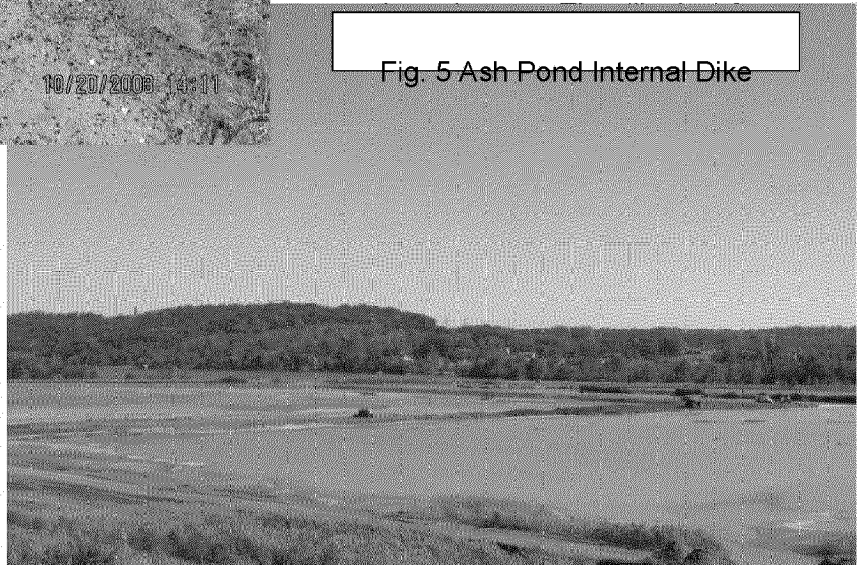
Fig. 5 Ash Pond Internal Dike

2 feet above elevation 760, the elevation of the water in the pond. The divider dikes will be constructed to build a base of fly ash for a dredge cell expansion, which will eventually cover approximately half of the existing main ash pond. See Figure 5 to the right.

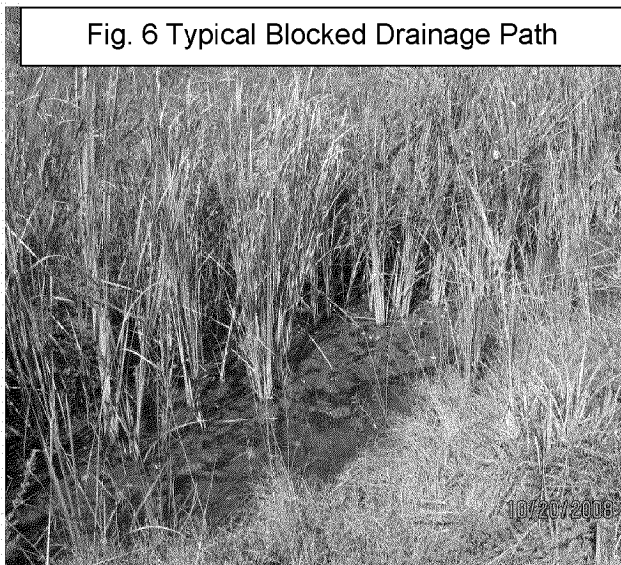
Fig. 6 Typical Blocked Drainage Path

be graded so they will drain, even if slowly. Also, thick vegetation in drainage ditches (Fig 6) should be thinned out or removed to keep from blocking the water flow. See Figures 6 and 7 above. Wheel ruts on benches or in a roads that are holding water should be filled with bottom ash and covered with stone. Due to extensive erosion in one area, a erosion washout of 2 feet wide by 20 feet long by 2 feet deep had formed (Fig 8). This area should be repaired by filling bottom with 6 inch lifts of compacted bottom ash until clay area is reached. Cap with 1 foot of clay using 6 inch compacted lifts. It is recommended that an erosion control blanket be used in this area for quicker vegetation growth. Monitor this area, especially after rain events, to assure that no settling occurs.

- Dredge cell drainage ditches should be kept free of cattails so they will flow as well as possible. Any existing cattails should be removed.
- Remove trees from the slopes of the dikes. Mowing at least twice a year is recommended to control the size of the trees. Preventing the trees from getting larger than 1" in diameter at the ground is preferred. Any trees larger than 3" in diameter at the base must be pulled from the dikes, roots and all. Repair and reseed the damaged area.

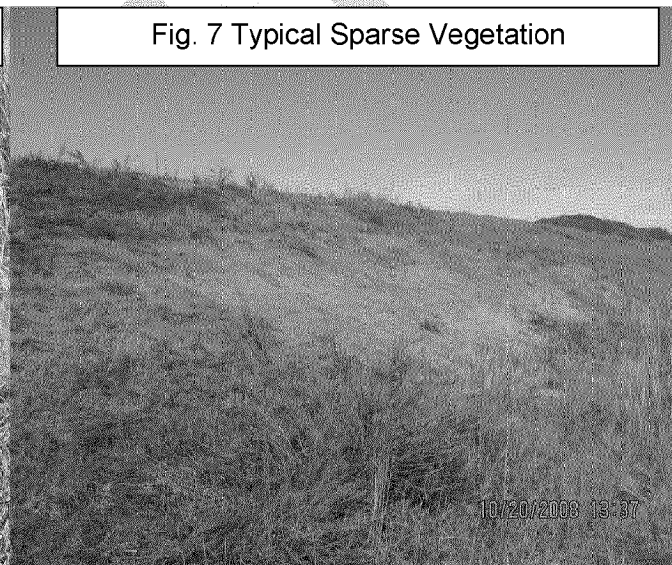
Fig. 7 Typical Sparse Vegetation

The interim dredge cell capacity has been depleted; however decant water from the raised dredge cells flows through the interim cell to the main ash pond. Water flow into the interim cell is essential for dust control. The divider dike between this cell and the active ash pond appeared to be in stable condition. Some areas of sparse vegetation (Fig 7) and poor bench drainage were observed on this dike. These areas should be reseeded and fertilized per T-1, section 580. Areas with poor drainage should

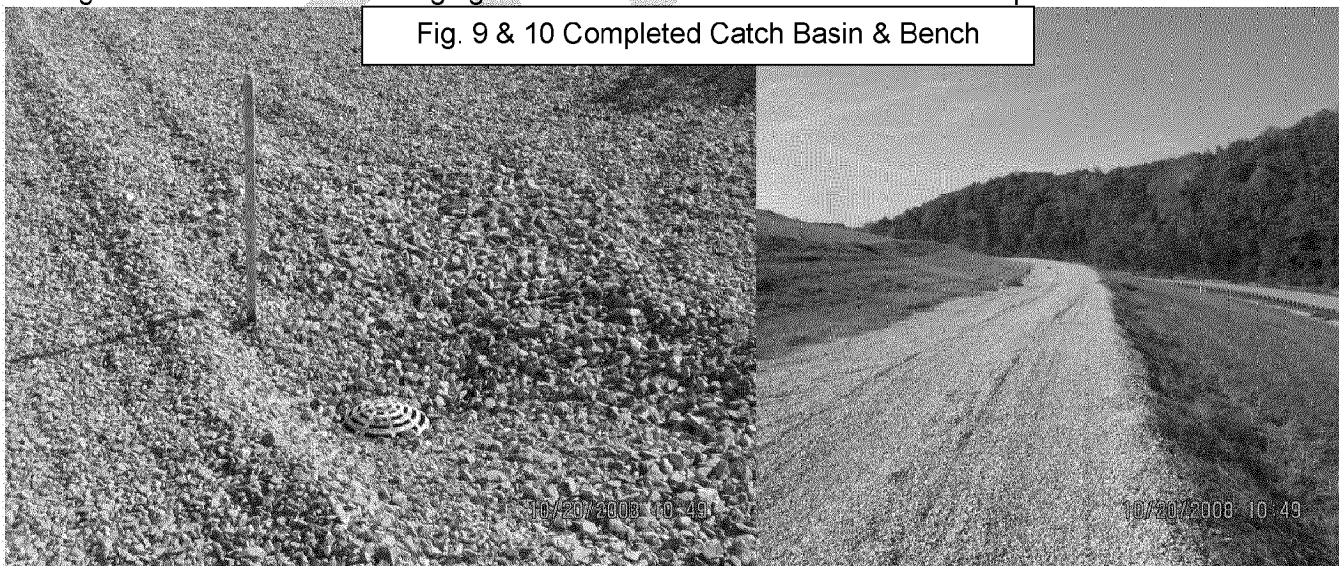
Fig. 9 & 10 Completed Catch Basin & Bench

this inspection. Since the last inspection, the lower benches have been re-graded to provide positive drainage to a series of catch basins which will divert the water collected to the lower drainage ditch. In addition to the catch basins and down drains, the benches were covered with a geomembrane, geotextile and then crushed stone to further reduce infiltration into the benches. See Figures 9 and 10 above.

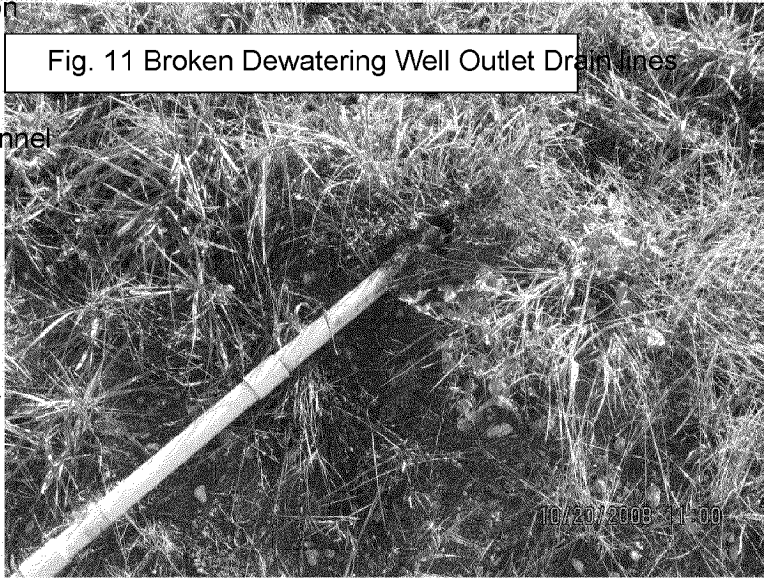
Fig. 11 Broken Dewatering Well Outlet Drain Lines

Drain lines with valves were installed on the old dewatering wells to allow personnel to relieve some of the water in these wells. These outlets drain empty directly into the riprap channel along Swan Pond Road. At the time of the inspection, the valves on some drains were closed in preparation for measurement of water levels and those wells showed water pressure above the dike slope. The valves of the other monitoring wells were open and they were flowing clear water to the drainage ditch. The inspectors noticed that some of these drains had been broken (Figure 11), possibly while the slopes were being mowed. These broken drains should be repaired so that the water is not draining freely down the slopes.

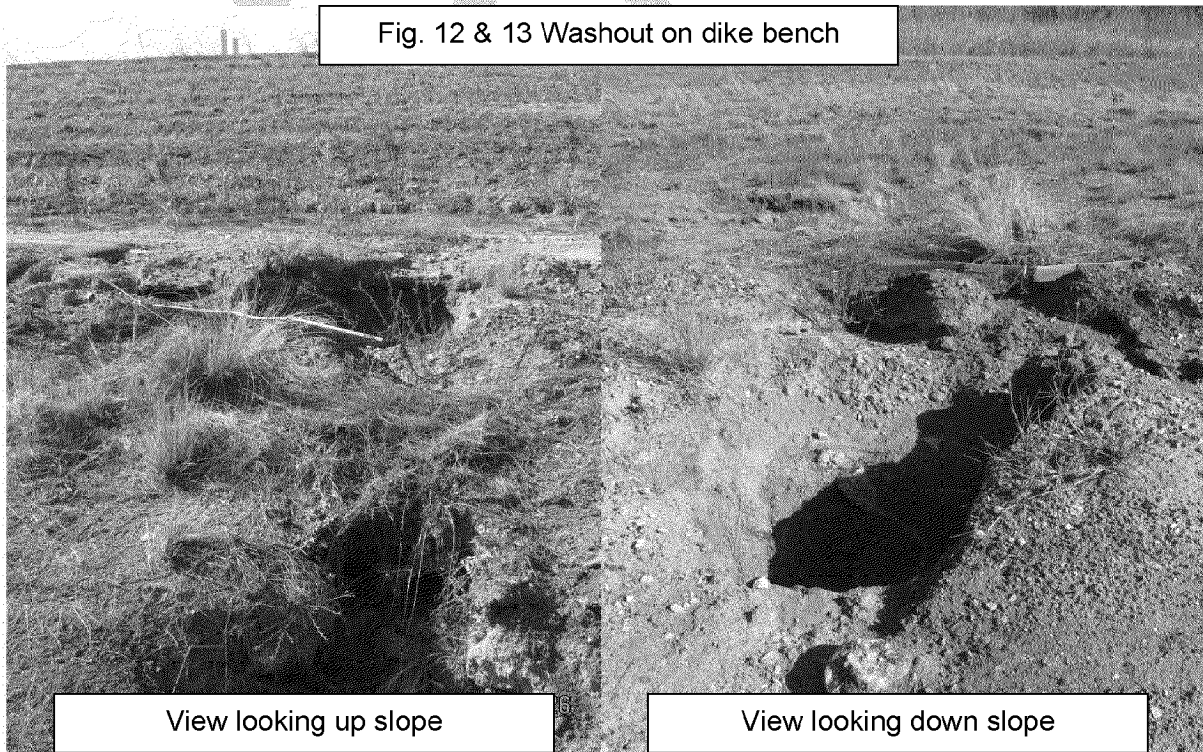
Fig. 12 & 13 Washout on dike bench

Plant operations have done a commendable job of mowing the dredge cell slopes. Small trees growing on the slopes have been cut level with the ground. If trees are too large to be mowed, the trees should be cut, the stumps removed, and the area backfilled with soil, compacted and seeded and fertilized. Several areas around the dikes of the dredge cells are in need of seeding and fertilizing. It is recommended these areas should be reseeded and fertilized per T-1, section 580. At the north end of the dredge cells, one of the lower dike benches has an area that has eroded and washed out (See Figures 12 and 13 below). This area should be repaired immediately by filling with clay in 6" lifts and compacting. After the area has been filled and compacted, reseeded and fertilized per

View looking up slope

View looking down slope

- Repair erosion washout on lower dike bench at North end of dredge cells. Repair eroded area by filling with clay in 6" lifts and compacting, then reseed and fertilize per T-1, section 580.

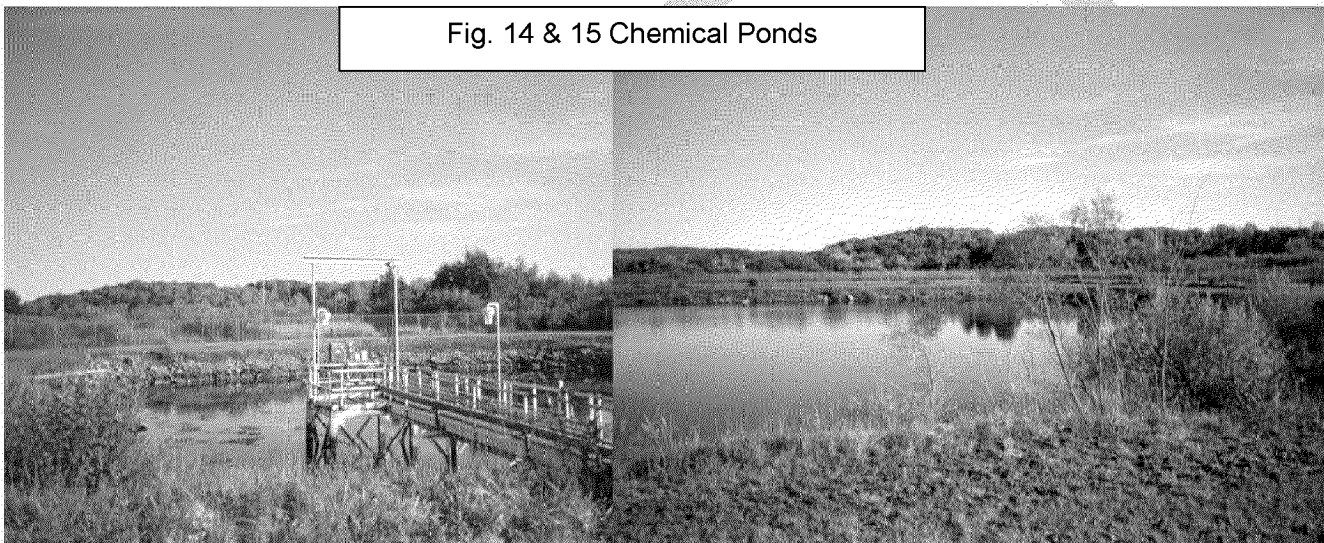
Fig. 14 & 15 Chemical Ponds

The chemical treatment ponds (iron and copper) are located southwest of the active ash pond. Both are excavated ponds ~~were excavated~~ and have no exterior slopes. The internal dike slopes are covered with riprap. These slopes were in good condition with some trees present. See Figures 14 and 15. Sediment in the ponds was tested in FY 2004 and found to be non-hazardous.

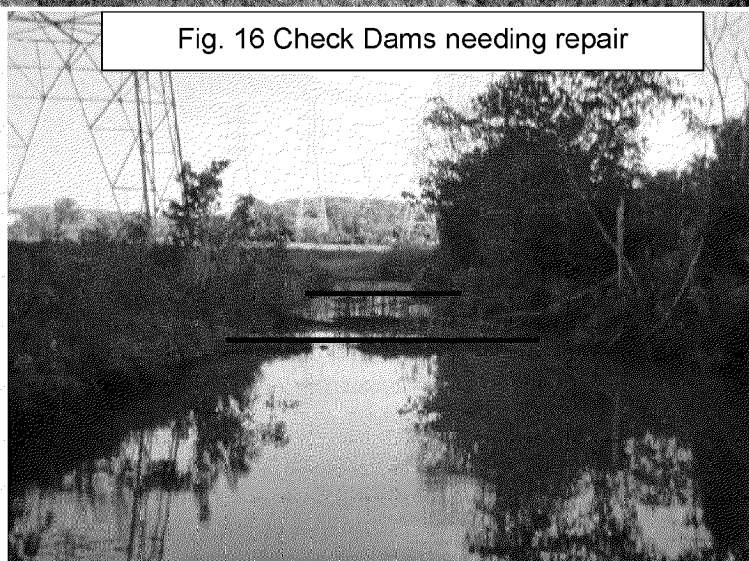
Fig. 16 Check Dams needing repair

the right shows rock check dams built to keep the coal fines away from the pumps. The check dams appear to be in need of repair and cleaning out. If maintained properly, the check dams will keep sediment from reaching the pumps. TVA drawing 10W225-1 (attached as API 2009-2) shows the pond and its intended bottom contours. The Coal yard drainage basin should be cleaned out annually.

- Dredge the Coal Yard Drainage Basin to restore its design contours and protect the pumps from further damage. There is an estimated 2,800 cubic yards of sediment in the original pond and an extra 3,400 cubic yards in the "V" section that needs to be removed as soon as reasonable. See the attached copy of 10W225-2. ~~Estimated at \$62,000, depending on haul distance.~~
- Repair and clean out riprap check dams in the coal yard drainage basin to keep solids away from the pumps.

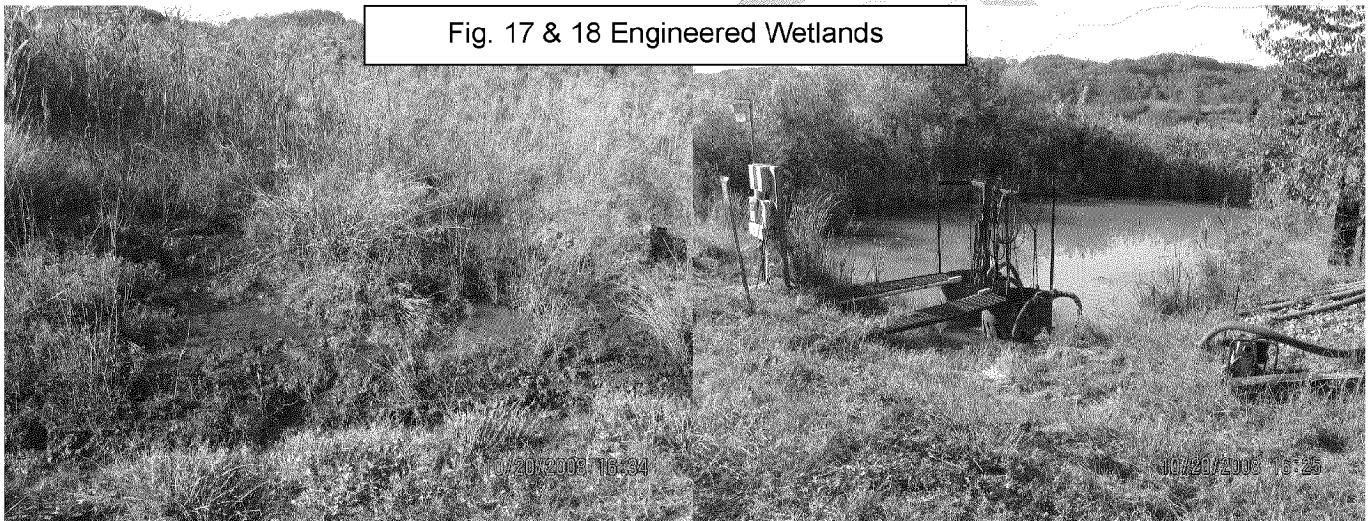
Fig. 17 & 18 Engineered Wetlands

The engineered wetlands along the southwest dike receive seepage that collects in the limestone drain below the bottom ash trench. The wetland appeared to be functioning, but the discharge is still pumped via two pumps to the ash pond, see Figures 17 and 18 below. Vegetation within the pump structures should be removed so that the pumps do not become clogged. Several trees were noticed along the interior slopes and should be removed by pulling up the roots. Repair the damage by compacting soil into the damaged areas.

- Remove all vegetation from within the pump structures
- Remove trees from the interior slopes. Preventing the trees from getting larger than 1" in diameter at the ground is preferred. Any trees larger than 3" in diameter at the base ~~must~~ be pulled from the dikes, roots and all. Repair and reseed the damaged area.

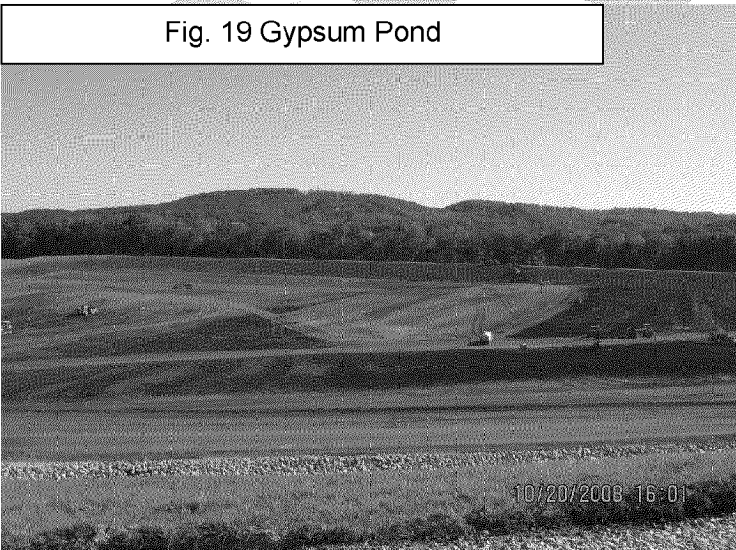
Fig. 19 Gypsum Pond

The gypsum pond is located on the peninsula, which is east of the plant. The pond was still being constructed at the time of this inspection, see Figure 19 below. Construction is scheduled to be finished on 6/01/08.

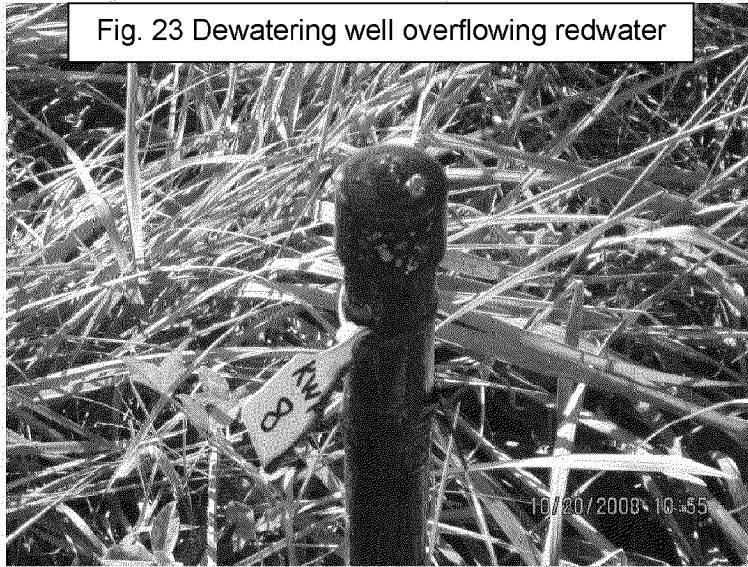
Fig. 23 Dewatering well overflowing redwater

Besides the redwater wetlands, there was only one spot that showed flowing redwater. At first thought to be a seep, it was discovered that the redwater was flowing out of a dewatering well that had a closed valve. The water was flowing down the slope into the riprap ditch. The riprap ditch was also stained some at the outlet area for this dewatering well.
