TENNESSEE VALLEY AUTHORITY

## KINGSTON FOSSIL PLANT

ANNUAL ASH POND DIKE  
STABILITY INSPECTION  
2009

Prepared by: Chris Buttram  
Date: January 12, 2009

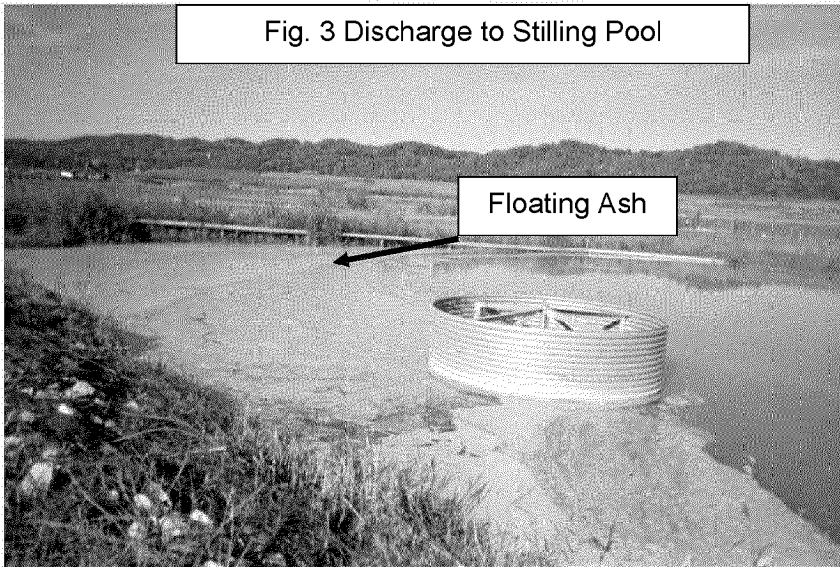
Fig. 3 Discharge to Stilling Pool

Floating ash near discharge structures, as seen in Figure 3 below, should be removed immediately to prevent an accidental release. Check the floating skimmer booms and maintain them to keep floating ash away. The seeps reported on the bench of Dike "C" north of the intake skimmer have not been reported since wheel ruts were repaired a few years ago. No seeps or wet spots were seen in this area during the inspection.

- Repair any dikes showing signs of erosion. Erosion ditches larger than a standard railroad crosstie should be repaired with compacted bottom ash or soil. Repeated repairs in the same location calls for riprap stabilization. EDS-Civil will assist in sizing the riprap and setting the limits if needed.
- Investigate the use of spraying to inhibit vegetation growth on the interior dikes of the stilling pond.
- Remove ash floating on the surface of the ash and stilling ponds, and check floating skimmer booms to ensure they are working properly.

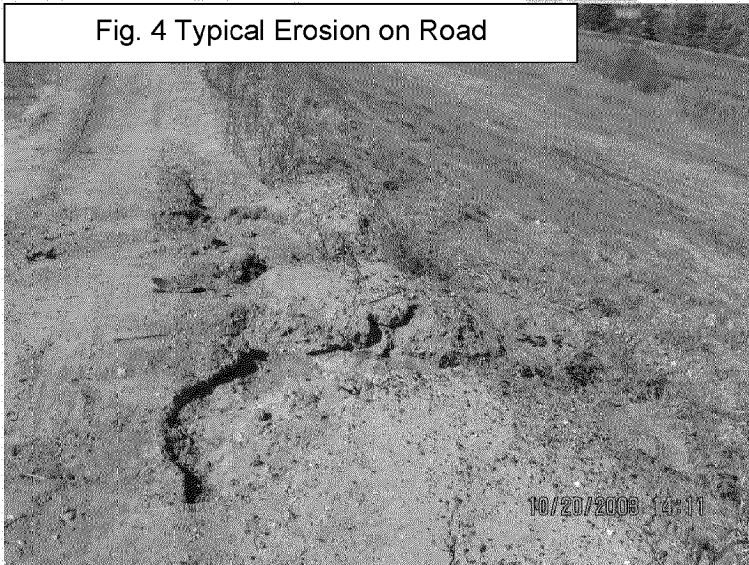
Fig. 4 Typical Erosion on Road

Some of the dike roads exhibit areas of erosion on the edges and some rutting, see Figure 4. This photo is typical of the eroded areas of the roads. Although it does not appear to be a significant problem, these eroded areas, as well as any ruts, should be graded out and the road covered with crushed stone to prevent larger erosion gullies.

- Repair rutting in the access and dike roadways, as well as benches. Fill with bottom ash and regrade as required to promote drainage.
- Repair broken dewatering well outlet pipes. These pipes should be draining directly into the lined ditch at the bottom of the cells.

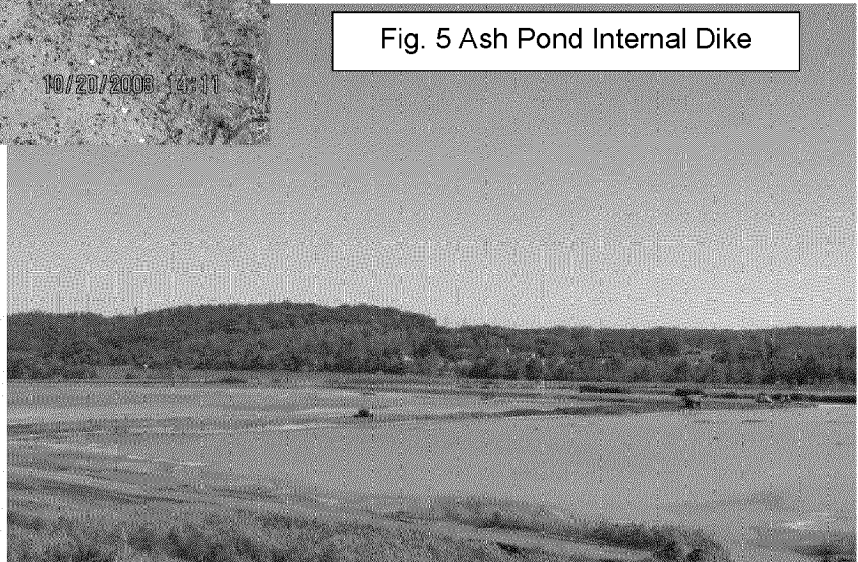
Fig. 5 Ash Pond Internal Dike

Construction of an internal divider dike inside the active ash disposal area is currently underway. The dike is 1 foot to

2 feet above elevation 760, the elevation of the water in the pond. The divider dikes will be constructed to build a base of fly ash for a dredge cell expansion, which will eventually cover approximately half of the existing main ash pond. See Figure 5 to the right.

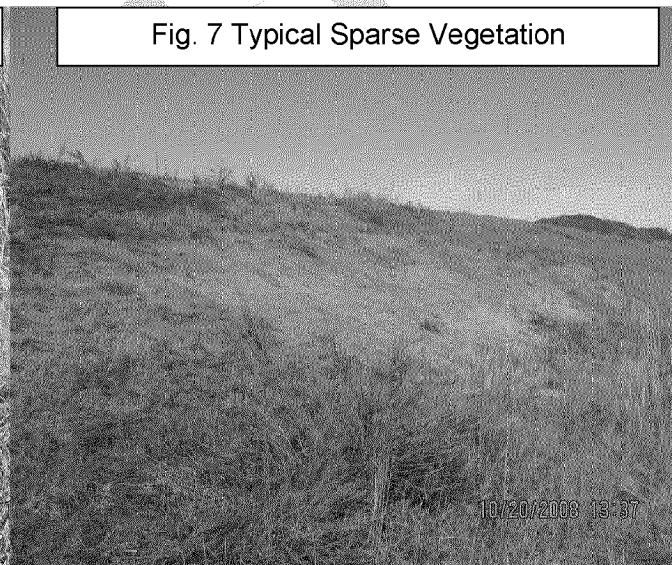
Fig. 7 Typical Sparse Vegetation

The interim dredge cell capacity has been depleted; however decant water from the raised dredge cells flows through the interim cell to the main ash pond. Water flow into the interim cell is essential for dust control. The divider dike between this cell and the active ash pond appeared to be in stable condition. Some areas of sparse vegetation and poor bench drainage were spotted on this dike. These areas should be reseeded and fertilized per T-1, section 580. Areas with poor drainage should

be graded so they will drain, even if slowly. Also, thick vegetation in drainage ditches should be thinned out or removed to keep from blocking the water flow. See Figures 6 and 7 above. Wheel ruts on benches or in a road that are holding water should be filled with bottom ash and covered with stone. Due to extensive erosion in one area, an erosion washout of 2 feet wide by 20 feet long by 2 feet deep had formed. This area should be repaired immediately. See Figure 8. Fill bottom layer with 6 inch lifts of compacted bottom ash until clay area is reached. Cap with 1 foot of clay via 6 inch compacted lifts. It is recommended that an erosion control blanket be used in this area for quicker vegetation growth. Monitor this area, especially after rain events, to assure that no settling occurs.

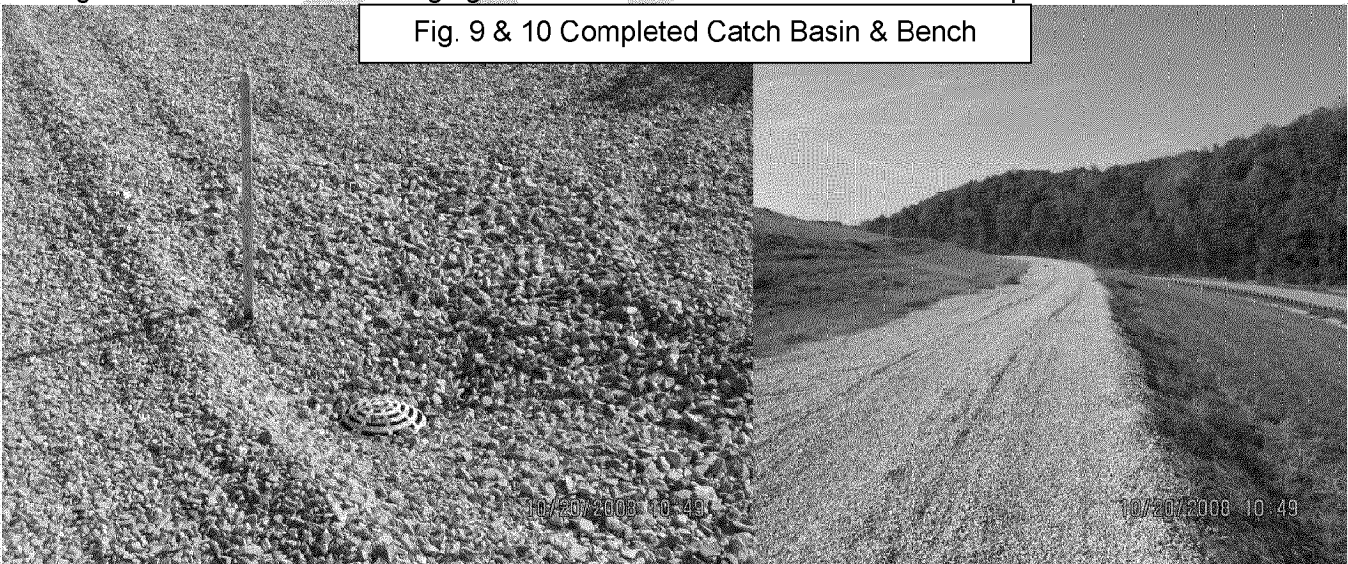
Fig. 9 & 10 Completed Catch Basin & Bench

this inspection. Since the last inspection, the lower benches have been re-graded to provide positive drainage to a series of catch basins which will divert the water collected to the lower drainage ditch. In addition to the catch basins and down drains, the benches were covered with a geomembrane, geotextile and then crushed stone to further reduce infiltration into the benches. See Figures 9 and 10 above.

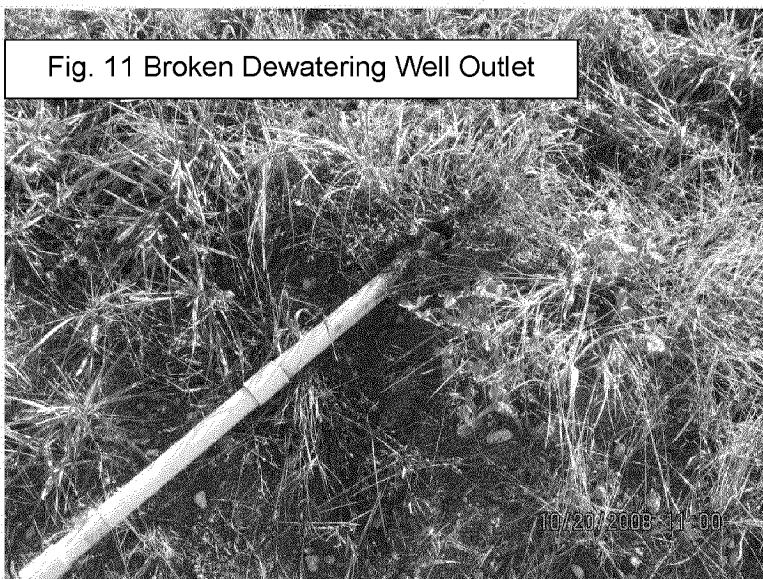
Fig. 11 Broken Dewatering Well Outlet

Outlets with valves were installed on the old dewatering wells to allow personnel to relieve some of the water in these wells. These outlets drain directly into the riprap channel along Swan Pond Road. At the time of the inspection, the valves on some outlets were closed in preparation for measurement and those wells showed water pressure above the dike slope. The valves of the other monitoring wells were open and they were flowing clear water to the drainage ditch. The inspectors noticed that some of these outlets had been broken (See Figure 11 below), possibly while the slopes were being mowed. These broken outlets should be repaired so that the water is not draining freely down the slopes.

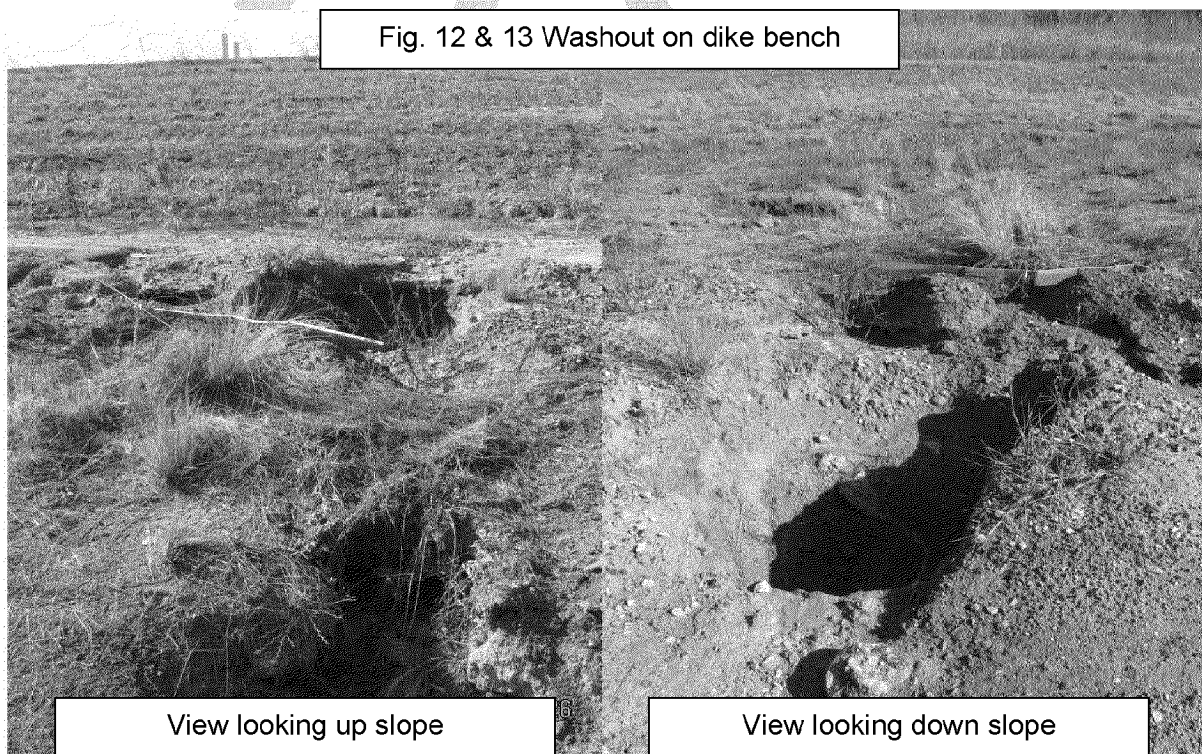
Fig. 12 & 13 Washout on dike bench

Plant operations have done a commendable job of mowing the dredge cell slopes. Small trees growing on the slopes have been cut level with the ground. If trees are too large to be mowed, the trees should be cut, the stumps removed, and the area backfilled with soil, compacted and seeded and fertilized. Several areas around the dikes of the dredge cells are in need of seeding and fertilizing. It is recommended these areas should be reseeded and fertilized per T-1, section 580. At the north end of the dredge cells, one of the lower dike benches has an area that has eroded and washed out (See Figures 12 and 13 below). This area should be repaired immediately by filling with clay in 6" lifts and compacting. After the area has been filled and compacted, reseed and fertilize per

T-1, section 580. Also at the north end of Cell 2, a small wet spot was noticed at the toe of the bottom dike. This wet spot was roughly 4 feet by 4 feet and approximately 600 feet from the northwest corner of Cell 2. The area was not soft and was believed to be in the spot of an old underdrain. The drain was not located at the time of this inspection. This area should be monitored and if conditions worsen, contact Chris Buttram, 423-751-3574.

- Repair erosion washout on lower dike bench at North end of dredge cells. Repair eroded area by filling with clay in 6" lifts and compacting, then reseed and fertilize per T-1, section 580.

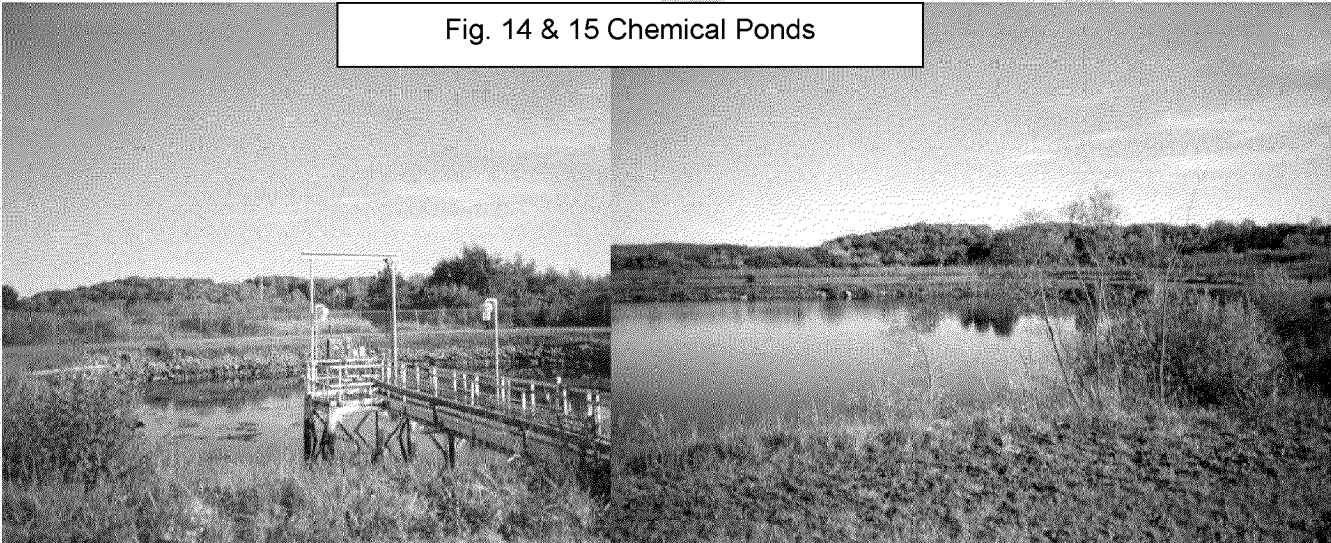
Fig. 14 & 15 Chemical Ponds

The chemical treatment ponds (iron and copper) are located southwest of the active ash pond. Both ponds were excavated and have no exterior slopes. The internal dike slopes are covered with riprap. These slopes were in good condition with some trees present. See Figures 14 and 15. Sediment in the ponds was tested in FY 2004 and found to be non-hazardous.

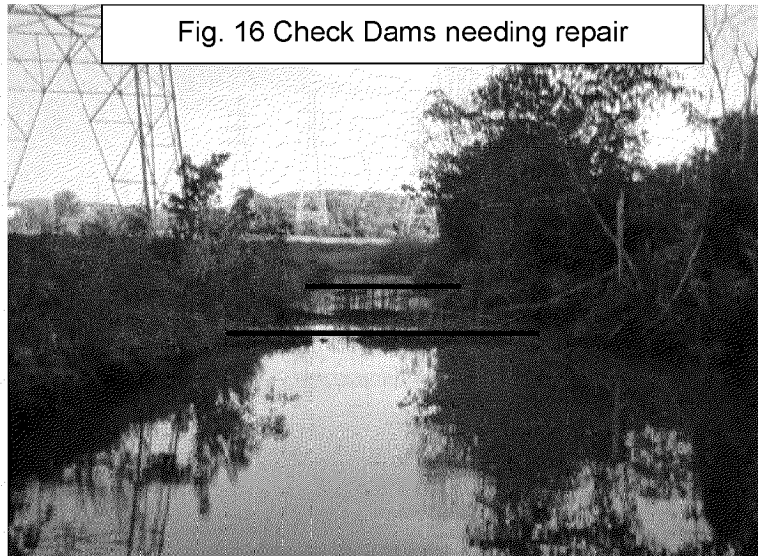
Fig. 16 Check Dams needing repair

the right shows rock check dams built to keep the coal fines away from the pumps. The check dams appear to be in need of repair and cleaning out. If maintained properly, the check dams will keep sediment from reaching the pumps. TVA drawing 10W225-1 (attached as API 2009-2) shows the pond and its intended bottom contours. The Coal yard drainage basin should be cleaned out annually.

- Dredge the Coal Yard Drainage Basin to restore its design contours and protect the pumps from further damage. There is an estimated 2,800 cubic yards of sediment in the original pond and an extra 3,400 cubic yards in the “V” section that needs to be removed as soon as reasonable. See the attached copy of 10W225-2. Estimated at \$62,000, depending on haul distance.
- Repair and clean out riprap check dams in the coal yard drainage basin to keep solids away from the pumps.

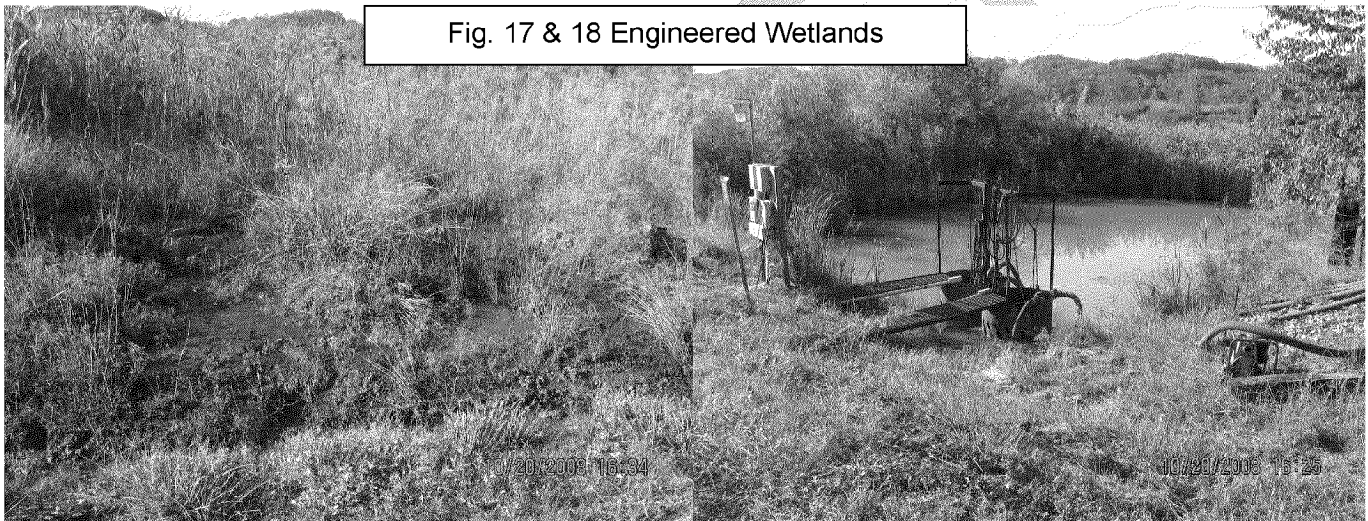
Fig. 17 & 18 Engineered Wetlands

The engineered wetlands along the southwest dike receive seepage that collects in the anoxic limestone drain below the bottom ash trench. The wetland appeared to be functioning, but the discharge is still pumped via two pumps to the ash pond, see Figures 17 and 18 below. Vegetation within the pump structures should be removed so that the pumps do not become clogged. Several trees were noticed along the interior slopes and should be removed by pulling up the roots. Repair the damage by compacting soil into the damaged areas.

- Remove all vegetation from within the pump structures
- Remove trees from the interior slopes. Preventing the trees from getting larger than 1” in diameter at the ground is preferred. Any trees larger than 3” in diameter at the base must be pulled from the dikes, roots and all. Repair and reseed the damaged area.

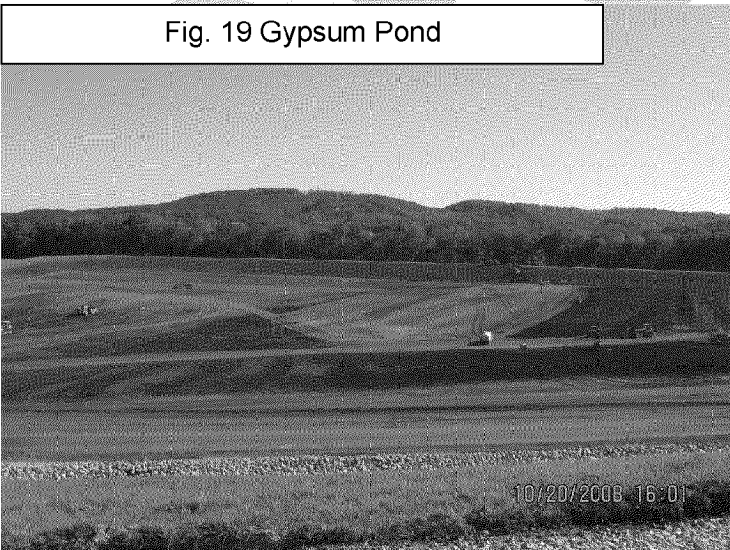
Fig. 19 Gypsum Pond

The gypsum pond is located on the peninsula, which is east of the plant. The pond was still being constructed at the time of this inspection, see Figure 19 below. Construction is scheduled to be finished on 6/01/08.
