TENNESSEE VALLEY AUTHORITY

KINGSTON FOSSIL PLANT

ANNUAL ASH POND DIKE
STABILITY INSPECTION
2009

Prepared by: Chris Buttram
Date: January 12, 2009

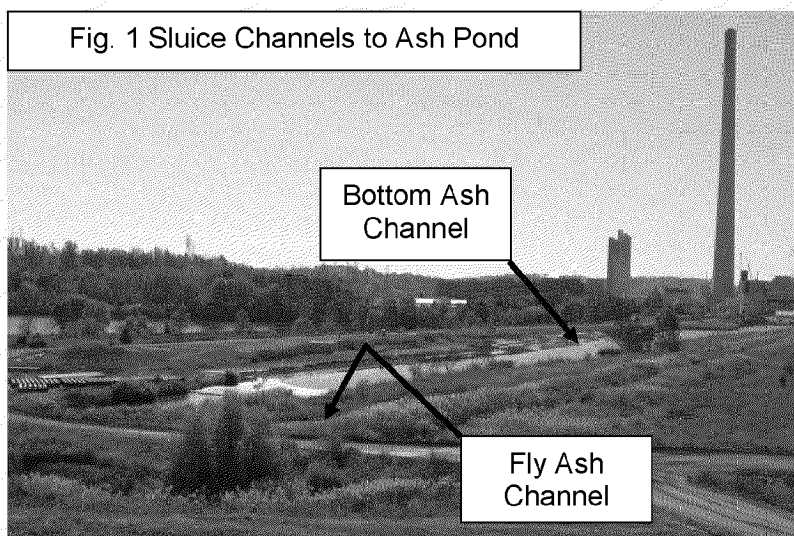
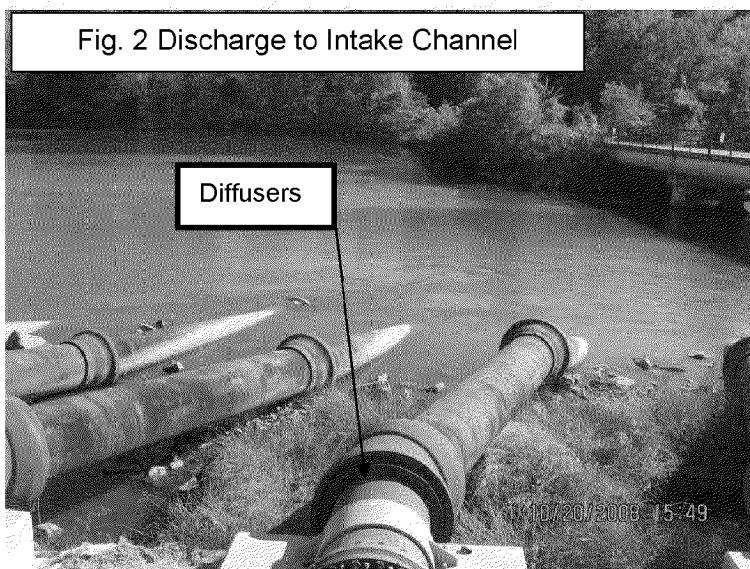
Fly ash is sluiced to a channel adjacent to the bottom ash channel and flows into the main ash pond. The fly ash channel was cleared of vegetation last year. Both channels flow northeast into the active ash pond. See Figure 1 and drawing API 2009.

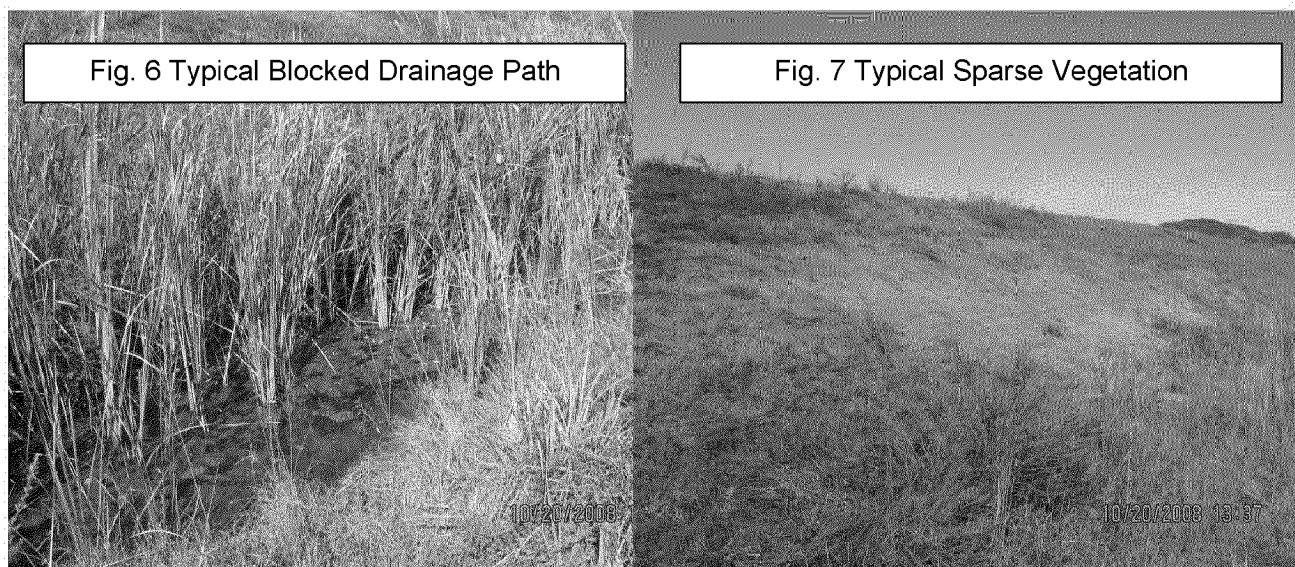
The interim dredge cell capacity has been depleted; however decant water from the raised dredge cells flows through the interim cell to the main ash pond. Water flow into the interim cell is essential for dust control. The divider dike between this cell and the active ash pond appeared to be in stable condition. Some areas of sparse vegetation (Fig. 7) and poor bench drainage were observed spotted on this dike. These areas should be reseeded and fertilized per T-1, section 580. Areas with poor

drainage should be graded so they will drain, even if slowly. Also, thick vegetation in drainage ditches (Fig. 6) should be thinned out or removed to keep from blocking the water flow. Wheel ruts on benches or in roads that are holding water should be filled with bottom ash and covered with stone.

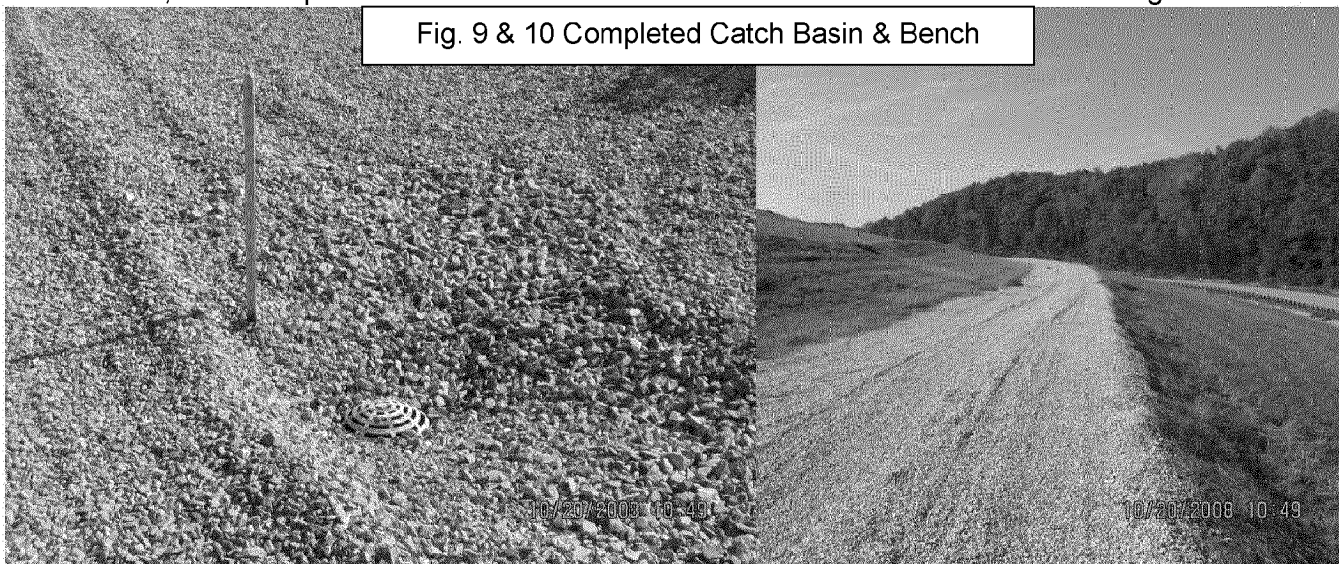
Previously, ash had been dredged into three separate cells, but in 2007, the ash reached levels that buried the divider dikes for Cell 3 and now there are only two large cells (1 and 2). Dredging to these cells was stopped in mid-November 2007 based on recommendations from EDS and Geosyntec Consultants, Inc. This preventative measure was taken to reduce water levels in the dredge cell

through the winter months. Dredging restarted in March 2008 and was still in operation at the time of this inspection. Since the last inspection, the lower benches have been re-graded to provide positive drainage to a series of catch basins which divert the water collected to the lower drainage ditch. In addition to the catch basins and down drains, the benches were covered with a geomembrane, geotextile and then crushed stone to further reduce infiltration into the benches. See Figures 9 and 10 above.

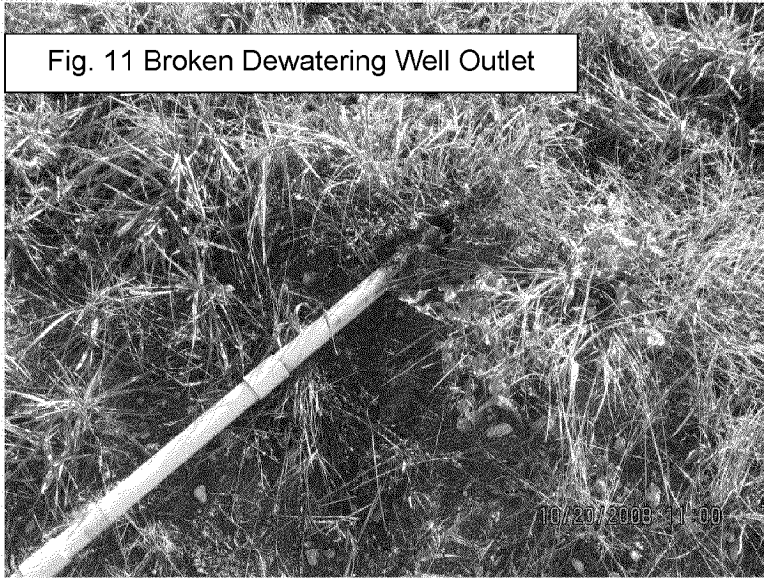
Fig. 11 Broken Dewatering Well Outlet

Drain lines with valves were installed on the old dewatering wells to allow personnel to relieve some of the water in these wells. These outlets empty directly into the riprap channel along Swan Pond Road. At the time of the inspection, the valves on some drains were closed in preparation for measurement of water levels and those wells showed water pressure above the dike slope. The valves of the other monitoring wells were open and were flowing clear water to the drainage ditch. Some of these drains had been broken (Figure 11), possibly while the slopes were being mowed.

These broken drains should be repaired so that the water is not draining freely down the slopes.

- Repair broken dewatering well outlet pipes. These pipes should be draining directly into the lined ditch at the bottom of the cells.
- Repair the 2' x 20' area of erosion on the east slope of the interim dredge cell. Fill bottom layer with bottom ash in 6" lifts and compact. When the clay layer is reached, cap with 1' of clay via 6" compacted lifts. Lastly, cover with an erosion control blanket to help stabilize the damaged area. After repairs have been made, continue to monitor area until good vegetation has stabilized the area.
- Repair erosion washout on lower dike bench at North end of dredge cells. Repair eroded area by filling with clay in 6" lifts and compacting, then reseed and fertilize per T-1, section 580.
- Continue to monitor the wet spot at the toe of the Cell 2 dike.

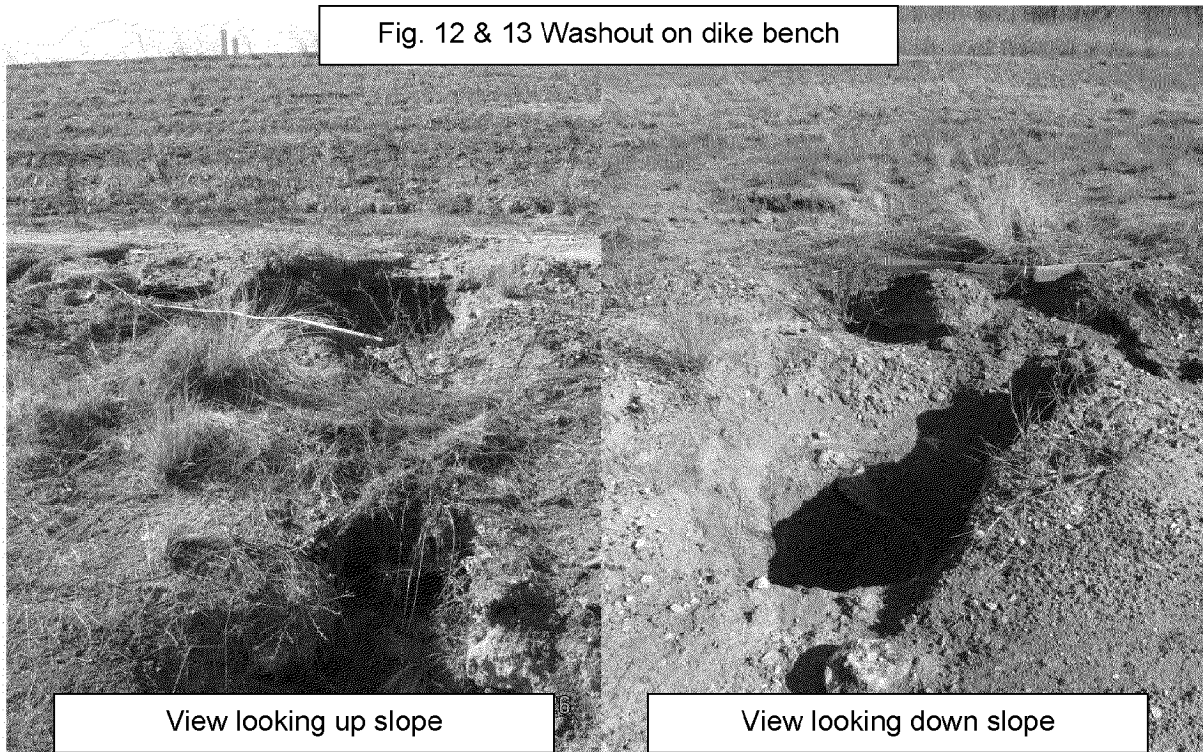
Fig. 12 & 13 Washout on dike bench

Plant operations has mowed the dredge cell slopes. Small trees growing on the slopes have been cut level with the ground. If trees are too large to be mowed, the trees should be cut, the stumps removed, and the area backfilled with soil, compacted and seeded and fertilized. Several areas around the dikes of the dredge cells are in need of seeding and fertilizing. It is recommended these areas should be reseeded and fertilized per T-1, section 580. At the north end of the dredge cells, one of the lower dike benches has an area that has eroded and washed out (See Figures 12 and 13 below). This area should be repaired by filling with clay in 6" lifts and compacting. After the area has been filled and compacted, reseed and fertilize per T-1, section 580. A small wet spot was noticed at

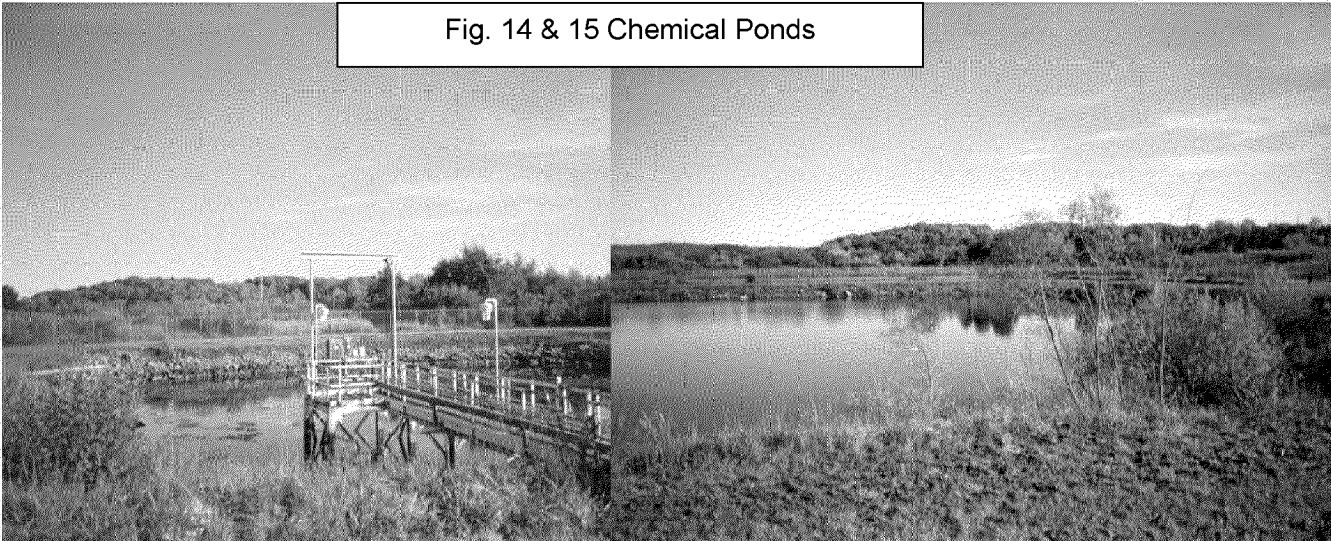
Fig. 14 & 15 Chemical Ponds

The chemical treatment ponds (iron and copper) are located southwest of the active ash pond. Both are excavated ponds and have no exterior slopes. The internal dike slopes are covered with riprap. These slopes were in good condition with some trees present. See Figures 14 and 15. Sediment in the ponds was tested in FY 2004 and found to be non-hazardous.

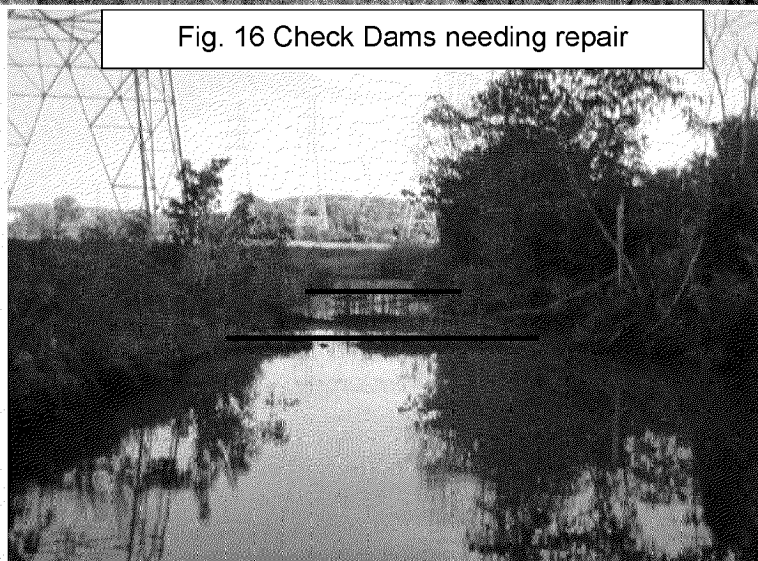
Fig. 16 Check Dams needing repair

contain coal yard sediment. Figure 16 shows rock check dams built to keep the coal fines away from the pumps. The check dams appear to be in need of repair and cleaning out. If maintained properly, the check dams will keep sediment from reaching the pumps. TVA drawing 10W225-1 (attached as API 2009-2) shows the pond and its intended bottom contours. The coal yard drainage basin should be cleaned out annually.

- Dredge the coal yard drainage basin to restore its design contours and protect the pumps from further damage. There is an estimated 2,800 cubic yards of sediment in the original pond and an extra 3,400 cubic yards in the "V" section that needs to be removed as soon as reasonable. See the attached copy of 10W225-2.
- Repair and clean out riprap check dams in the coal yard drainage basin to keep solids away from the pumps.

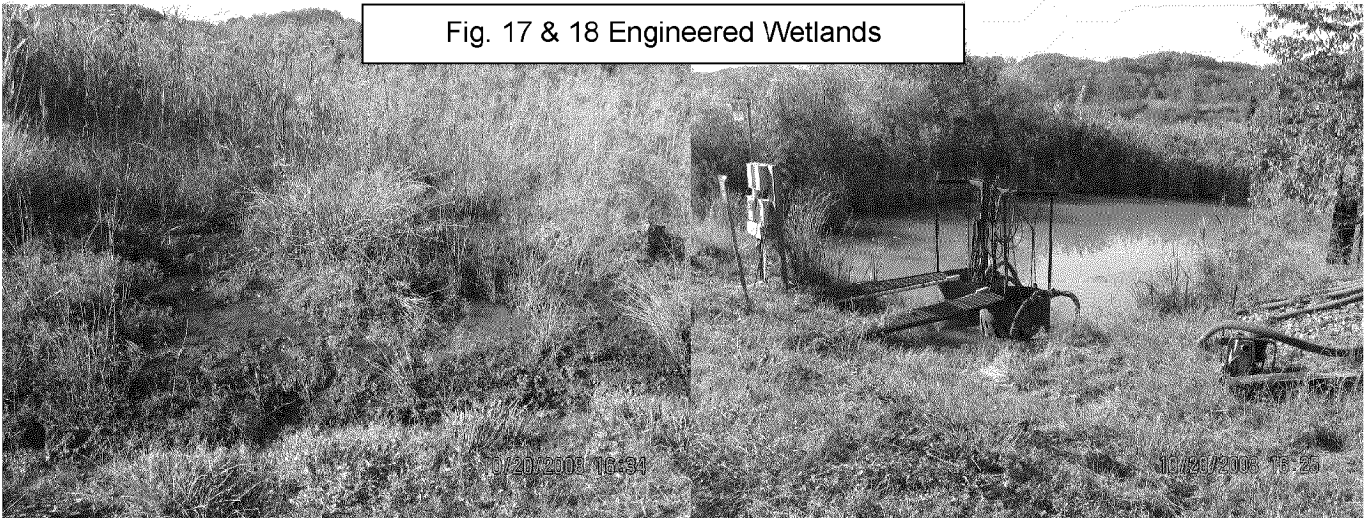
Fig. 17 & 18 Engineered Wetlands

The engineered wetlands along the southwest dike receive seepage that collects in the limestone drain below the bottom ash trench. The wetland helps naturally remove iron and raise the pH of the water before it is pumped to the ash pond. The wetland appeared to be functioning and the discharge is still pumped via two pumps to the ash pond, see Figures 17 and 18 below. Vegetation within the pump structures should be removed so that the pumps do not become clogged. Several trees were noticed along the interior slopes and should be removed by pulling up the roots. Repair the damage by compacting soil into the damaged areas.

- Remove all vegetation from within the pump structures

- Remove trees from the interior slopes. Preventing the trees from getting larger than 1" in diameter at the ground is preferred. Any trees larger than 3" in diameter at the base must be pulled from the dikes, roots and all. Repair and reseed the damaged area.

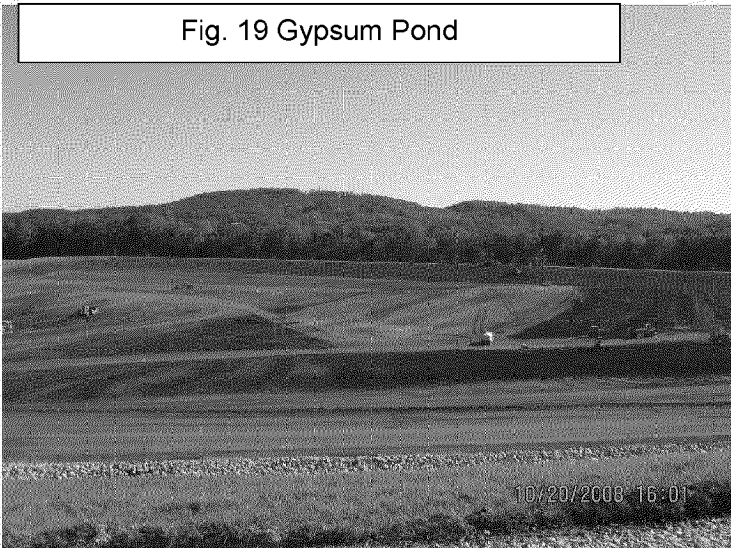
Fig. 19 Gypsum Pond

The gypsum pond is located on the peninsula, which is east of the plant. The pond was still being constructed at the time of this inspection, see Figure 19 below. Construction is scheduled to be finished on 6/01/09.

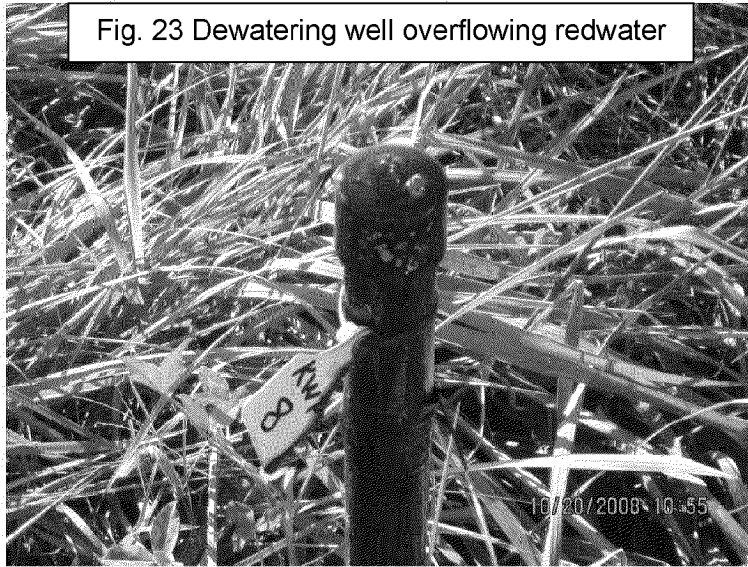
Fig. 23 Dewatering well overflowing redwater

Besides the wetlands, there was only one spot that showed flowing redwater. When dissolved iron from the ash and water mix, it tends to give the water a red appearance. This area was first thought to be a seep, but it was discovered that the redwater was flowing out of a dewatering well that had a closed valve. The water was flowing down the slope into the riprap ditch. The riprap ditch was also stained some at the outlet area for this dewatering well.
