TVA – Kingston Fossil Plant

Presentation to Plant Manager - Kingston Fossil Plant

Summary of Actions Taken
To Address Seepage through
Dredge Cell Dike And Recommended
Path Forward

27 March 2007

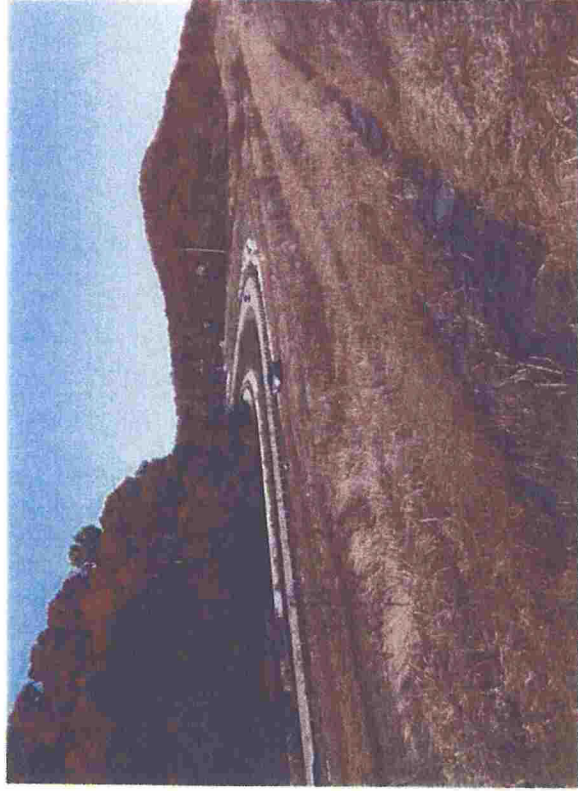
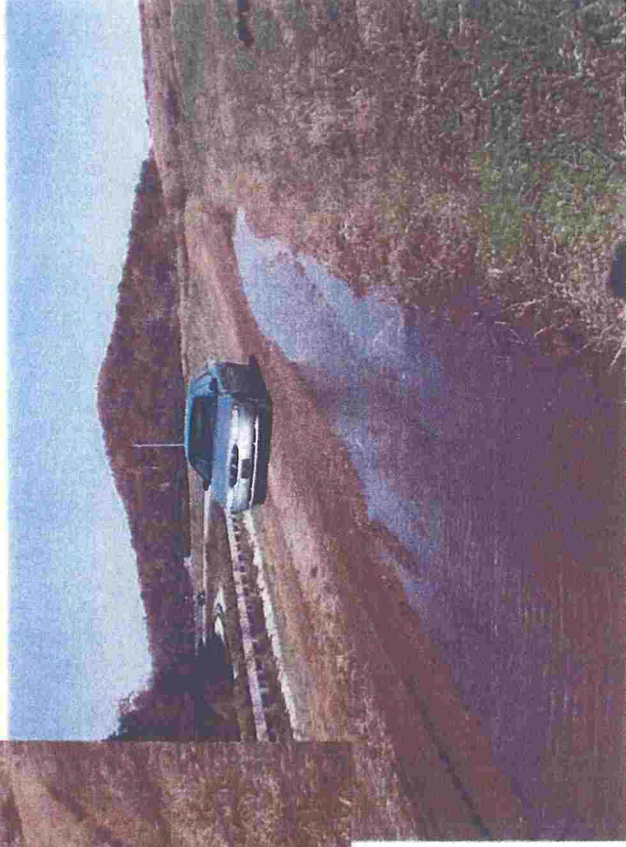
Photos taken November 2, 2006
(dry weather conditions)
Note water on benches in
general vicinity of seeps

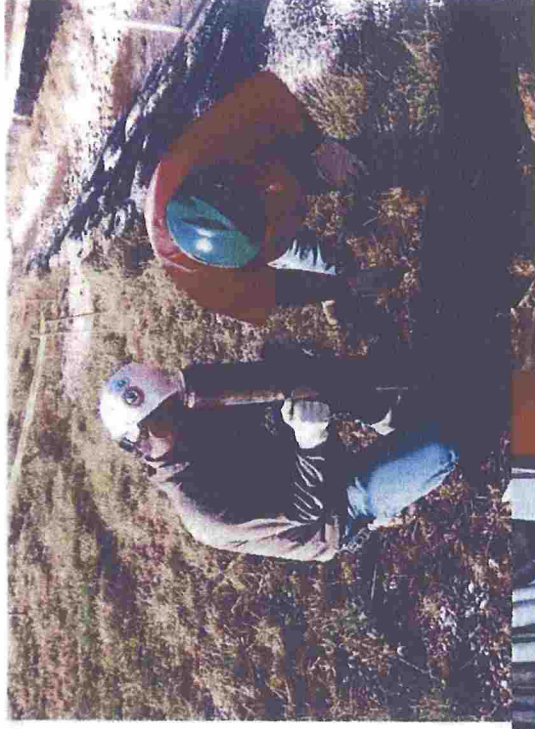
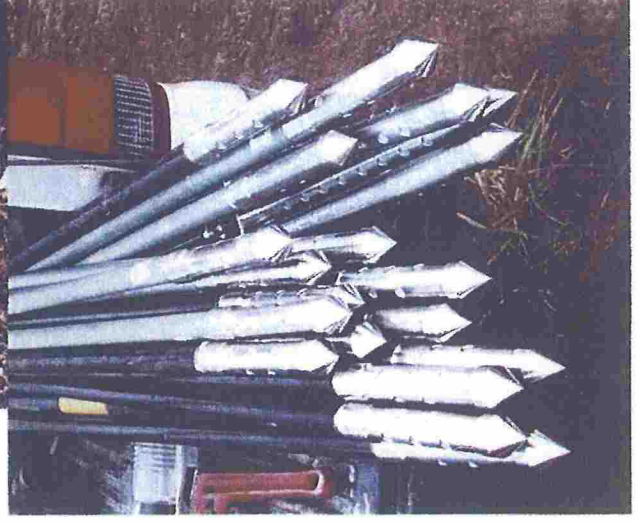
- Installed 33 drive-point piezometers along the toe of the slope
- Measured water levels and developed a water level profile
- Identified the area of concern based on the water levels that are within a foot or less of the ground surface
- In some instances water levels in piezometers were above the ground surface

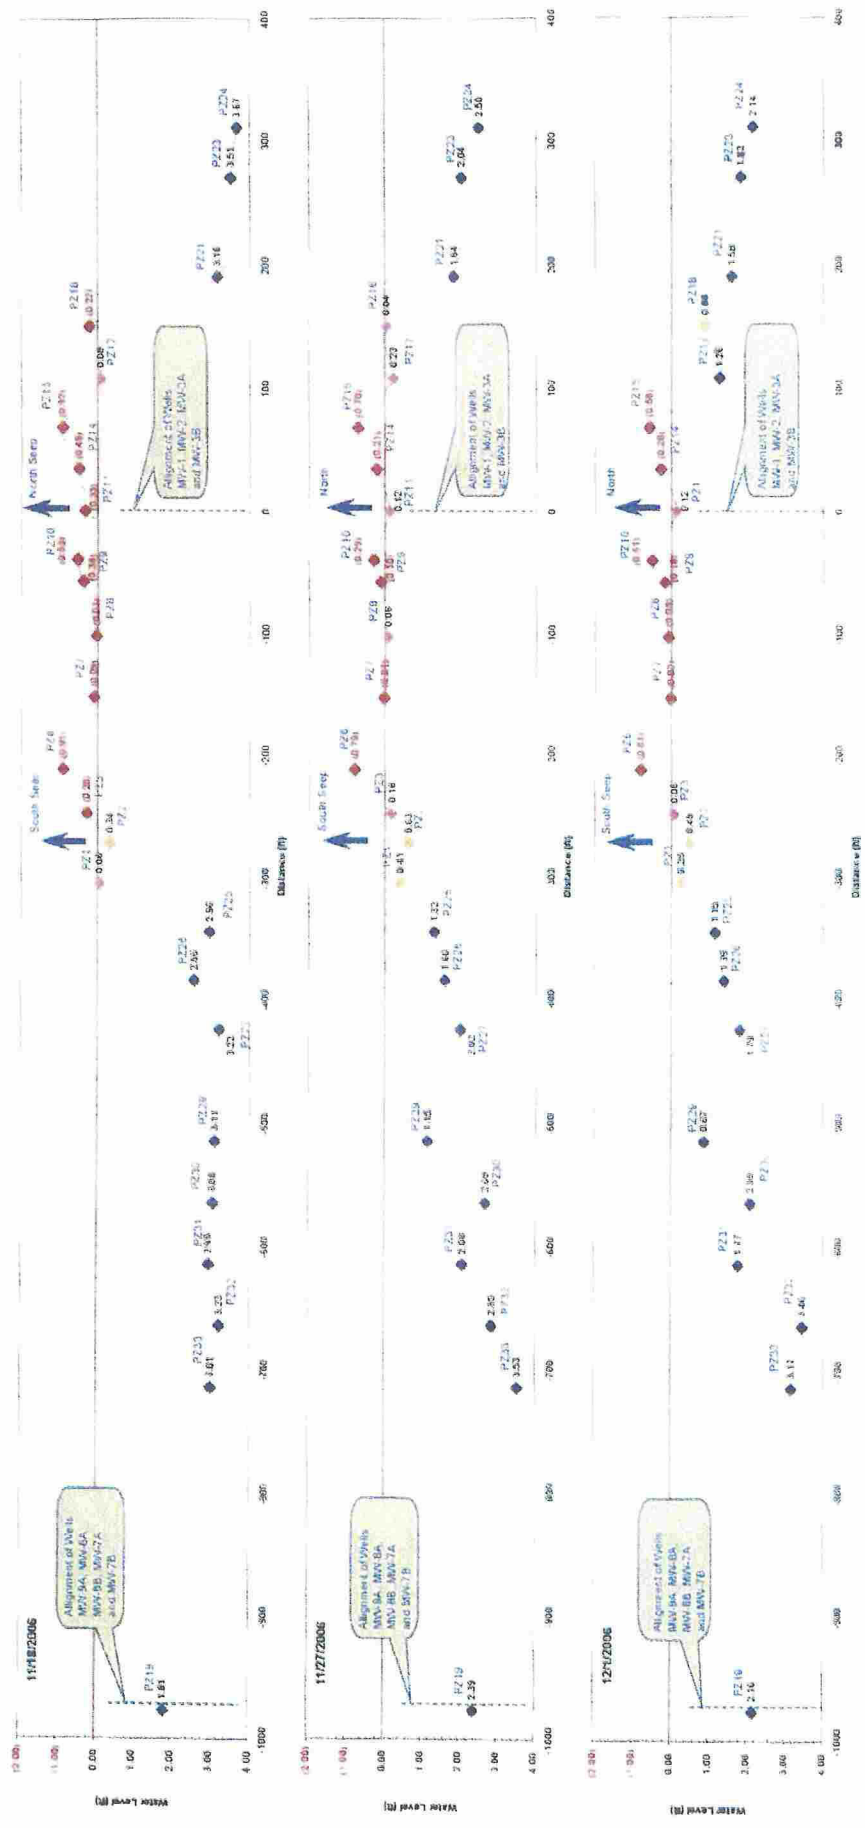
Zone of elevated Water Levels ~ 500 ft

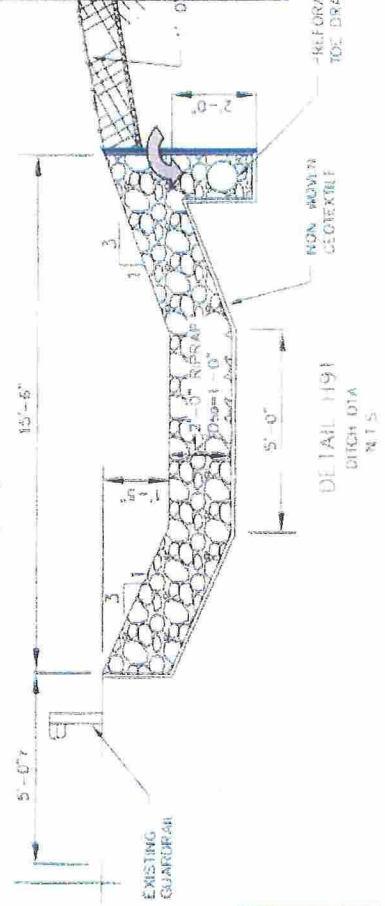
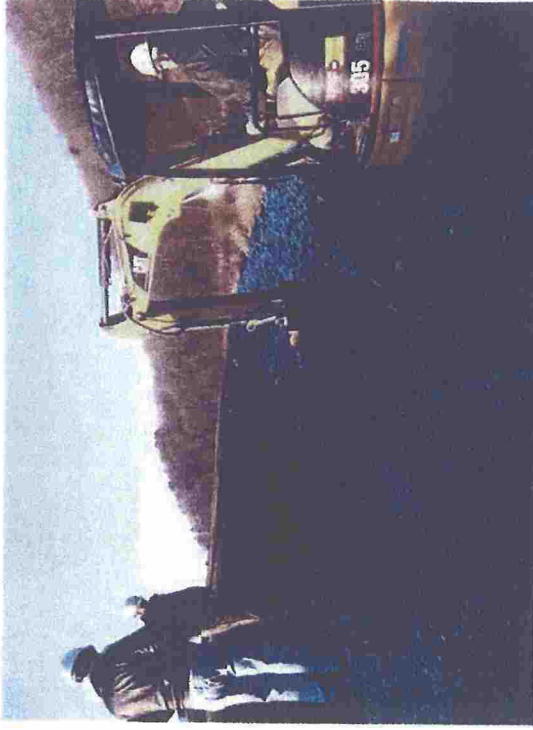
- Excavation at toe, note:
 - water level is below ditch invert, drainage pipe is below water and not draining freely
 - observed non-woven geotextile beneath rip-rap per design
 - woven geotextile at drain/ash interface appears shorter than as designed, and ash may be in pipe trench

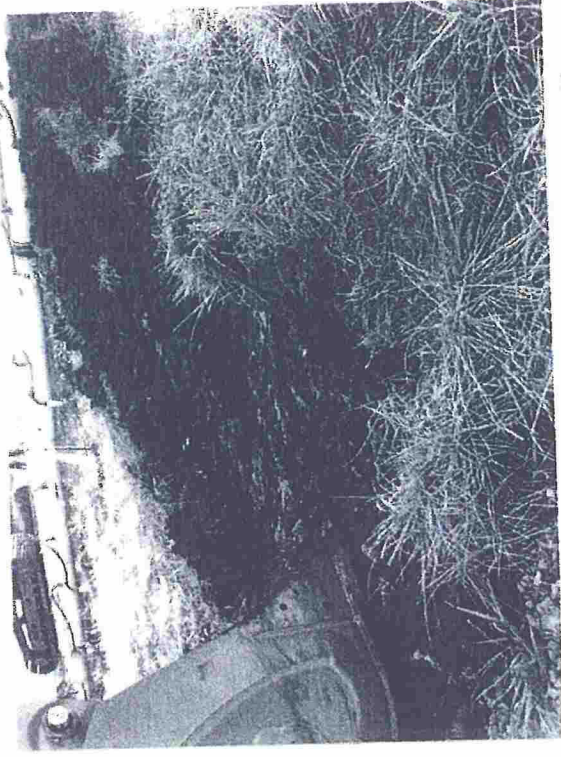
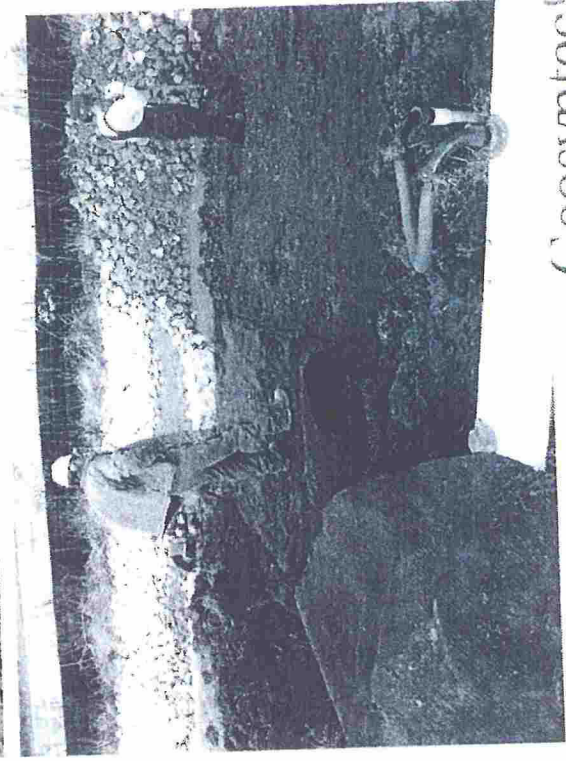
- Removed top soil over the geonet drainage layer
 - no water evident in geonet
 - some clay in contact with ash; no geotextile separator (woven geotextile in trench does not provide separation between soil and ash)
- Geonet was cut into panels and peeled back

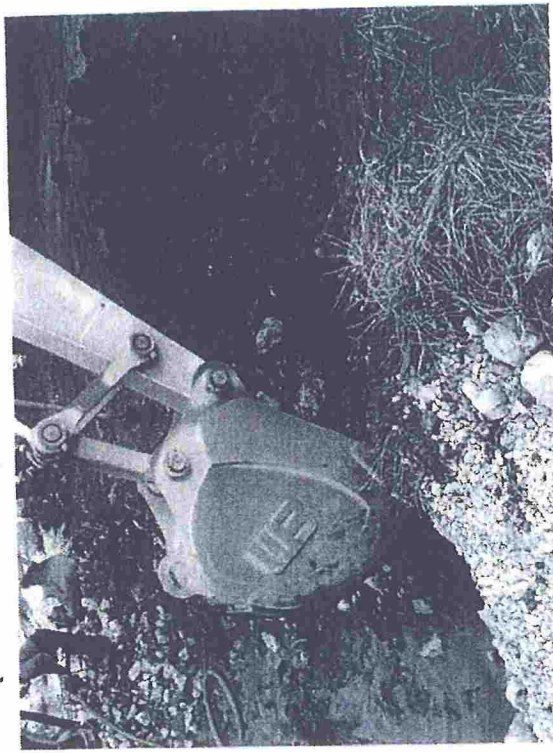
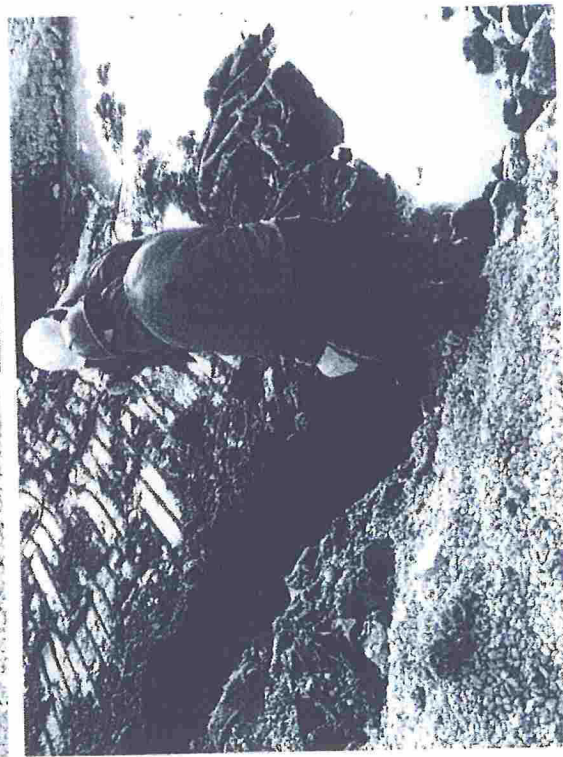
- Fly ash excavation
 - relatively dry
 - very stable (dewatering system functioning)
 - groundwater level was at about 1 ft below ditch invert

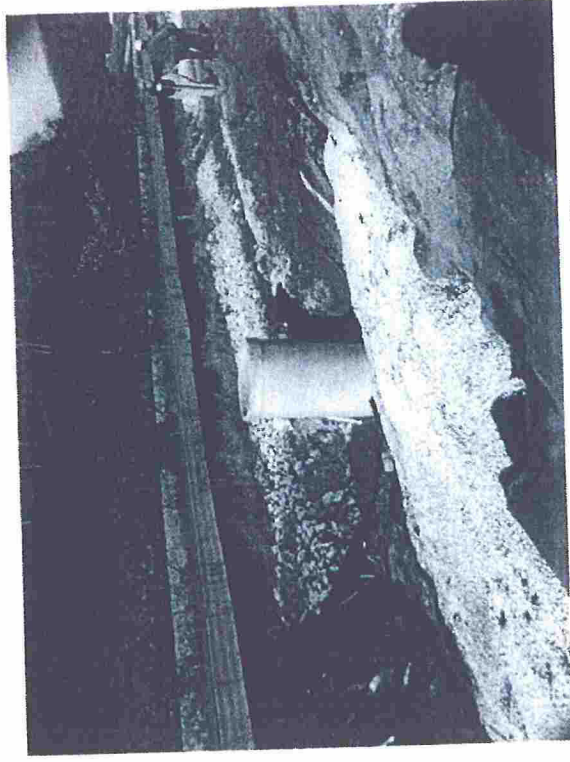
■ Attempts to dewater and expose the toe drain pipe were not successful due to pump capacity and excess water.

■ Groundwater level was at about 1 ft below ditch invert.

- Placed the spring box (36-in concrete pipe) over the geotextile (see next slide).
- Backfilled the area surrounding the concrete pipe with gravel.
- Placed gravel inside the concrete pipe (~1 to 2 ft)
- Completed the placement of gravel blanket layer.

■ Placed gravel over the pipe and a layer of geotextile over gravel.

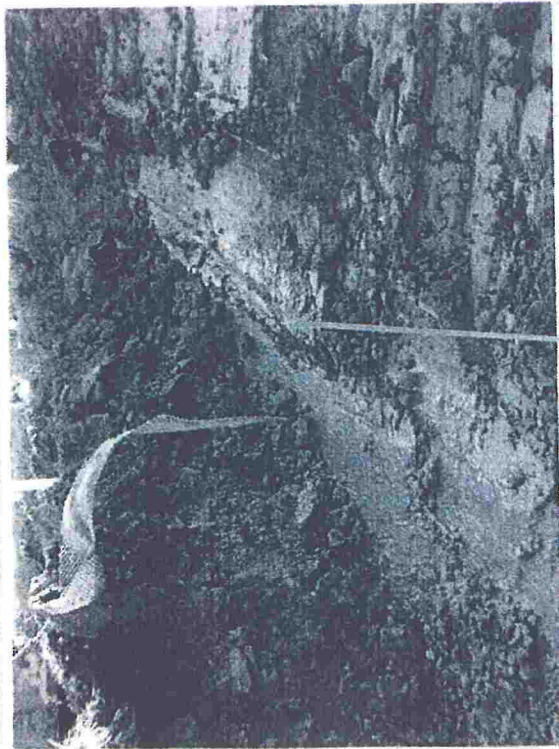
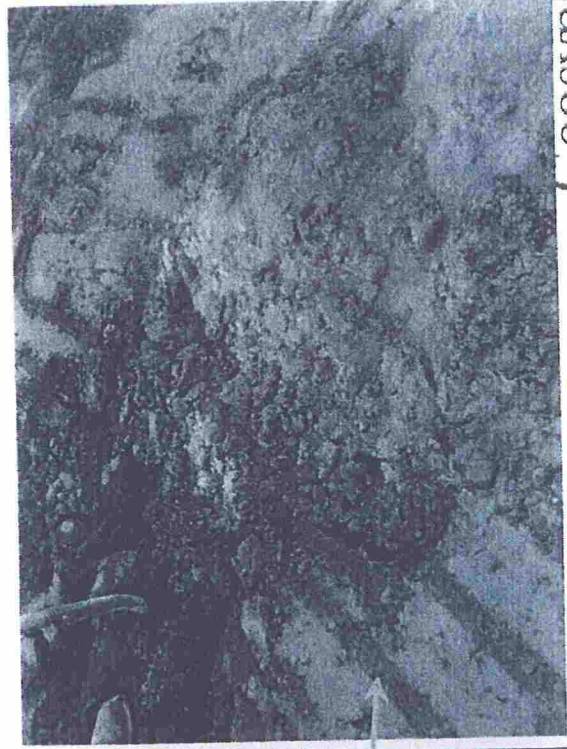
- Seepage and soft ground was observed adjacent to undisturbed area.
- Seepage and flowing (slumping) ash at the center of the excavated section was observed approximately 2 ft down slope from the wellpoints.
