RE: VIBECORE SAMPLES FROM SKIMMER WALL DOCK AREA

VibeCore Sampling Results - South Dock

Figure 1

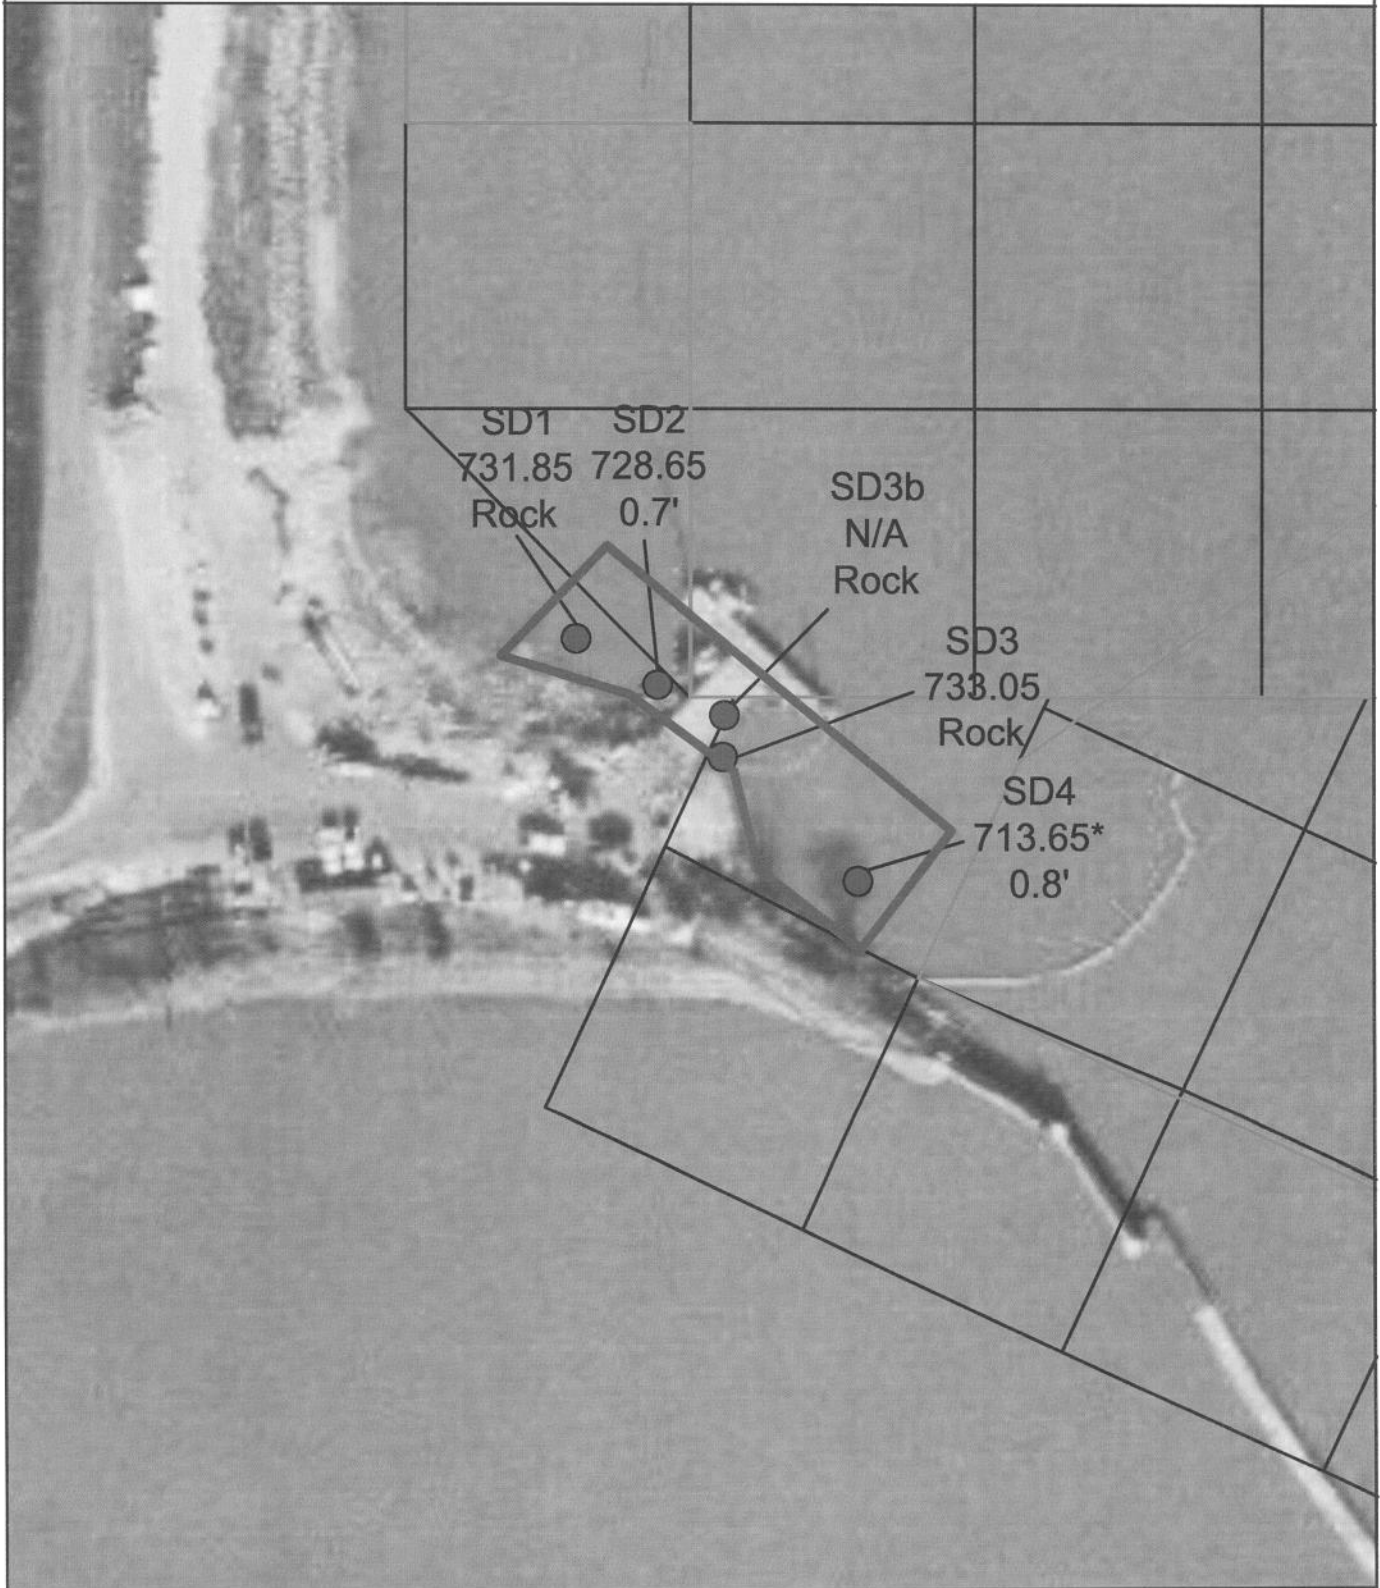
There is the potential for ash to accumulate around the unloading zone at the skimmer wall dock associated with mechanical dredging. To determine the quantity of material remaining, 5 vibecore samples were taken. Of the 5 samples, only 2 showed any ash (.7 ft and .8 ft). Using these results and projecting over the operational area of 14,000 square feet, an estimate of ash remaining is approximately 200 cubic yards. In accordance with the dredge plan, this material does not meet the criteria for removal.

- Ash Recovered
- No Ash Present

* Bottomed in Ash
