JOHN SEVIER FOSSIL PLANT - ANNUAL INSPECTION OF WASTE DISPOSAL  
AREAS

**JOHN SEVIER FOSSIL PLANT (JSF)  
NPDES PERMIT NO. TN0005436  
ANNUAL ASH POND DIKE INSPECTION  
2000**

# JOHN SEVIER FOSSIL PLANT ANNUAL ASH POND DIKE STABILITY INSPECTION 2008

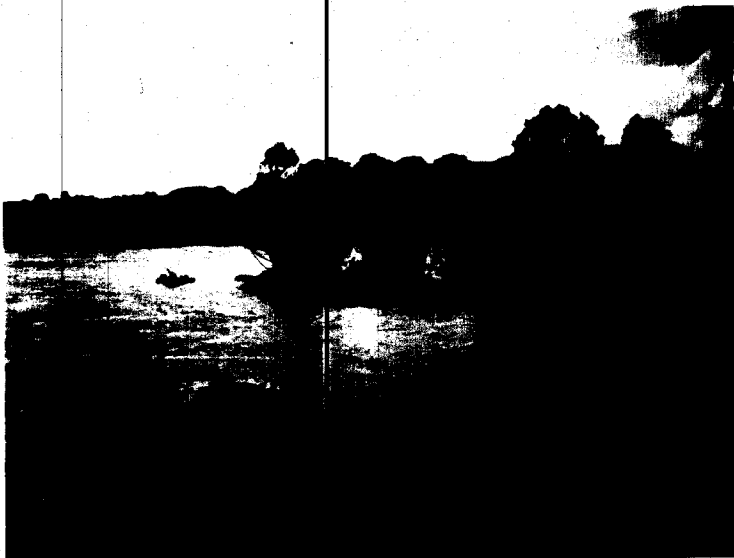
2 - Part of dike that slid into reservoir intact with trees still standing on the dike

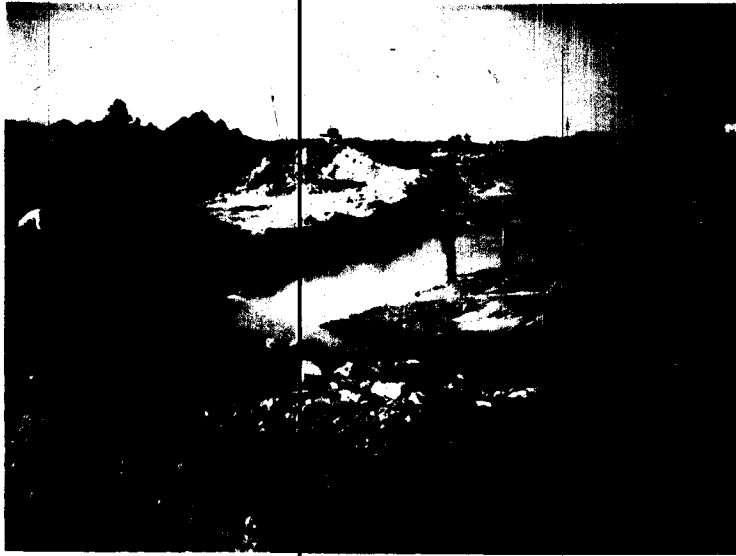
4 - Pump being installed behind the break after it was plugged

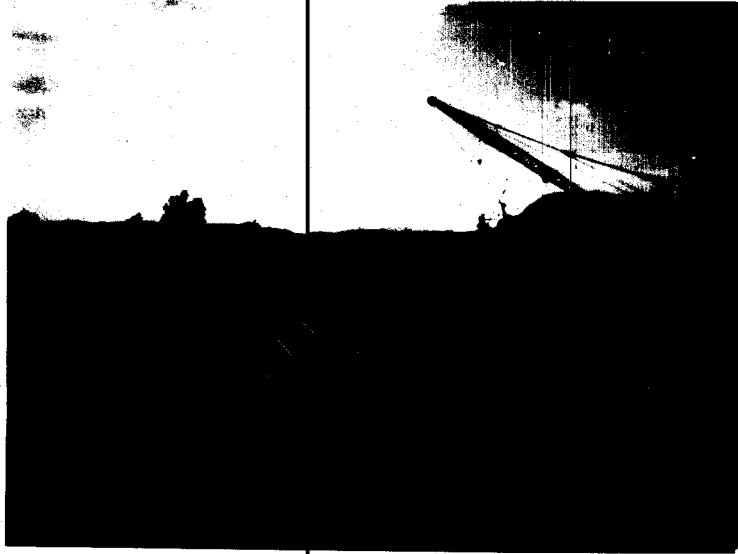
5 - The divider dike between E and F ponds being breached

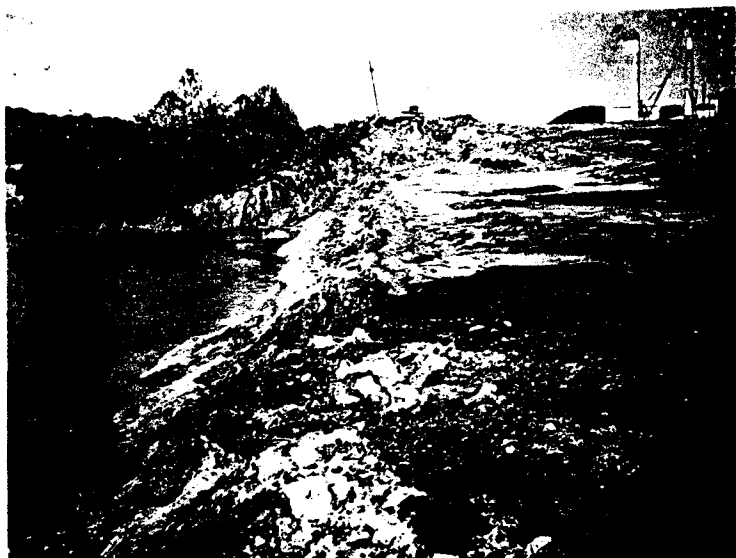
1 - Break in dike looking east, with lower gap in foreground being plugged

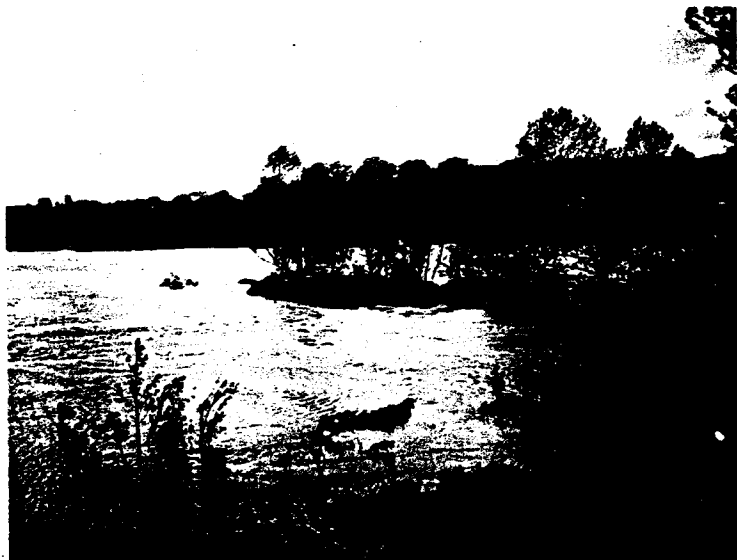
2 - Part of dike that slid into reservoir intact with trees still standing on the dike

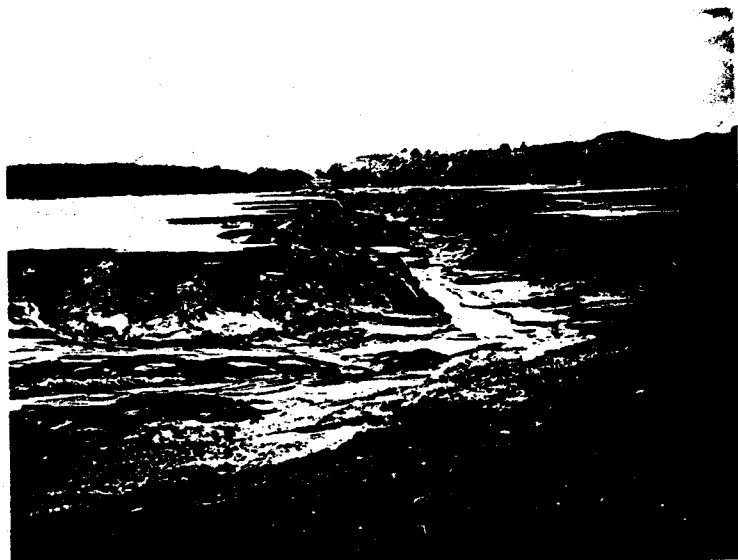
3 - Channel eroded in ash pond showing ash that had washed out

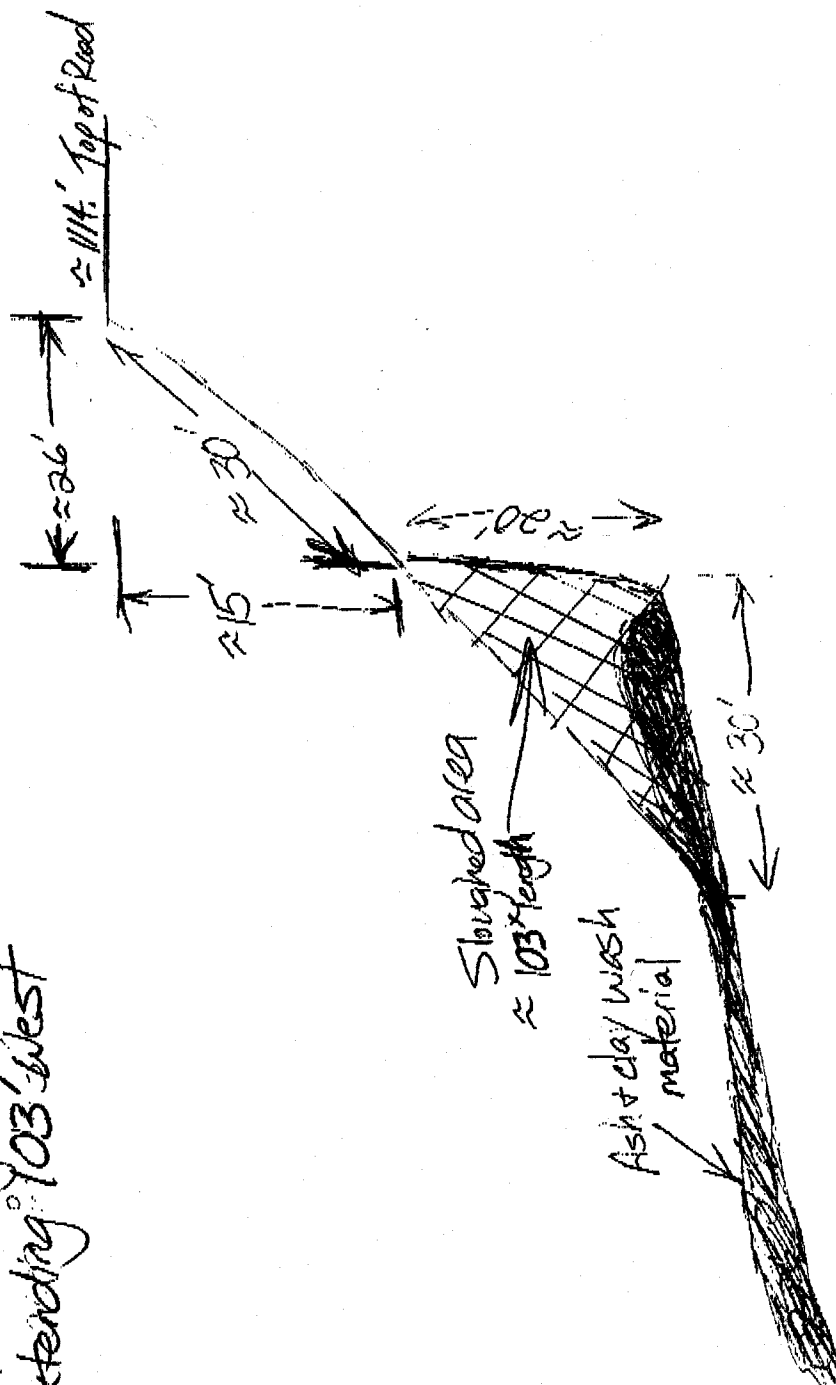
Location of sloughed area is 32' West of Monument JSDS #7  
and extending 103' West

\* Propose earthenfill (clay) worked into sloughed area. Decrease slope by extending toe. Place riprap over fill area from toe to near top.

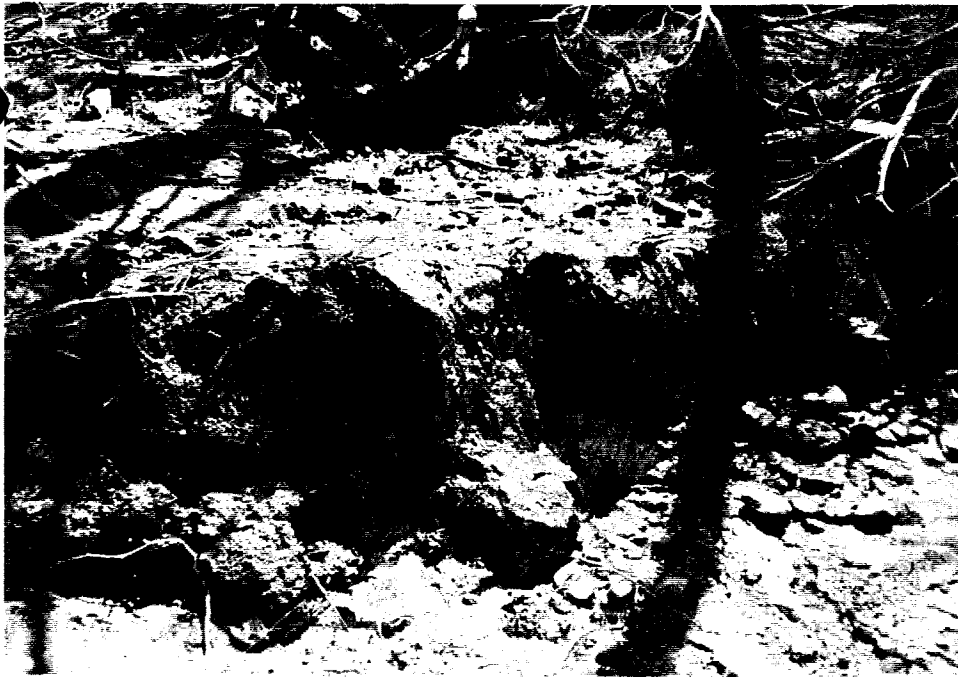
PICTURE 1 - VISIBLE  
SEEPS ALONG CHEROKEE  
RESERVOIR

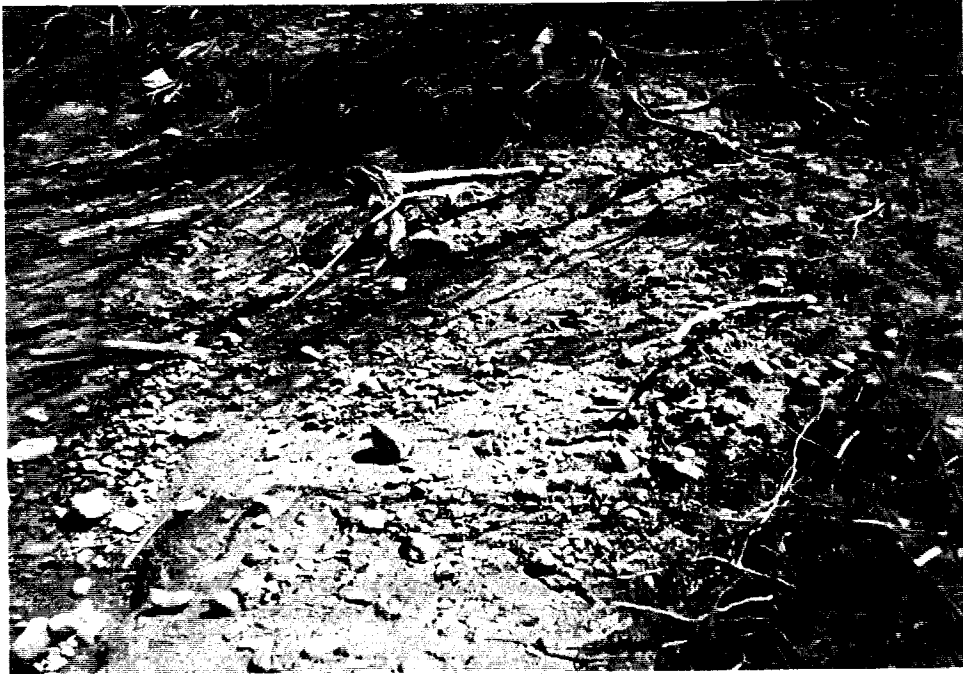
PICTURE 2 - VISIBLE  
SEEPS ALONG CHEROKEE  
RESERVOIR

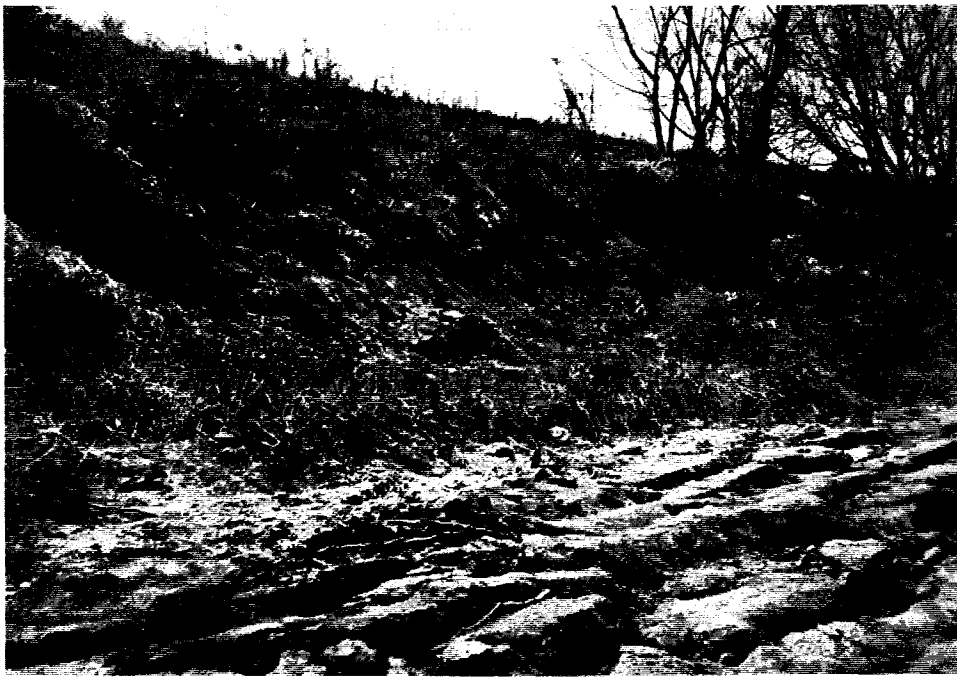
PICTURE 3 - DIKE-  
SLUFFING (100 FEET)

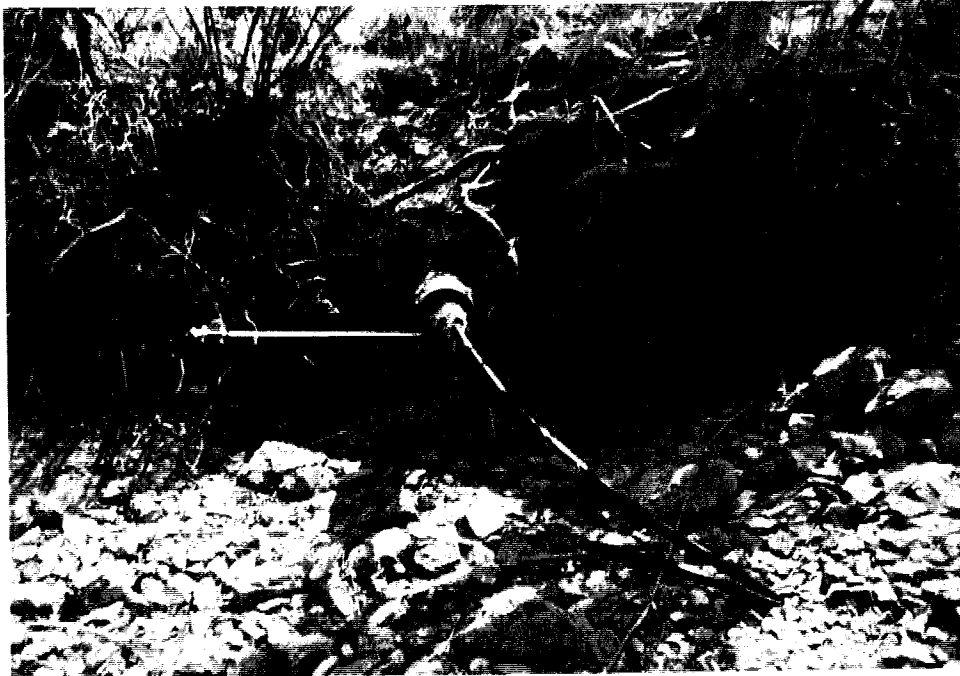
PICTURE 4 - 8" CMP  
PIPE (ONE OF FOUR  
THAT WAS PLUGGED)

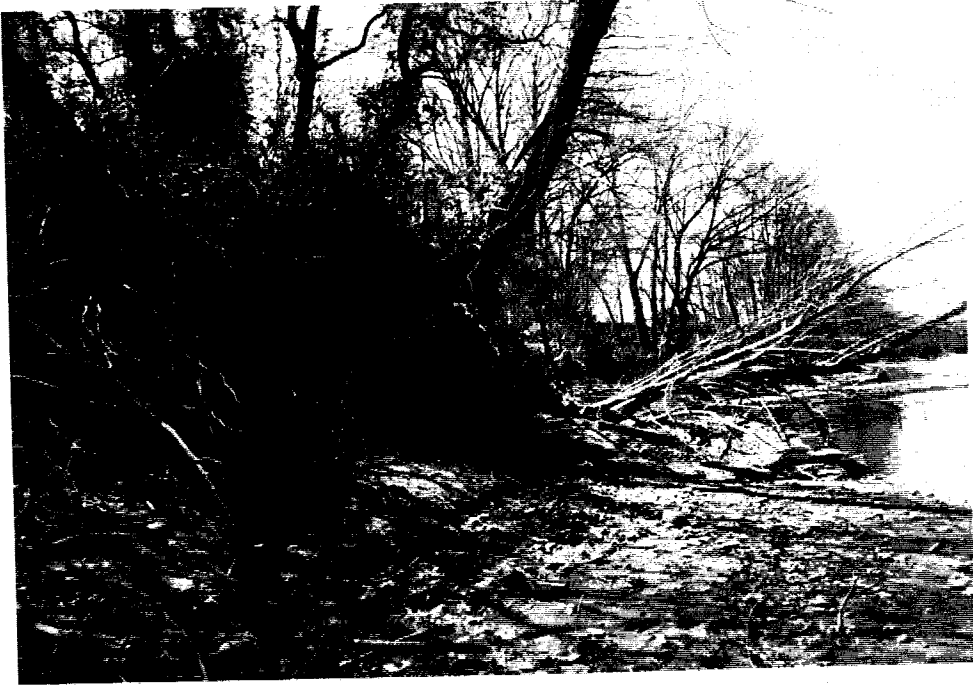
PICTURE 5 - TREES  
ALONG THE TOE OF  
DIKE THAT HAVE  
UPROOTED

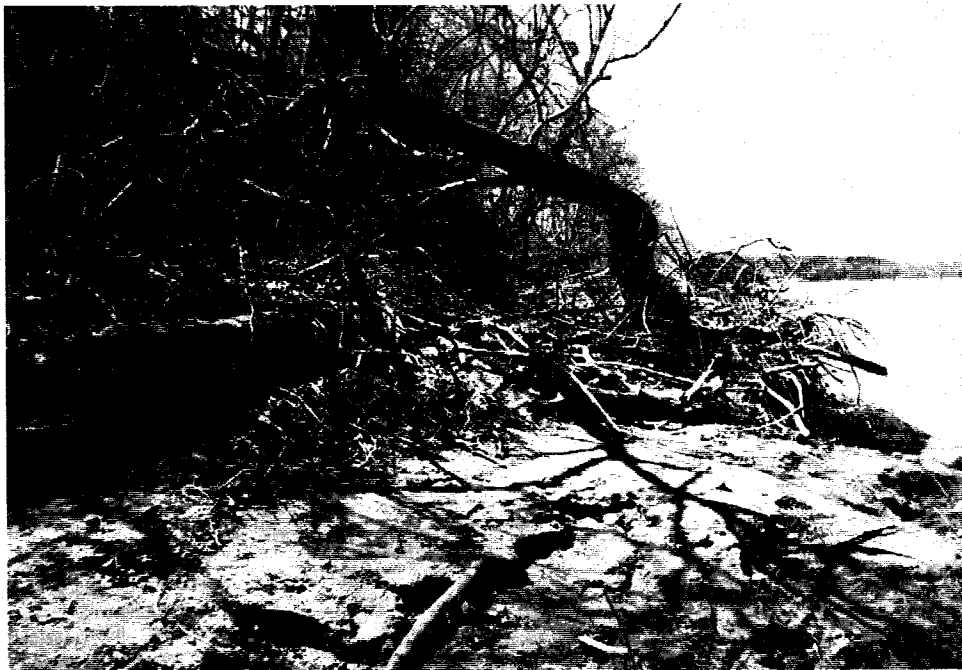
PICTURE 6 - TREES  
ALONG THE TOE OF  
DIKE UPROOTED AND  
FALLEN INTO CHEROKEE  
RESERVOIR

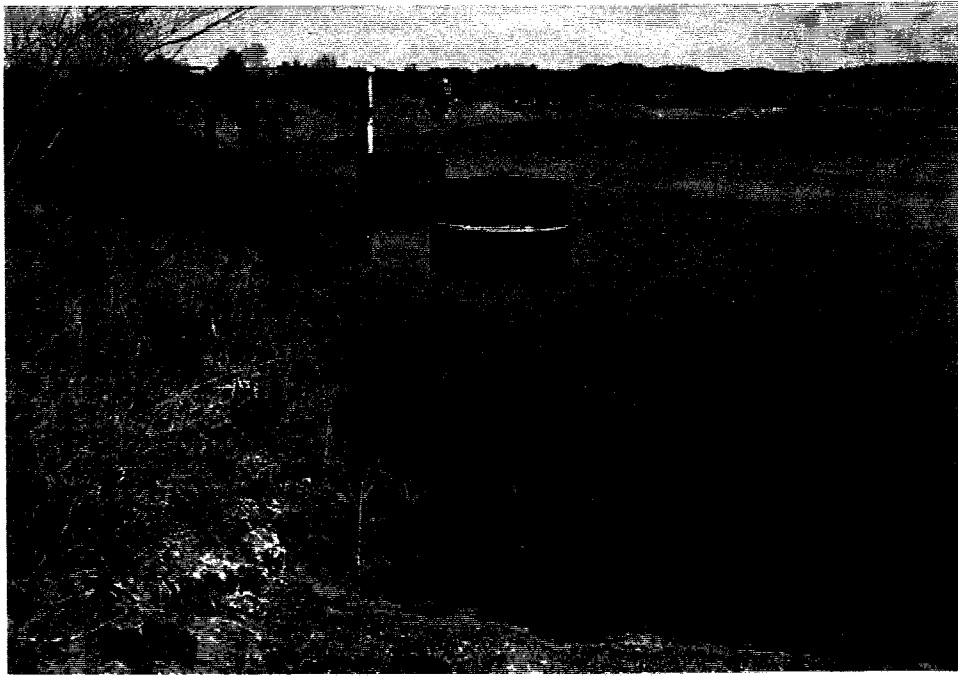
PICTURE 7 -  
SPILLWAYS IN GOOD  
CONDITION

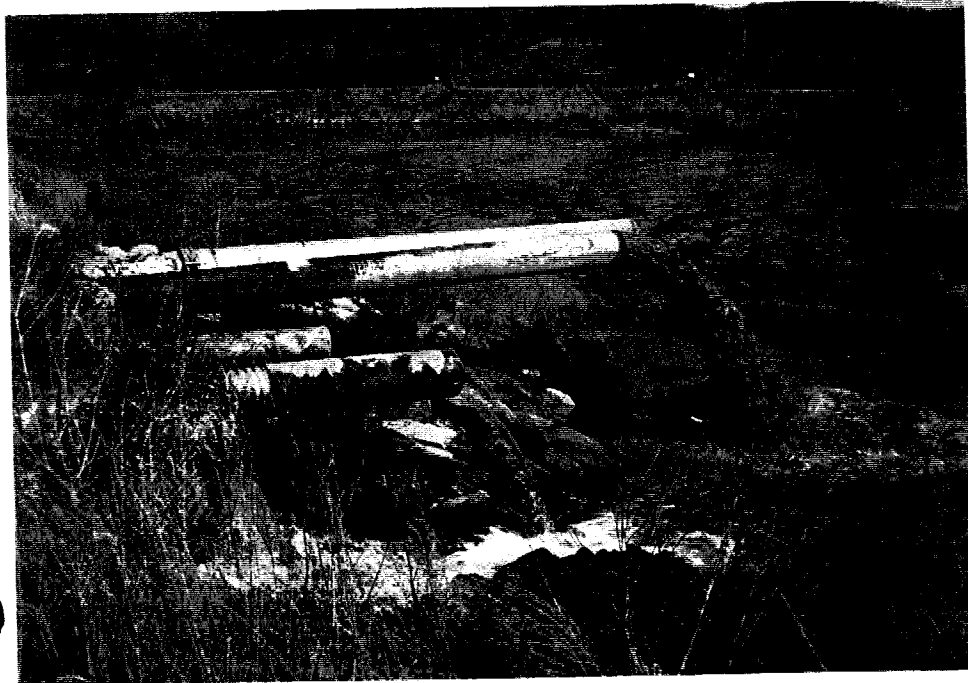
PICTURE 8 - BOTTOM  
ASH BEING SLUICED IN  
AREA 2

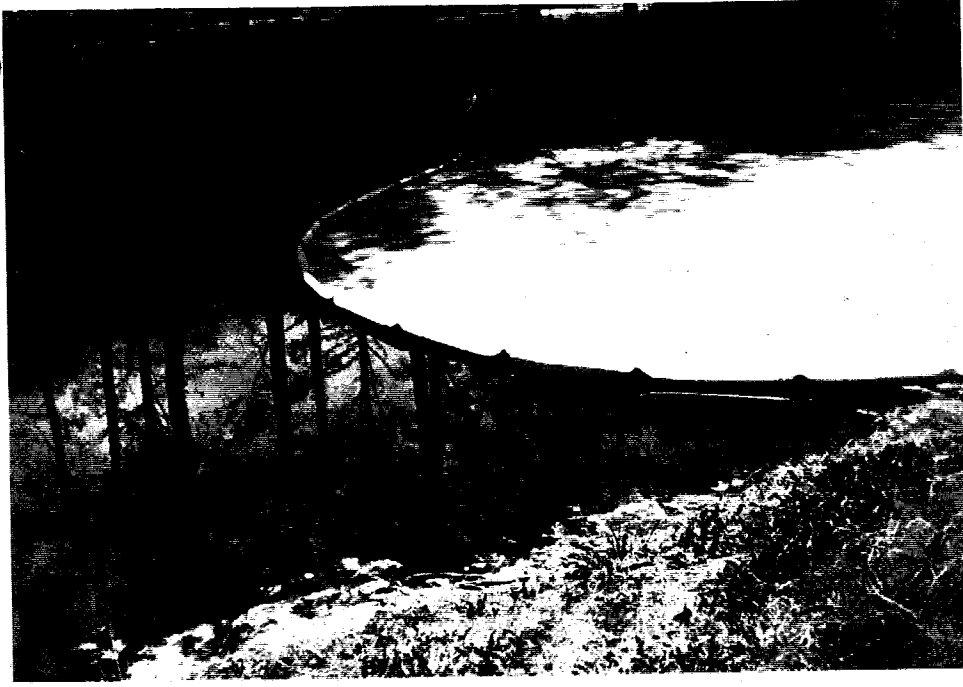
PICTURE 9 - ASH IN  
WEST END OF SOUTH  
PERIMETER DRAINAGE  
DITCH

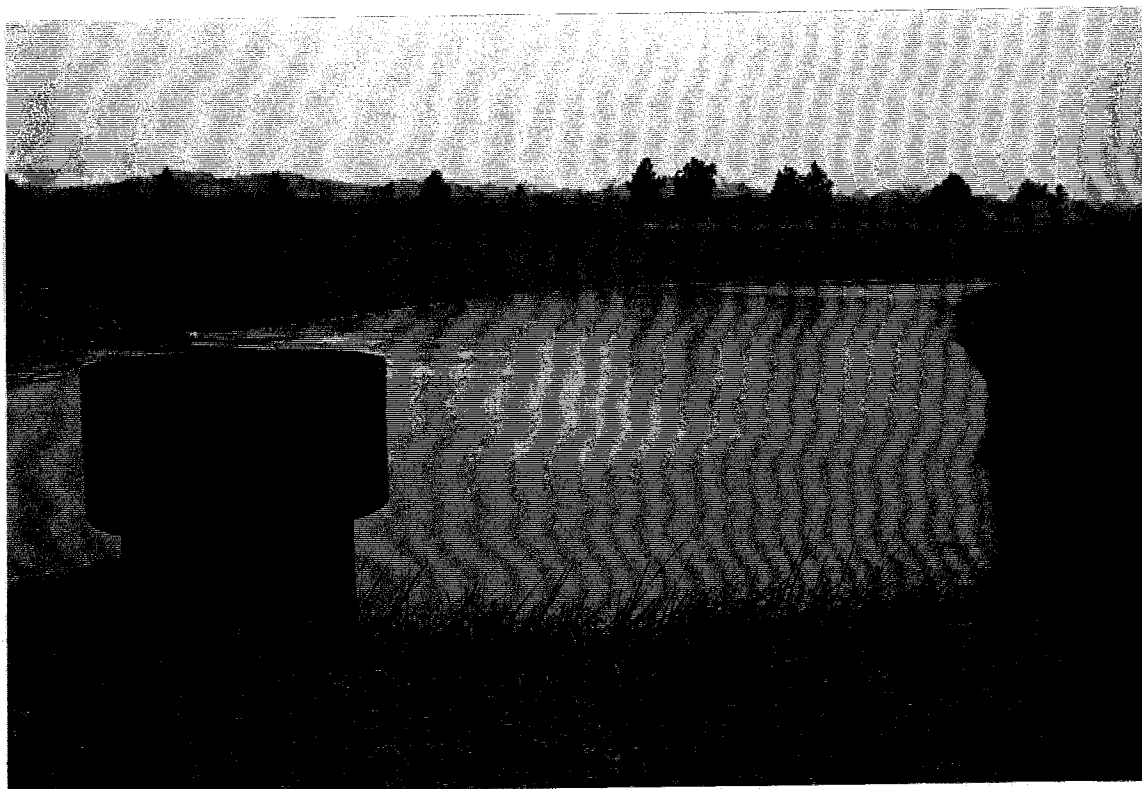
2. ORIGINAL AREA - STORMWATER RUNOFF POND SOUTHEAST OF ASH STACK

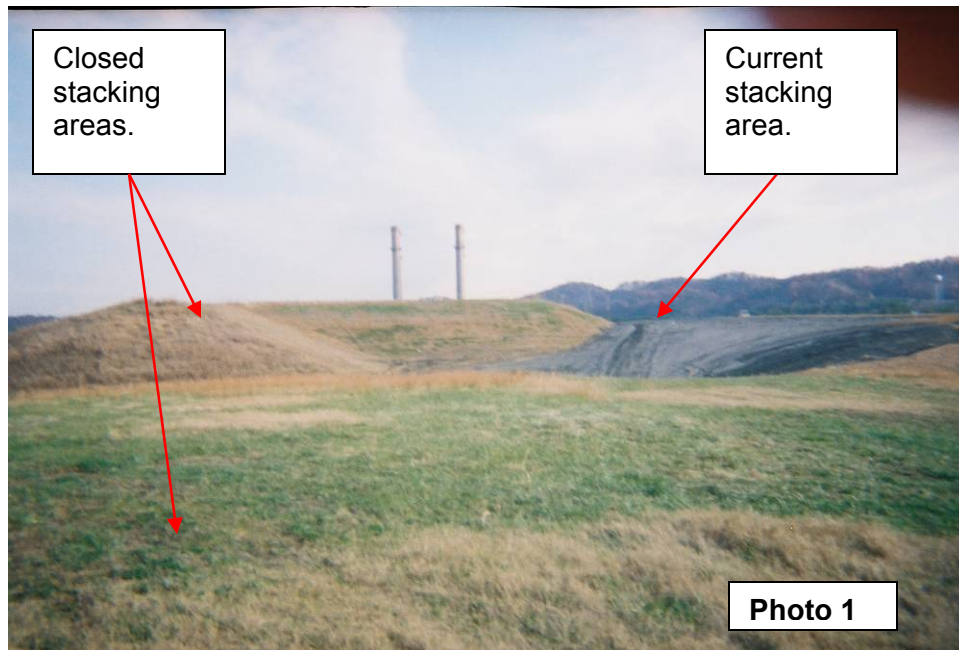
All fly ash that is not marketed commercially is dry stack in the southeast portion of this area. Except for the active stacking area of about 30 acres the dry fly ash stack has been covered with earth, seeded, and is developing a vegetative cover (Photo 1).

Photo 1. Looking East. Current Stacking Area.

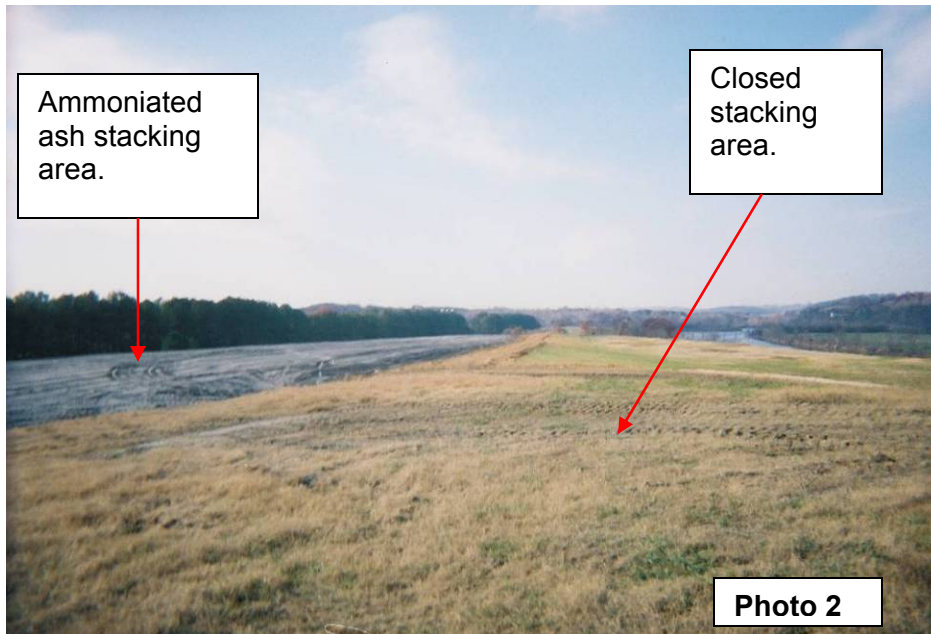
Photo 2. Looking West. Ammoniated ash stacking.

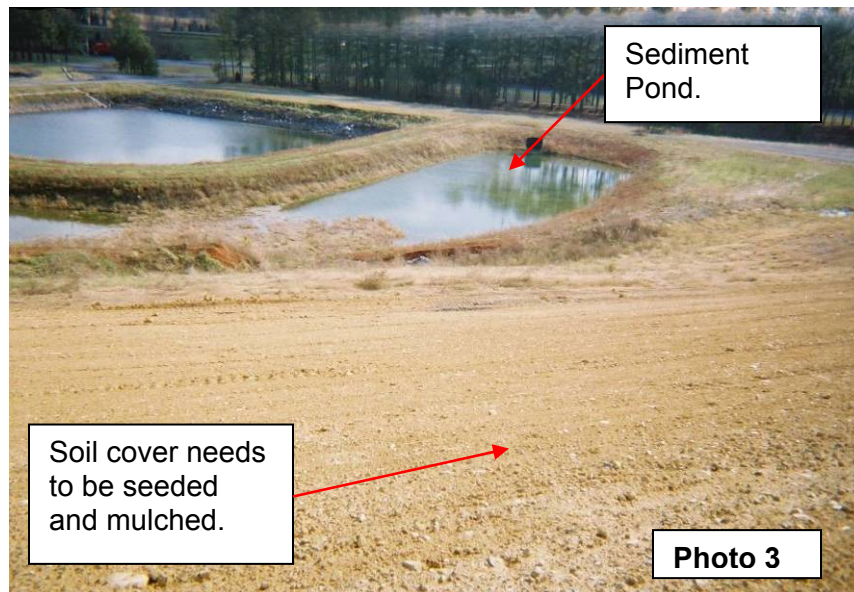
The sediment pond located in the southeast corner, beside the chemical ponds was cleaned in 2006. Since then, the plant has controlled the sediment in the pond well. At time of inspection, the south ditch was full and needed cleaning. The slopes in the sediment pond are all below grade and in good condition. The slope just above the pond was freshly graded and covered with soil, but no vegetation (Photo 3). The sediment in the pond should be removed to ensure it can operate as designed and the new slope above the pond should be seeded and mulched as soon as possible.

Photo 3. Looking Southeast. Sediment Pond for Dry Ash Stack.

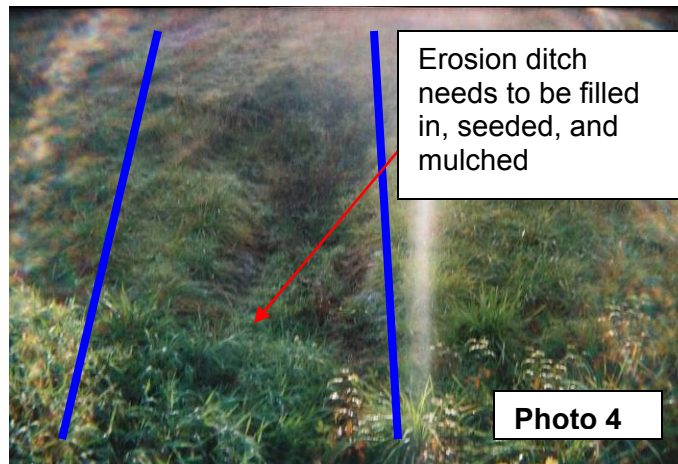
The north side of the stack along the river has good vegetative cover and appears to be stable. However, an animal burrow was noted at coordinates N 735092.220 E 2890091.437. It should be filled in with clay, seeded and mulched. There was also an erosion ditch in the first dike lift starting at coordinate N 734948.036 E 2889943.705 and end of ditch coordinate N 734977.298 E 2889908.436. The ditch was about 4 feet wide by 12 feet long and about 2 feet deep (Photo 4). This ditch also needs to be filled in with clay, seeded, and mulched.

Photo 4. Erosion Ditch.

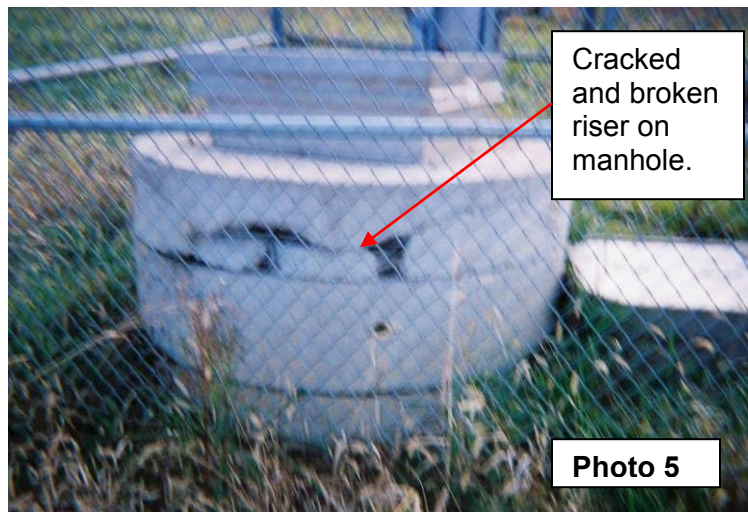
The seepage collection system continues to function effectively. The effluent from this system is pumped to the Coal Yard Drainage Basin and then to the Bottom Ash Pond. Note the missing pieces of concrete in the north side of the riser (Photo 5).

Photo 5. Northeast Seepage Collection Manhole.

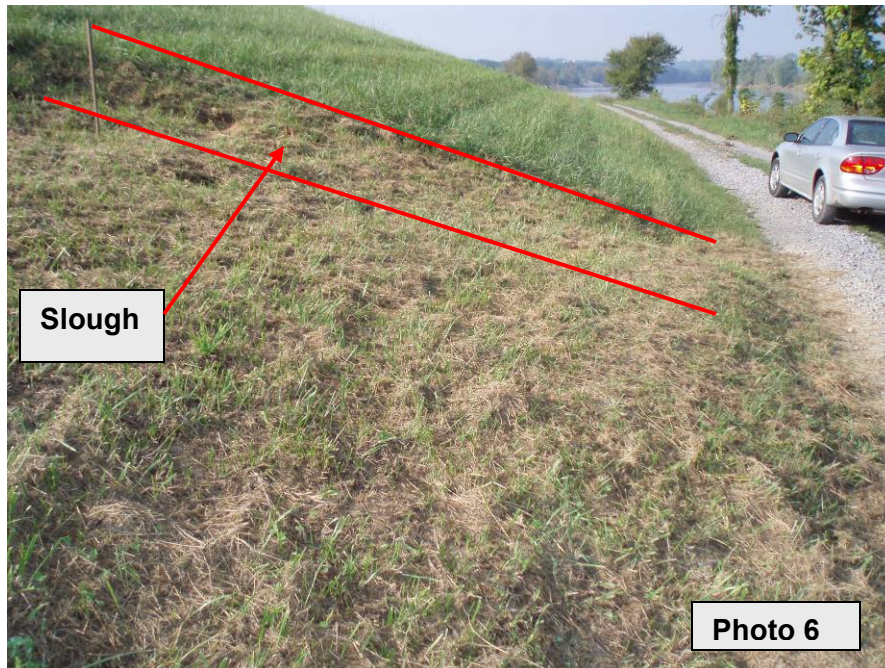
Photo 6. North Side of Dry Stack. Slough in 2007.

A slough (50' x 25') was discovered in the lower slope of the ash stack, near the river, in September 2007 and EDS was called to investigate the cause (Photo 6). EDS and Central Support and Repair (CS&R) dug in the area but were unable to determine the cause. Excavation in the area of the slough found no water or wet soul. The top three, or so, feet of material was dry (Photo 7).

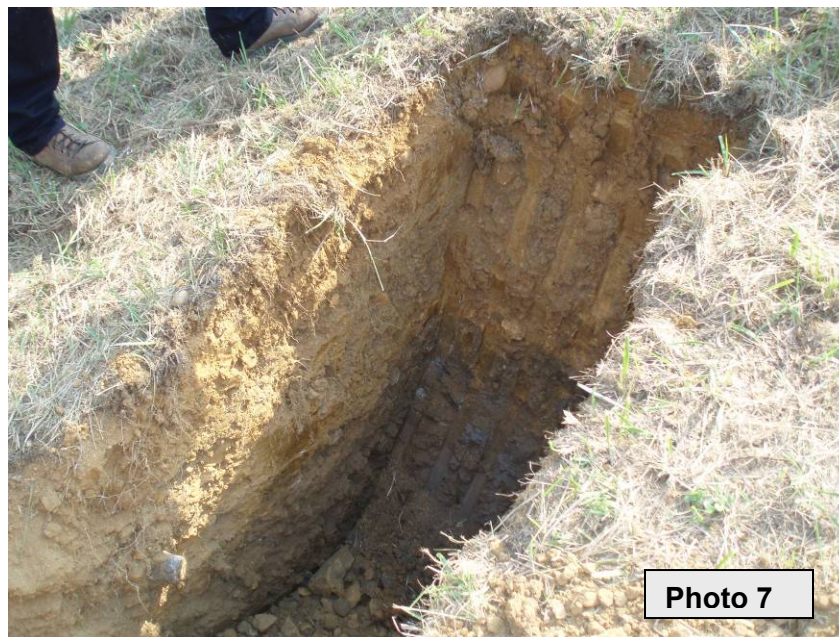
Photo 7. North Side of Dry Stack. Slough in 2007.

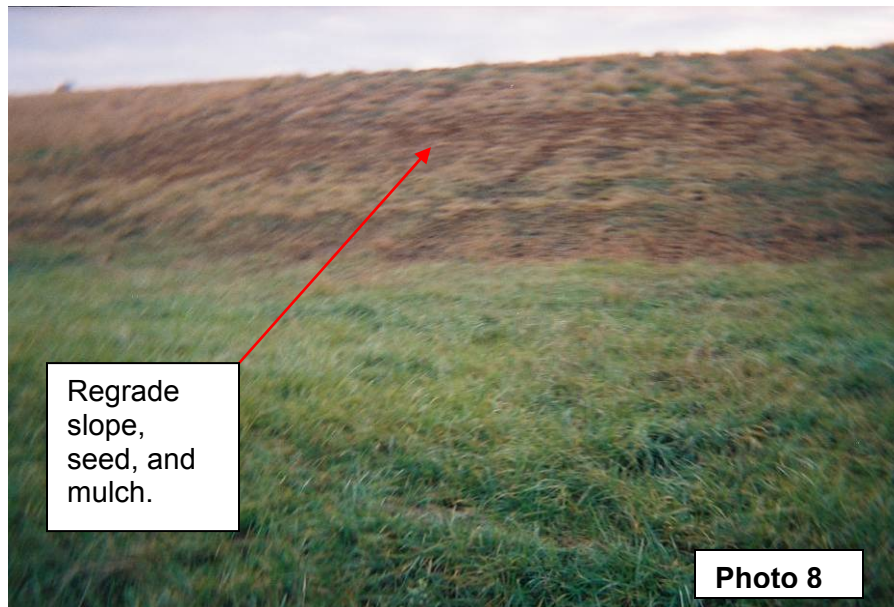
Photo 8. Slough area beside Northeast Seepage Collection.

The plant needs to reseed, fertilize and mulch the area shown in Photo 8, on the north slope of the ash stack before erosion occurs.

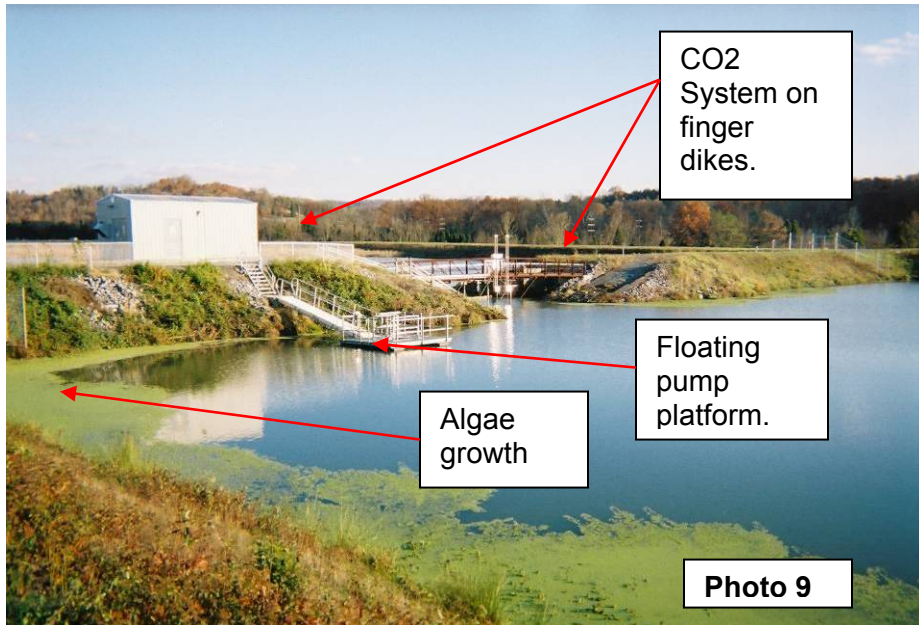
A carbon dioxide system has been installed between the Bottom Ash Pond and the stilling pool. The system started operation in early May 2007 to lower the pH of the water discharging into Polly Branch. The plant has to perform maintenance to the pump screens on the floating pump platform due to the algae growth in the pond (Photo 9).

Photo 9. CO2 System in the Bottom Ash Pond.

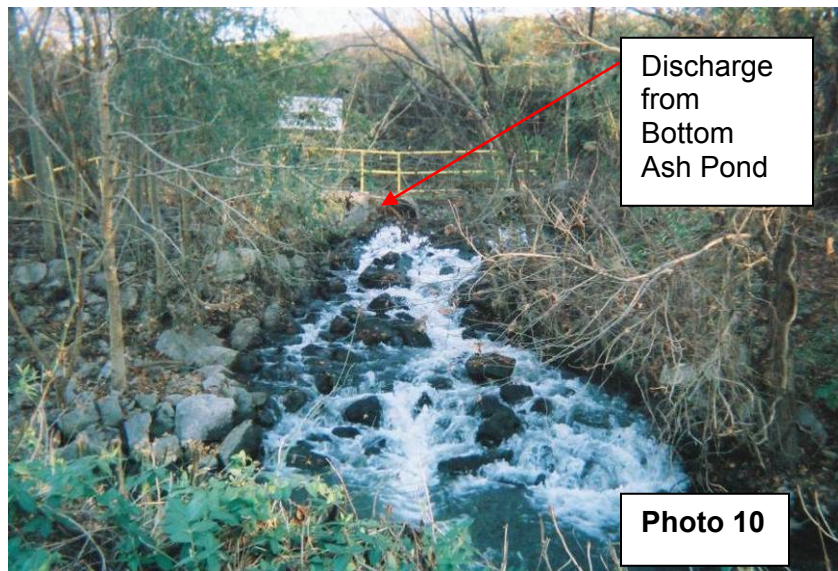
The outfall and discharge channel below the outfall are in good condition with no signs of erosion. The headwall and discharge pipes into Polly Branch are also in very good condition, showing no visible erosion.

Photo 10. Bottom Ash Pond. Discharge Pipes.

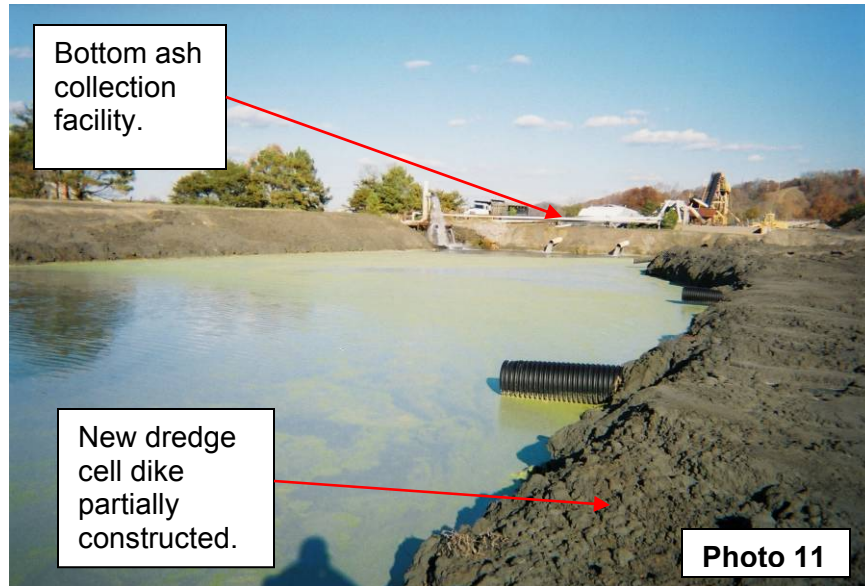
Photo 11. Bottom Ash Pond. New Dredge Cell Dike Construction.

Appalachian Products, Inc. has constructed a dredge cell in the east end of the bottom ash pond (Photo 11). The pond has had no engineering. The capacity of the discharge weirs is unknown (Photo 13 & 14). The dikes have been constructed without compaction, with excessively steep side slopes, approximately  $\frac{3}{4}H:1V$ , and narrow tops about the width of a trackhoe (Photo 12).

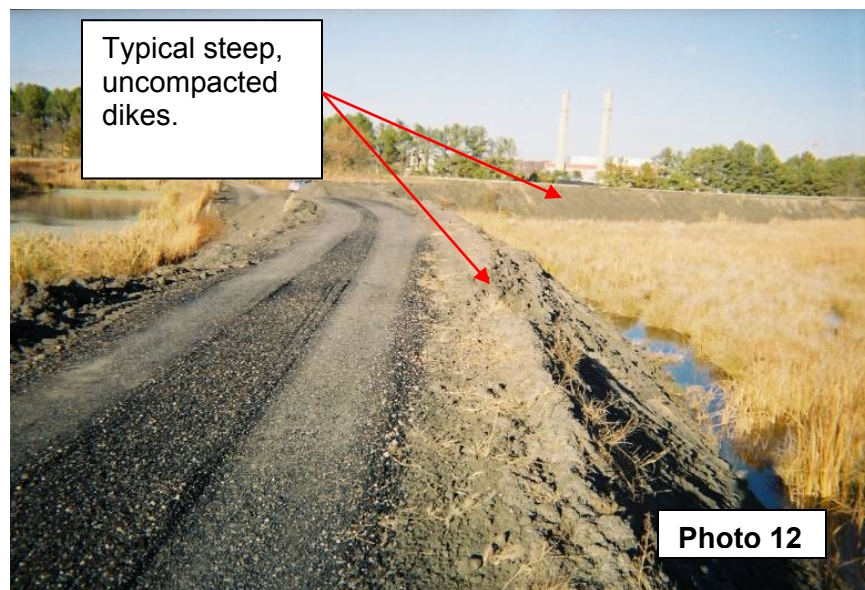
Photo 12. Bottom Ash Pond. Typical Steep Uncompacted Dikes.

EDS recommends against the use of this dredge cell in the condition found during the inspection. We do not believe it will be stable enough to withstand internal water pressure. The slopes should be flattened to 3H:1V and compacted to at least 90% of maximum density before use. Compaction testing should be done to ensure the minimum density is achieved. We are also unsure the discharge structures can pass storm water and dredge flow. Since there is no emergency spillway, this is a concern.

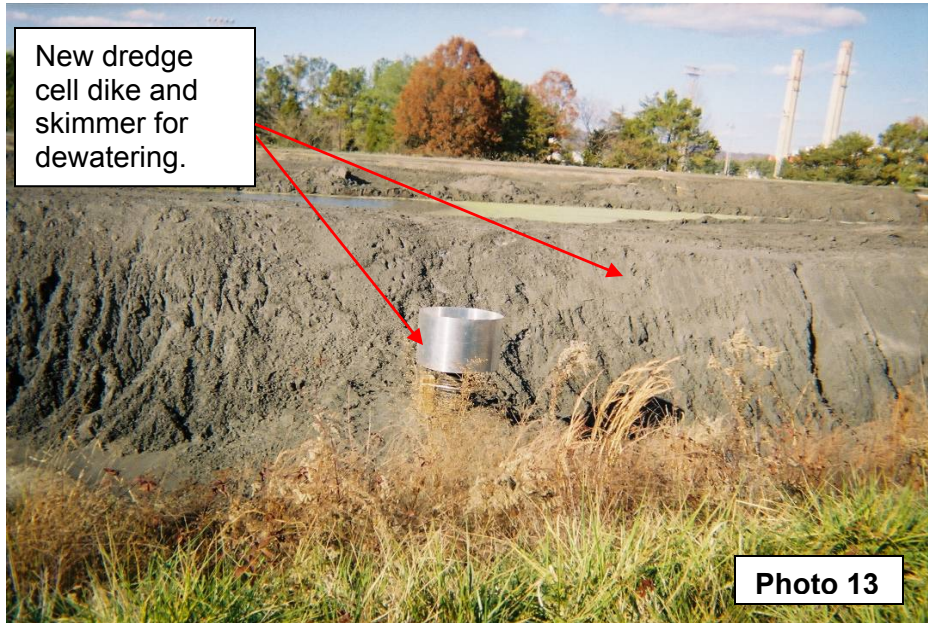
Photo 13. Bottom Ash Pond. New Dredge Cell Dike and Skimmer.

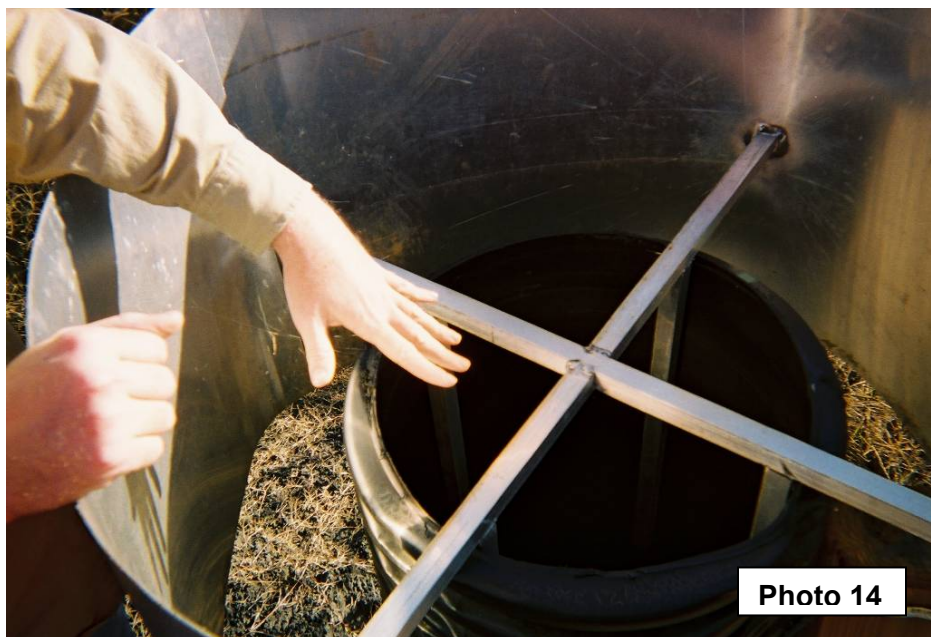
Photo 14. Bottom Ash Pond. Dredge Cell Spillway and Skimmer

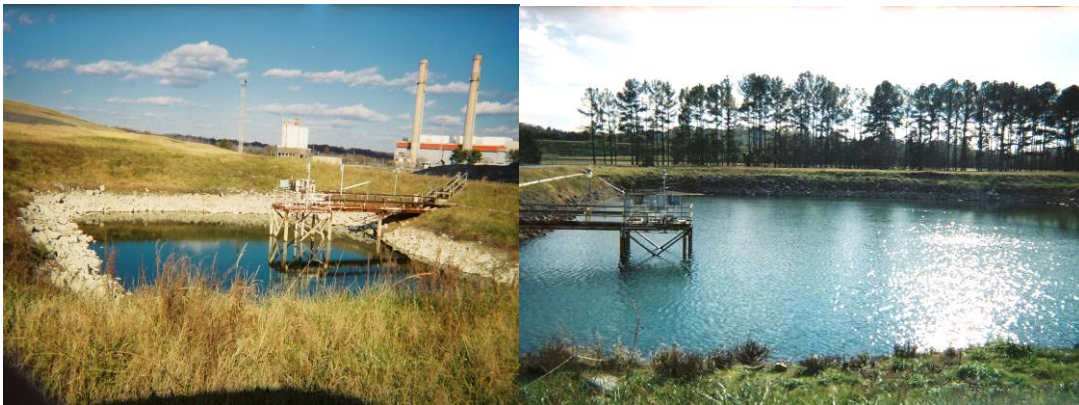
The iron and copper chemical treatment ponds are located just south of the dry stack and west of the coal pile. Both ponds were excavated below grade and have only interior slopes. All interior slopes of these ponds are covered with riprap and are in good condition. Trees are growing in the interior slopes inside the ponds (Photo 15). EDS recommends cutting the trees so they will not increase in size and interfere with the slope's stability.

Photo 15. Chemical Ponds.

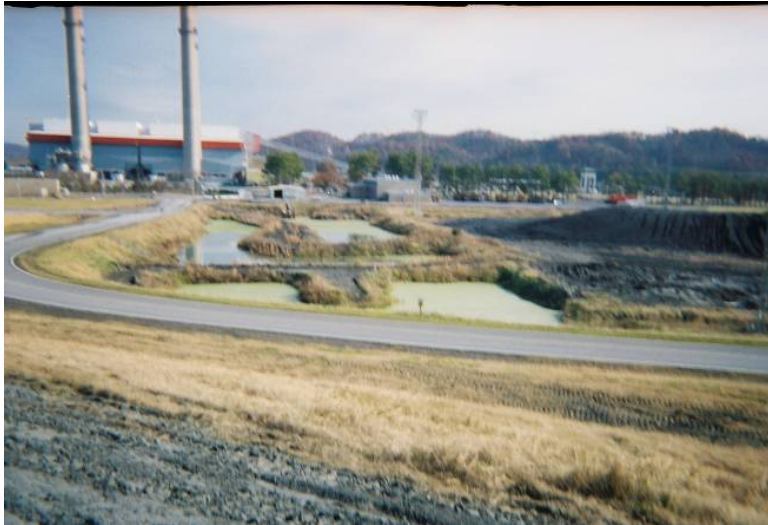
be kept clean because high water elevation causes water to back up into the underdrain system beneath the Coal Pile (Photo 16).

Photo 16. Coal Yard Drainage Basin.
