**Report of Geotechnical  
Exploration**

Peabody Ash Pond  
Paradise Fossil Plant  
Muhlenberg County, Kentucky

Prepared for:  
**Tennessee Valley Authority**  
**Chattanooga, Tennessee**

**February 9, 2010**

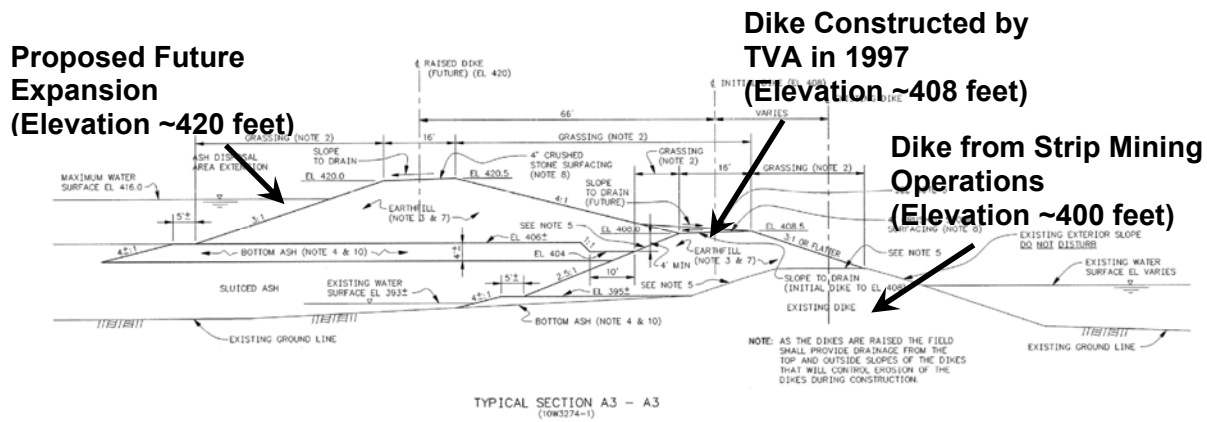
**Figure 4. Cross Section of Dike from Historic Drawing No. 10W3274-3**

Based on the historic documentation reviewed, the Peabody Ash Pond site was built on land that was previously strip mined and reclaimed. The land was originally not owned by TVA and was purchased sometime between 1988 and 1996 and later turned into fly ash disposal area. The previous strip mining operations left earthen fill dikes along the southern and eastern sides with approximate crest elevation of 400 feet. It is our understanding that the existing dikes left over from strip mining operations were too low to allow the pond to be operated above the 100-year flood elevation. In order to meet the environmental standards at that time, and for the pond to be totally above the 100-year flood elevation (while allowing enough retention time for suspended solids), TVA raised the dikes to crest elevation 408 feet. A divider dike was constructed in the northeast portion of the area to form a stilling pool. Figure 5 provides a schematic representation of dike construction obtained from the historic drawing number 10W3274-3 (dated January, 1996) provided by TVA. A copy of this drawing is also presented in Appendix A.

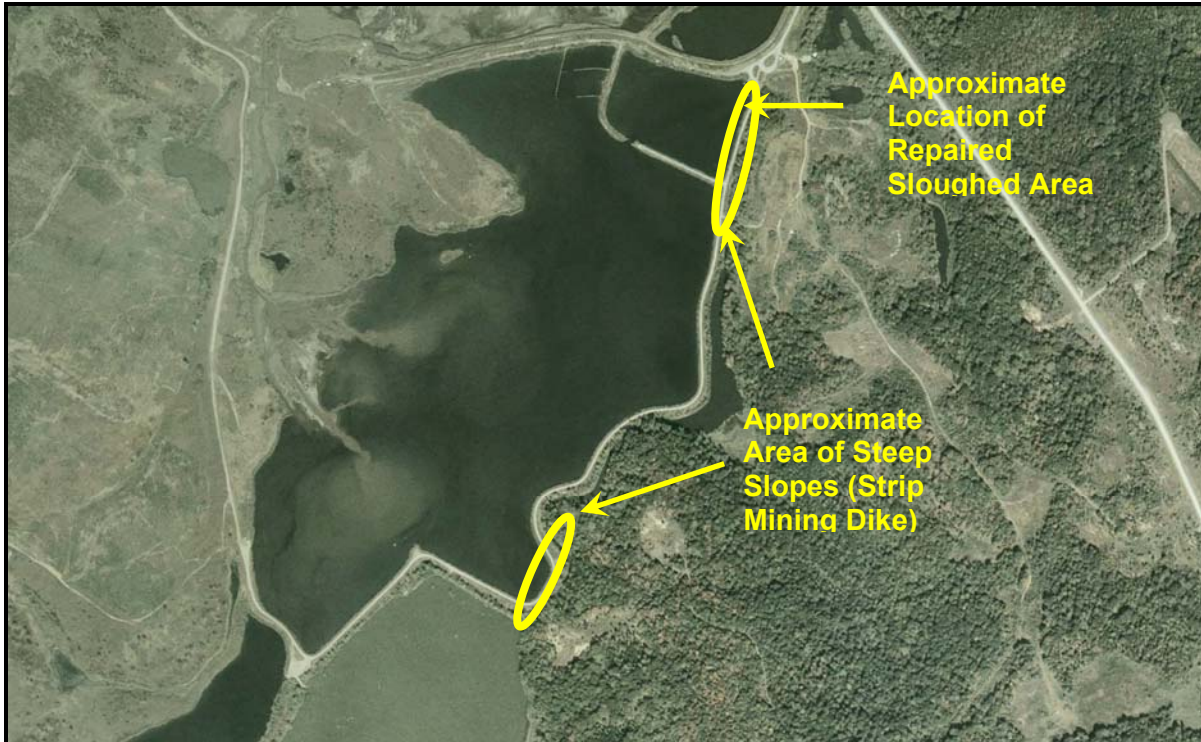
**Figure 5. Approximate Location of Repaired Sloughed Area**

The exterior slopes consist of dense brush, weeds and tall trees with some intermingled grass. Tall trees were mostly noted along the original dike that was left undisturbed when the impounding dike was constructed. Most of the trees are 12 inch diameter or less, but some larger trees were also noted. There are two areas where the small earthen fill dike formed during past strip mining operations has slopes that toe out or transition into a drainage channel with a steep bank. While the historical information (Figure 5) shows the slope of the small earthen dike as 3:1, today there are areas where the channel bank slope is steeper. In one area near the northeast corner of the pond (see Figure 6), the steep slope resulted in some sloughing.

The sloughed area was approximately 35 feet in width and 10 feet in height extending from the top of original dike (at elevation 400 feet) to the toe of the slope (at elevation 390 feet). Following an issuance of work plan by Stantec, the sloughed area was repaired by TVA. Repair measured consisted of removing vegetation and loose material in the area and slope armoring using filter fabric and Class II channel lining. The work was completed in August, 2009.

As indicated in Section 5 of this report, the Peabody Ash Pond was built on land previously strip mined and reclaimed. The strip mining operations left small earth dikes along the southern and eastern sides of the facility that toe out along a drainage channel. The ash pond dikes were built as an extension of these earth dikes as shown in Figure 4. There are two areas (see Figure 5) where the toe of the strip mine dike transitions into a steep drain channel bank, presumably created as a result of channel flow scouring. It is possible that similar scouring caused sloughing of the same earth dike near the northeast side of the ash pond, which was repaired in 2009.

It is recommended that the drainage channel adjacent to the strip mine dike be armored where the channel bank slope is steeper than 2.5H:1V. If left unattended, these areas may eventually cause sloughing similar to the one observed near the northeast side of the ash pond. The repair work should begin by mowing the dense vegetation covering these areas. After proper inspection of the mowed surfaces, the vegetation in bank areas to be repaired should be stripped. The corrective measures will likely include flattening of the slopes and armoring using sand and crushed limestone filter.
