**WIDOWS CREEK FOSSIL PLANT
ANNUAL ASH POND DIKE STABILITY INSPECTION
FY 2009**

The waste disposal areas at Widows Creek Fossil Plant (WCF) were inspected for dike structural stability on October 15 and 16, 2008 by Kelly Evans of TVA Fossil Engineering Design Services (EDS) and Jamie Dotson of TVA Fuel By-products. The previous annual inspection was performed on December 5 and 6, 2007. The results of the inspection of the Coal Yard Drainage Basin, Coal Yard Perimeter Ditch, Limestone Pile Drainage Basin, Wet Gypsum Stacking Area, Stilling Pond for the Wet Gypsum Stacking Area, Active Ash Pond, Stilling Pond for Active Ash Pond, Dredge Cell, Perimeter Dikes, Red Water Pond, Chemical Treatment Pond, and the Abandoned Ash Disposal Area are listed below. A summary of recommendations is also provided. Estimated costs are based on the 2009 RSMEANS Building Construction Cost Data (quotes are advised for more accurate estimate).

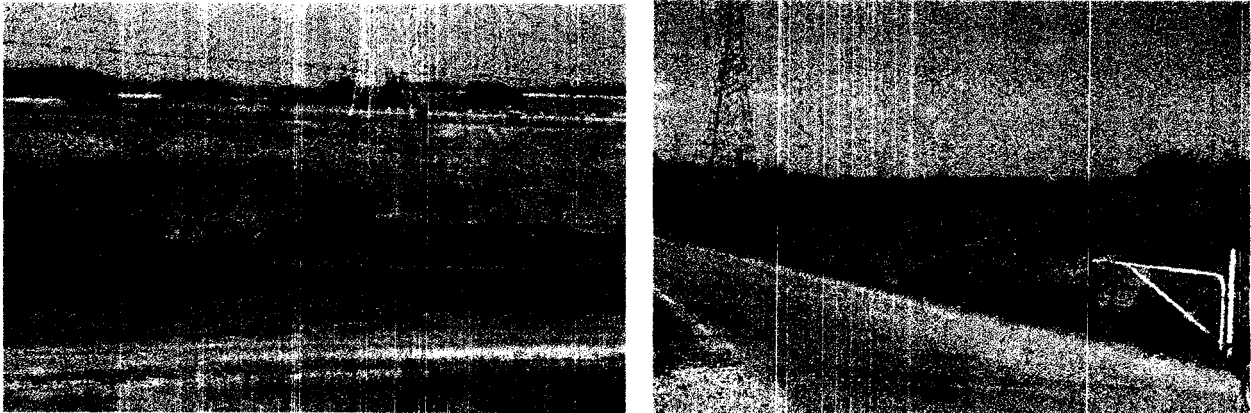
First, Mr. Parker and his crew has done an excellent job mowing, cleaning off the dikes and removing trees. Here are a few shots of the dikes' current condition.

The work has left parts of the dikes without vegetation. These areas should be reseeded and fertilized following the T-1 Specs (attached). This is an excellent time of year to do that. The picture on the left shows an area just above the ditch that has a steep slope. This should be graded to match the slope of the dike. It is probably the result of ditch maintenance.
