Annual Performance Report April 2006 Through March 2007 for the Shiprock, New Mexico, Site

June 2007

Office of Legacy Management

Work Performed by S.M. Stoller Corporation under DOE Contract No. DE-AC01-02GJ79491
for the U.S. Department of Energy Office of Legacy Management, Grand Junction, Colorado

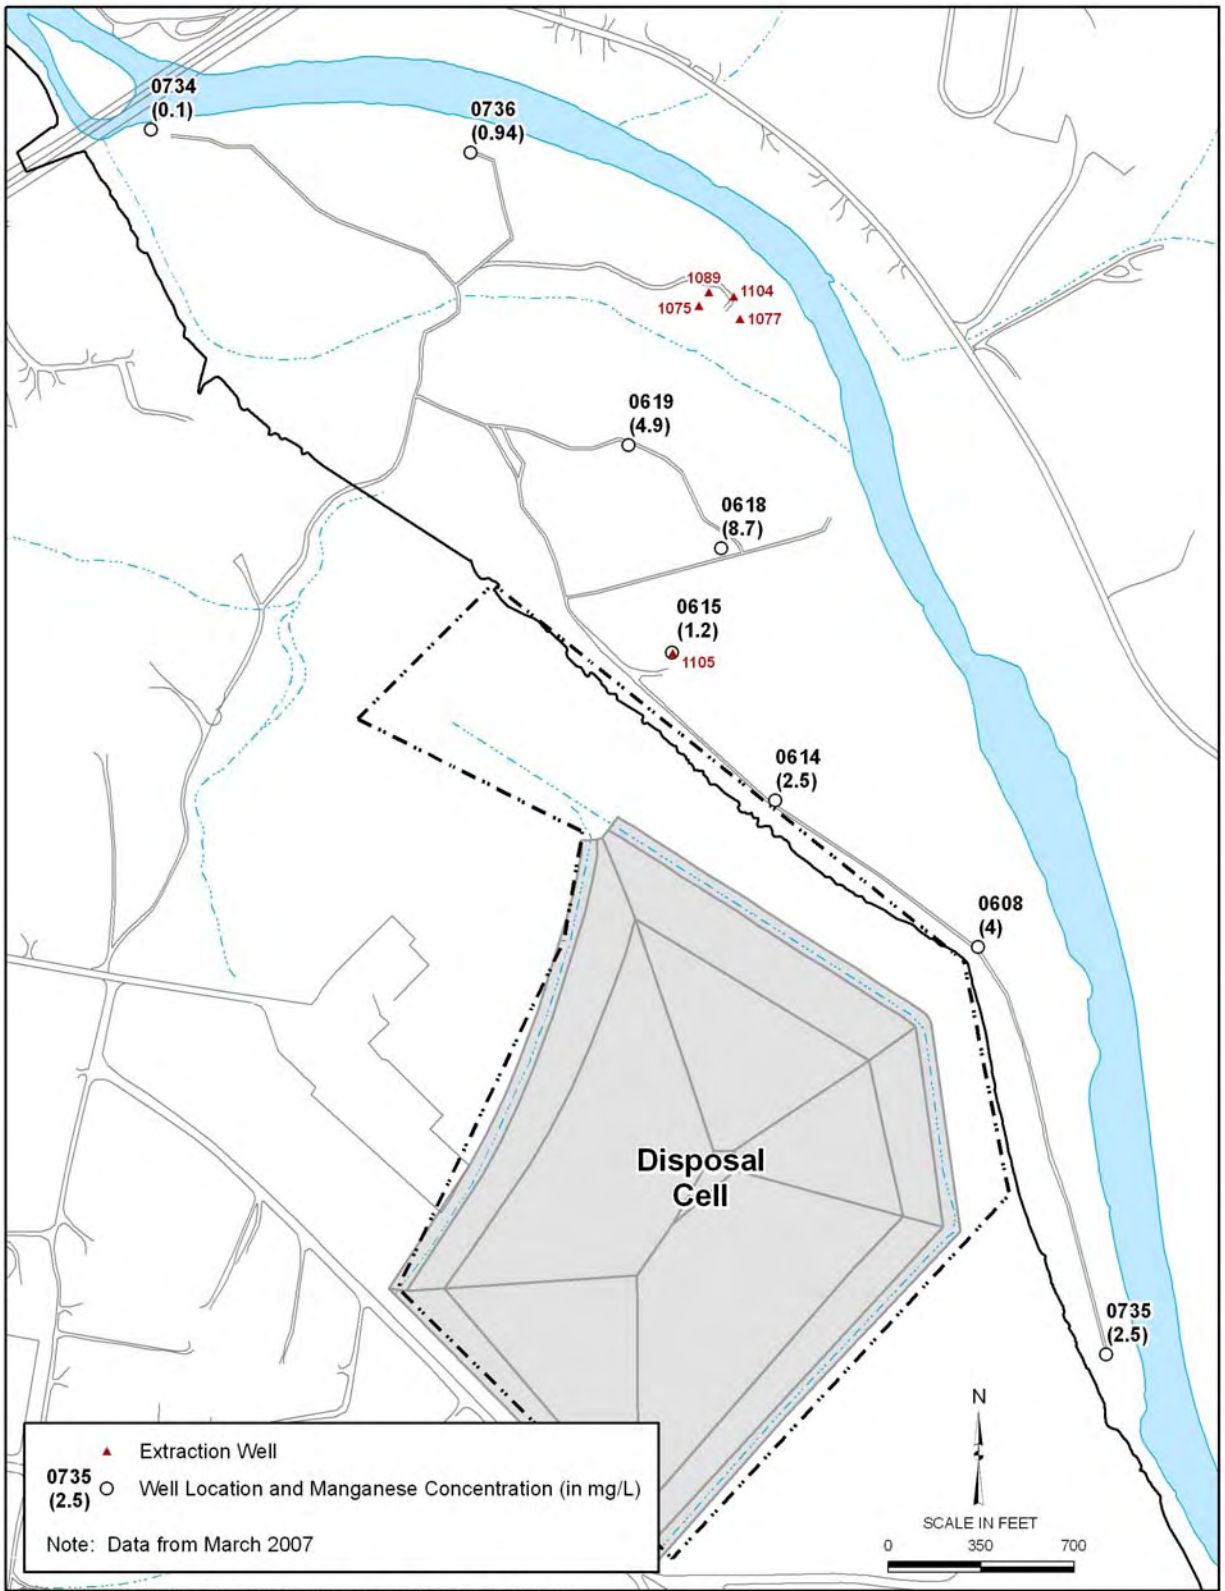
Figure 2-6. Floodplain Manganese Ground Water Concentrations

Concentrations of manganese have been variable over the past 4 years, ranging from 0.01 mg/L to 8.70 mg/L during the March 2007 sampling event (Figure 2–6). There is noticeable but inconsistent variation on a seasonal basis in some of the wells. Over the past 4 years there has been a downward trend in manganese concentrations in ground water in four of the nine wells (Figure 2–13).

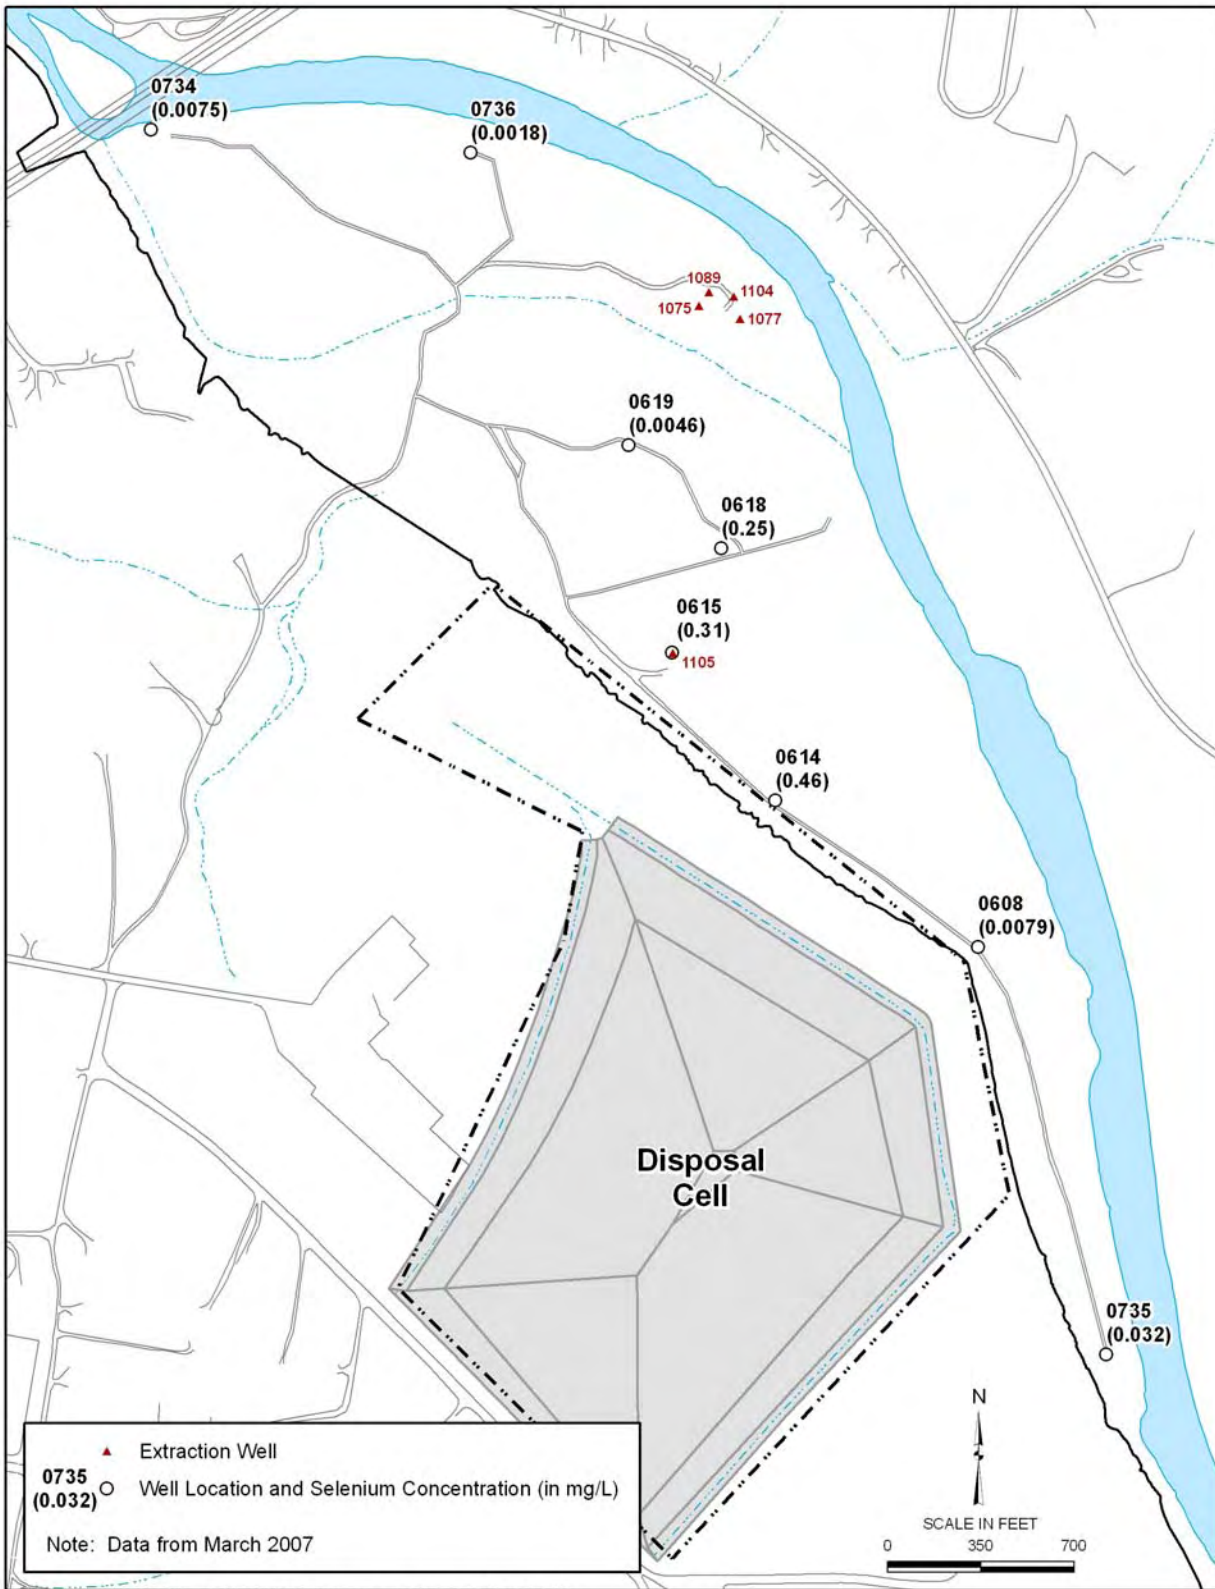
Figure 2–8. Floodplain Selenium Ground Water Concentrations

Concentrations of selenium in ground water have generally been decreasing over the past 4 years (Figure 2-8). The maximum concentration during the March 2007 sampling event was 0.46 mg/L; levels were greater than 0.05 mg/L in only three of the nine monitor wells (Figure 2-15).

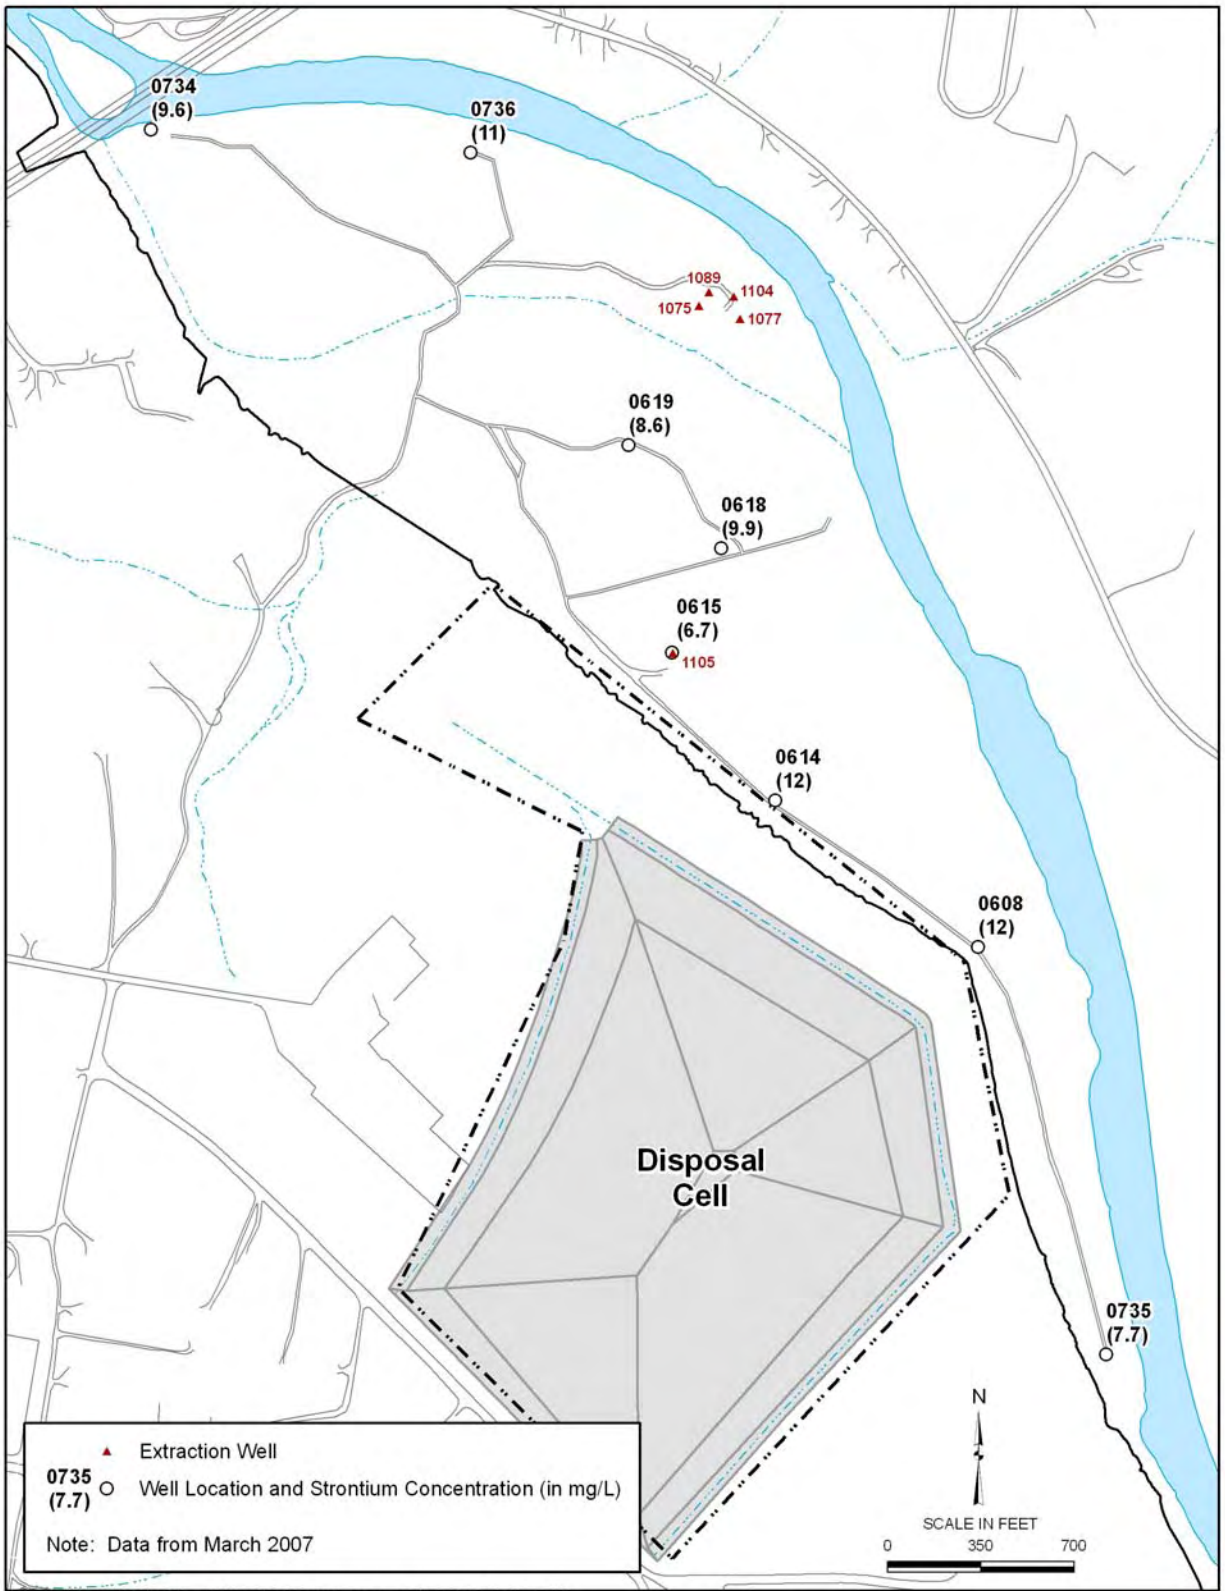
Figure 2-9. Floodplain Strontium Ground Water Concentrations

Concentrations of strontium have generally decreased over the past 4 years (Figure 2-9). Concentrations decreased or were stable in six of the nine monitor wells and ranged from less than 1 mg/L to 12 mg/L during the March 2007 sampling event (Figure 2-16).

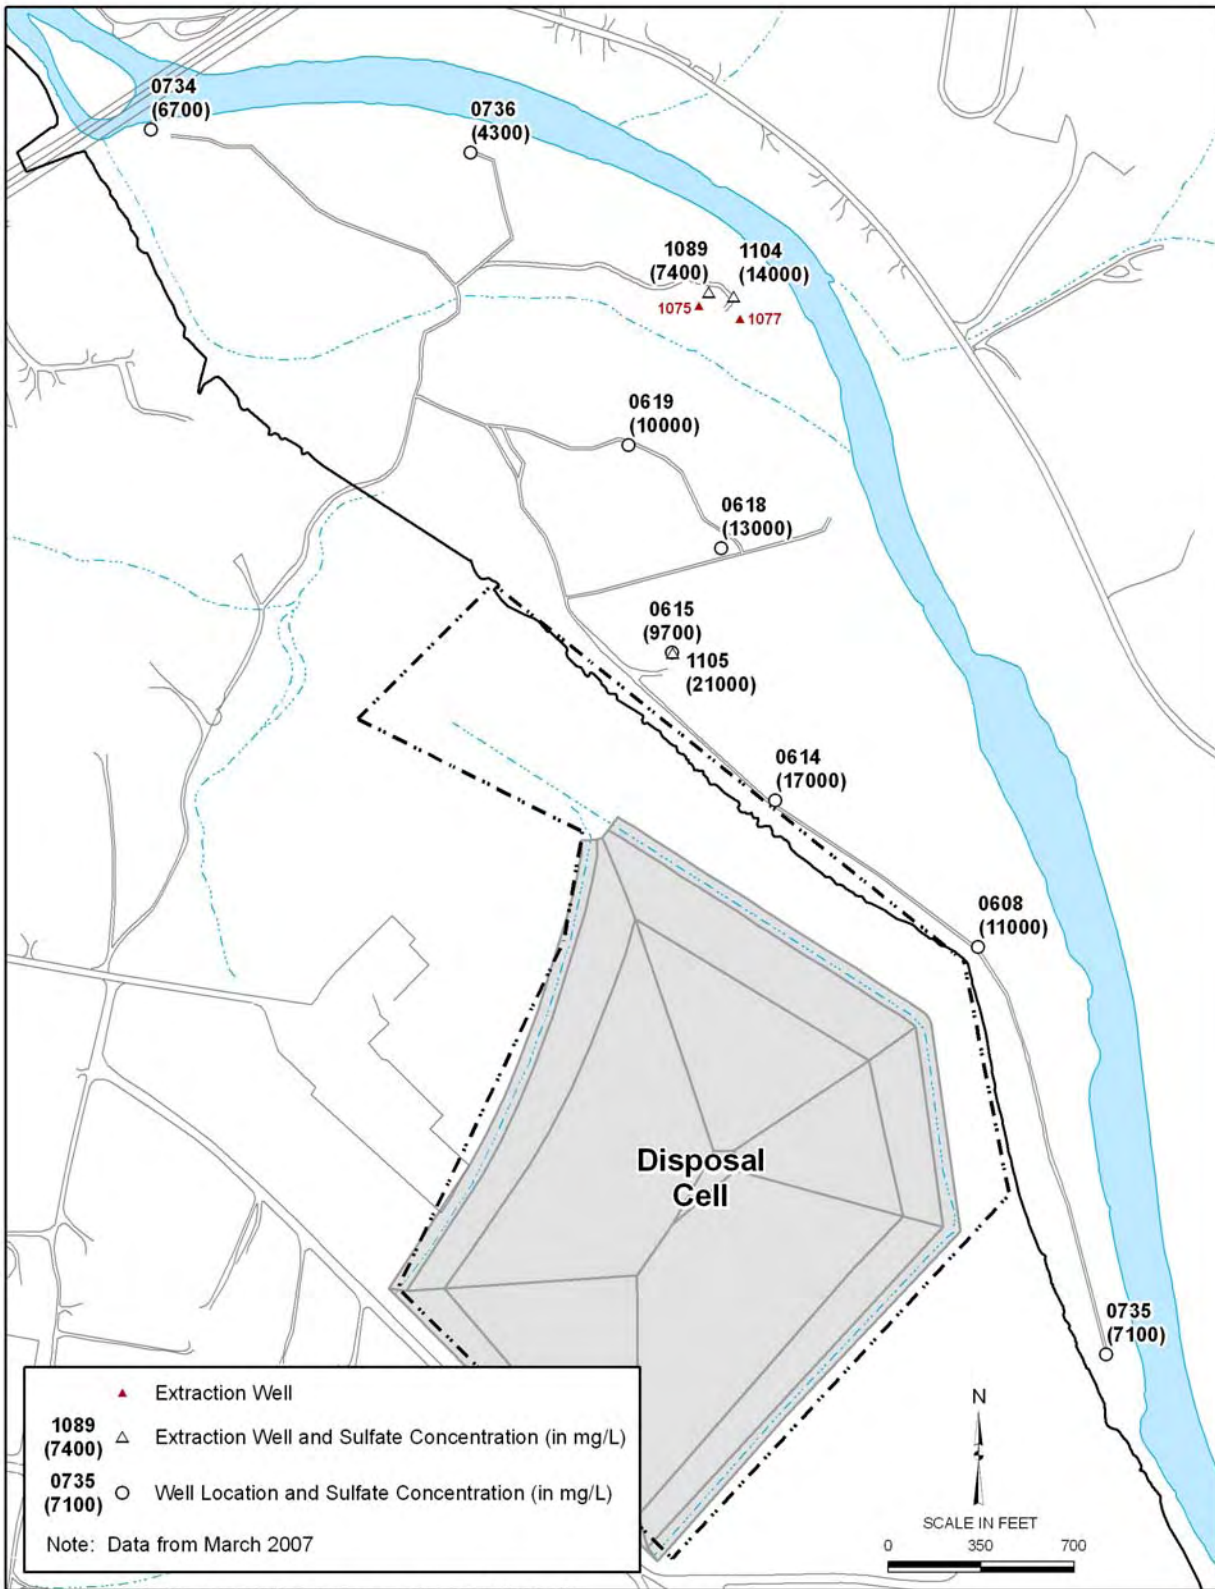
Figure 2-10. Floodplain Sulfate Ground Water Concentrations

Sulfate concentrations in ground water have generally increased over the past 4 years (Figure 2-10). Again, variability is noted in some wells with recent decreases but overall upward trends, which may be the effect of seasonal variation and interaction with surface water from the San Juan River (Figure 2-17).

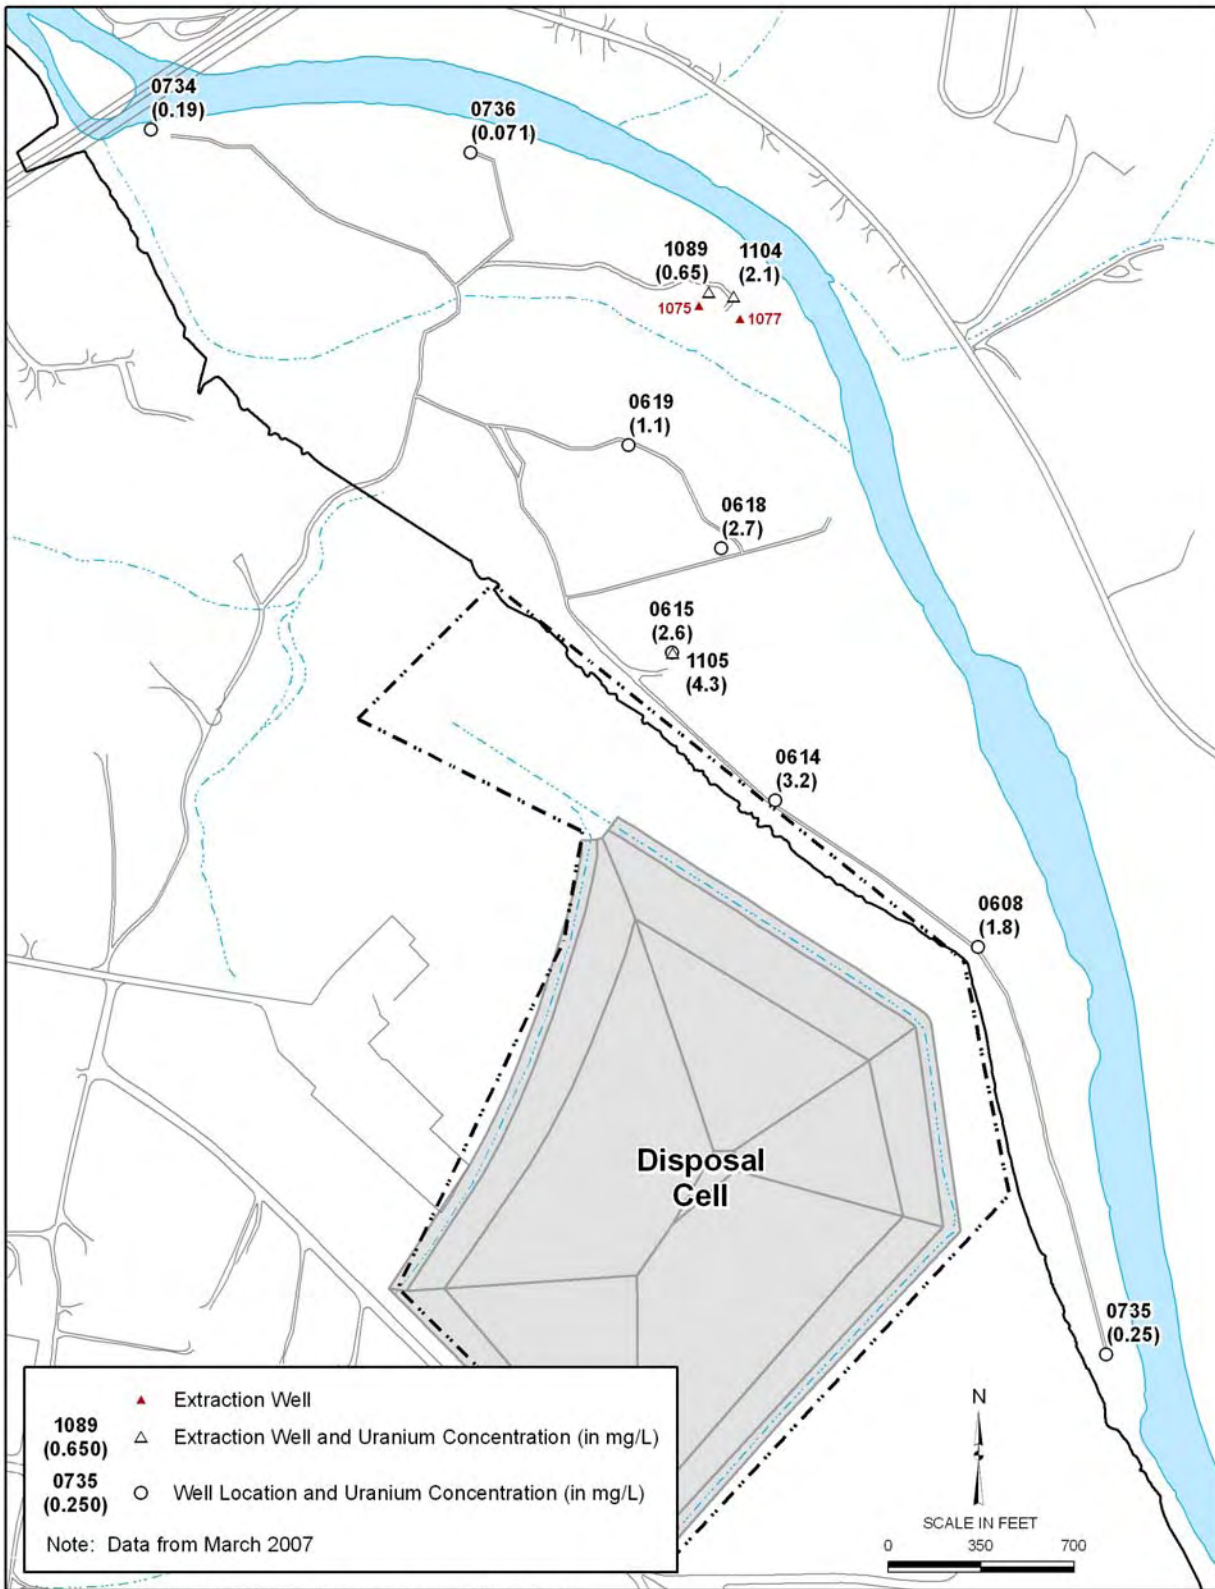
Figure 2-11. Floodplain Uranium Ground Water Concentrations

Uranium concentrations in ground water ranged from 0.071 mg/L to 3.200 mg/L during the March 2007 sampling event (Figure 2-11). Trends over the past 4 years have been variable; concentrations increased in some wells and decreased in others. Again, seasonal variations may be contrary to longer-term trends (Figure 2-18).

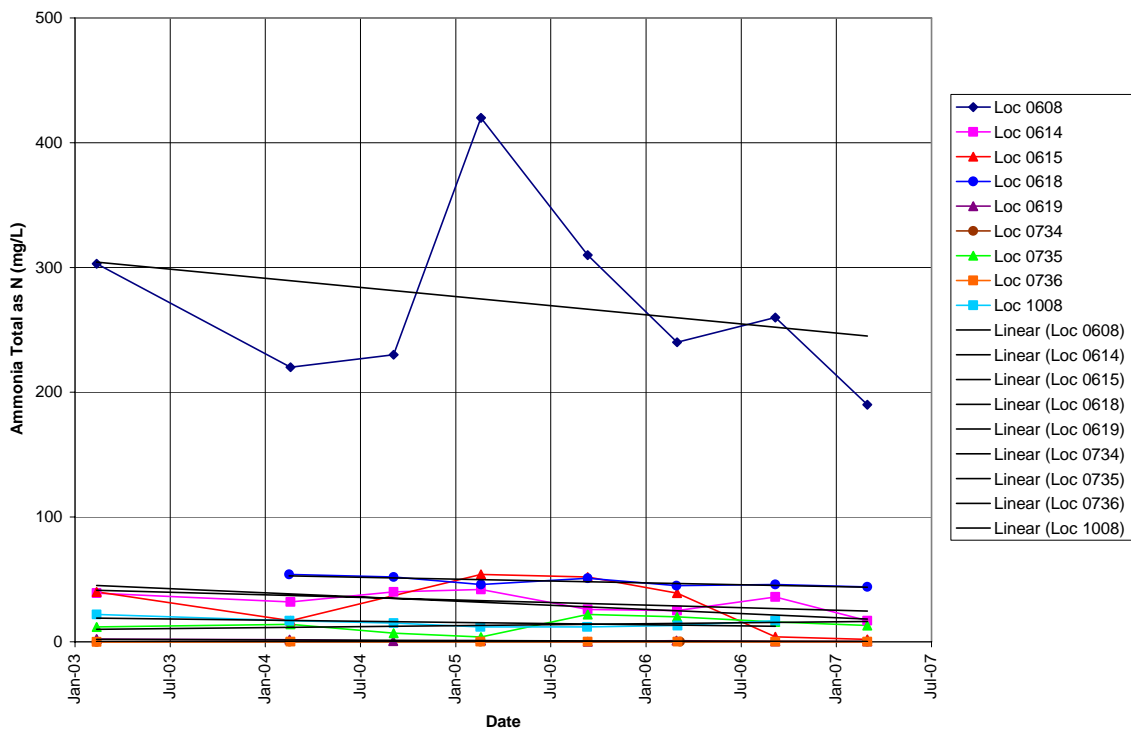
Figure 2–12. Floodplain Ammonia (Total as Nitrogen) Ground Water Concentrations Versus Time

Ammonium concentrations in ground water have generally decreased over the past 4 years (Figure 2–12). The maximum concentration in monitor well 0608 adjacent to the disposal cell has decreased from 240 mg/L to 190 mg/L over the past year; this compares with 303 mg/L in March 2003 (Figure 2–12). Concentrations in all other wells are less than 50 mg/L and generally stable.

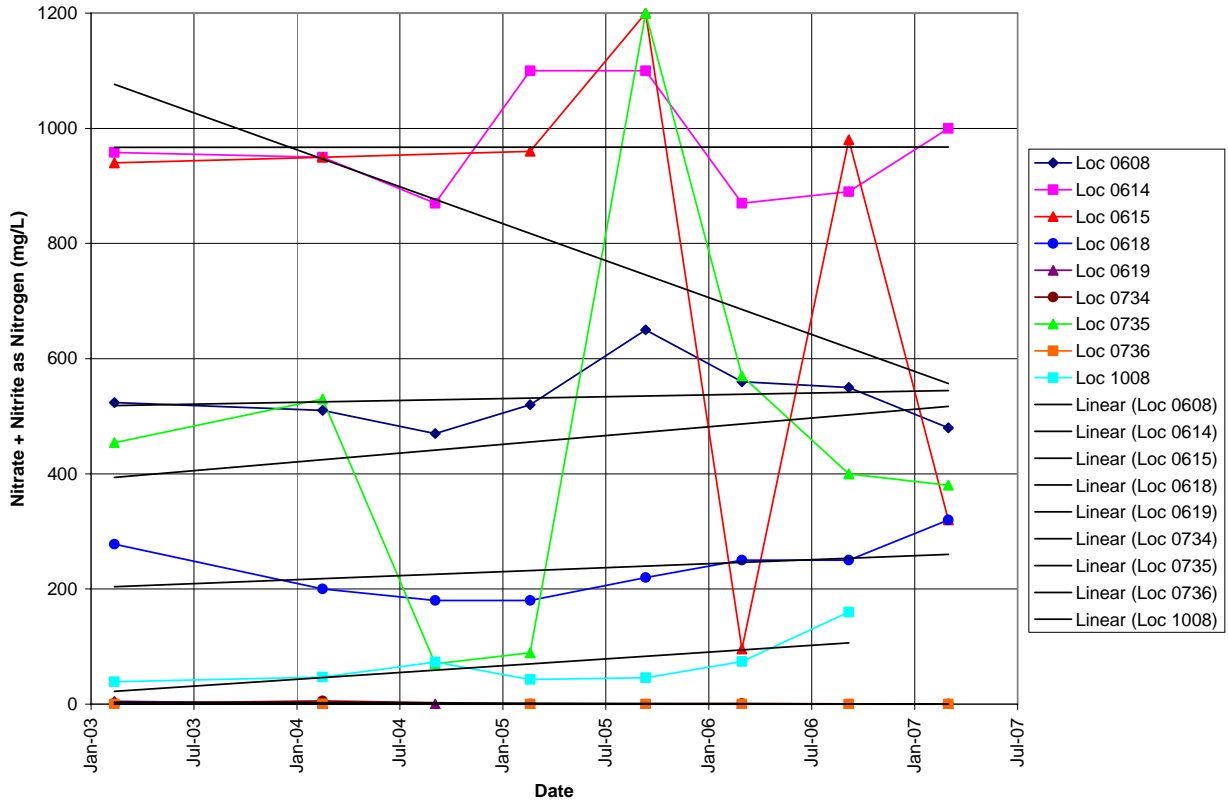
Figure 2–14. Floodplain Nitrate + Nitrite (as Nitrogen) Ground Water Concentrations Versus Time

Nitrate concentrations in ground water ranged from less than 1 mg/L to 1,000 mg/L and have increased slightly in three of the nine monitor wells over the past 4 years (Figure 2–7). Concentrations remained relatively stable at five of the locations. Again, there has been seasonal variation in some of the wells contrary to the longer-term trends (Figure 2–14).

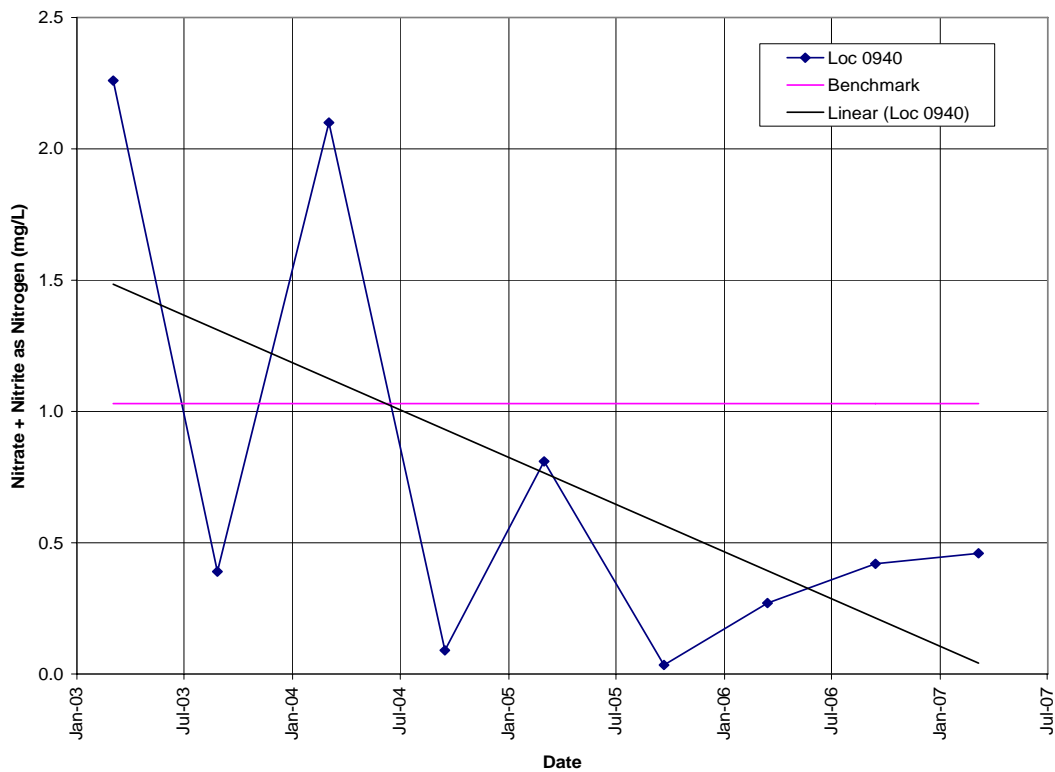
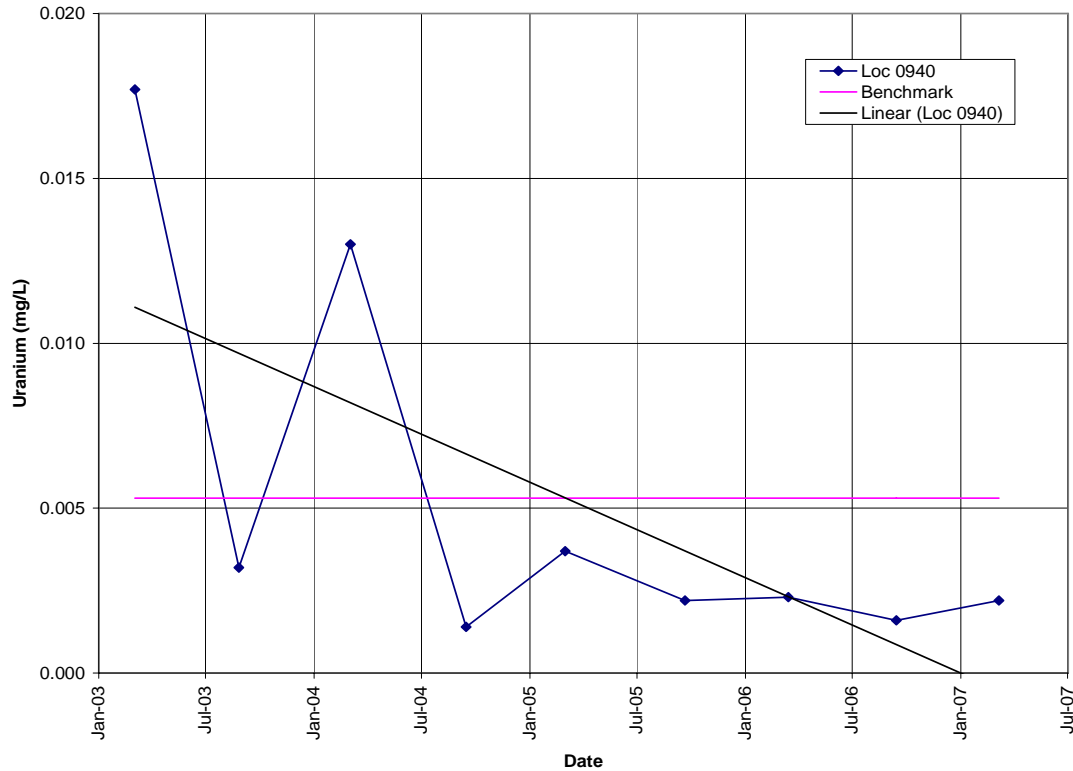
Another indication that pumping of ground water from the floodplain system is having an effect is the fact that concentrations of nitrate and uranium in surface water in the San Juan River (location 0940) have remained below the upgradient background benchmark values (statistically derived), even during low flow periods, since 2004 (Figure 2–19 and Figure 2–20).

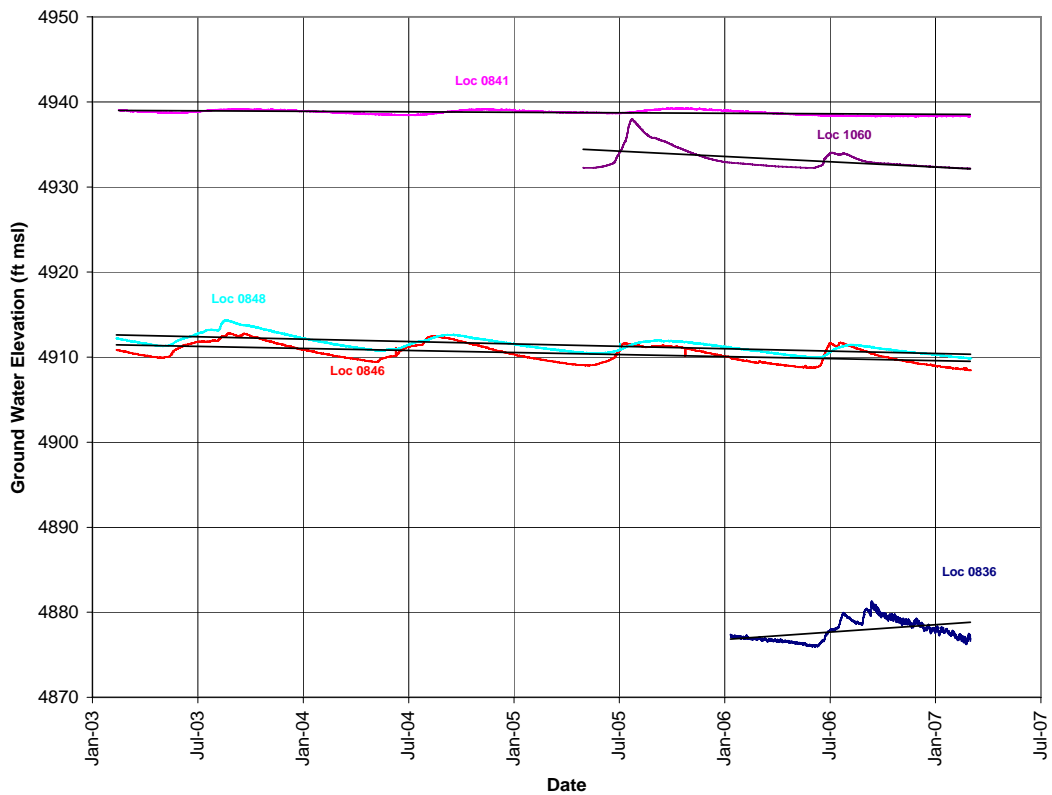
Figure 2-23. Terrace West Datalogger Ground Water Elevations

Plots of ground water elevation data versus time collected by dataloggers in terrace west wells 0836, 0841, 0846, 0848, and 1060 are shown in Figure 2–23. Although water levels have generally decreased during the past 4 years, ground water elevations are also influenced by irrigation practices in the terrace west area. Therefore, information from these dataloggers does not appear to be as relevant to assessing performance of the remediation system at the Shiprock site.

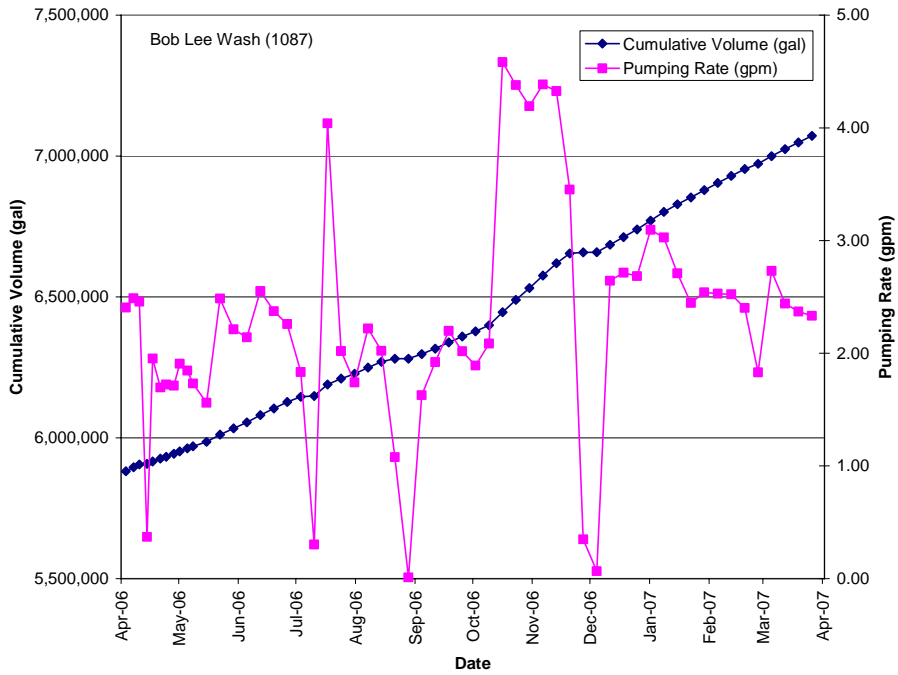
Figure 3–14. Bob Lee Wash Pumping Rate and Cumulative Ground Water Volume Extracted

Extraction rates and cumulative flow volumes for the pump installed in the Bob Lee Wash (location 1087) drain are presented in Figure 3–14. During the current performance period, the average pumping rate from Bob Lee Wash was 2.27 gpm, and approximately 1,191,000 gallons of water were removed by the ground water interceptor drain.

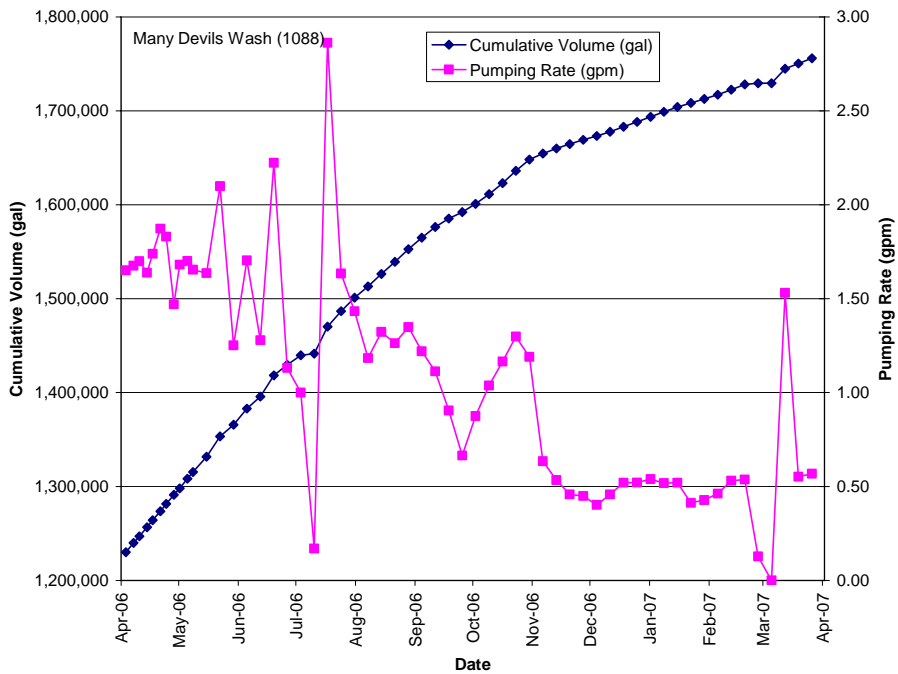
Figure 3–15. Many Devils Wash Pumping Rate and Cumulative Ground Water Volume Extracted

The pumping rates and volume of water removed from the ground water interceptor drain in Many Devils Wash (location 1088) are presented in Figure 3–15. During the current performance period, the average pumping rate from Many Devils Wash was 1.09 gpm, and approximately 526,000 gallons of water were removed by the ground water interceptor drain.
