2010 Review and Evaluation of the Shiprock Remediation Strategy

January 2011

U.S. DEPARTMENT OF
ENERGY

Legacy
Management

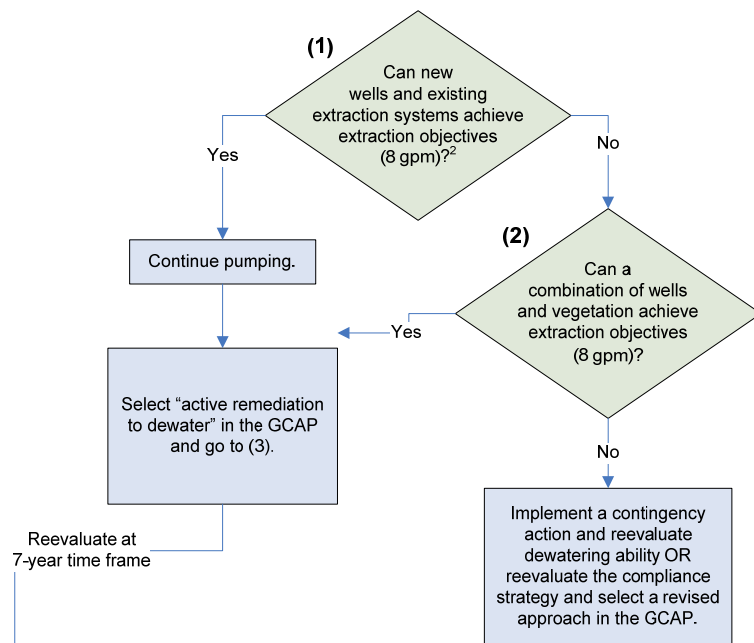
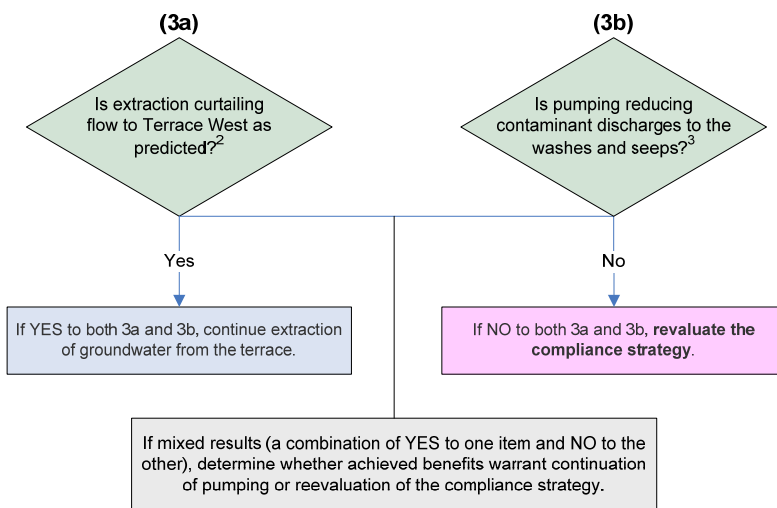
Terrace Decision Process
 Source: DOE 2005 (Addendum 1, Exhibit 1)

- As of October 2010, despite expansion of the extraction system, the 8 gpm objective has not been achieved. For the last 2 years, total combined terrace extraction rates have been about 2 gpm, well short of the 8 gpm goal.
- Although the 8 gpm extraction objective has not been attained, progress has been made in terms of the overall dewatering objective (see below). The extent to which this is due to pumping or other influences (e.g., cessation of irrigation on the west terrace and/or drought conditions) is not clear.

- Although it is premature to evaluate the long-term decision endpoints at this time, some interim observations can be made:
- As shown in Figure 5, water levels have declined, particularly in the western portion of the terrace. However, the extent to which flow to the west terrace has been "curtailed" is not clear.

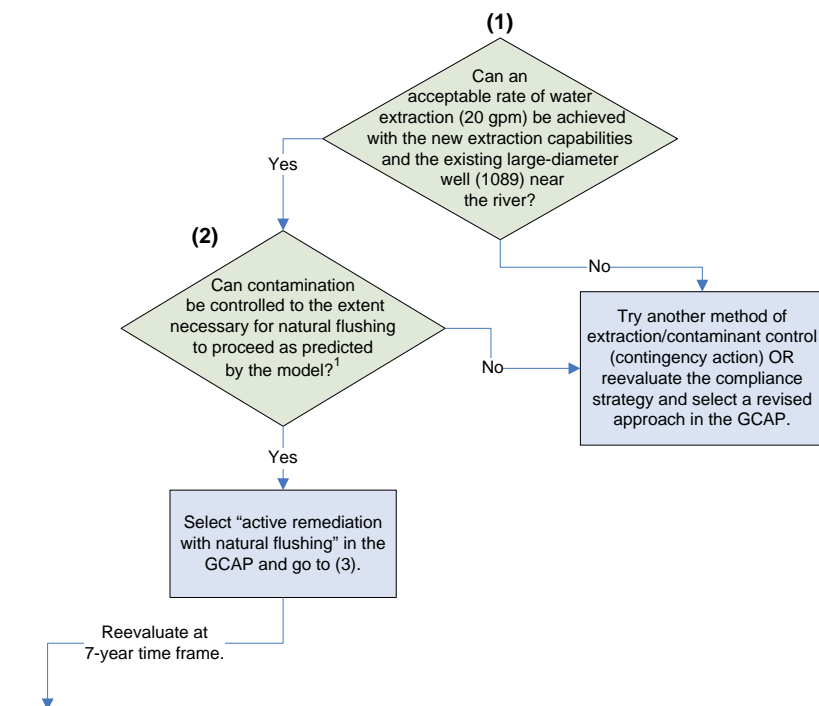
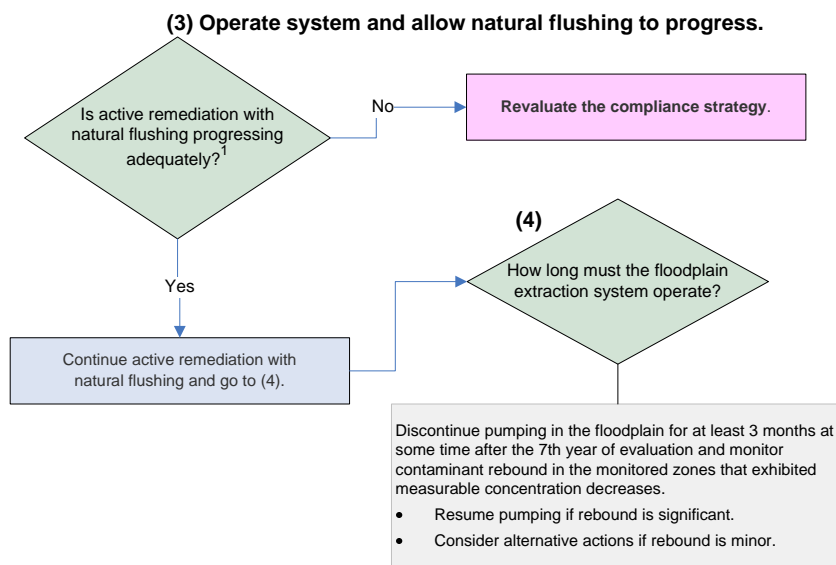
Floodplain Decision Process
 Source: DOE 2005 (Addendum 1, Exhibit 2)

- At the time this decision matrix was developed, it was recognized that wells 1089 and 1104 were not meeting objectives. In 2006, DOE installed two trenches at the base of the escarpment to improve extraction rates. The 20-gpm rate is now being achieved.
- Decreases in contaminant concentrations (uranium, sulfate, nitrate) are apparent in a number of floodplain wells (DOE 2009a).
- In large part, because of the two trenches, progress has been made in terms of extraction rates and contamination control.

- Although it is premature to evaluate the long-term decision endpoints at this time, some interim observations can be made:
- Significant declines in contaminant concentrations are evident in trench area wells.
 - Contaminant concentrations in well 1089 area are variable, and no clear conclusions can be drawn at this time.
 - Although studies are ongoing, the trenches appear to be effective in extracting contaminated water from the floodplain and reducing contaminant concentrations in nearby groundwater (DOE 2009c).

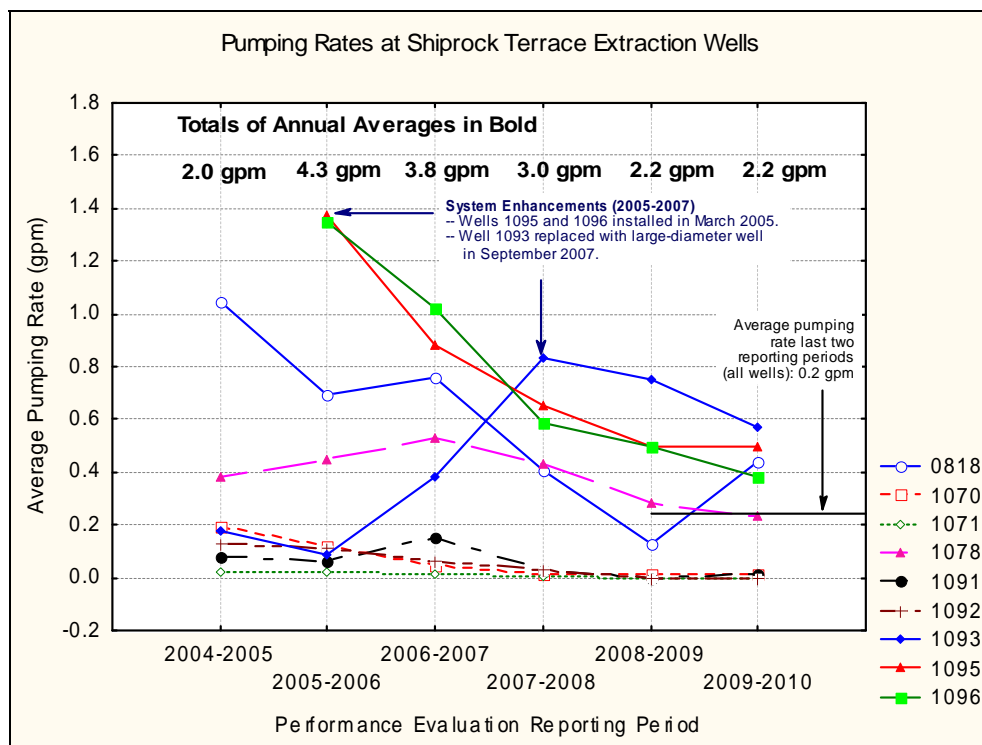
Figure 4. Pumping Rate Summary for Terrace Extraction Wells

As recommended in the Conceptual Model Report, DOE expanded the terrace extraction well network between 2005 and 2007. Two new wells (1095 and 1096) were installed near the evaporation pond in March 2005, and in September 2007, DOE installed a new large-diameter well (1093R) to increase the probability of collecting a larger volume of water (see Attachment 1). As of September 2010, despite expansion and enhancement of the terrace extraction system, the 8 gpm objective has not been achieved. The combined pumping rate from terrace extraction wells has ranged between 2 and 4 gpm since remediation started (2 gpm in the last 2 years), well short of the 8 gpm objective (Figure 4).

Since 2005, DOE has also redeveloped several wells on the terrace to improve well yields. These and other well restoration methods proved ineffective. During pumping tests performed in 2008, the wells evaluated in the immediate vicinity of the current system did not produce enough water to justify adding any additional infrastructure.

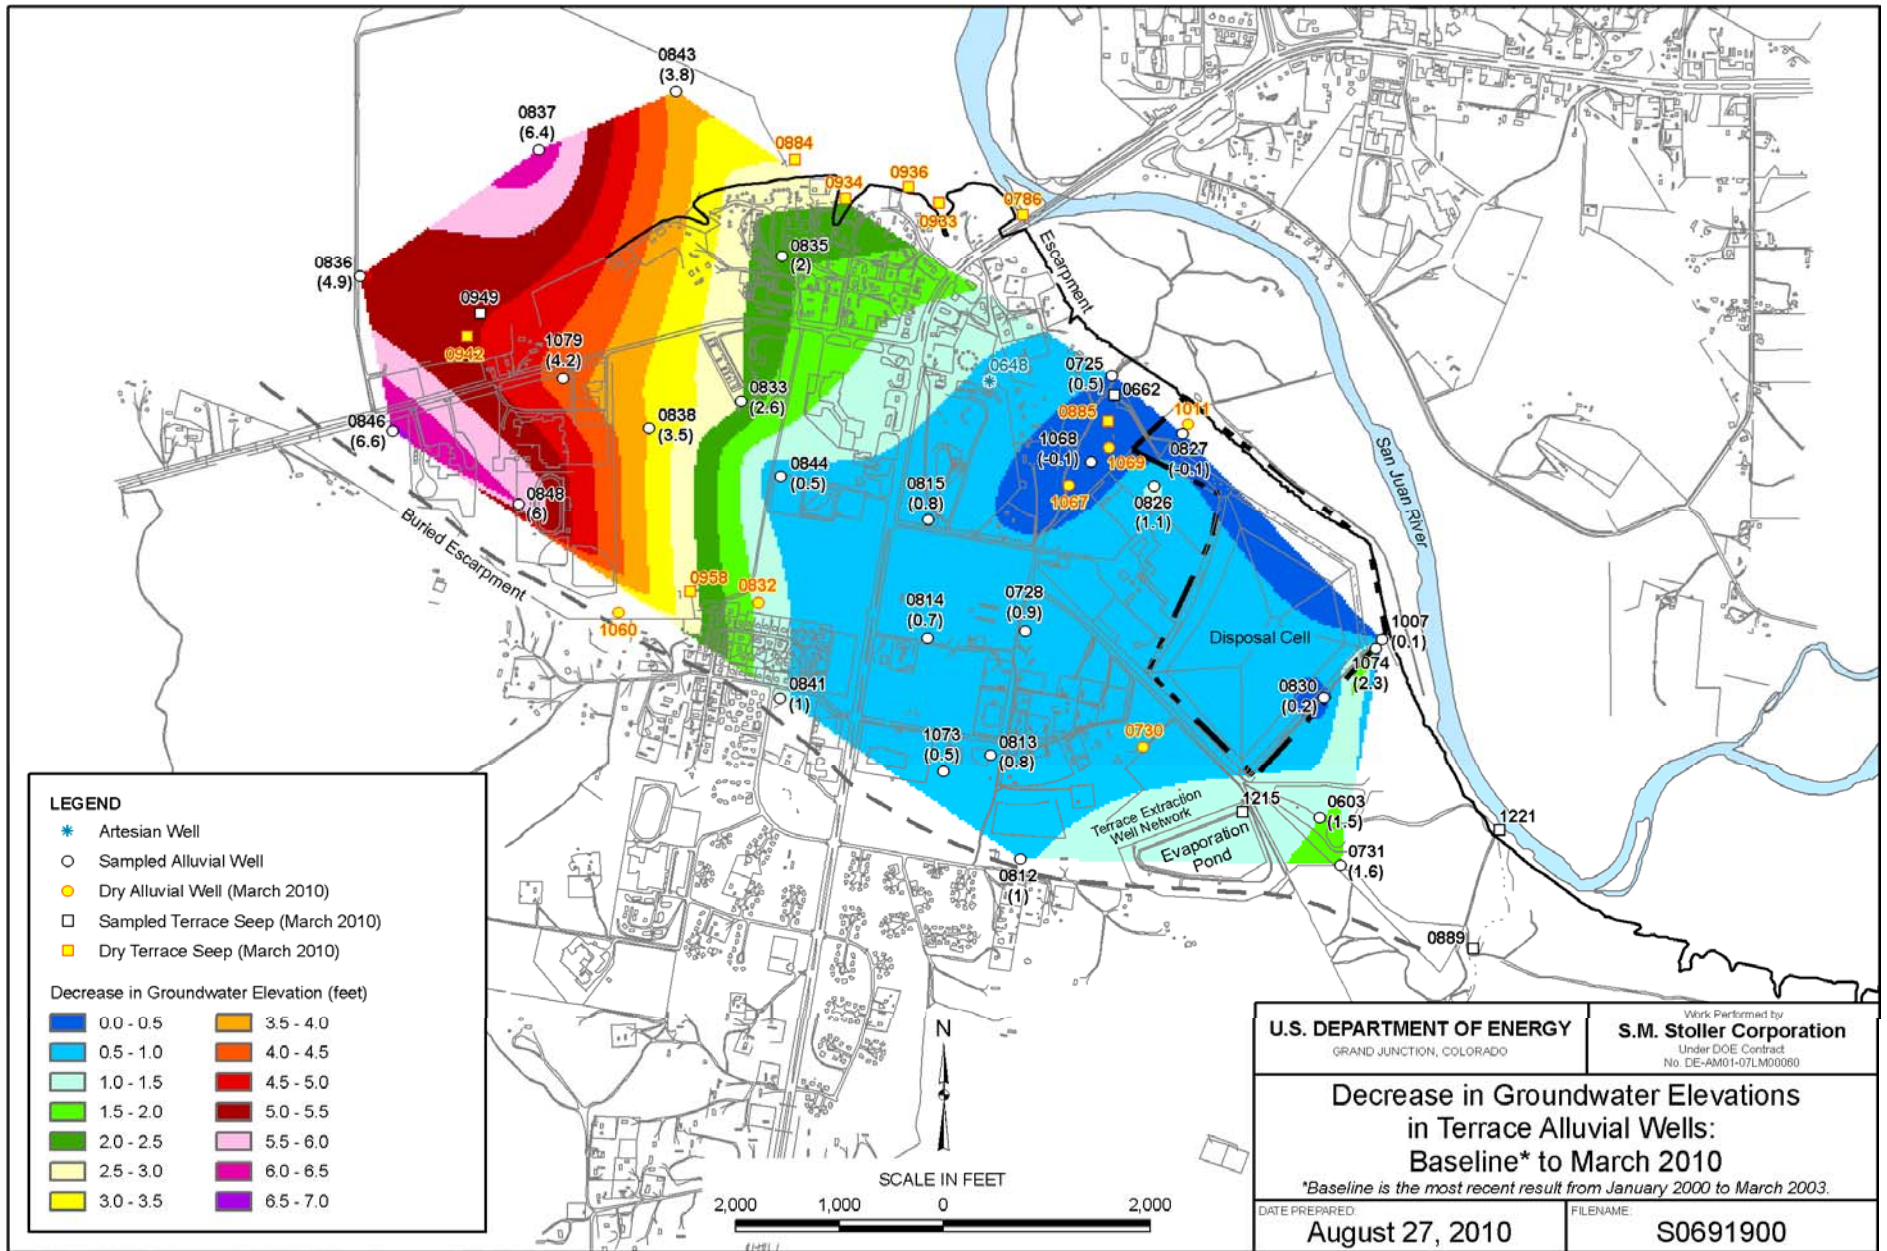
Figure 5. Decrease in Groundwater Elevations in Terrace Alluvial Wells (March 2003—March 2010)

- As shown in Figure 5, water levels on the terrace declined, particularly in the western portion of the terrace. Groundwater elevations measured in 26 groundwater wells in March 2010 have decreased relative to the baseline period of January 2000 to March 2003. A corresponding decrease in flow from seeps along the floodplain and in areas of the western portion of the terrace has also been observed. However, the extent to which flow to the west terrace has been curtailed is not clear.

- Despite the water level declines and drying of seeps noted above, no significant decline in contaminant concentrations is apparent at terrace monitoring locations.

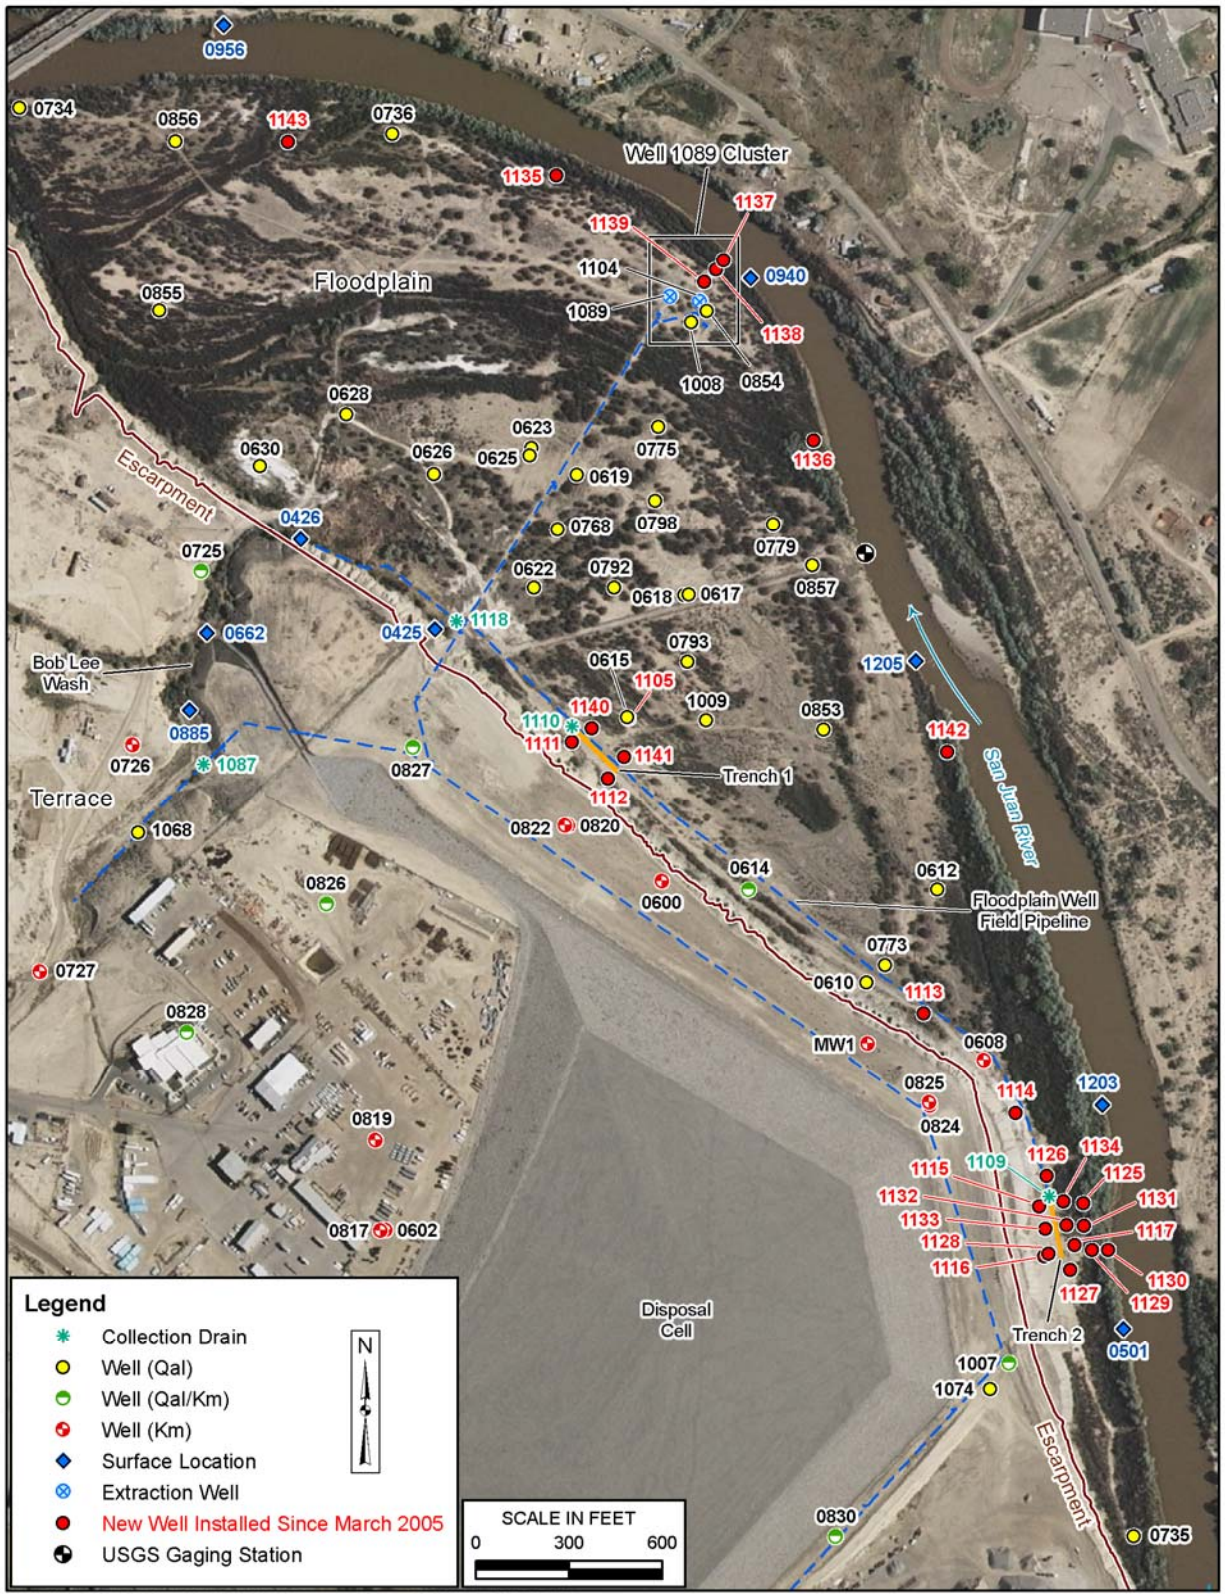
Figure 6. Subset of Shiprock Sampling Network Showing Floodplain Wells Installed Since 2005

DOE issued a report in March 2009 that evaluated the effectiveness of the Trench 2 remediation system in the southern part of the floodplain (DOE 2009c). The trench and the horizontal collection well installed in it are located near the base of the Mancos Shale escarpment.

The report concludes that the Trench 2 remediation system has met its design objectives, which are to:

The report shows that much of the success of the Trench 2 remediation system can be attributed to its ability to induce inflow of river water into the alluvial aquifer underlying the floodplain. Accordingly, the freshwater zone created between the trench and the river consists almost solely of river-derived water. Observed decreases of contaminant concentration in groundwater lying between the trench and the Mancos Shale escarpment since pumping at the trench began suggest that river water is also drawn into this area, diluting the water discharging across the escarpment.
