16.0 Shiprock, New Mexico, Disposal Site

16.1 Compliance Summary

The Shiprock, New Mexico, Uranium Mill Tailings Radiation Control Act (UMTRCA) Title I Disposal Site was inspected on June 16, 2010. The disposal cell and all associated surface water diversion and drainage structures remained in good condition and were functioning as designed.

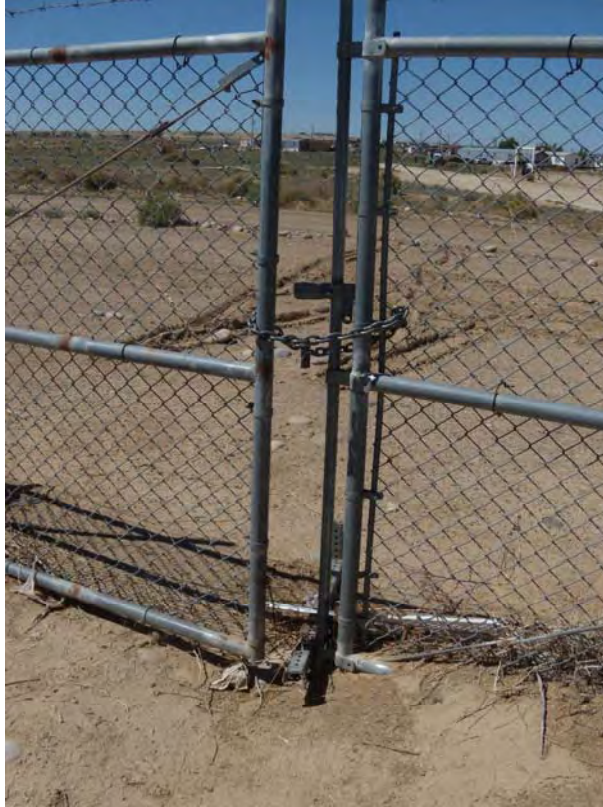
All three vehicle access gates—the main entrance gate at the east corner of the site (near the terrace escarpment); the gate providing terrace access at the northwest corner of the site, and the former entrance gate at the west corner of the site—were locked, intact and functional. However, the former entrance gate at the west corner had a 6-inch gap between its vertical poles that could allow passage of a small child (PL–1). This gap will be repaired. Two entrance sign pairs are placed near the main entrance gate and two are placed near the former entrance gate. One pictorial sign was missing at the former entrance at the west corner of the site. The remaining entrance signs were in good condition and had decals listing correct telephone numbers for DOE and the Navajo AML/UMTRA Office.

SHP 6/2010. PL-1. Vertical gap approximately 6 inches wide in west access gate.

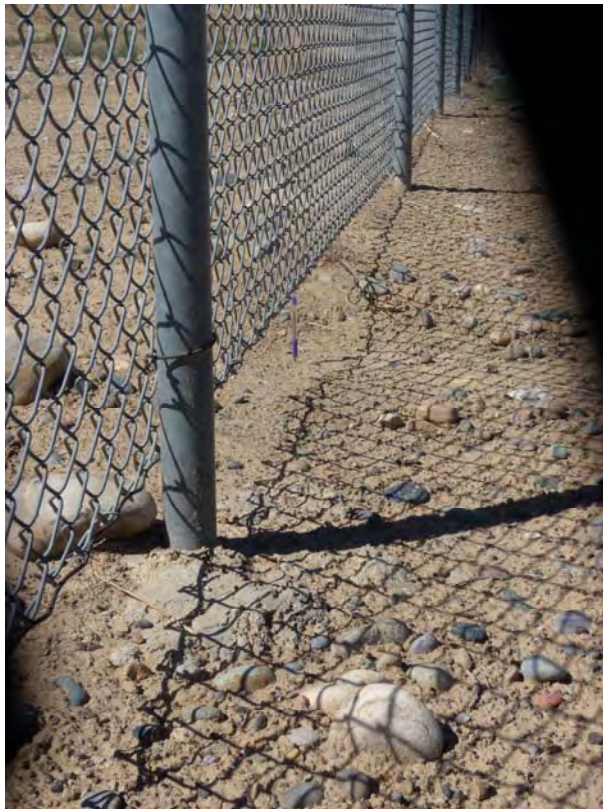
16A There are gaps beneath the fence, most formed by animals, along the site perimeter. Two six-inch gaps were identified near perimeter sign P3 (PL–2), between perimeter signs P4 and P5, and between perimeter signs P14 and P15. These gaps, like the gap in the west entrance gate, could provide access to children, who live and play immediately west of the site. Therefore, these gaps will be filled.

SHP 6/2010. PL-2. Two- six-inch gaps under fence near P3.

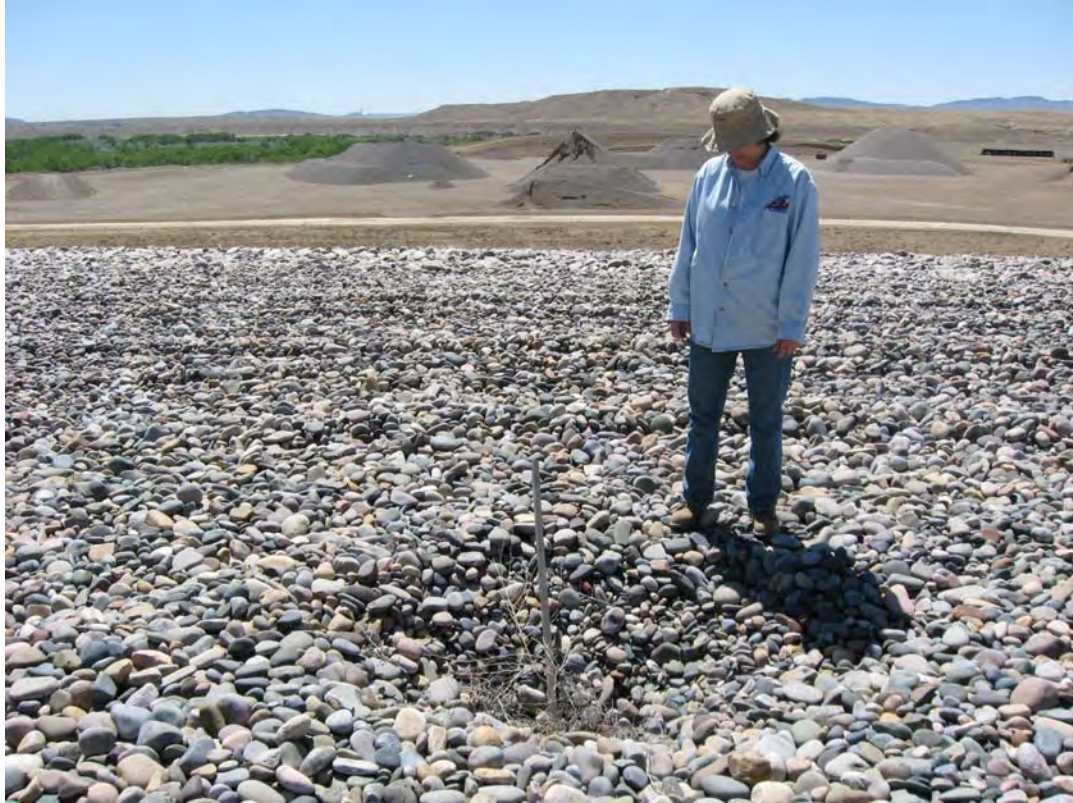
Disposal Cell, Diversion Channels, and Outflow Channel—The riprap-covered top and side slopes of the cell are in good condition; no evidence of settling or slumping was found. A conical depression was identified along the southeast edge of the disposal cell cover (PL-3). Since the 2009 inspection, several similar conical depressions have been found, but these appear to be vestiges of test pits dug for initial cell cover studies. Although no displacement of materials is apparent in these areas, these depressions will be measured and monitored in the future, and

follow-up actions will be taken if necessary. The depressions were mapped during the 2010 inspection with a Global Positioning System (GPS) unit and pit locations are shown on Figure 16–1. The condition of the historical test pits will continue to be monitored during future annual inspections.

SHP 6/2010. PL-3. Historical test pit on disposal cell cover .

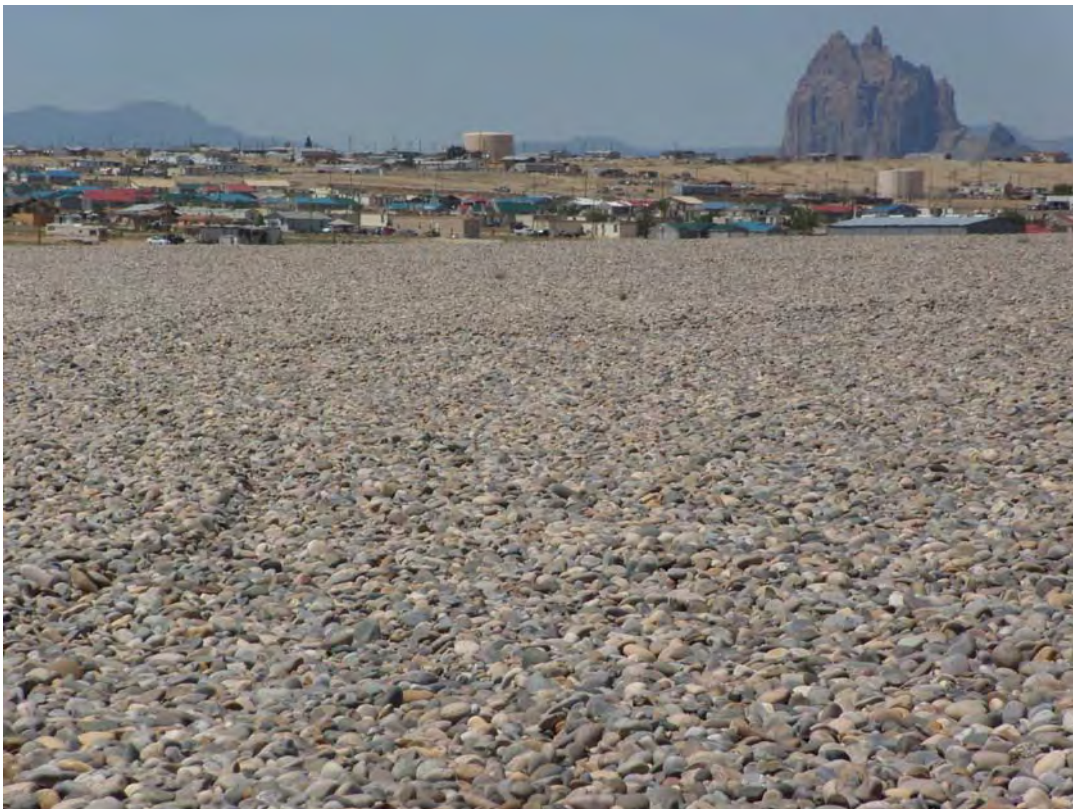
Vehicle ruts are apparent on the surface of the cell (PL–4); these ruts were probably formed in the fall of 2008 during vegetation spraying. This treatment was effective, as all vegetation on the cell cover and in the diversion channels and outflow channel was dead at the time of the 2010 inspection.

SHP 6/2010. PL-4. Disposal cell cover showing vehicle ruts and dead vegetation.

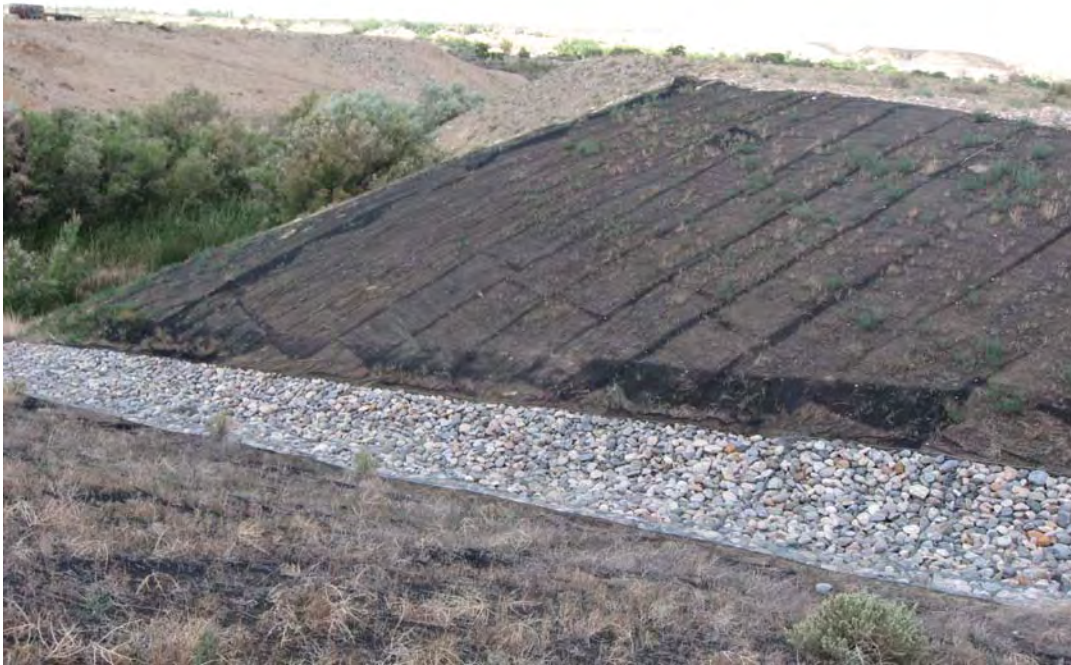
Site drainage is ultimately directed toward the outflow channel at the northwest corner of the site. The outflow channel was reconstructed in 2003 to repair damage caused by severe storms in 2001 and 2002, and an energy dissipation basin was constructed immediately above Bob Lee Wash. An erosion area along the southwest bank of the off-site portion of the outflow channel, fully repaired in 2008, was in good condition. The lower, steeper portion of the off-site outflow channel and the energy dissipation structure also remained in good condition. However, erosion control fabric installed on the side slopes of the lower channel had come loose along one edge; this section of fabric requires repair (PL–5).

SHP 6/2010. PL-5. Loose erosion fabric on slope of hill above outflow channel.
